***City of Molalla
Clackamas County, Oregon***

I/I FLOW MAPPING

MARCH 2018

Project No. 100.26

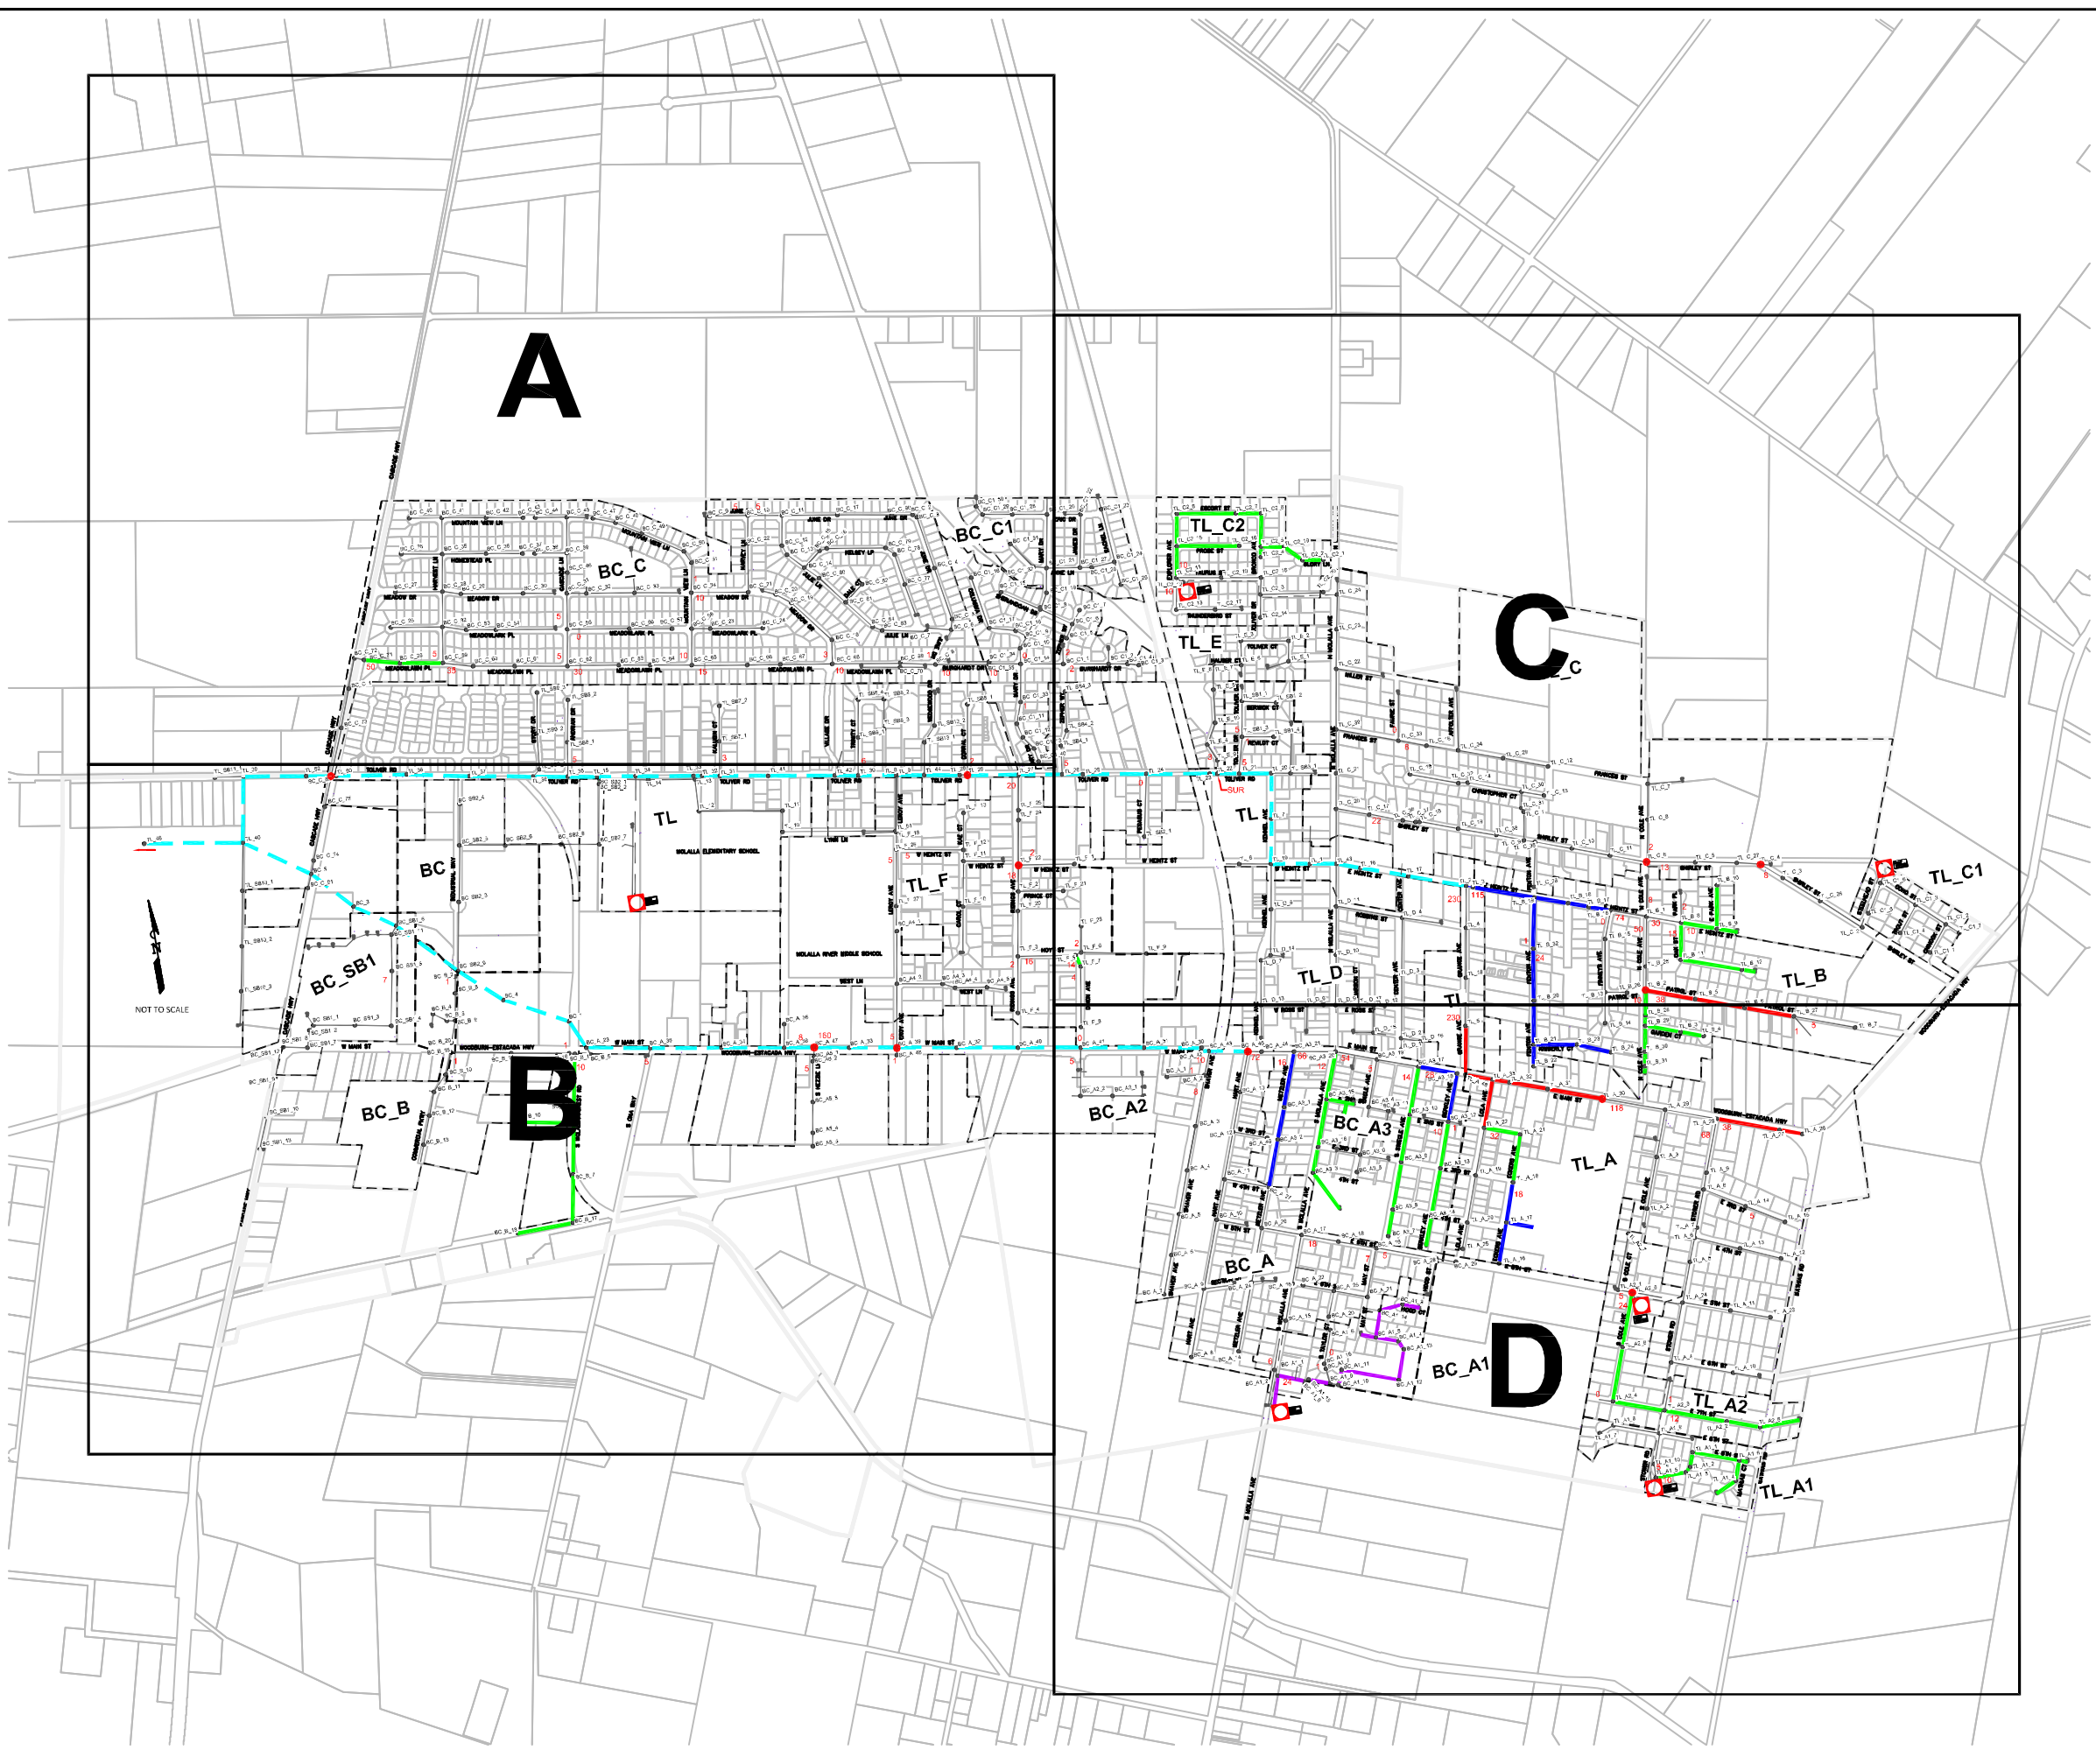
APPENDIX A: KEY MAP

Flow mapping results, using the City's existing collection system map, are provided in the Appendices. Appendix A is a Key Map indexing the locations of the flow maps provided in Appendix B. Appendix B includes Figures A, B, C, and D. Line segments have been color coded to illustrate the approximate I/I flow that was measured and recorded.
