# CITY OF MOLALLA

## SMOKE TESTING REPORT

OCTOBER 2017

**Project No. 100.26**

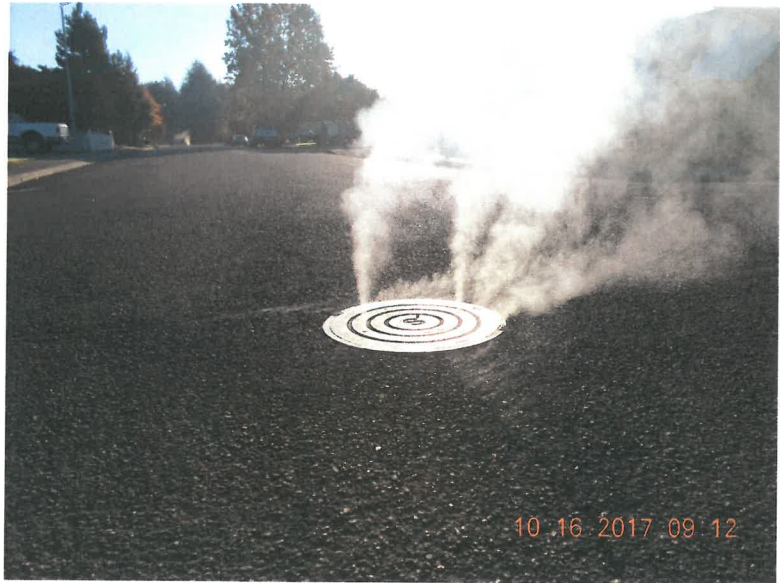
- Smoke coming from around the ring and the cracks in the road next to the manhole.
- 
- 
- 
-

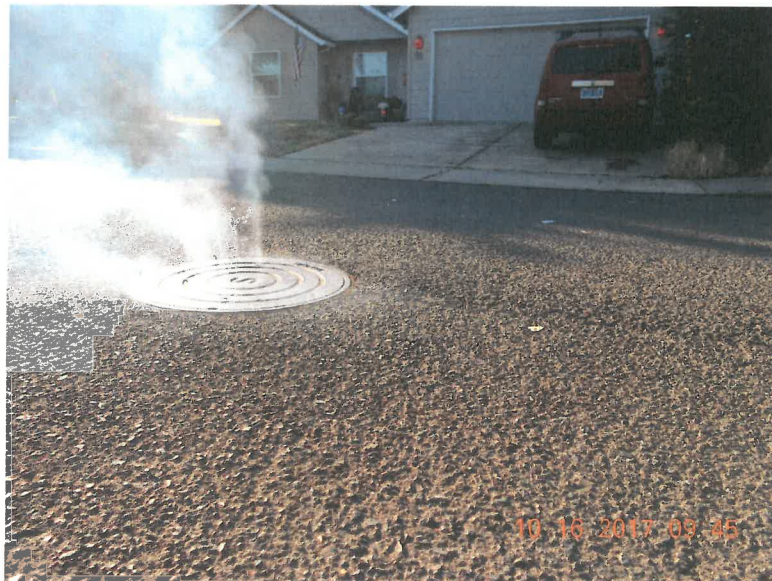
- Smoke coming from around the ring and the cracks in the road next to the manhole.
- 
- 
- 
-

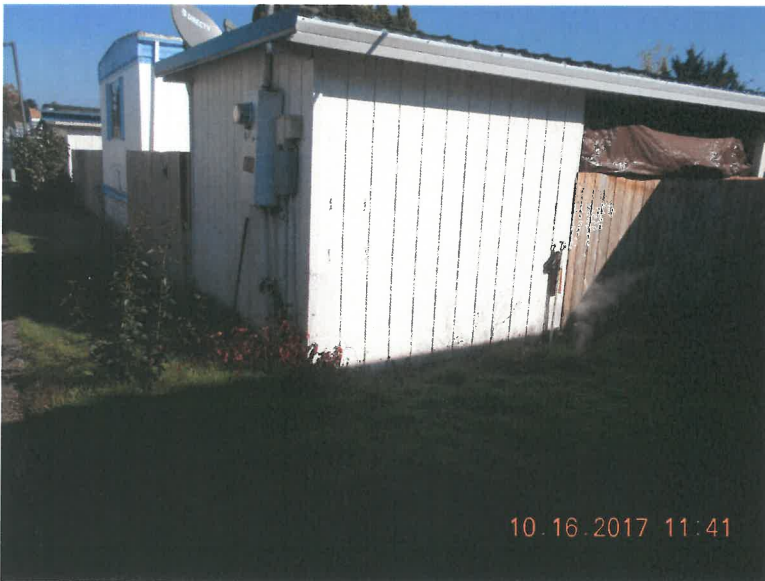
- Located at Unit #723 of Twin Firs Mobile Home Park
- Smoke coming from open cleanout, located behind the shed
- Smoke coming out of broken cleanout cap on the side of the shed
- 
-

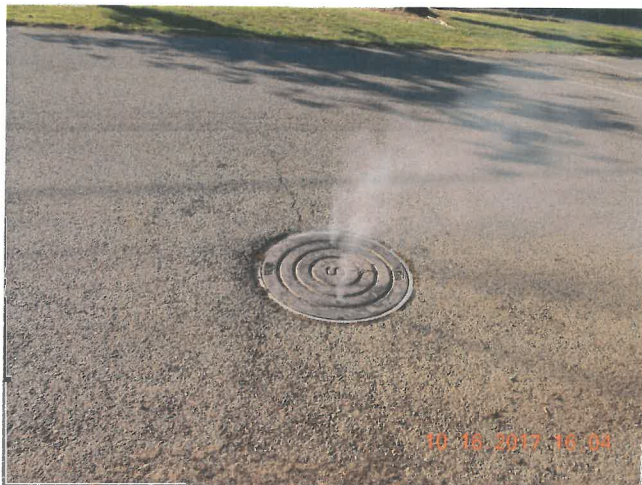
- Little bit of smoke leaking around the rim
- 
- 
- 
-

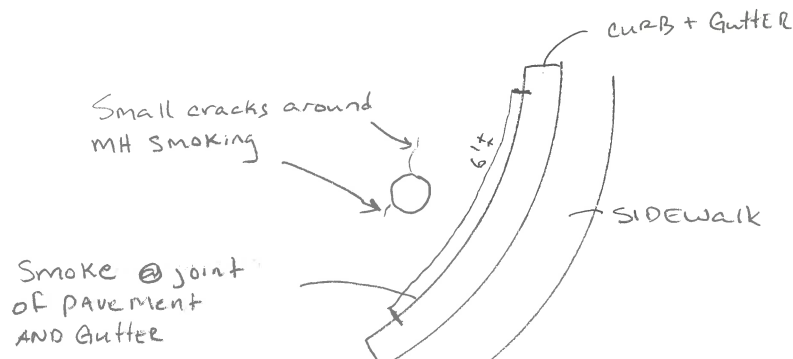
- Smoke leaky out around the rim of the manhole, the cracks in the road around the manhole and along the joint between the ac pavement and concrete gutter
- 
- 
- 
-

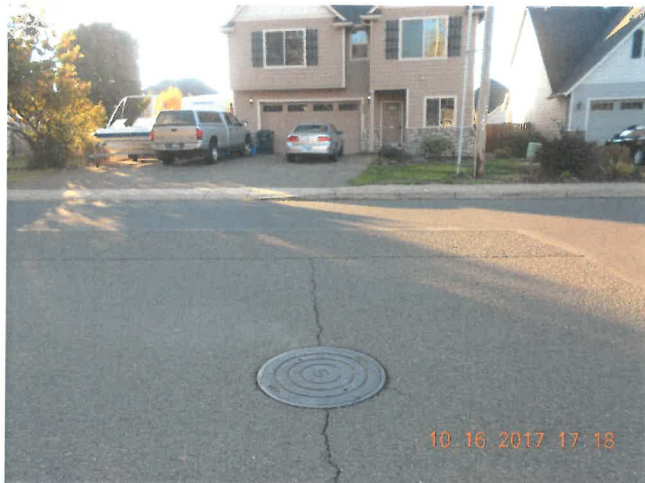
- Smoke leaking slightly around the rim of the manhole
- 
- 
- 
- 
-

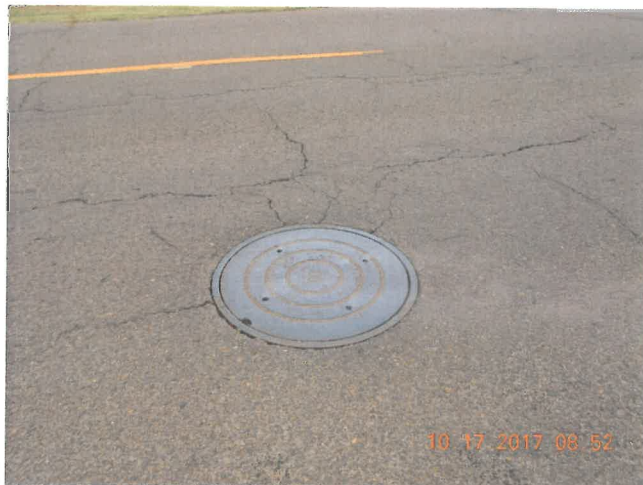
- Smoke leaking around rim of manhole
- 
- 
- 
-

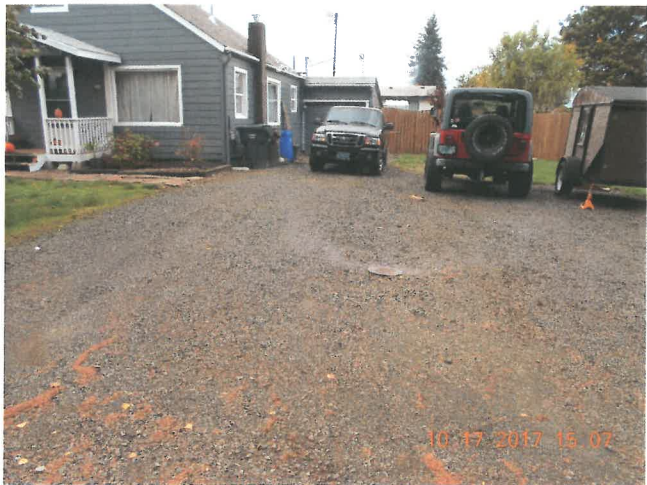
- Smoke leaking around the cleanout cap
- 
- 
- 
-

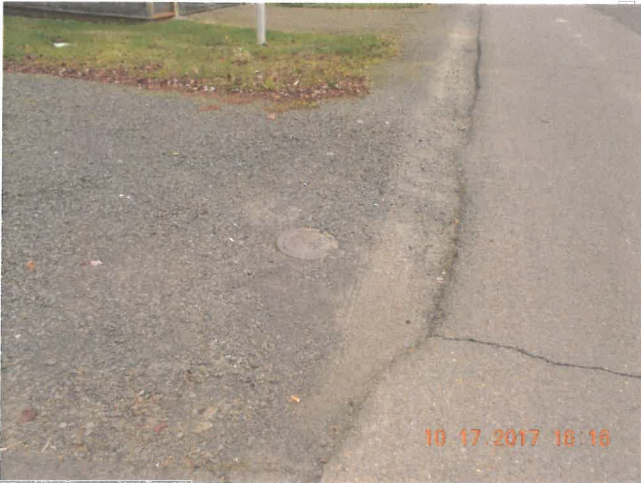
- 1. Smoke leaking around cleanout cap
- 2. Smoke coming out of irrigation valve box
- 3. Smoke coming out of cleanout with no cap
- 
-

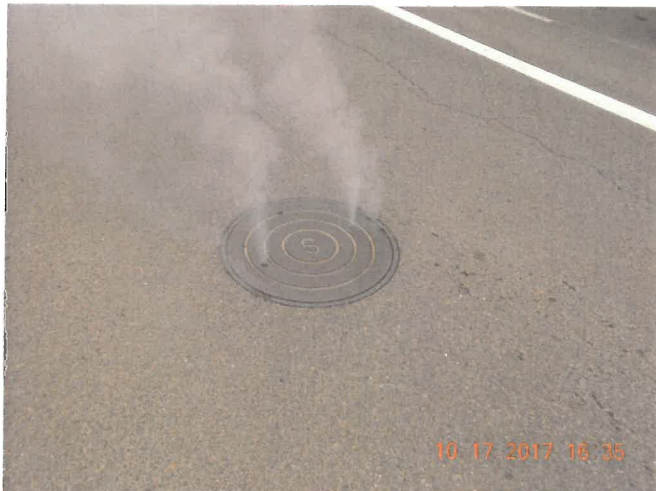
- Smoke leaking around rim of manhole
- 
- 
- 
-

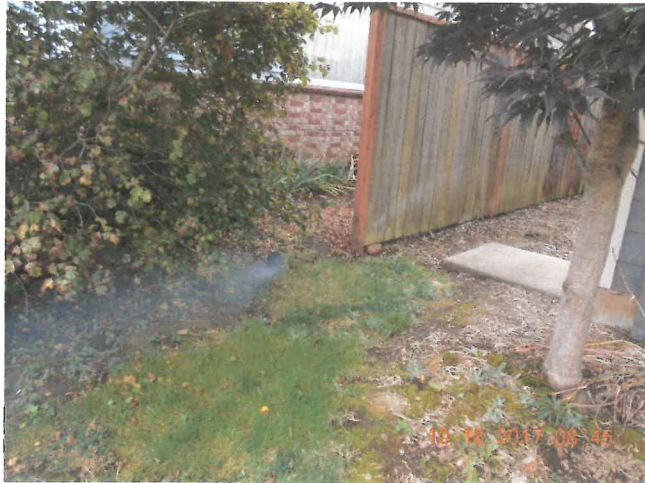
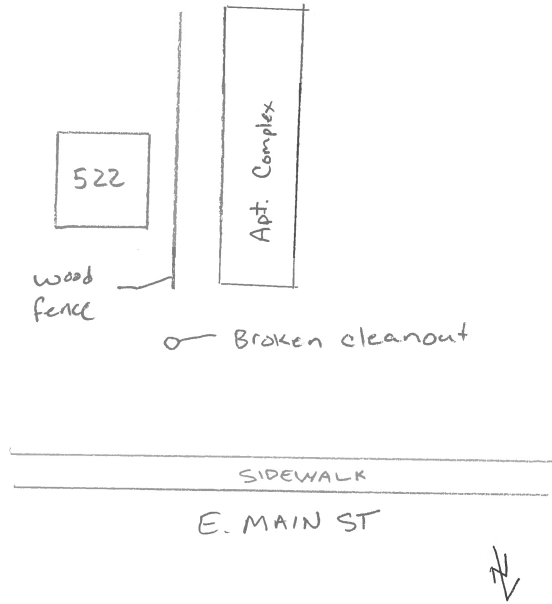
- Smoke coming out of broken cleanout
- 
- 
- 
- 
-

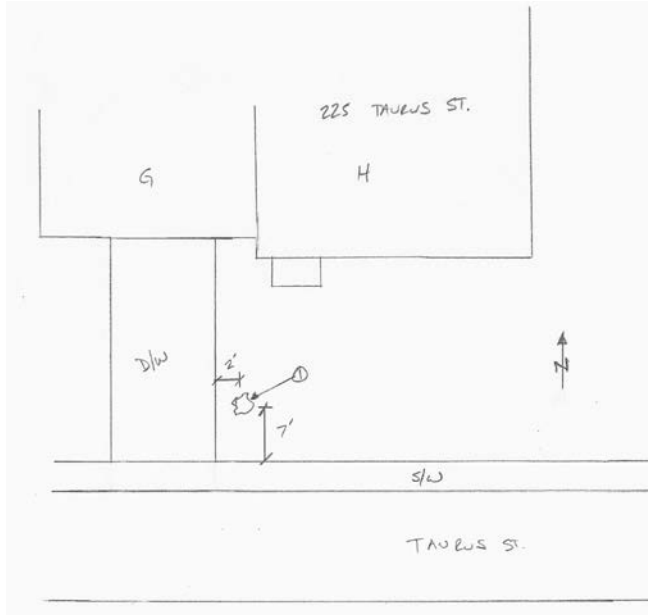
- Smoke in front yard, just east of driveway edge. No cleanout found in area of smoke.
- 
- 
- 
- 
-

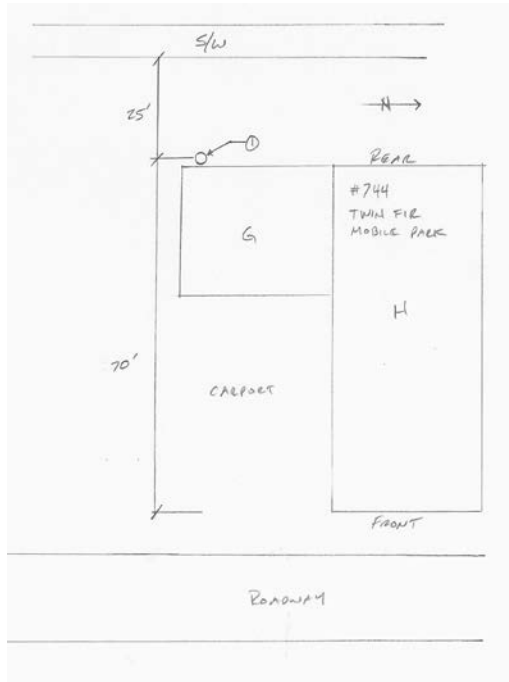
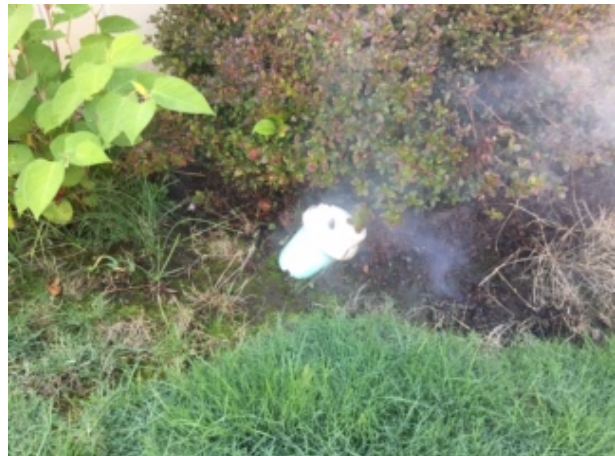
- Broken sewer cleanout cap behind garage.
- 
- 
- 
-

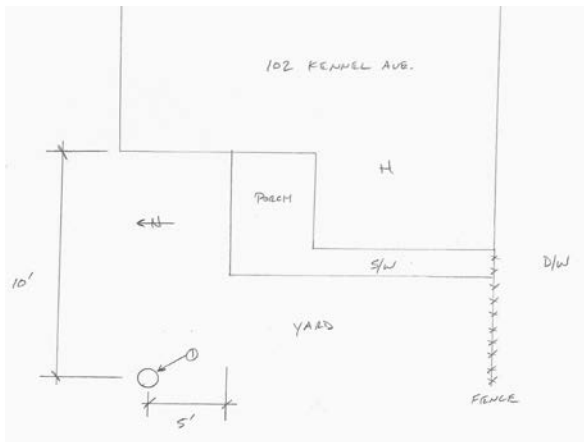
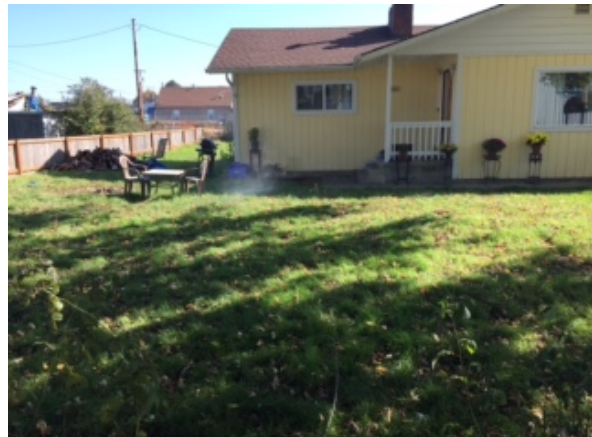
- Broken sewer cleanout cap in front yard.
- 
- 
- 
-

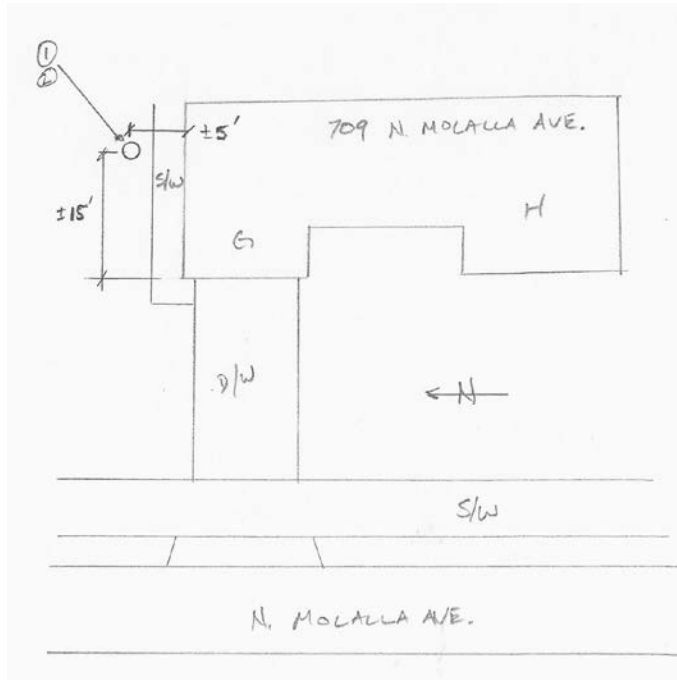
- Broken cleanout cap on north side of garage, adjacent to concrete sidewalk.
- 
- 
- 
- 
-

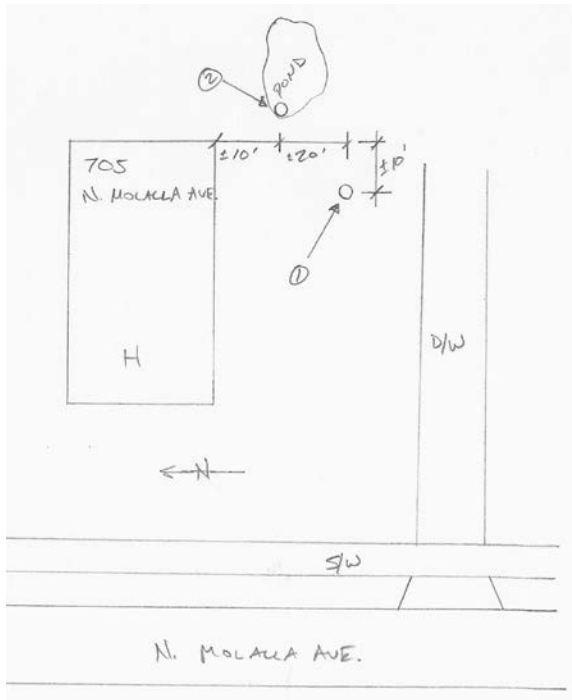
- Broken cleanout cap on south side of house, between house and driveway.
- Smoke from landscape pond overflow pipe. Pond is southeast of house.
- 
- 
-

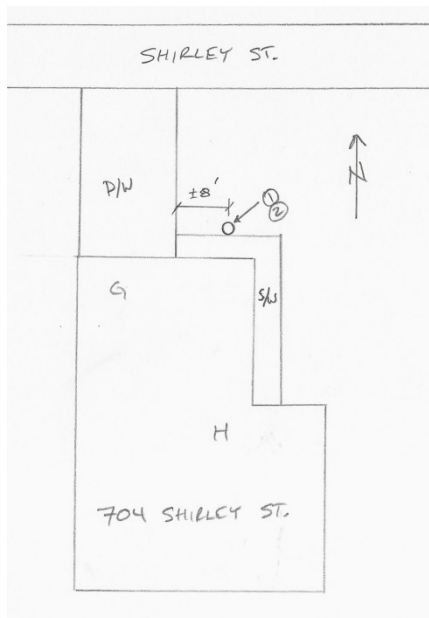
- .Smoke from broken cleanout cap, located next to concrete walkway, under planter.
- 
- 
- 
- 
-

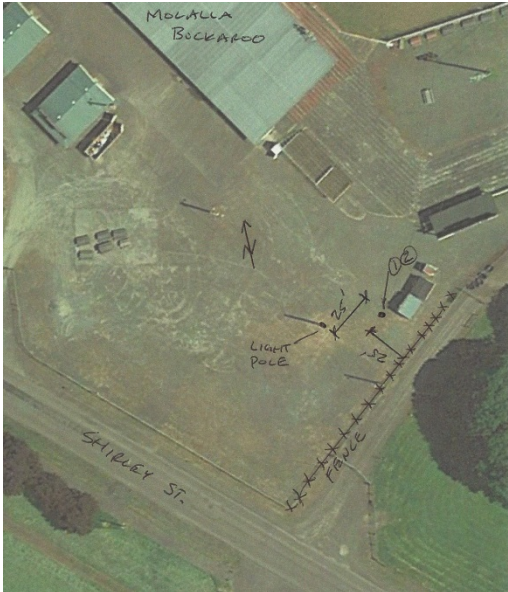
- Smoke from broken cleanout cap inside a water meter box. Cleanout is located on the north east side of the gravel parking area.
- 
- 
- 
-

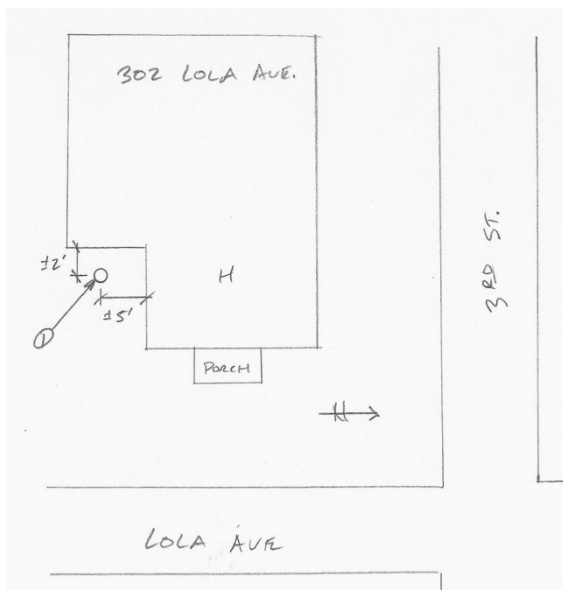
- Smoke from cleanout area. Could not confirm if the cap was broken or missing.
- 
- 
- 
-

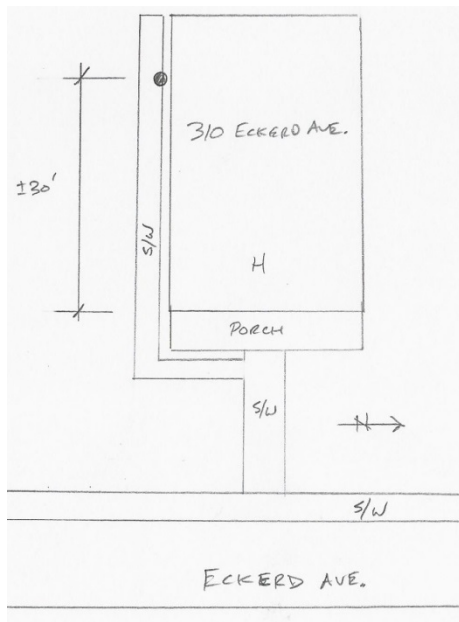
- Smoke from cleanout area. Could not confirm if the cap was broken or missing.
- 
- 
- 
-

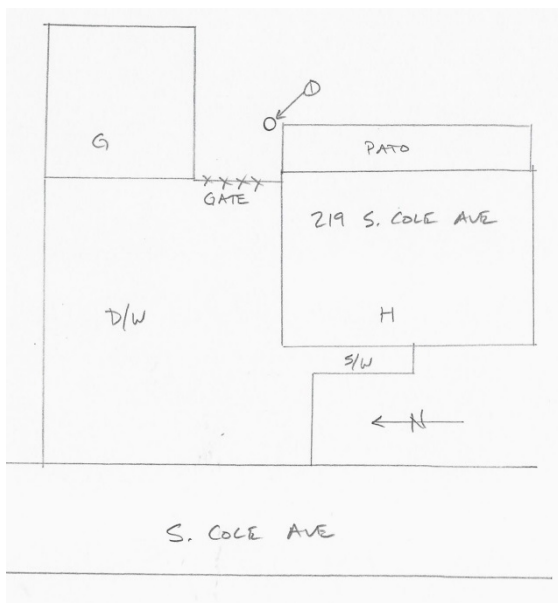
- Smoke from cleanout area. Could not confirm broken or missing cleanout cap.
- 
- 
- 
- 
-

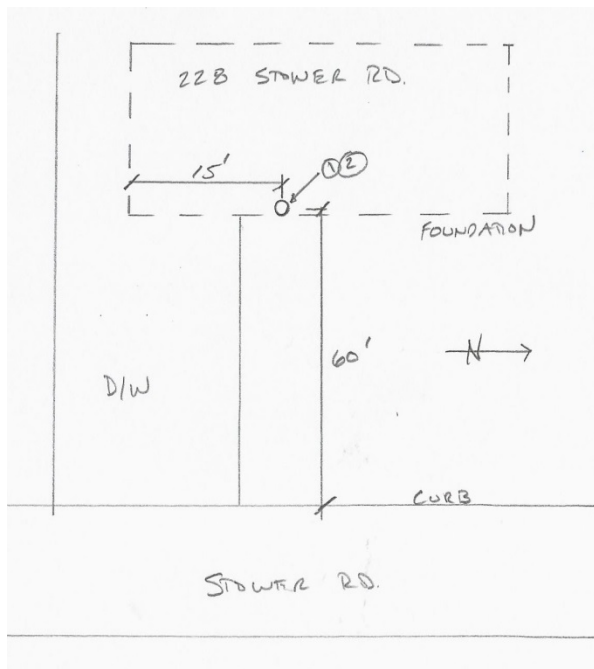
- House has been removed. Smoke from uncovered sewer connection in foundation.
- 
- 
- 
-

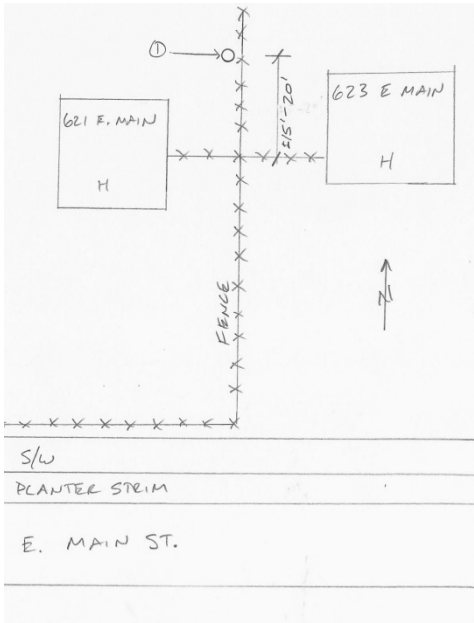
- Smoke from fence line, between backyards of 621 and 623 Main St.
- Could not confirm broken or uncovered cleanout.
- 
- 
-

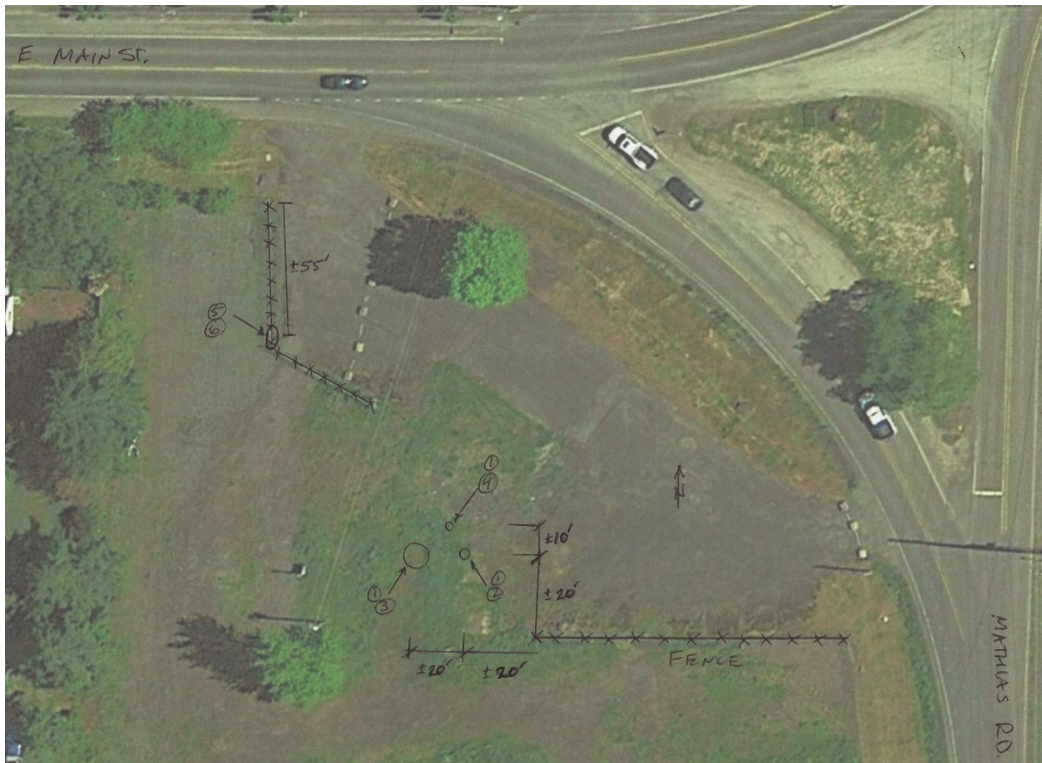
- See aerial for picture locations.
- No. 2 – Cleanout covered with concrete block and open stub out pipe.
- No. 3 – Smoke from gravel area covering broken service lateral.
- No. 5/6 – Smoke from fence line. Possible broken service lateral under fence line.

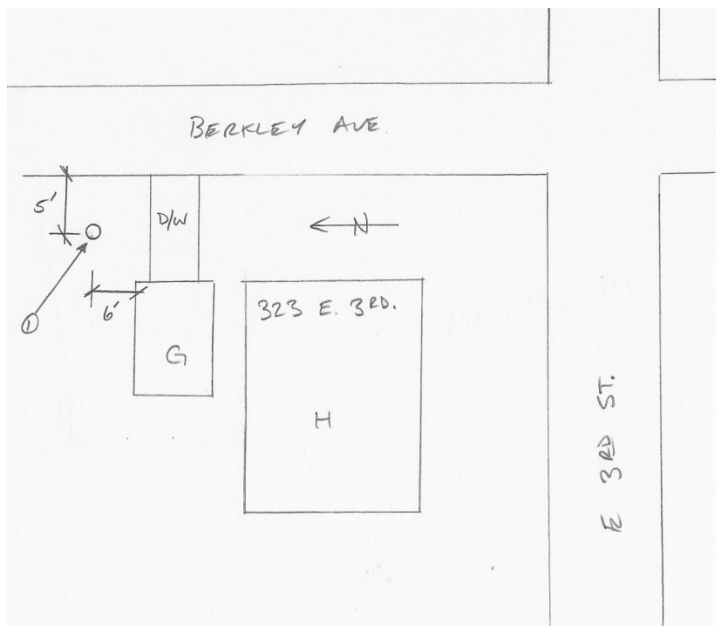
- Broken cleanout cap, located in gravel area under trailer.
- 
- 
- 
- 
-

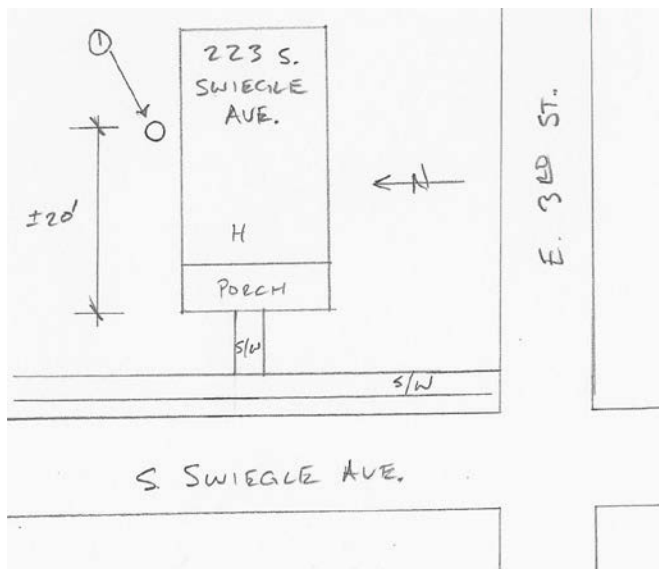
- Smoke from cleanout area on north side of house. Could not confirm broken or missing cap.
- 
- 
- 
- 
-

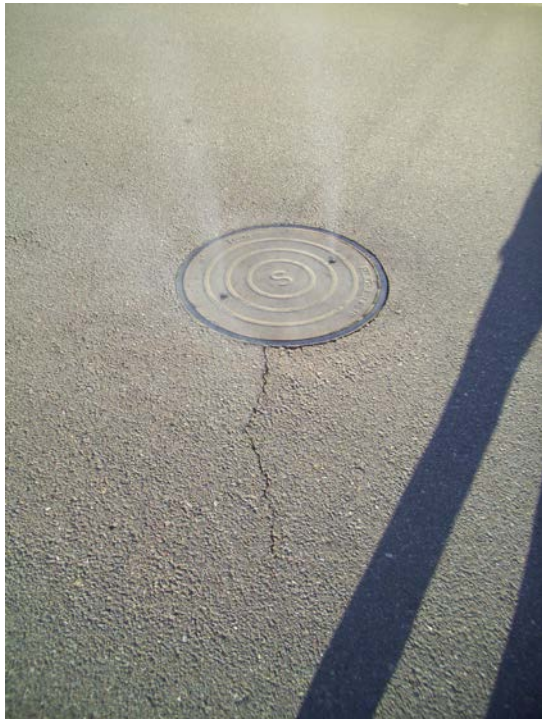
- Smoke coming from crack in pavement east of the manhole lid.
- 
- 
- 
-

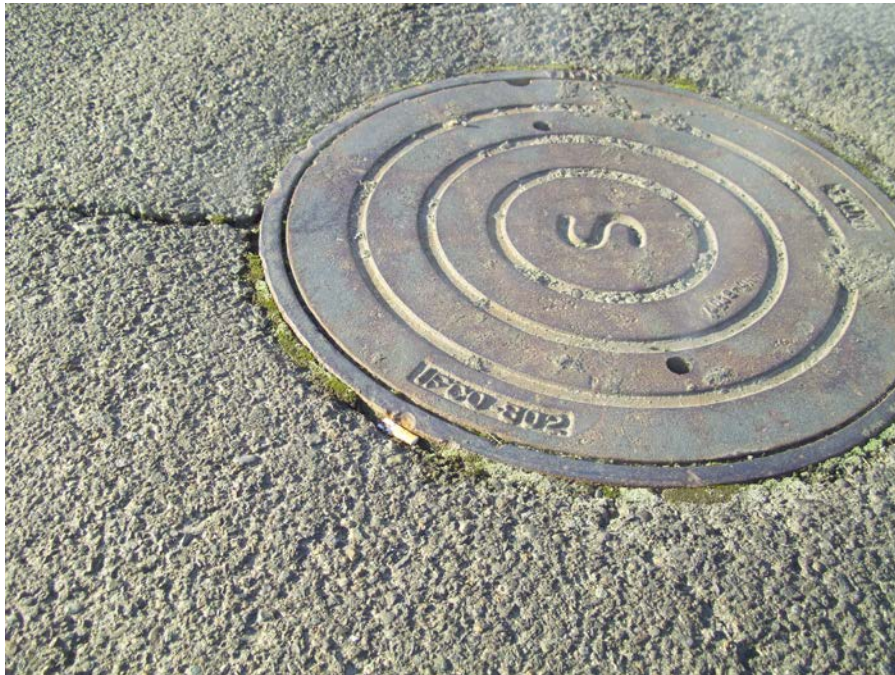
- Smoke coming from crack in pavement east of the manhole lid.
- 
- 
- 
-

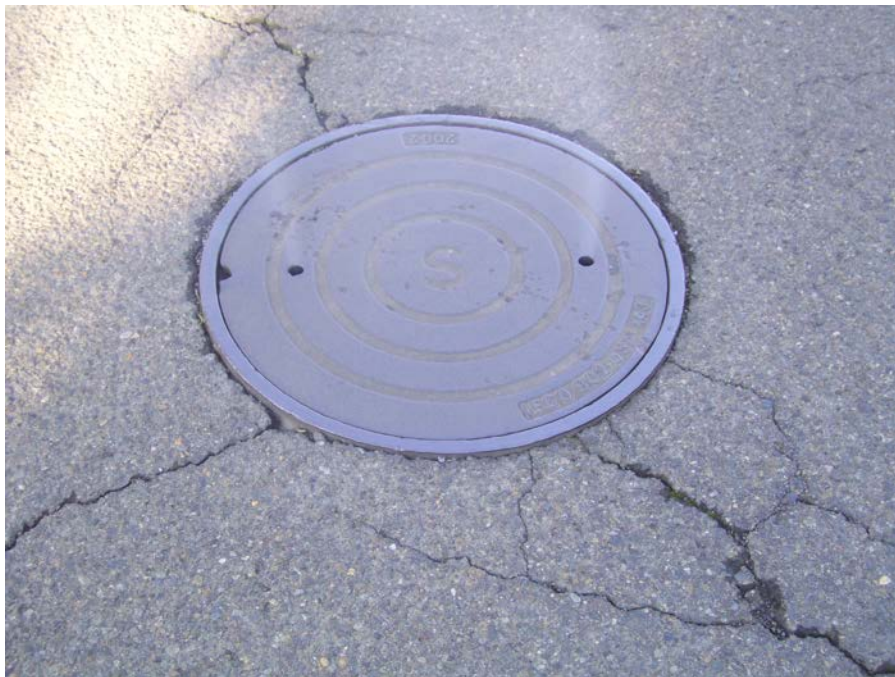
- Smoke coming from crack in pavement south of the manhole lid.
- 
- 
- 
-

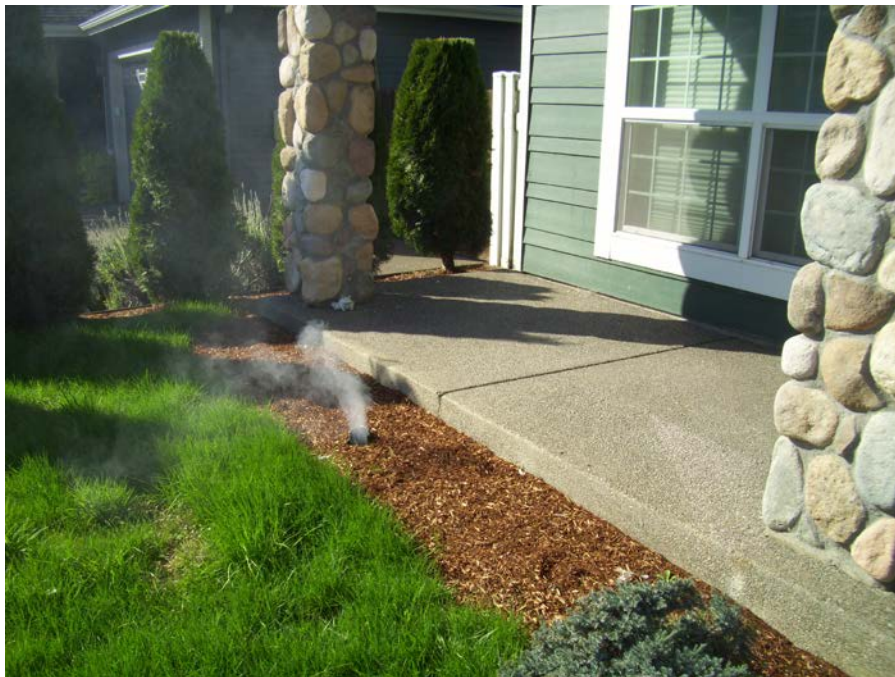
- Cleanout has broken pipe and missing lid.
- 
- 
- 
-

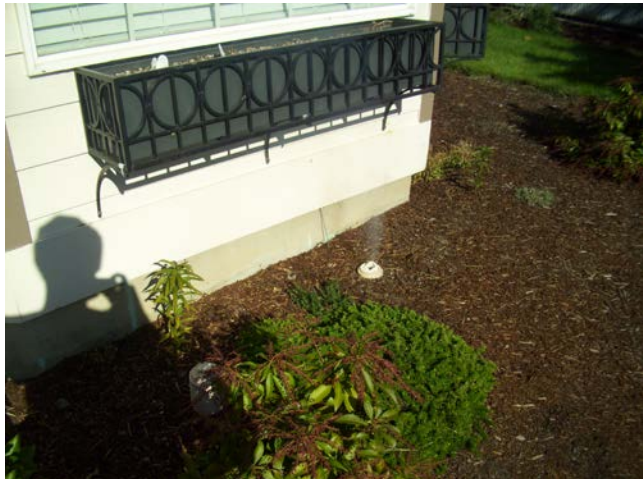
- Cleanout has broken lid.
- 
- 
- 
- 
-

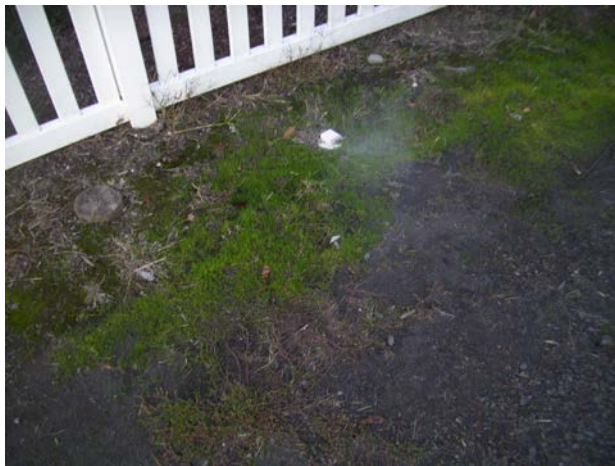
- Broken cleanout lid.
- 
- 
- 
-

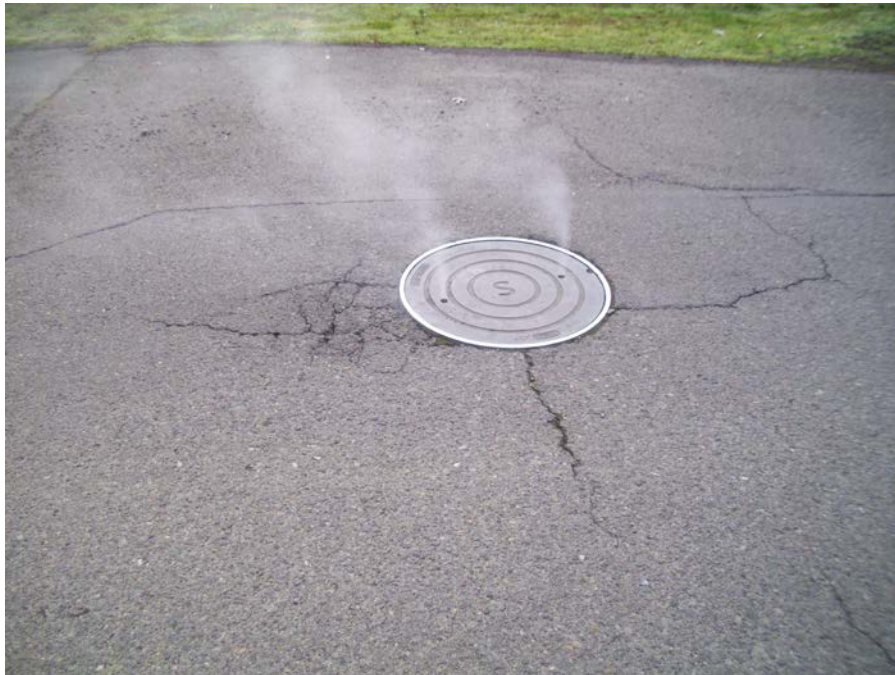
- Smoke coming from cracks in pavement south of the manhole.
- 
- 
- 
- 
-

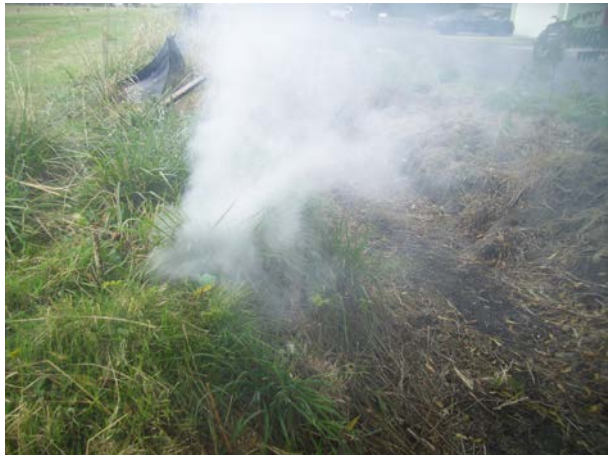
- Cleanout pipe broken next to ditch.
- 
- 
- 
-

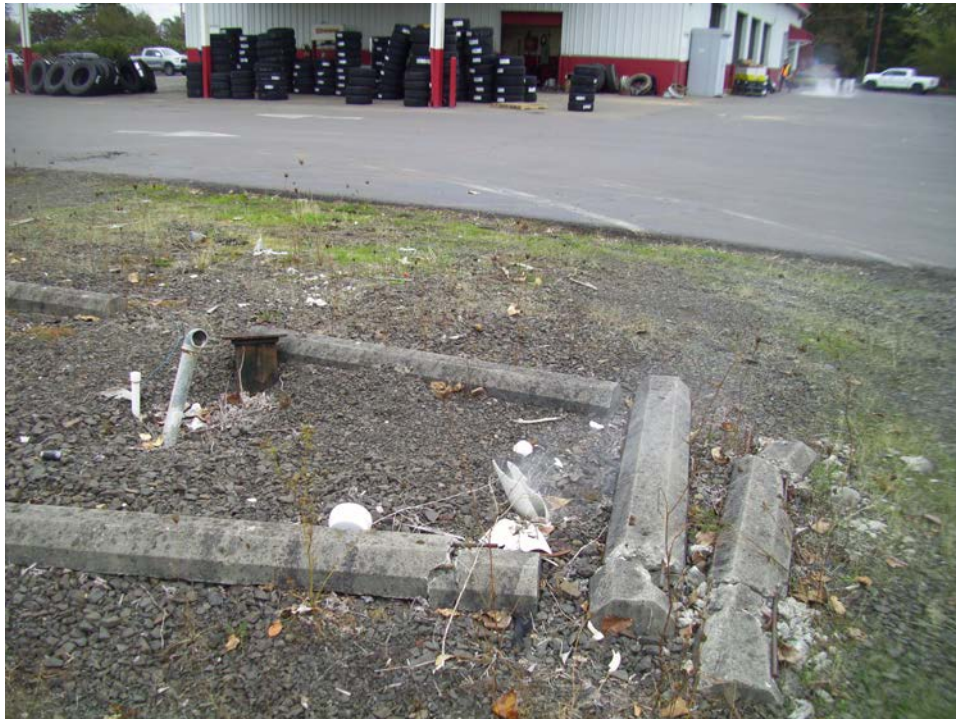
- Broken cleanout pipe.
- 
- 
- 
-

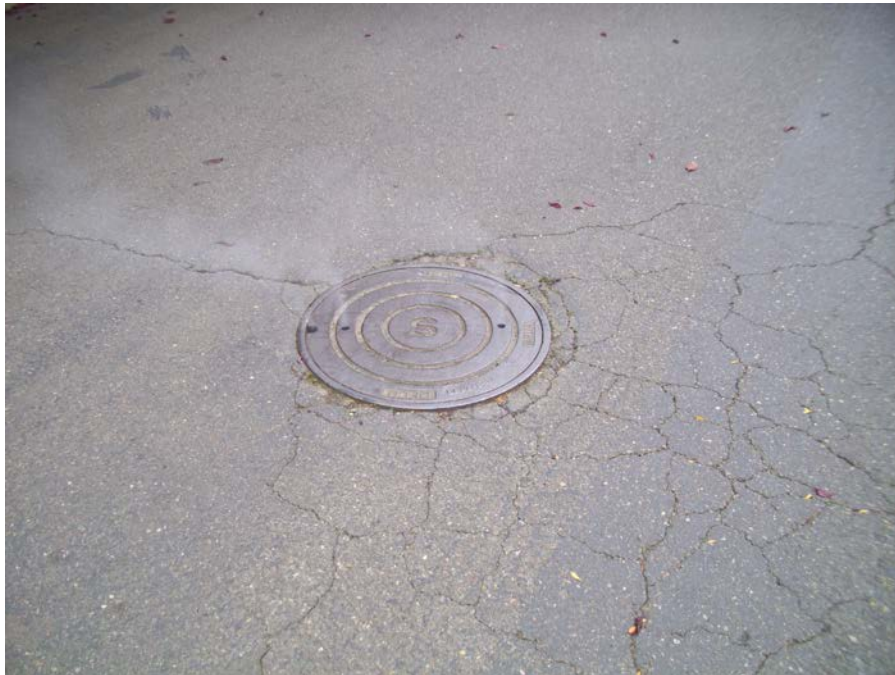
- Smoke coming from crack in pavement south of the manhole lid.
- 
- 
- 
-

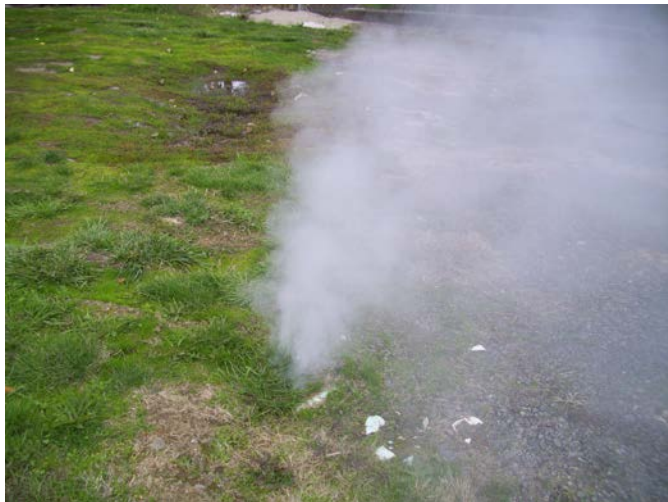
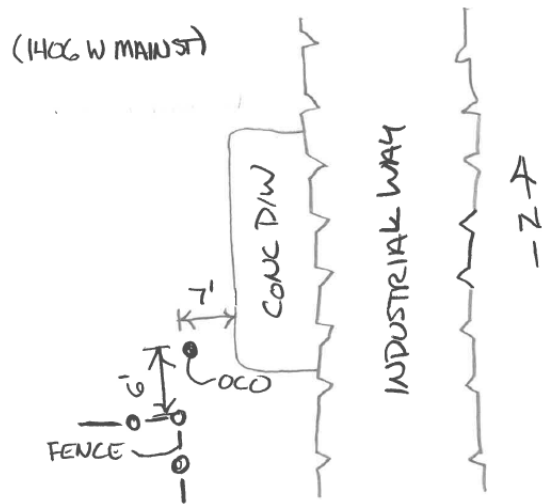
- Cleanout pipe broken at surface.
- 
- 
- 
- 
-

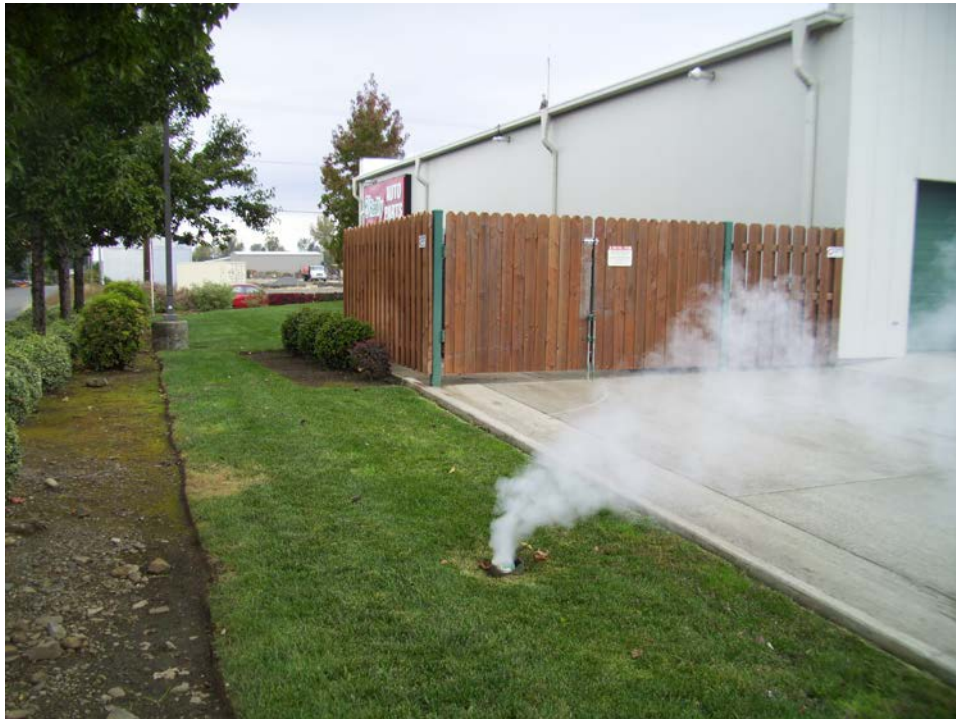
- Broken cleanout cap.
- 
- 
- 
-

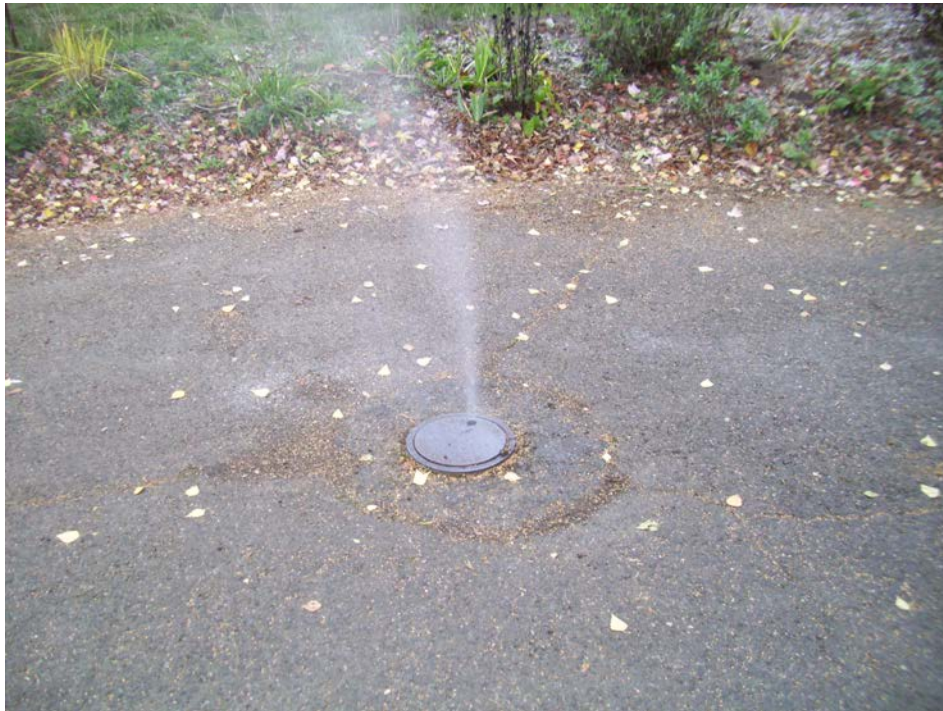
- Smoke coming from cracks in asphalt around cleanout lid.
- 
- 
- 
-

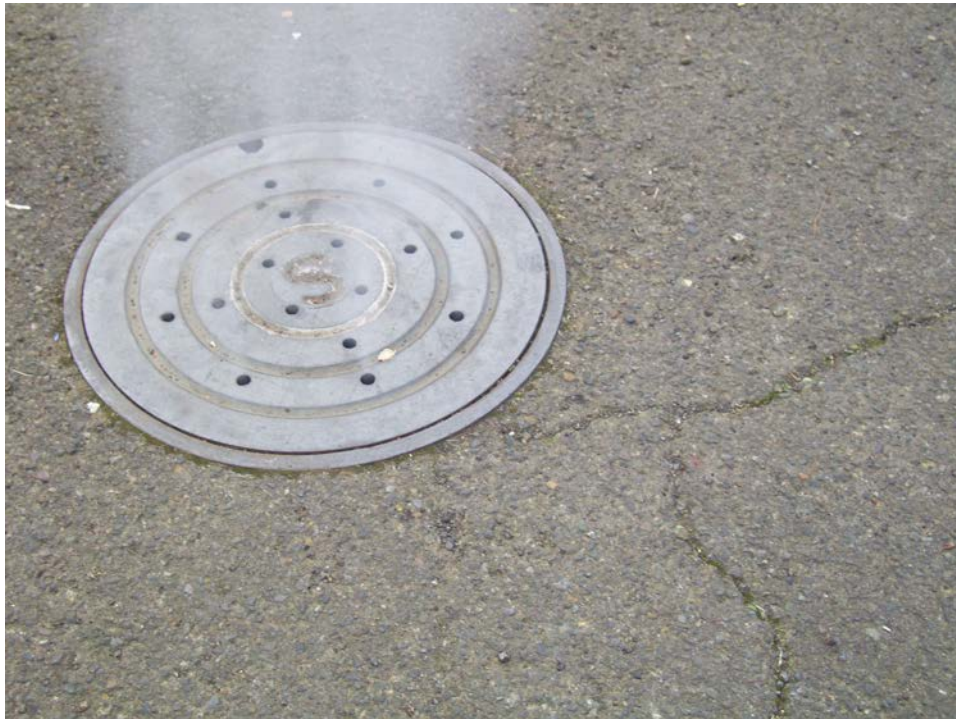
- Manhole BC\_A1\_4: Smoke coming from crack in pavement west of the manhole lid.
- Manhole BC\_A1\_5: Smoke coming from crack in pavement near manhole lid.
- 
- 
-

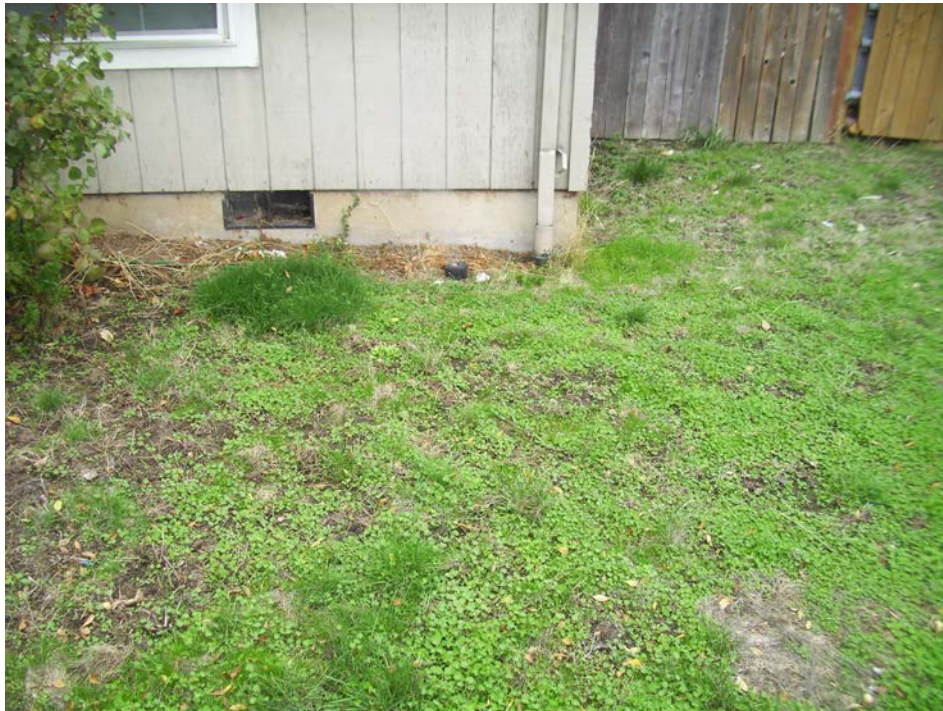
- Smoke coming from broken cleanout cap.
- 
- 
- 
-

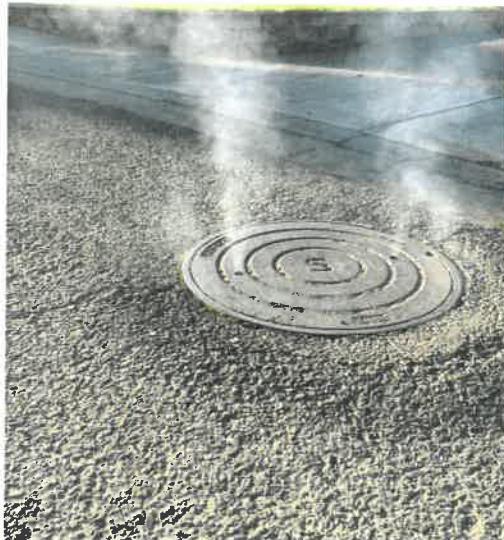
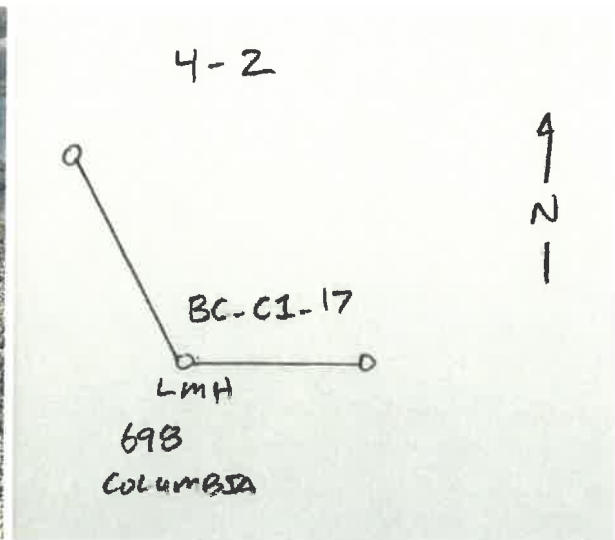
- Leaking around manhole rim.
- 
- 
- 
-

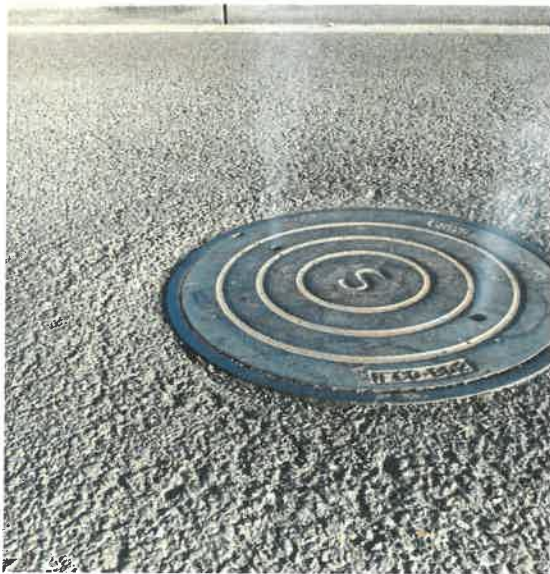
- Leaking around manhole rim.
- 
- 
- 
-

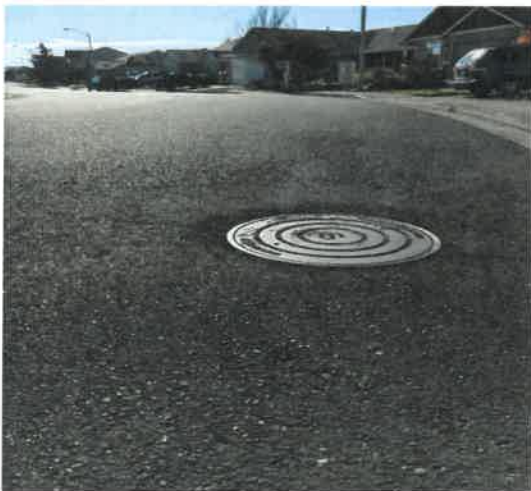
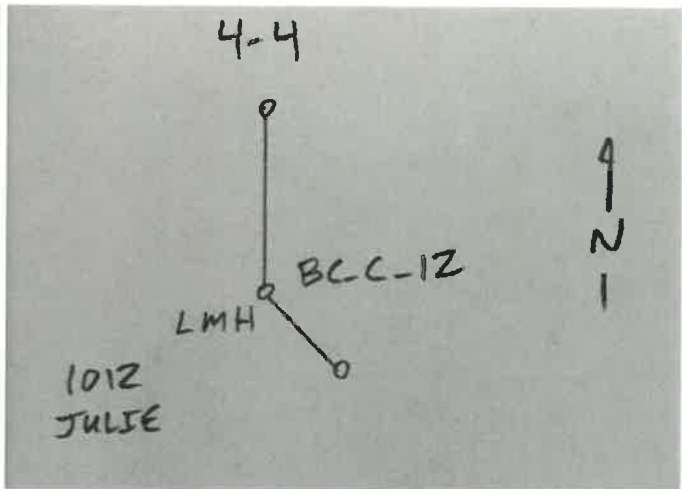
- Leaking around manhole rim.
- 
- 
- 
- 
-

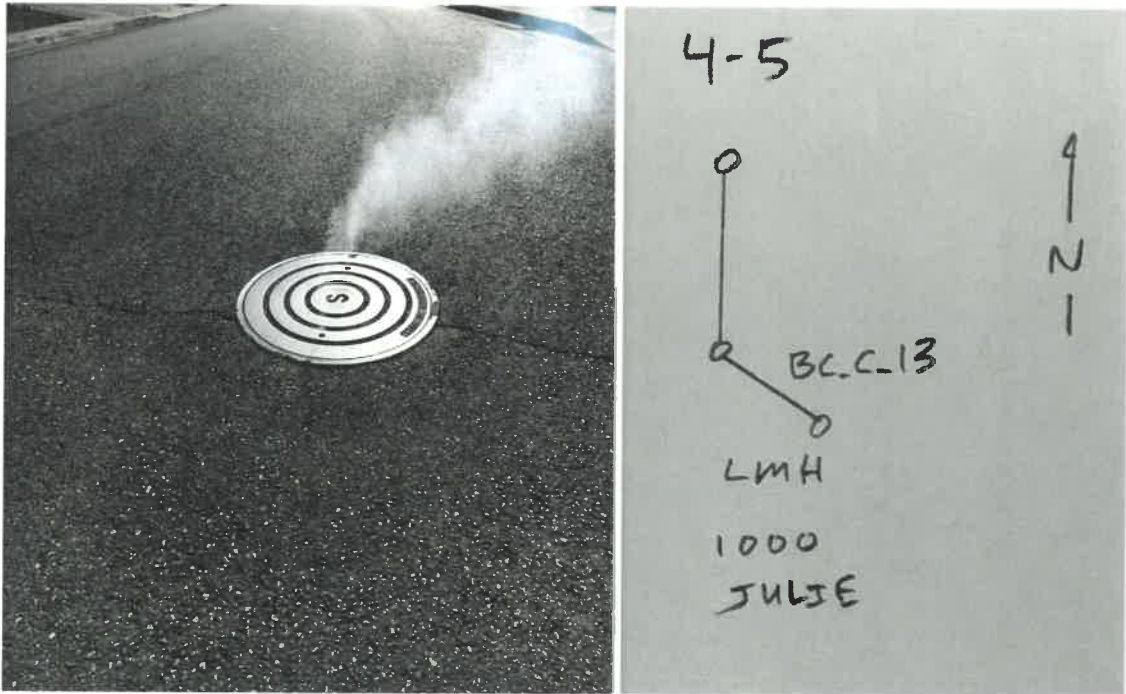
- Leaking around manhole rim and surrounding cracks in asphalt.
- \_\_\_\_\_
- \_\_\_\_\_
- \_\_\_\_\_
- \_\_\_\_\_

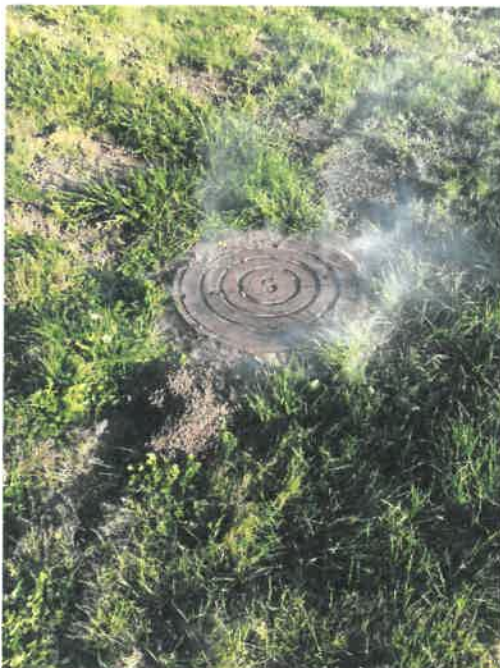
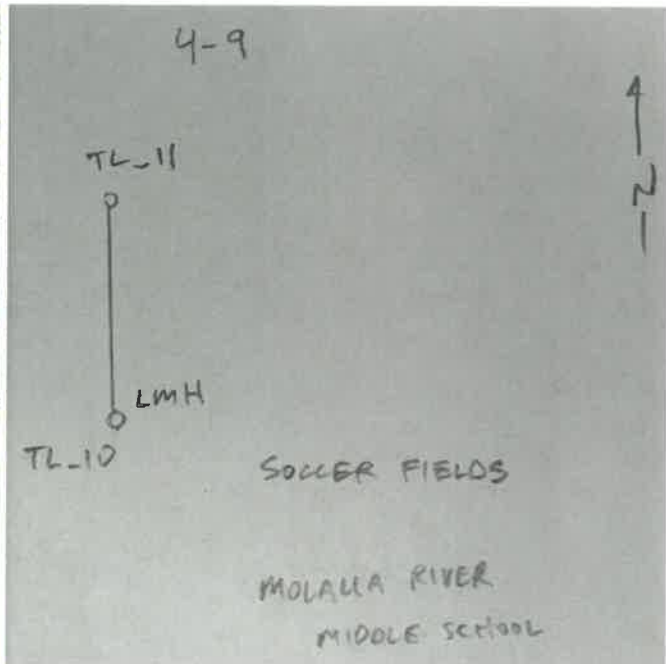
- Manhole was located at perimeter of soccer field. Manhole was leaking significantly around adjacent soil.
- Also refer to aerial on following page.
- 
- 
-
