# CITY OF MOLALLA

## SMOKE TESTING REPORT

OCTOBER 2017

**Project No. 100.26**

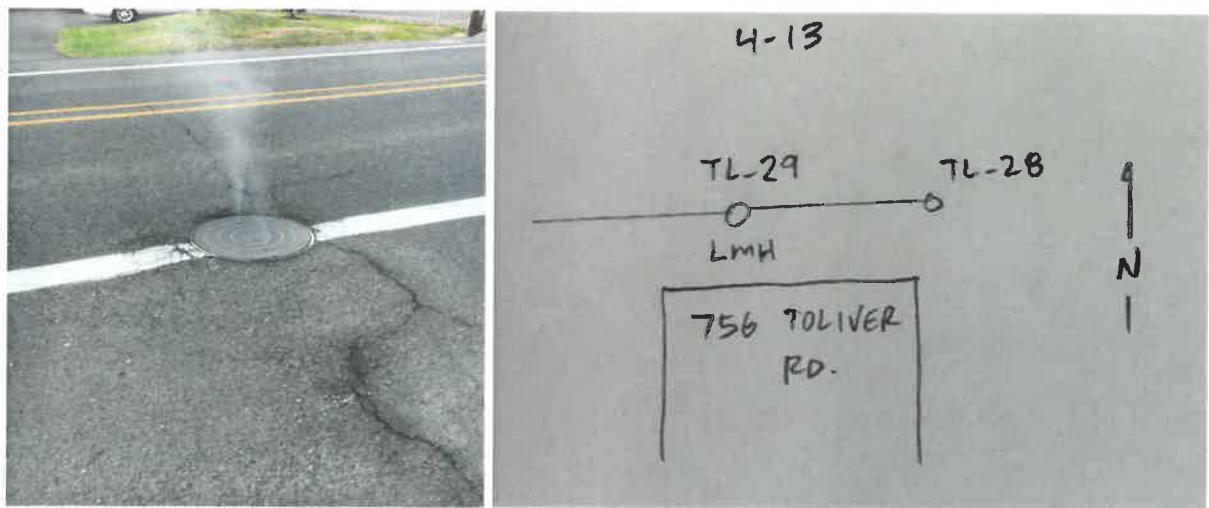
- Manhole was leaking around rim and surrounding cracks around manhole.
- 
- 
- 
- 
-

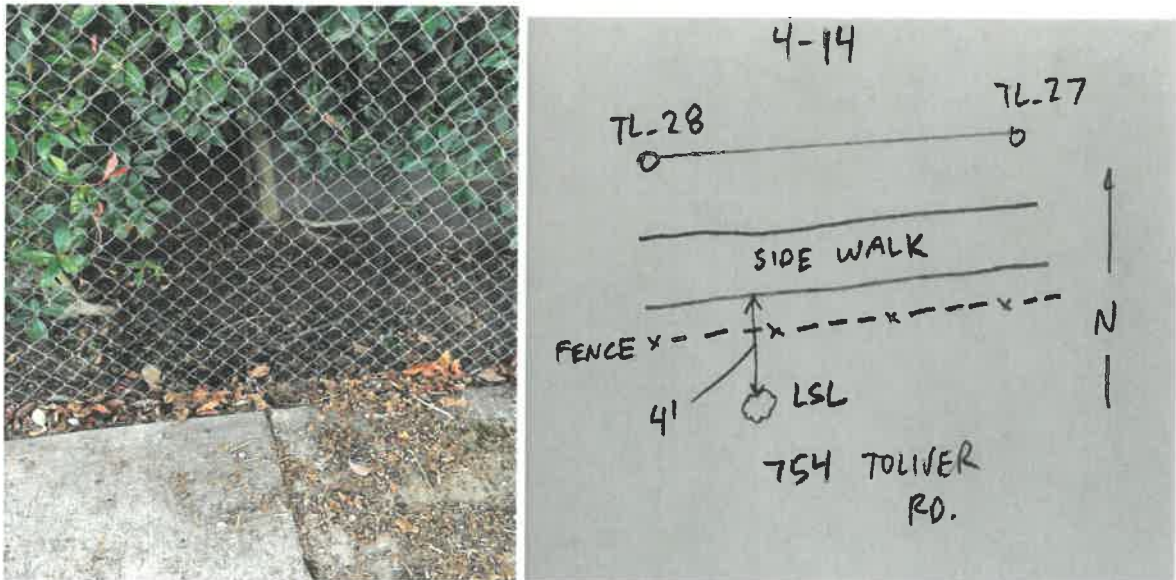
- Service lateral was leaking significantly immediately south of chain link fence. With brush, it was difficult to see, but there was a large amount of smoke, and the area was recessed.
- Also refer to aerial on following page.
- 
- 
-

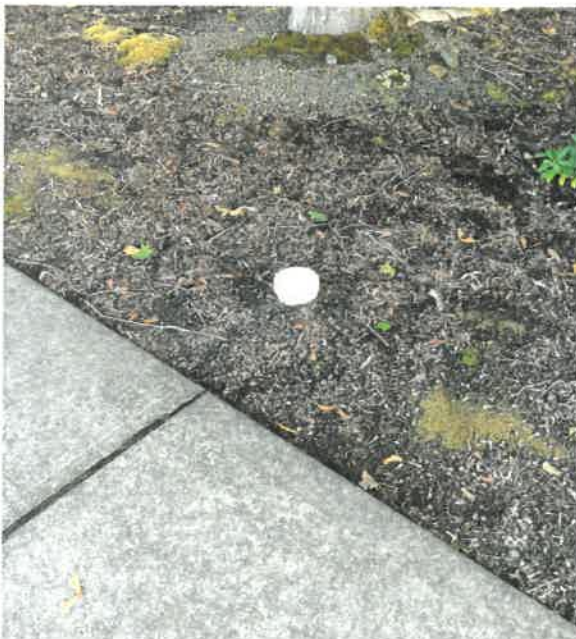
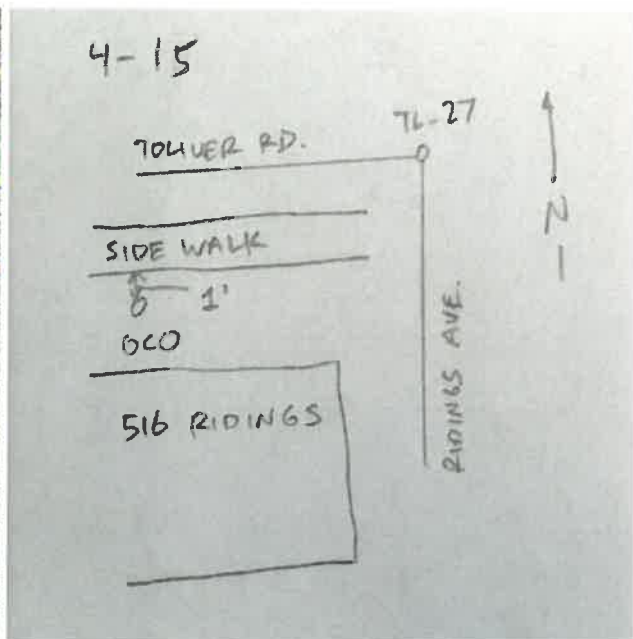
- Open cleanout west of side walk. Exposed pipe was cracked.
- 
- 
- 
- 
-

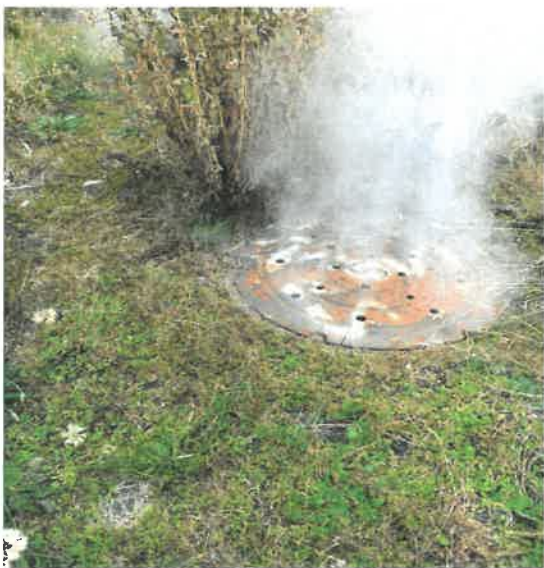
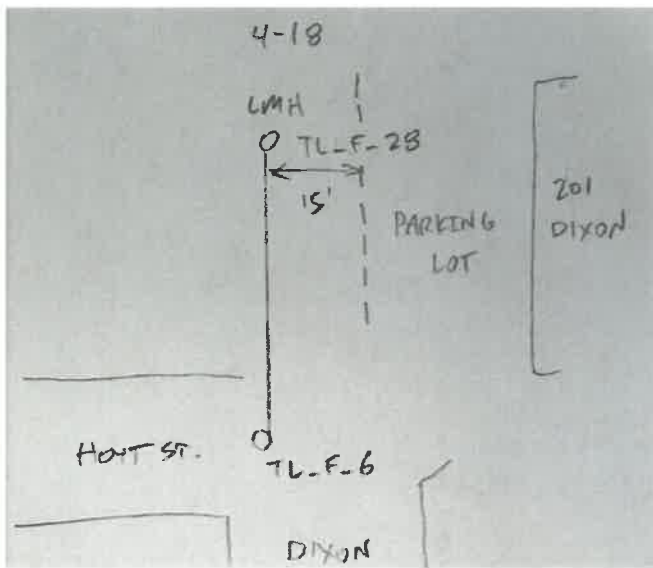
- Manhole located to the west of the parking lot was leaking into surrounding soil.
- Also refer to the aerial on the following page.
- 
- 
-

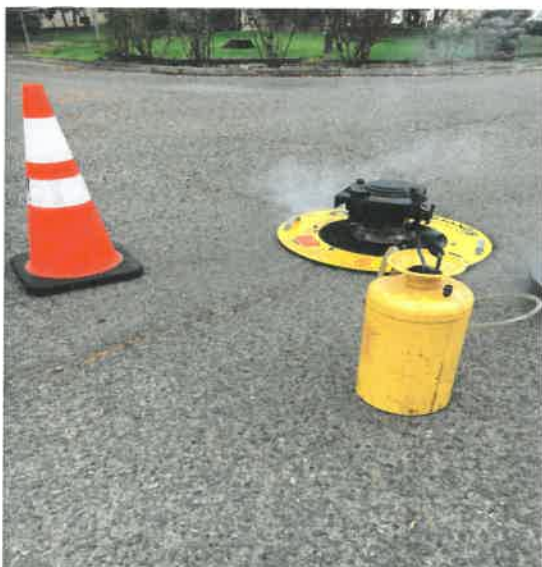
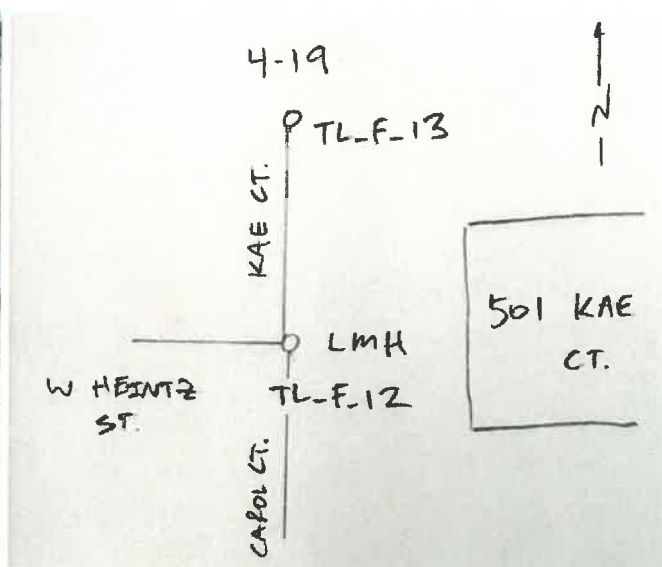
- We set up the smoke machine on this manhole and smoke exited from cracks in adjacent asphalt.
- \_\_\_\_\_
- \_\_\_\_\_
- \_\_\_\_\_
- \_\_\_\_\_
- \_\_\_\_\_

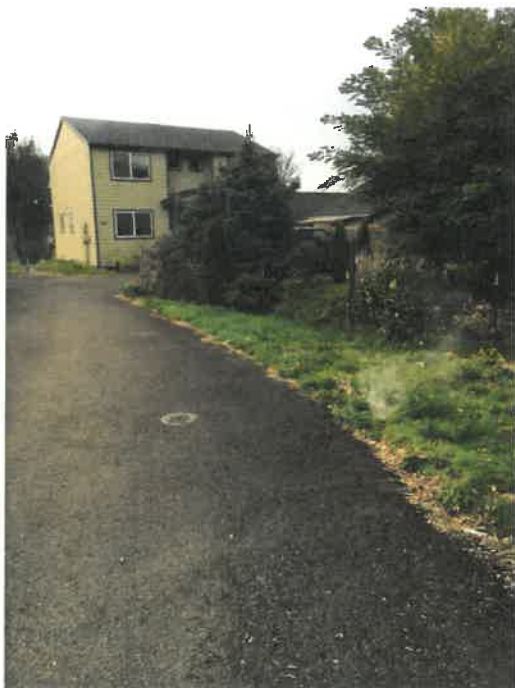
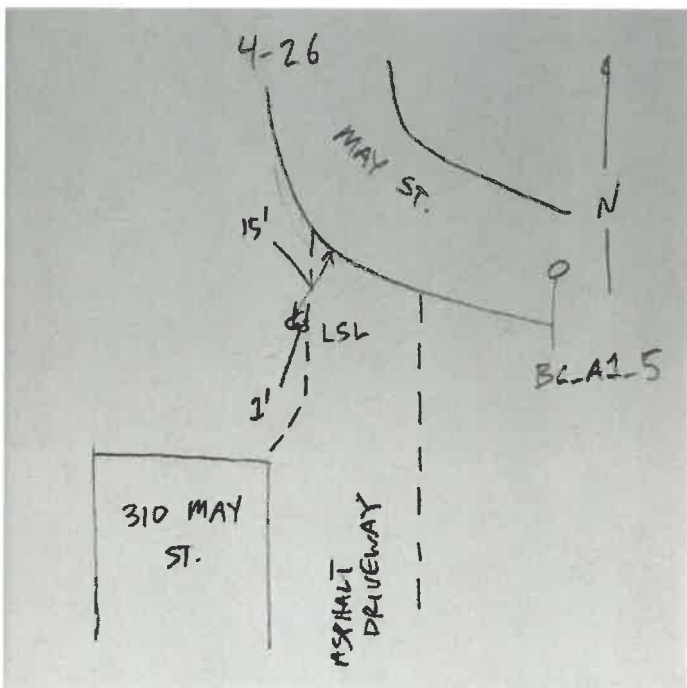
- Service lateral was leaking to the west of the drive way, approximately 15 ft from May Street.
- Also refer to aerial on following page.
- 
- 
-

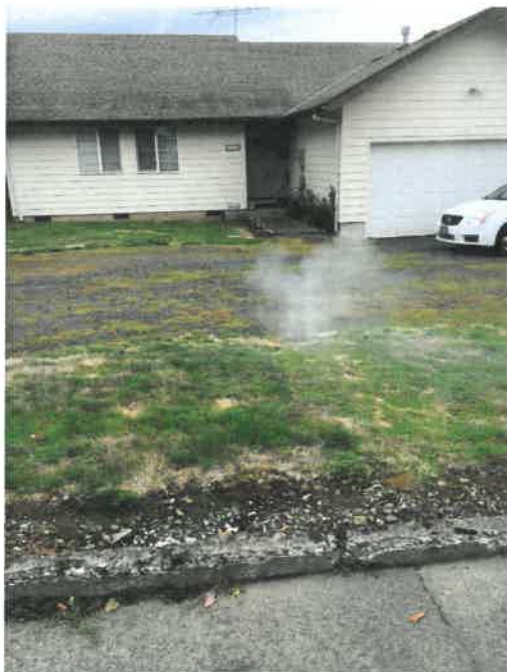
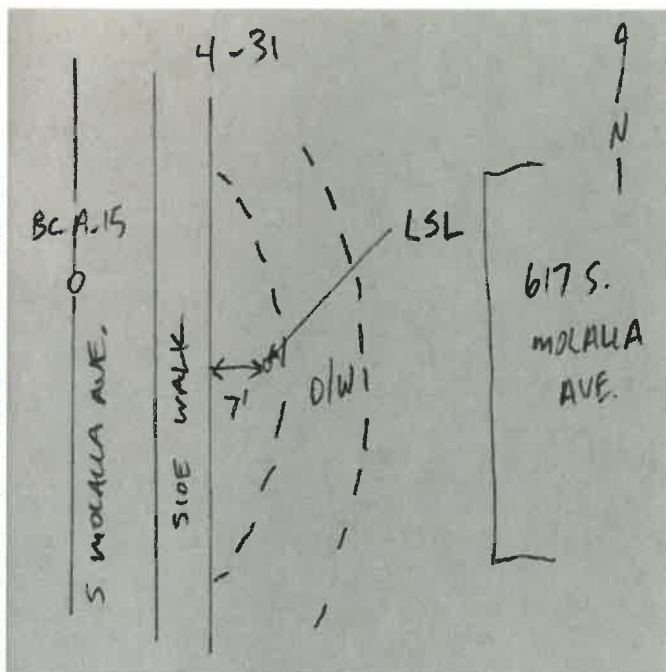
- Leaking service lateral or open cleanout located on western edge of gravel drive way. Smoke exited significantly.
- Also refer to aerial on following page.
- 
- 
-

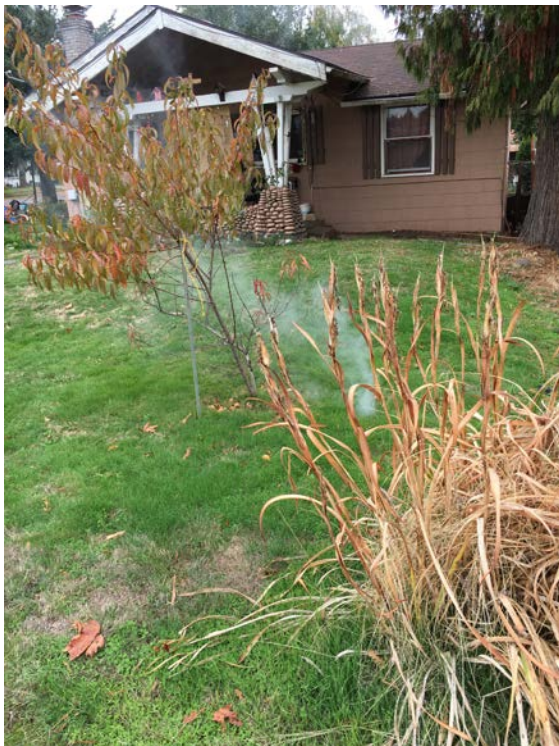
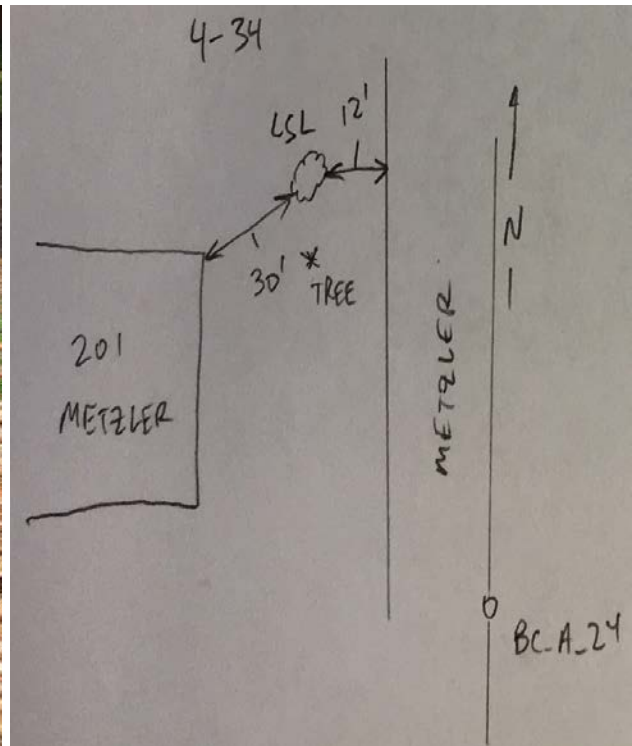
- Leaking service lateral located to the north of a small tree.
- Also refer to aerial on following page.
- 
- 
-
