Community Development Department

October 13, 2022

RE: Aeration Basin Drawdown and Inspection

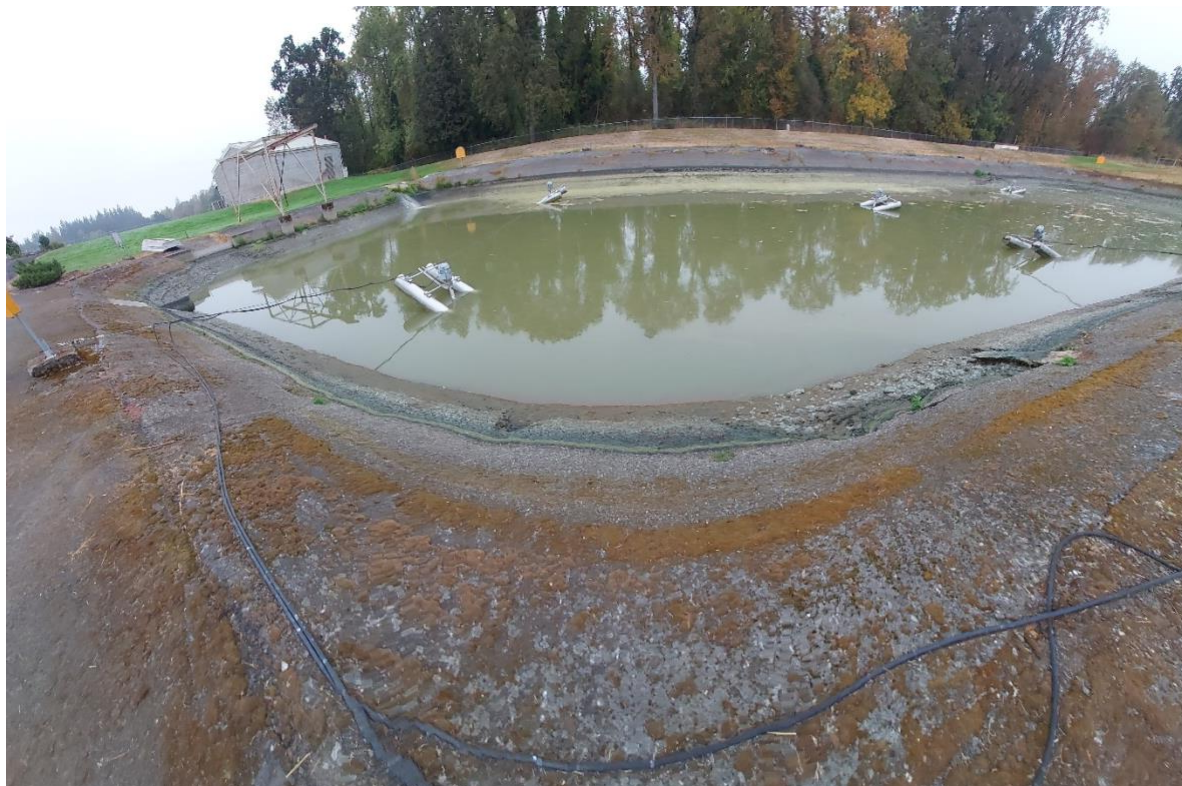
The City of Molalla has drawn down and bypassed its influent Aeration Basin due to the development of holes in the Asphalt Lining. This report documents the situation and findings as we understand them today. On October 5th 2022 the Lead Operator contacted me regarding what appeared to be a hole developing in the asphalt lining of the influent aeration basin at the Molalla WWTP. The observed hole is as it appeared that day are shown in the image (right). I asked him to organize a drawdown of the aeration basin so that

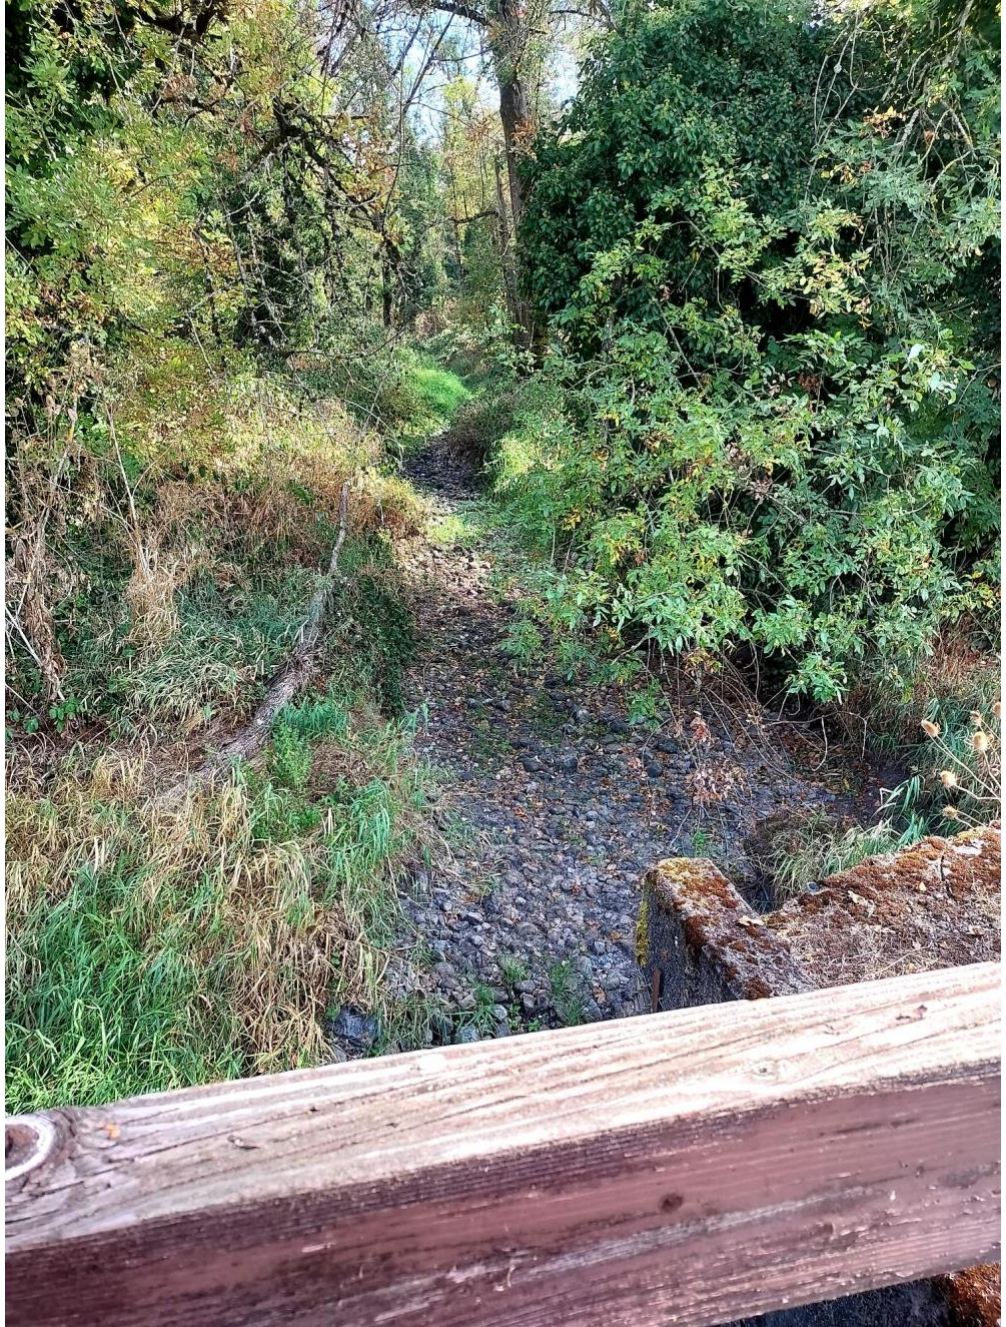
The first concern was whether any raw sewerage from the Aeration Basin was immediately leaking in to Bear Creek to the North. However, an inspection of the creek bed revealed it was dry to the east in the direction of the Aeration Basin, no leaking was immediately evident. The image below is taken from the Driveway bridge at the wastewater plant, facing East up the creek, along side the aeration basin. The

nearest standing water in the creekbed was observed to the West of this bridge, but this pool (1) did not appear to be flowing, and (2) had obvious signs of aquatic creatures (tadpoles and small fish) indicating to us during our inspection that the pool had good dissolved oxygen, not the low oxygen one would expect of raw sewage from the Aeration Basin.
