## **Website Posting**

**August 1, 2023**

Re: City of Molalla Sewage System Overflow on July 25, 2023

## Map of Impacted Area

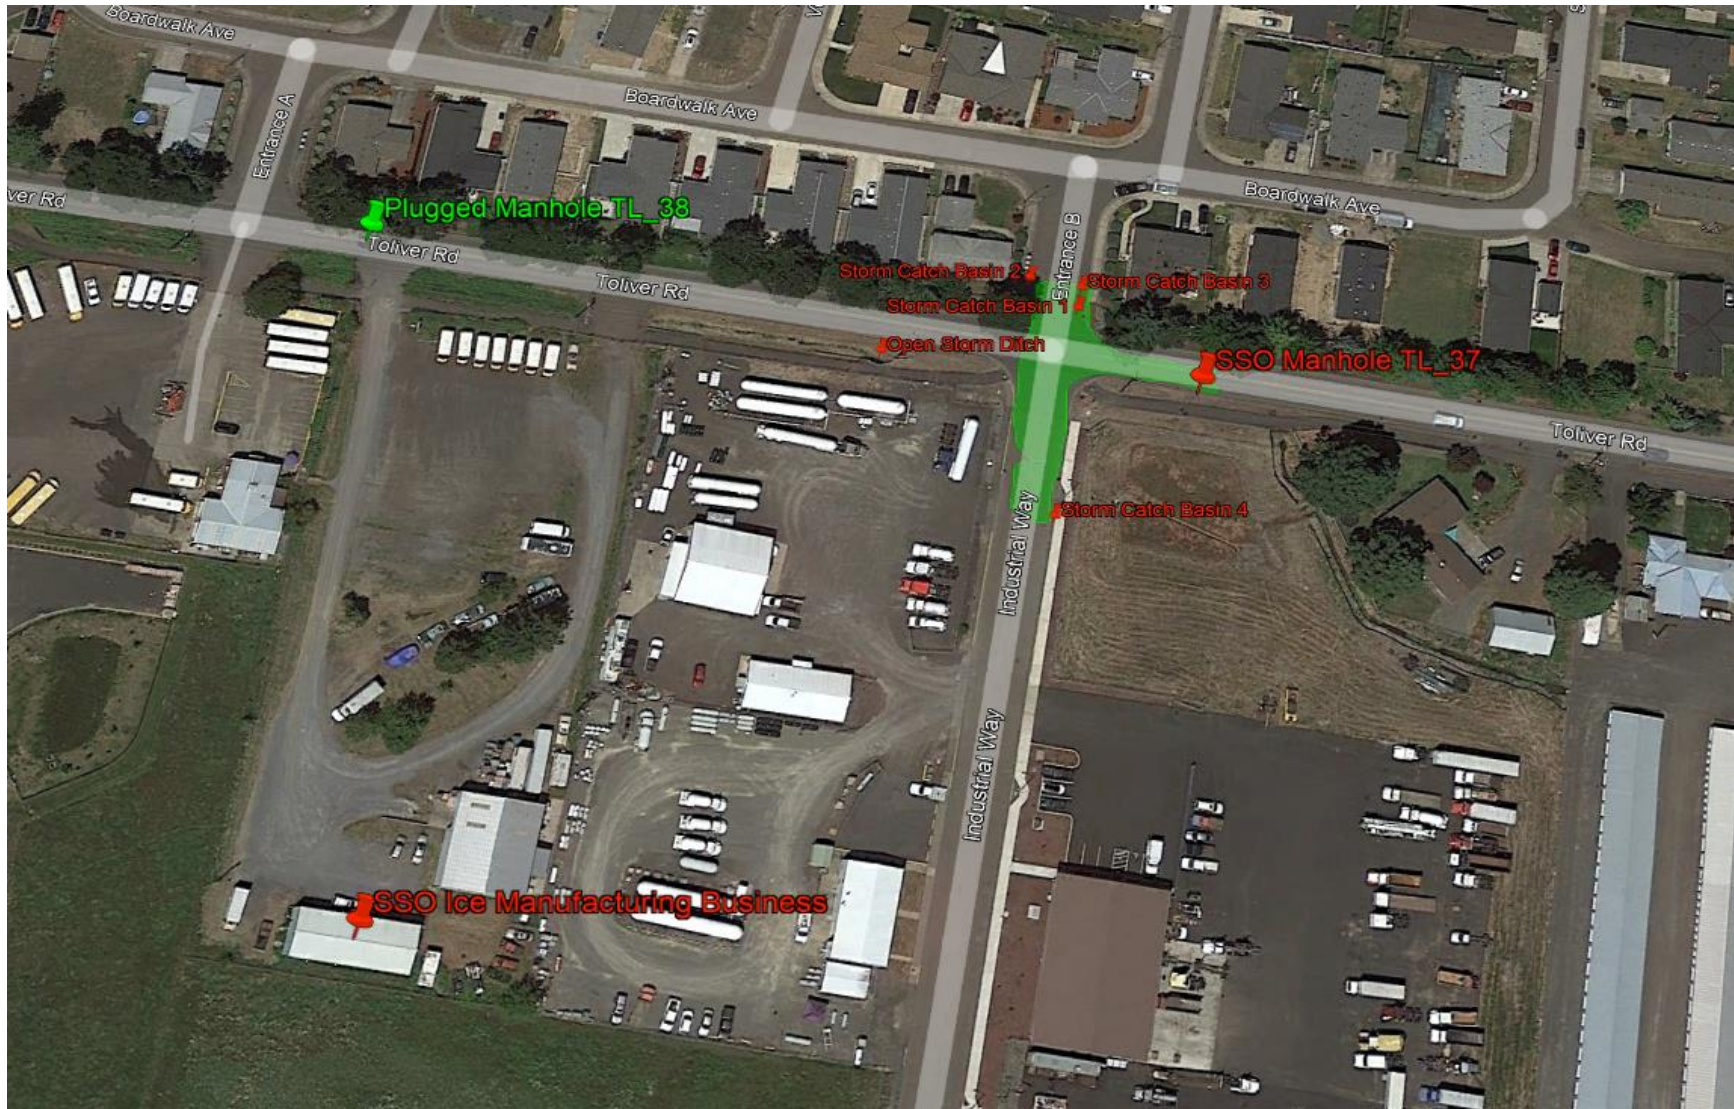
- 2 Red Pins (SSO Manhole TL\_37 and SSO Ice Manufacturing Business) – the points of SSO
- 3 Red Pins (Storm Catch Basin 1-4) – where the SSO entered the storm system
- 1 Red Pin (Open Storm Ditch) – daylight point of storm system where catch basins drain to and where residual SSO settled
- 1 Green Pin (Plugged Manhole TL\_38) – the manhole that the contractor plugged
- Green Translucent Overlay – the spill area

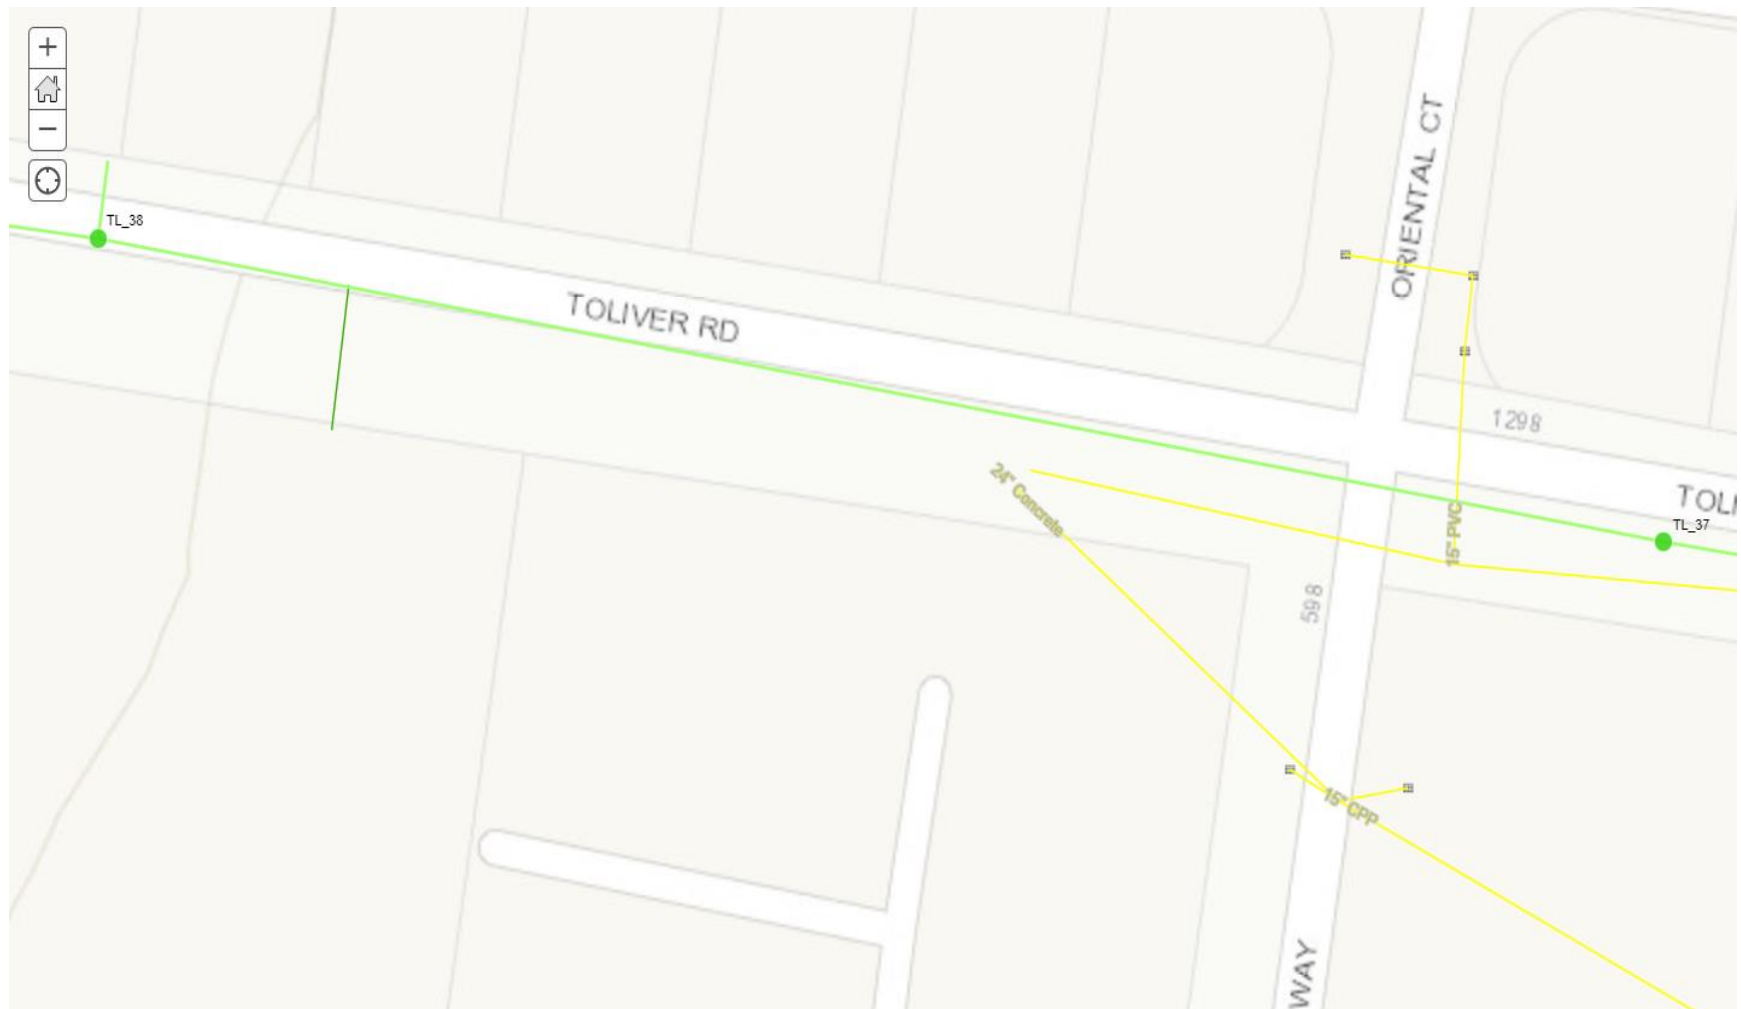
## GIS Map of Impacted Area

- Manhole TL\_38 was plugged by the contractor.
- Untreated wastewater backed up the sewer main and began discharging at TL\_37 and the lateral just east of TL\_38 and.
- The water flowed into the catch basins on Oriental Court and flowed into the open ditch. The “24” Concrete” is the location where the pipes daylight into the ditch.

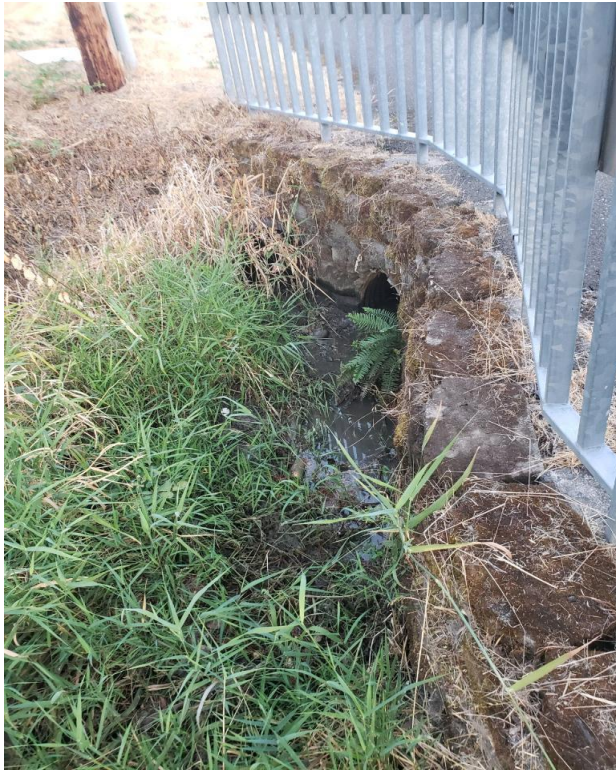
Figure 1 Open Ditch

I have attached a map to this report for ease of understanding. The location of the spill(s) were a manhole on Toliver Road and an Ice Manufacturing Company at 1320 Industrial Way. The spilled untreated wastewater entered 3 stormwater catch basins that cross Toliver Rd and daylight into an open ditch adjacent to Toliver Rd. All water not contained in the catch basins, residual in the storm mains, and discharged through the Ice Company's plumbing, settled in a small low point of the open ditch immediately adjacent to the storm main discharge point. It did not travel more than 15 feet from the storm pipe.

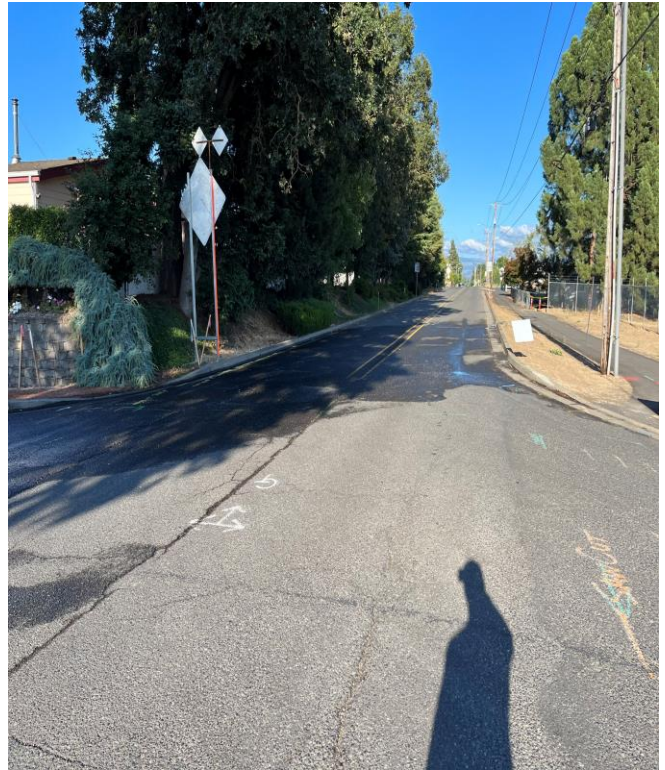
Figure 2 Toliver Rd at Industrial Way

2. At approximately 6:10 pm on 7/25/23 the on-call public works duty was notified by a neighbor that water appeared to be spilling out the top of a manhole located on Toliver Rd about 75 feet east of Industrial Way.
