## MEMORANDUM

PROJECT NAME Aeration Basin Asphalt Liner Failure  
City of Molalla

PROJECT NO. 198.28

**RE: Aeration Basin Drawdown and Inspection**

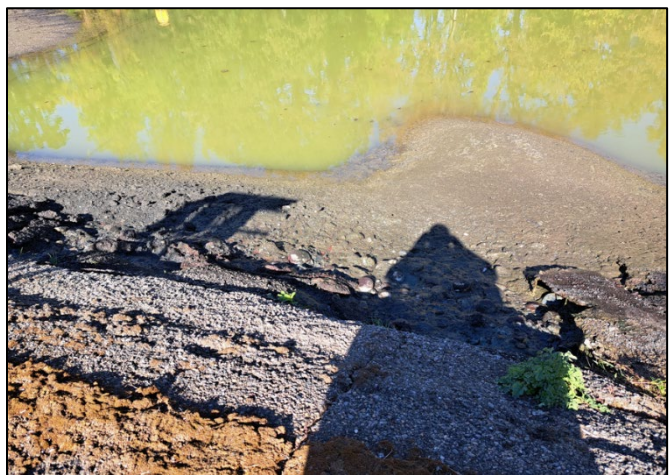
**FIGURE 1  
AERATION BASIN LINER FAILURE**

During the week of October 3<sup>rd</sup>, the City of Molalla (City) lowered the Aeration Basin to inspect and repair a suspected hole developing in the asphalt liner. After lowering the liquid level in the Aeration Basin, the City determined that the asphalt liner would require a comprehensive repair plan.

Spot repairs of the Aeration Basin, with asphalt or shotcrete, is an option that could repair damaged areas in the basin. The effectiveness of the spot repairs is unpredictable and achieving allowable leakage standards set forth by Oregon DEQ is uncertain. More research regarding spot repair methods is warranted. Further discussions with DEQ regarding the performance requirements of spot repairs is also recommended. We would recommend a leak test following the spot repairs, if completed.

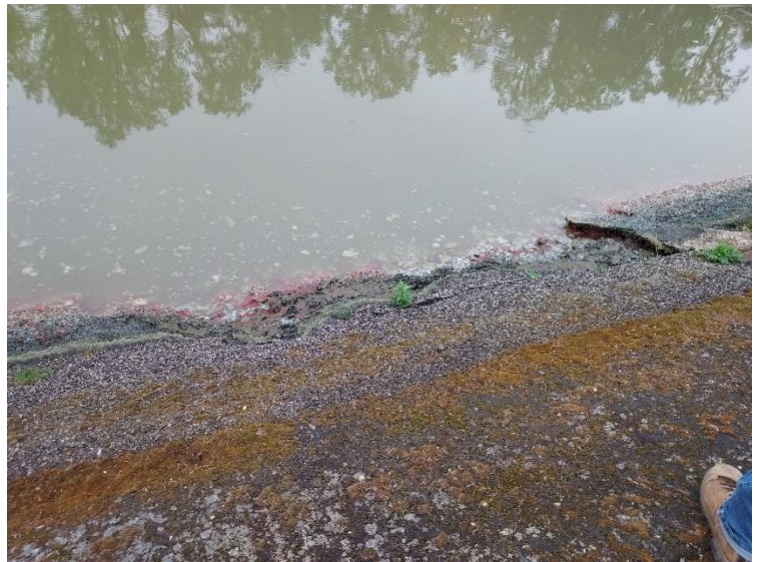
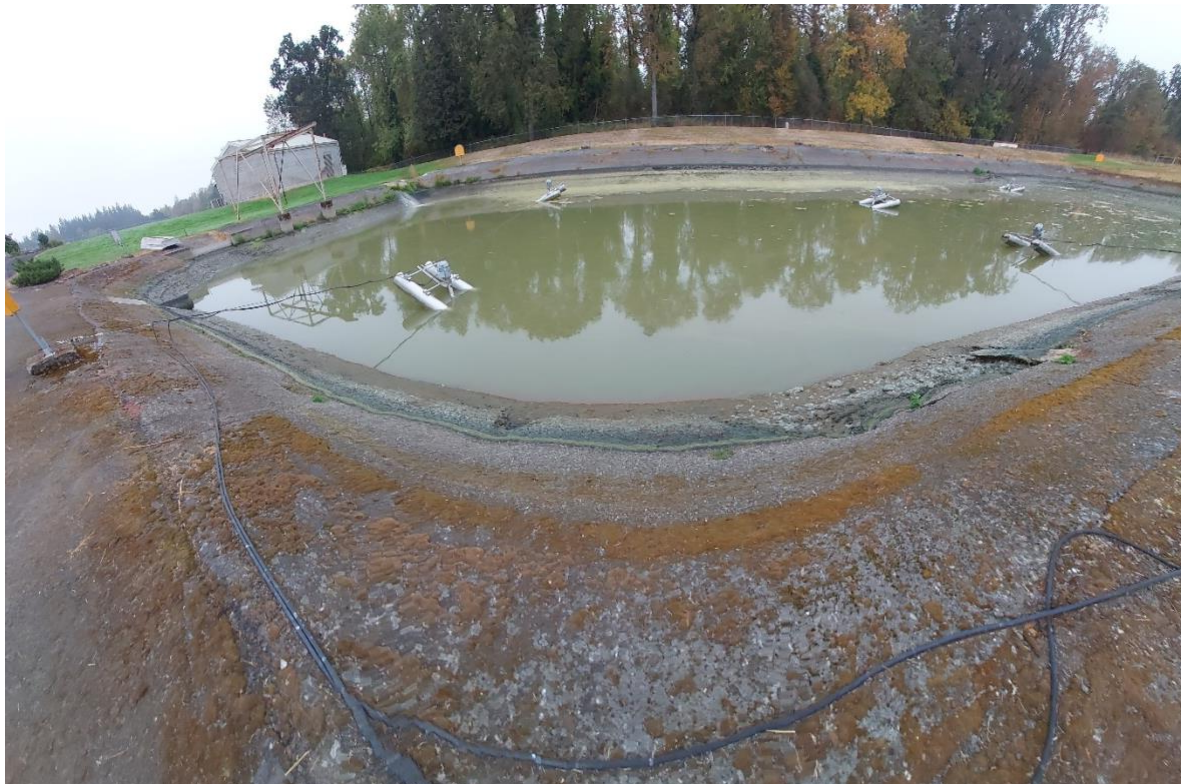
The City of Molalla has drawn down and bypassed its influent Aeration Basin due to the development of holes in the Asphalt Lining. This report documents the situation and findings as we understand them today. On October 5<sup>th</sup> 2022 the Lead Operator contacted me regarding what appeared to be a hole developing in the asphalt lining of the influent aeration basin at the Molalla WWTP. The observed hole is as it appeared that day are shown in the image (right). I asked him to organize a drawdown of the aeration basin so that

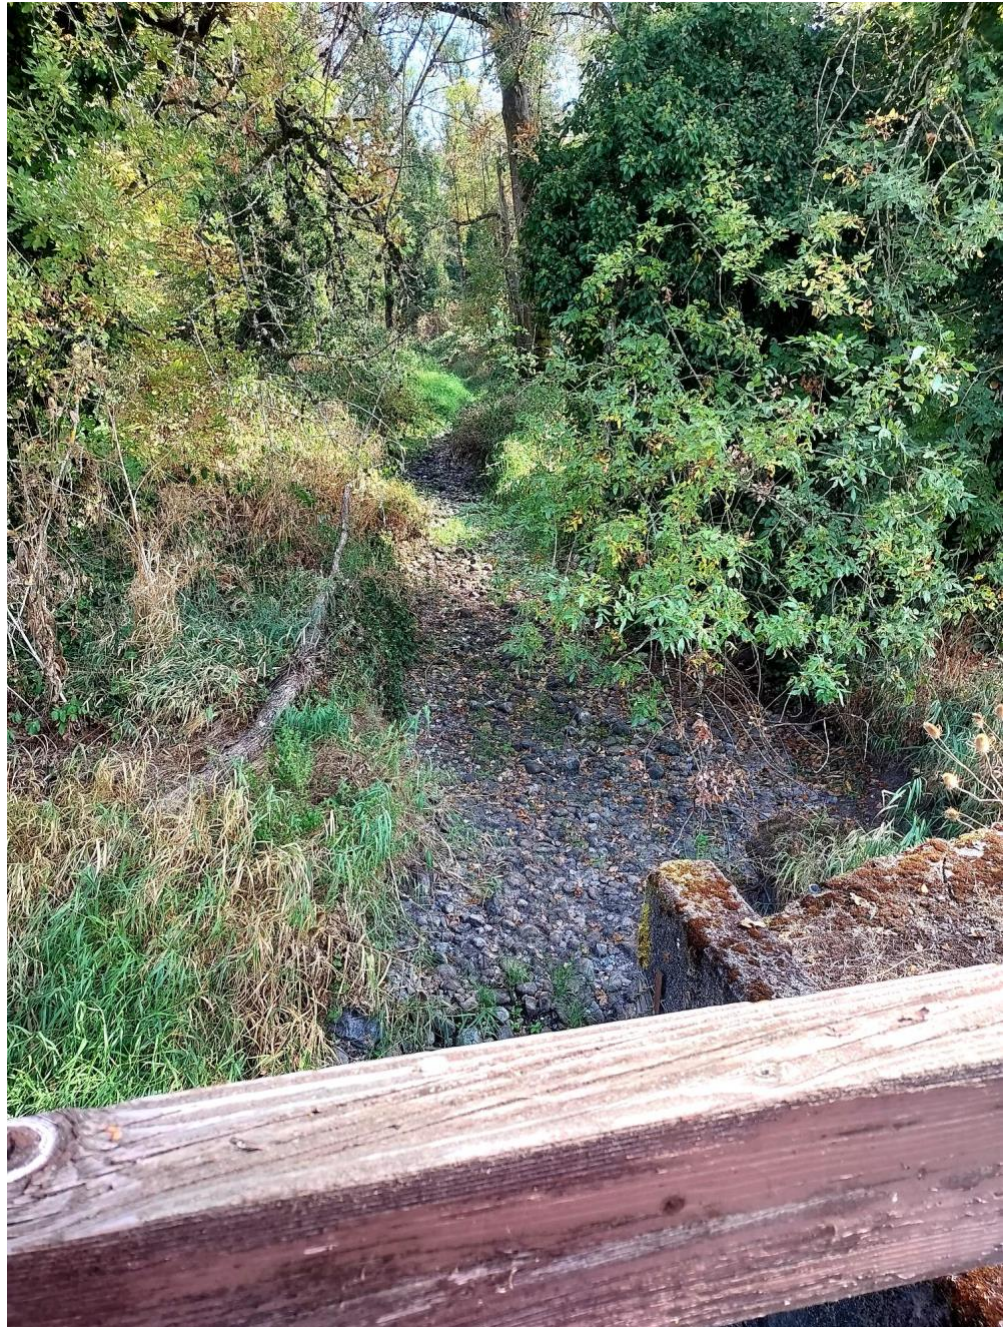
The first concern was whether any raw sewerage from the Aeration Basin was immediately leaking in to Bear Creek to the North. However, an inspection of the creek bed revealed it was dry to the east in the direction of the Aeration Basin, no leaking was immediately evident. The image below is taken from the Driveway bridge at the wastewater plant, facing East up the creek, along side the aeration basin. The

nearest standing water in the creekbed was observed to the West of this bridge, but this pool (1) did not appear to be flowing, and (2) had obvious signs of aquatic creatures (tadpoles and small fish) indicating to us during our inspection that the pool had good dissolved oxygen, not the low oxygen one would expect of raw sewage from the Aeration Basin.

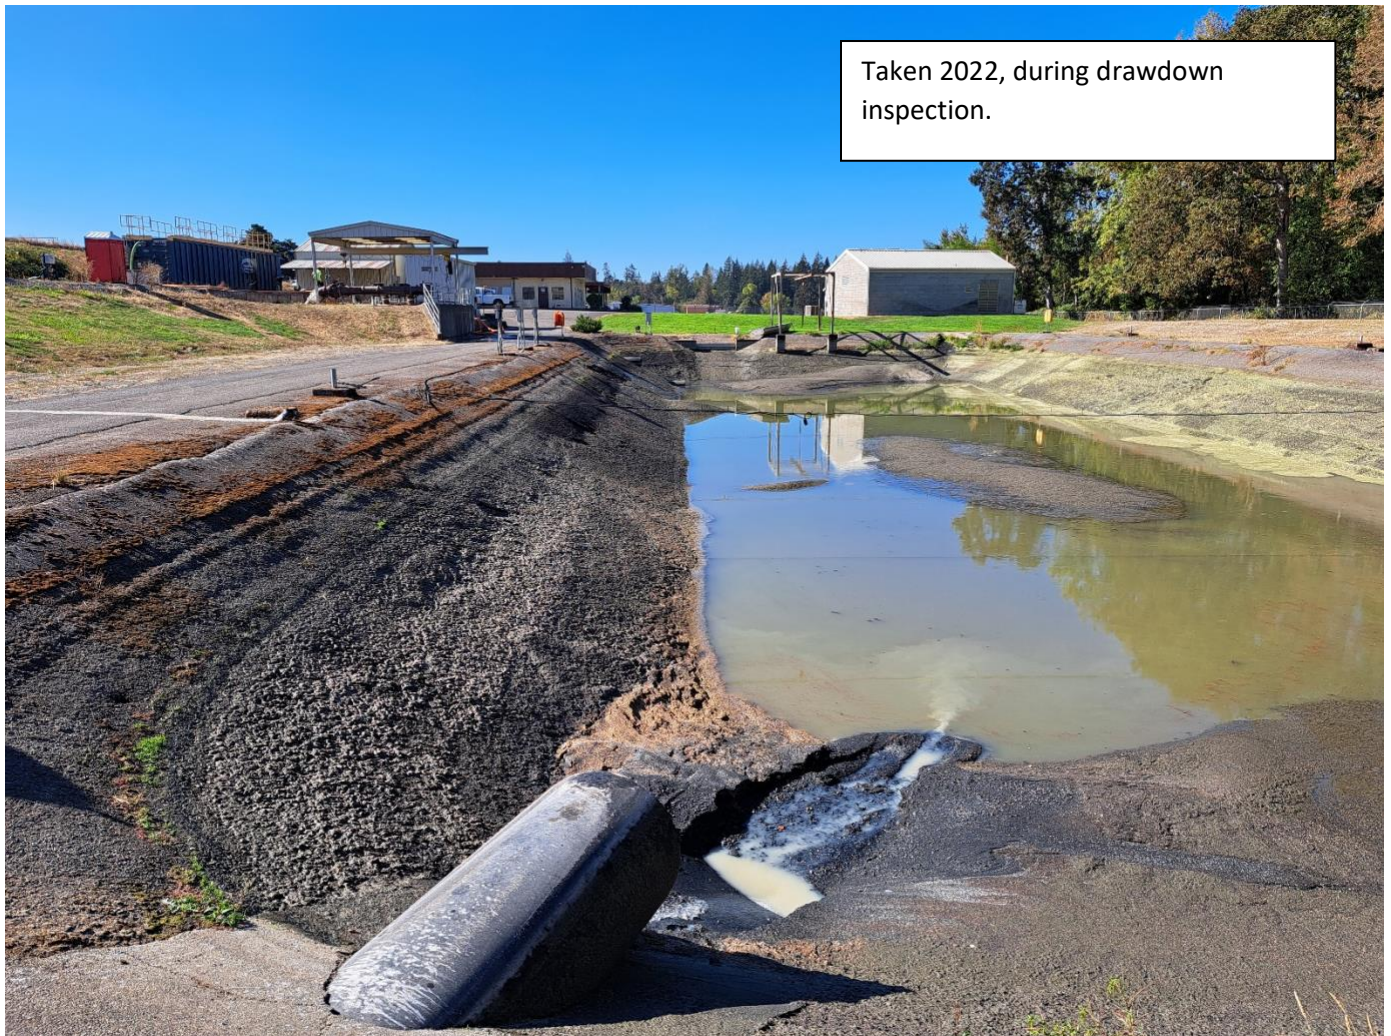
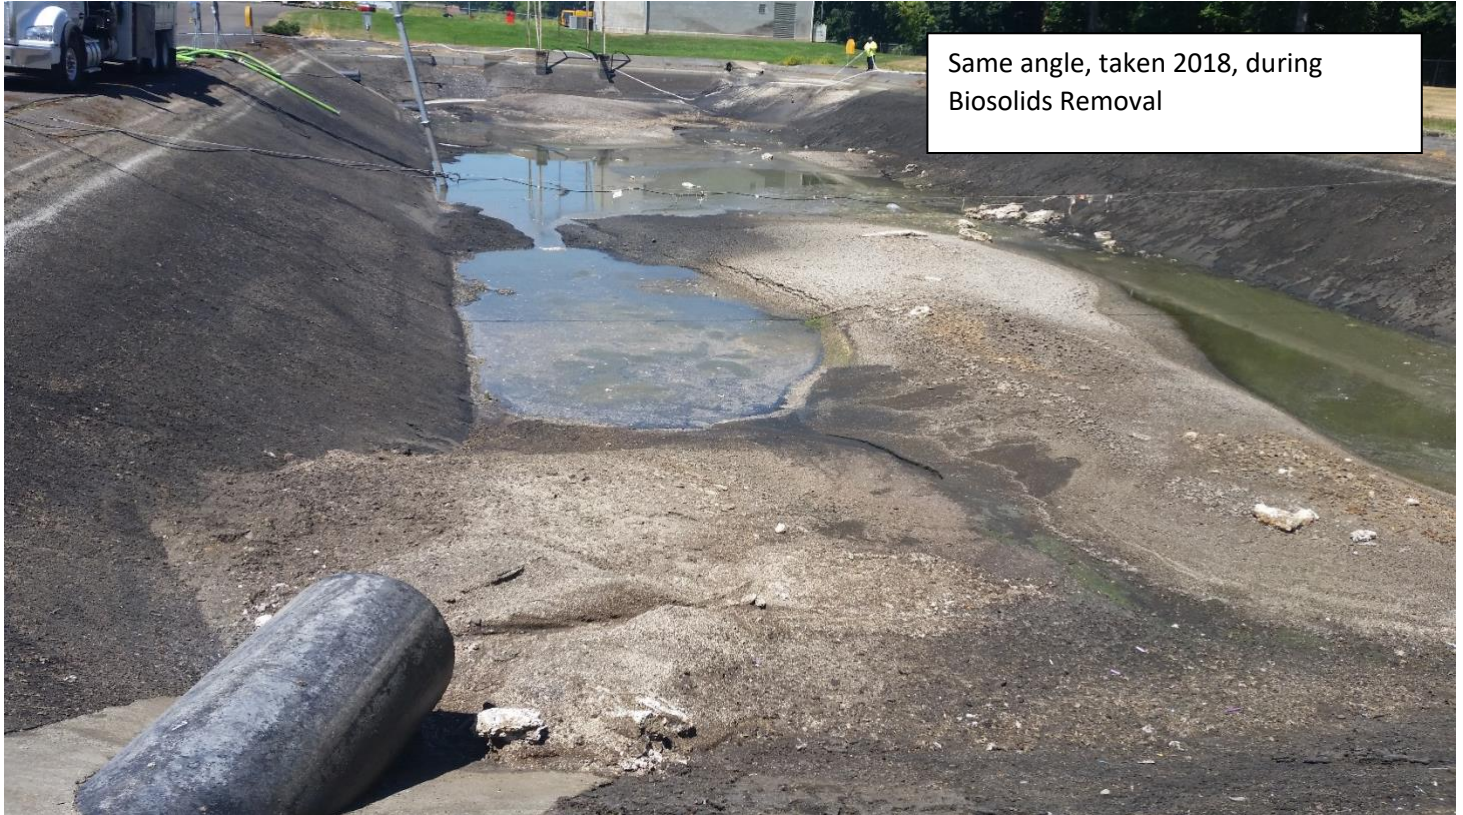
- a. Walkaround: the entire structure was found to be in poor condition with multiple holes in the asphalt lining below the normal high-water level.
- b. Shovel Checks: I descended the side of the structure suspended by a rope and worked the area that appeared to be still asphalt with a shovel. The asphalt came apart with ease.
- c. Hand Checks: I pulled gently on portions of the asphalt lining that appeared to be in good shape and they flaked away under my fingers.

Two photographs below follow. The first is from the inspection on October 11<sup>th</sup>, 2022. The second is the same angle, photo from archives, on the dewatered aeration basin taken during biosolids removal in 2018.

Upon these findings the Transfer Pump Station was configured to permanently bypass the aeration basin. The Basin may experience water entering as the winter months approach, but the intent is to keep it clear of raw influent until further notice. The City expects that the transfer pumps can keep up with the expected peak winter flows, and the City does not believe equalization of raw sewerage in the basin should be required (peak influent flows observed are in the 9.0 MGD range, whilst the two large transfer pumps (Grundfos Model S3.45.A.1.20.1070.8) are plated to run Qmax of 9,827 gpm each which should be more than sufficient. A small amount of water is required to be left in the basin so that these Transfer Pumps do not cycle so much that they will burn up.
