RE: 2015 ANNUAL INFLOW & INFILTRATION REPORT

This report is to provide an annual summary of the actions the City of Molalla has taken for the 2015 calendar year in accordance with City's Inflow and Infiltration Assessment and Reduction Plan and NPDES Permit No. 101514.

2015 MOLALLA INFLOW & INFILTRATION REPORT

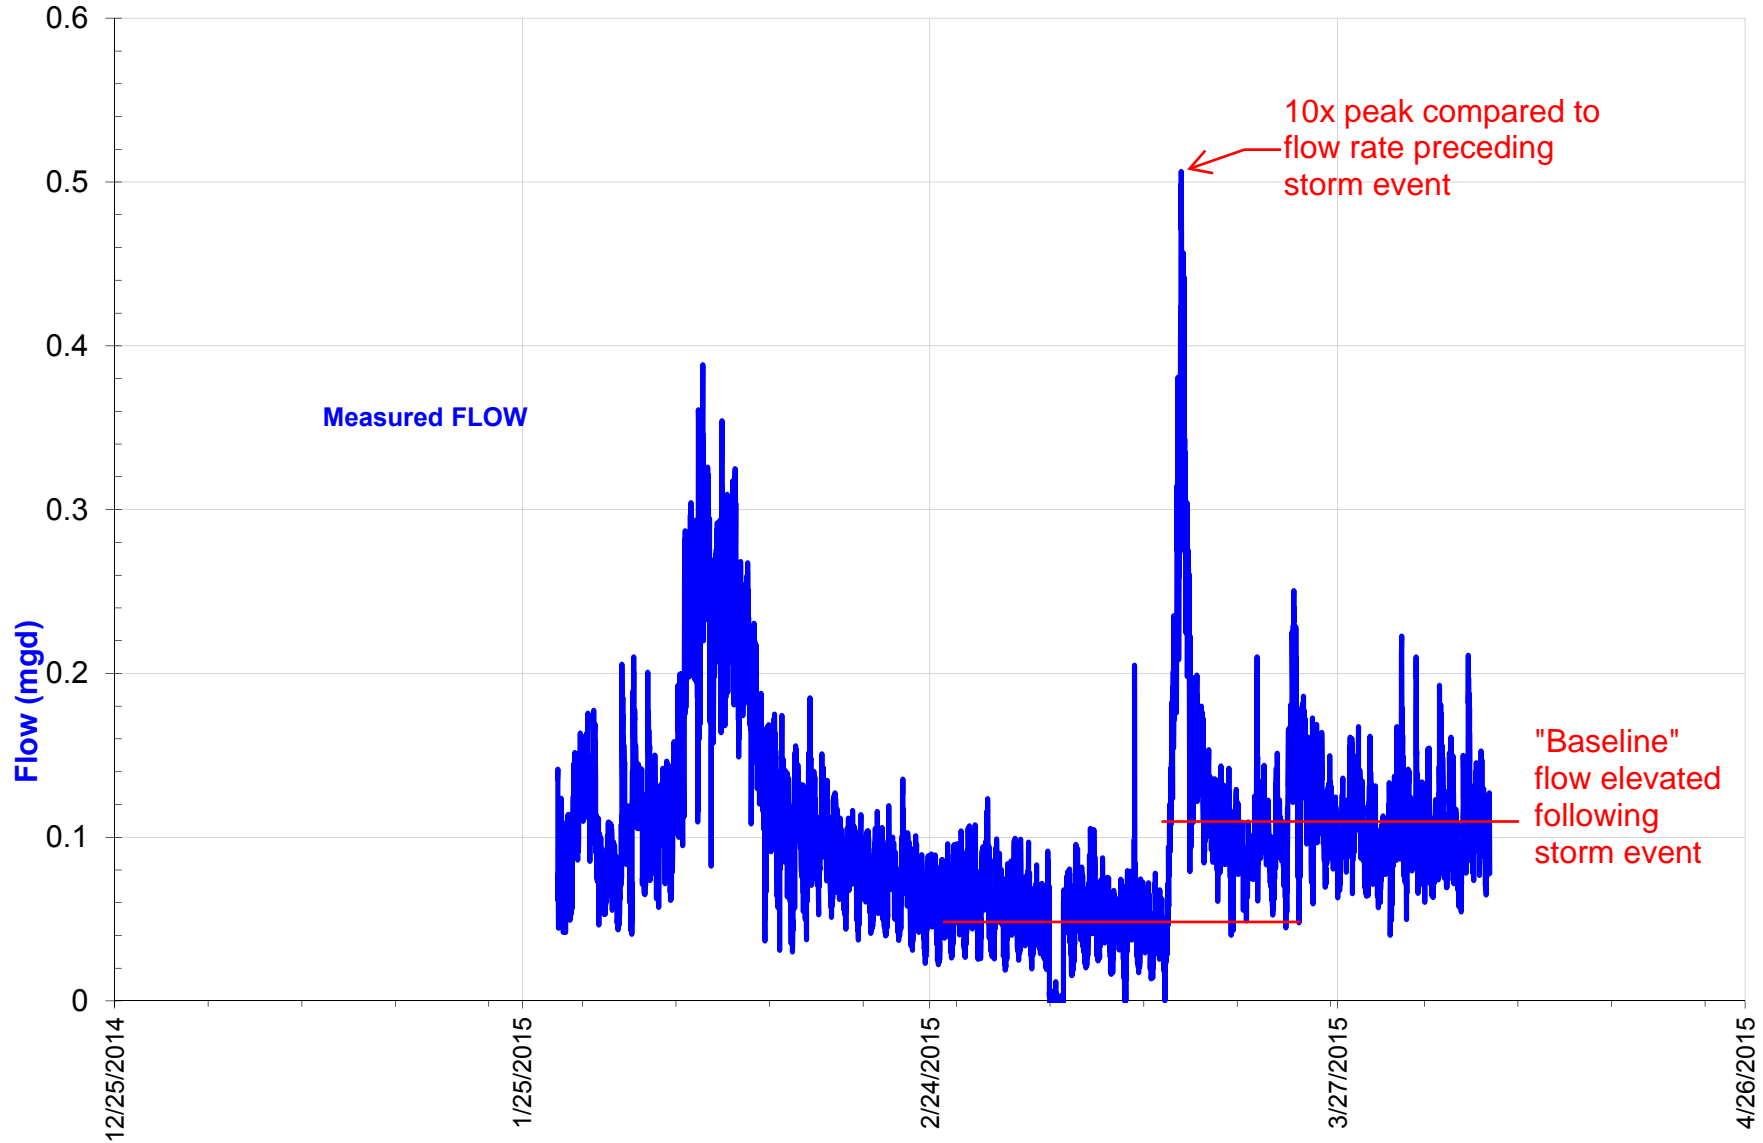
Peaking factors (peak flow rate compared to the average flow rate immediately preceding the storm) for the bigger storm on March 15.

- Flow Meter Site 002, Tolliver – 5x peaking factor
- Flow Meter Site 003, Pool and Sp'eah – 6x peaking factor
- Flow Meter Site 004, Grange – 10x peaking factor
- Flow Meter Site 005, Heintz – 6x peaking factor
- Flow Meter Site 006, Shirley – 9x peaking factor
- Flow Meter Site 007, Hwy 213 – 3x peaking factor
- Flow Meter Site 008, Molalla Ave – 6x peaking factor

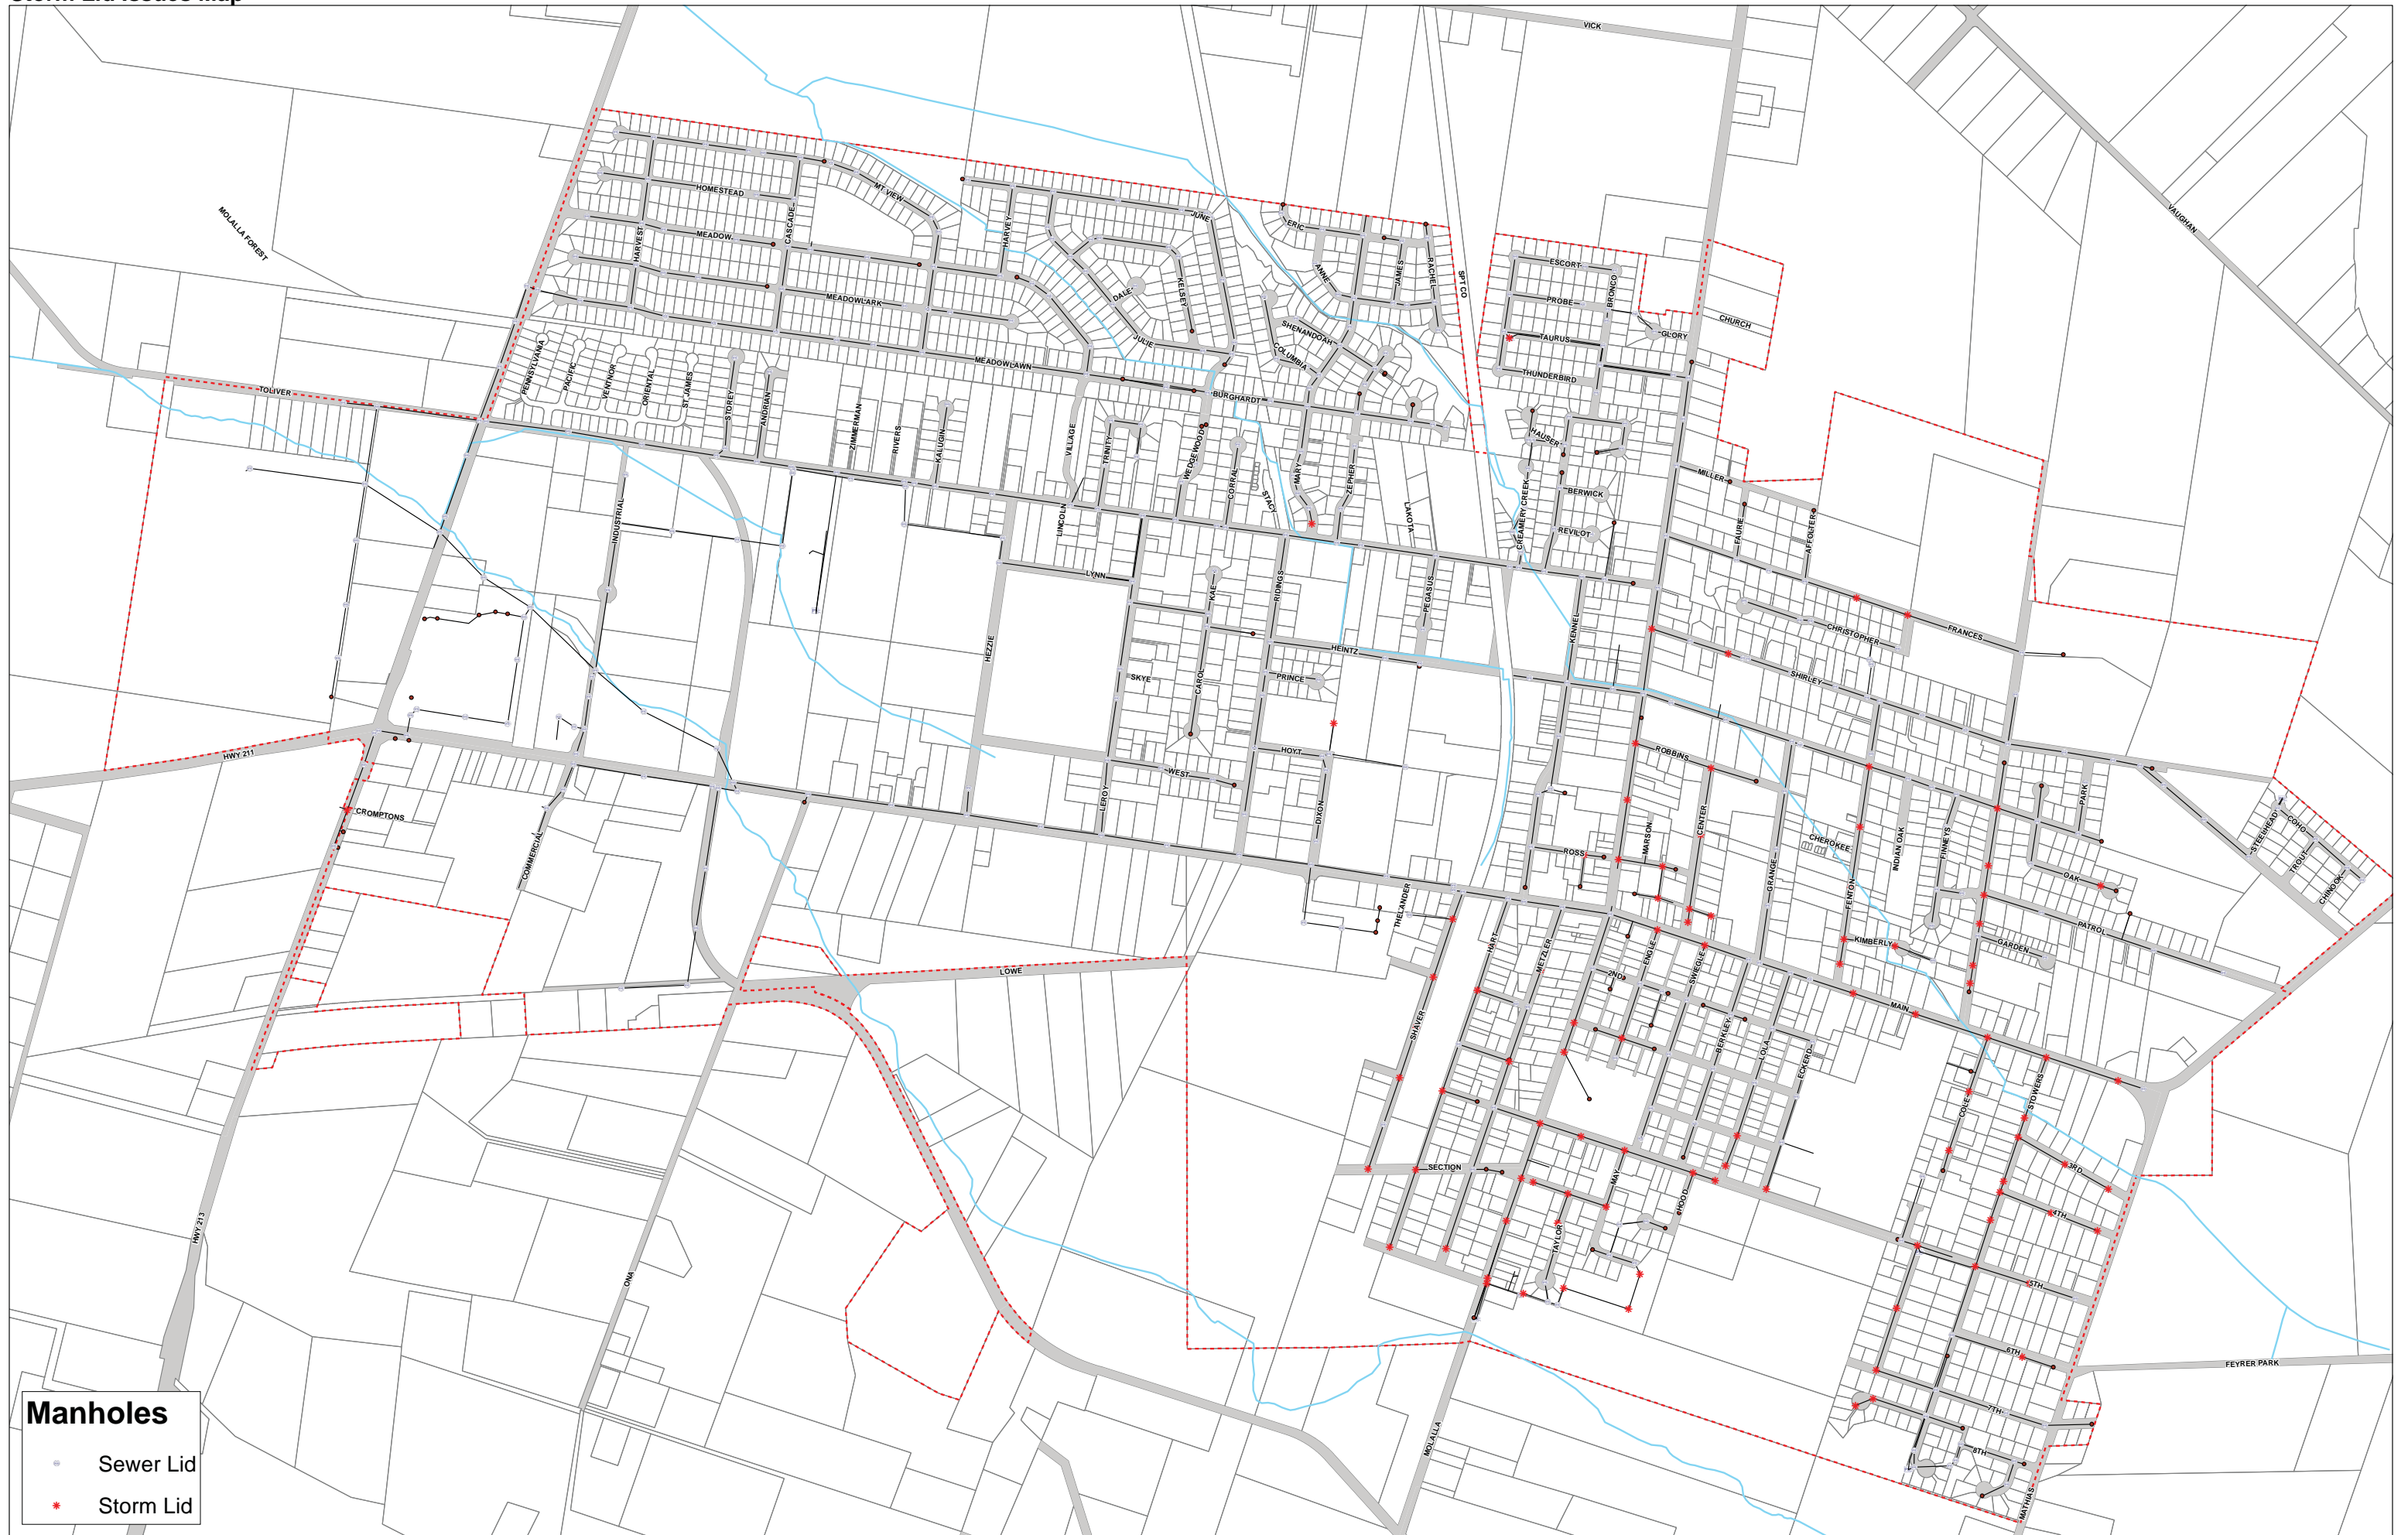
Manhole Lid Replacements	<p>In Early December, through review of the manhole inspection data, it was identified the City had approximately 114 sewer manhole with storm sewer lids and a small collection of storm manholes with sewer lids. The storm sewer lid locations were mapped, see Appendices. Storm sewer lids have 16 holes per lid, where sewer lids have only two (2) holes thus reducing the possibility of rain water entering the sewer system. To address this issue, public works identified all the non-conforming sewer lid locations on a map and swapped storm for sewer lids wherever possible. Next the city purchased 96 sewer lids and replaced the storm lids. This is a simple project, but an effective way to simply minimize inflow into the sewer collections system.</p>	100%
--------------------------	----------------------------------------------------------------------------------------------------------------------------------------------------------------------------------------------------------------------------------------------------------------------------------------------------------------------------------------------------------------------------------------------------------------------------------------------------------------------------------------------------------------------------------------------------------------------------------------------------------------------------------------------------------------------------------------------------------------------------------------------------------------------------------	------
