**Public Works Department**  
117 N Molalla Avenue  
PO Box 248  
Molalla, Oregon 97038  
Phone: (503) 829-6855  
Fax: (503) 829-3676

**RE: 2016 ANNUAL INFLOW & INFILTRATION REPORT**

## 2016 MOLALLA INFLOW & INFILTRATION REPORT

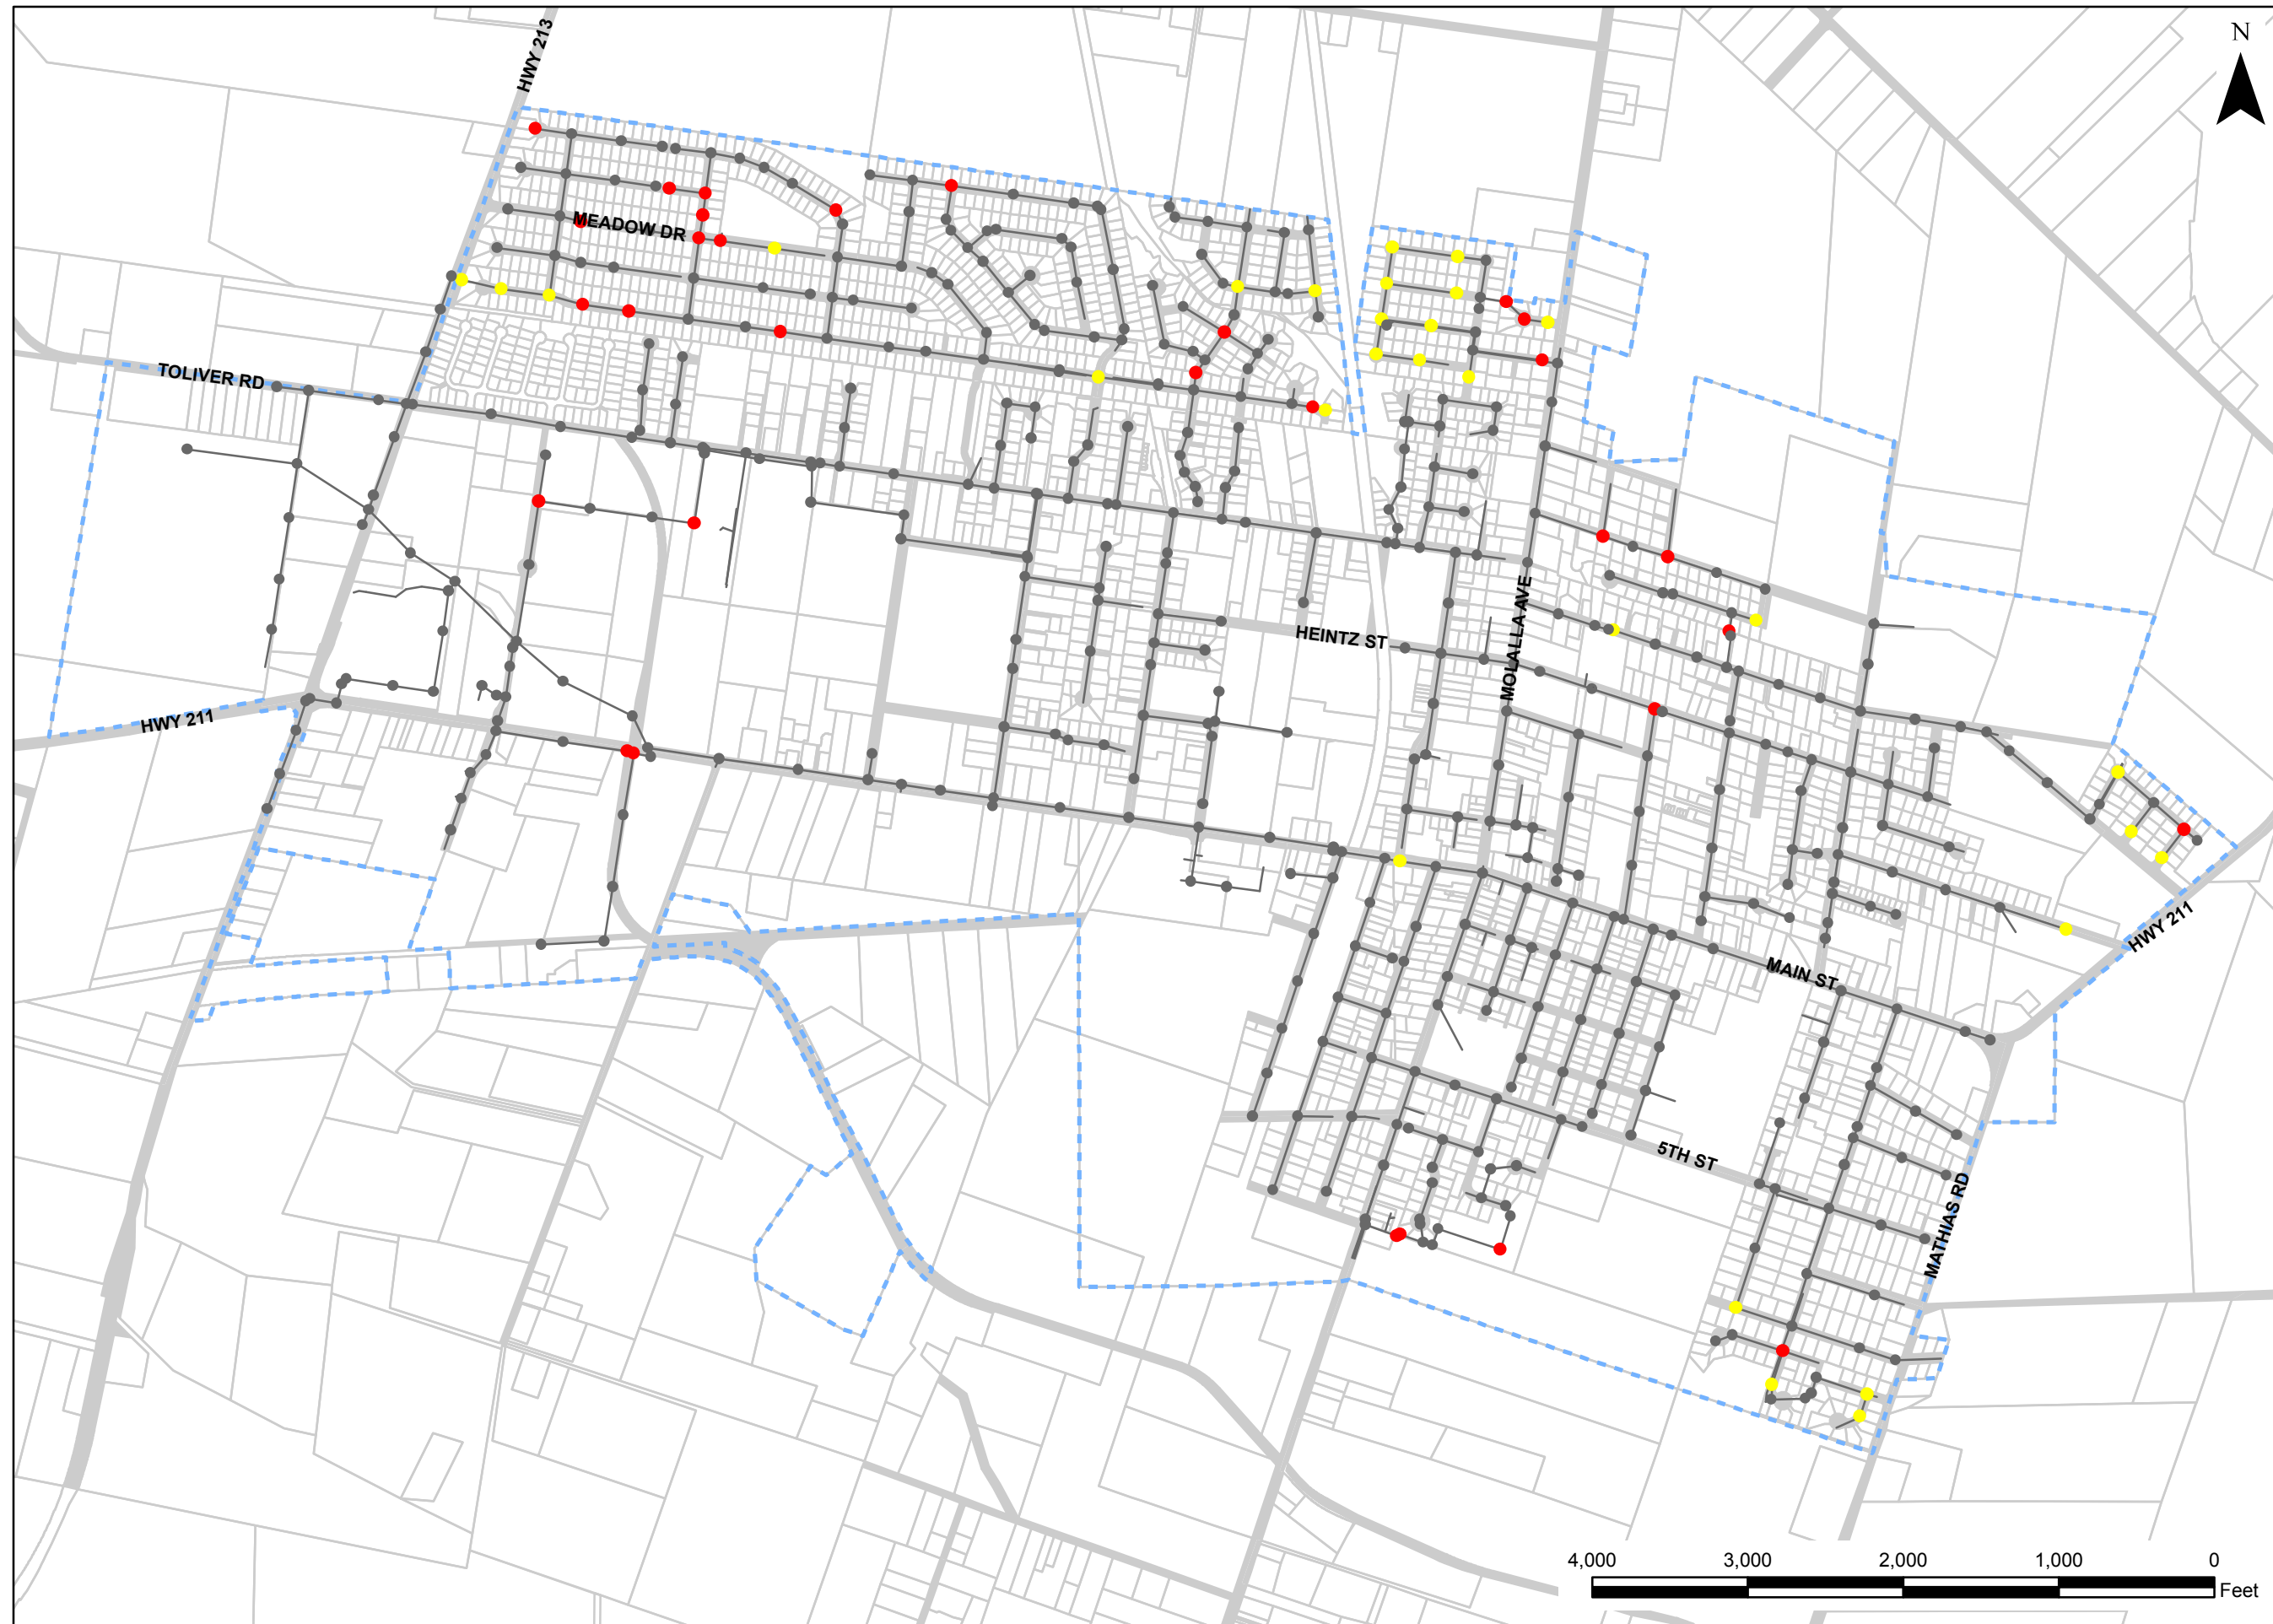
**Appendix A:**  
Summer Manhole  
Infiltration

| Project/Task | Description & Information |
|---|---|
| Manhole Inspections | Public Works inspected and evaluated the condition of its sanitary sewer manholes between June and August of 2016 to identify summer infiltration. All of the City's five hundred-twenty nine manholes were assessed for defining characteristics, current condition, and I/I assessment during low groundwater conditions. The crew found thirty-one (31) manholes with significant infiltration and twenty-nine (29) with minor infiltration. These manholes will be scheduled for repairs in the spring/summer of 2017 pending an acceptable bid and adequate budget. Mapping of these manholes was completed in September 2016 with a wet-season inspection planned for the winter of 2017. A map showing summer infiltration has been provided in the Appendix A. |

- Major Infiltration (31)
- Minor Infiltration (29)
- No Infiltration Observed

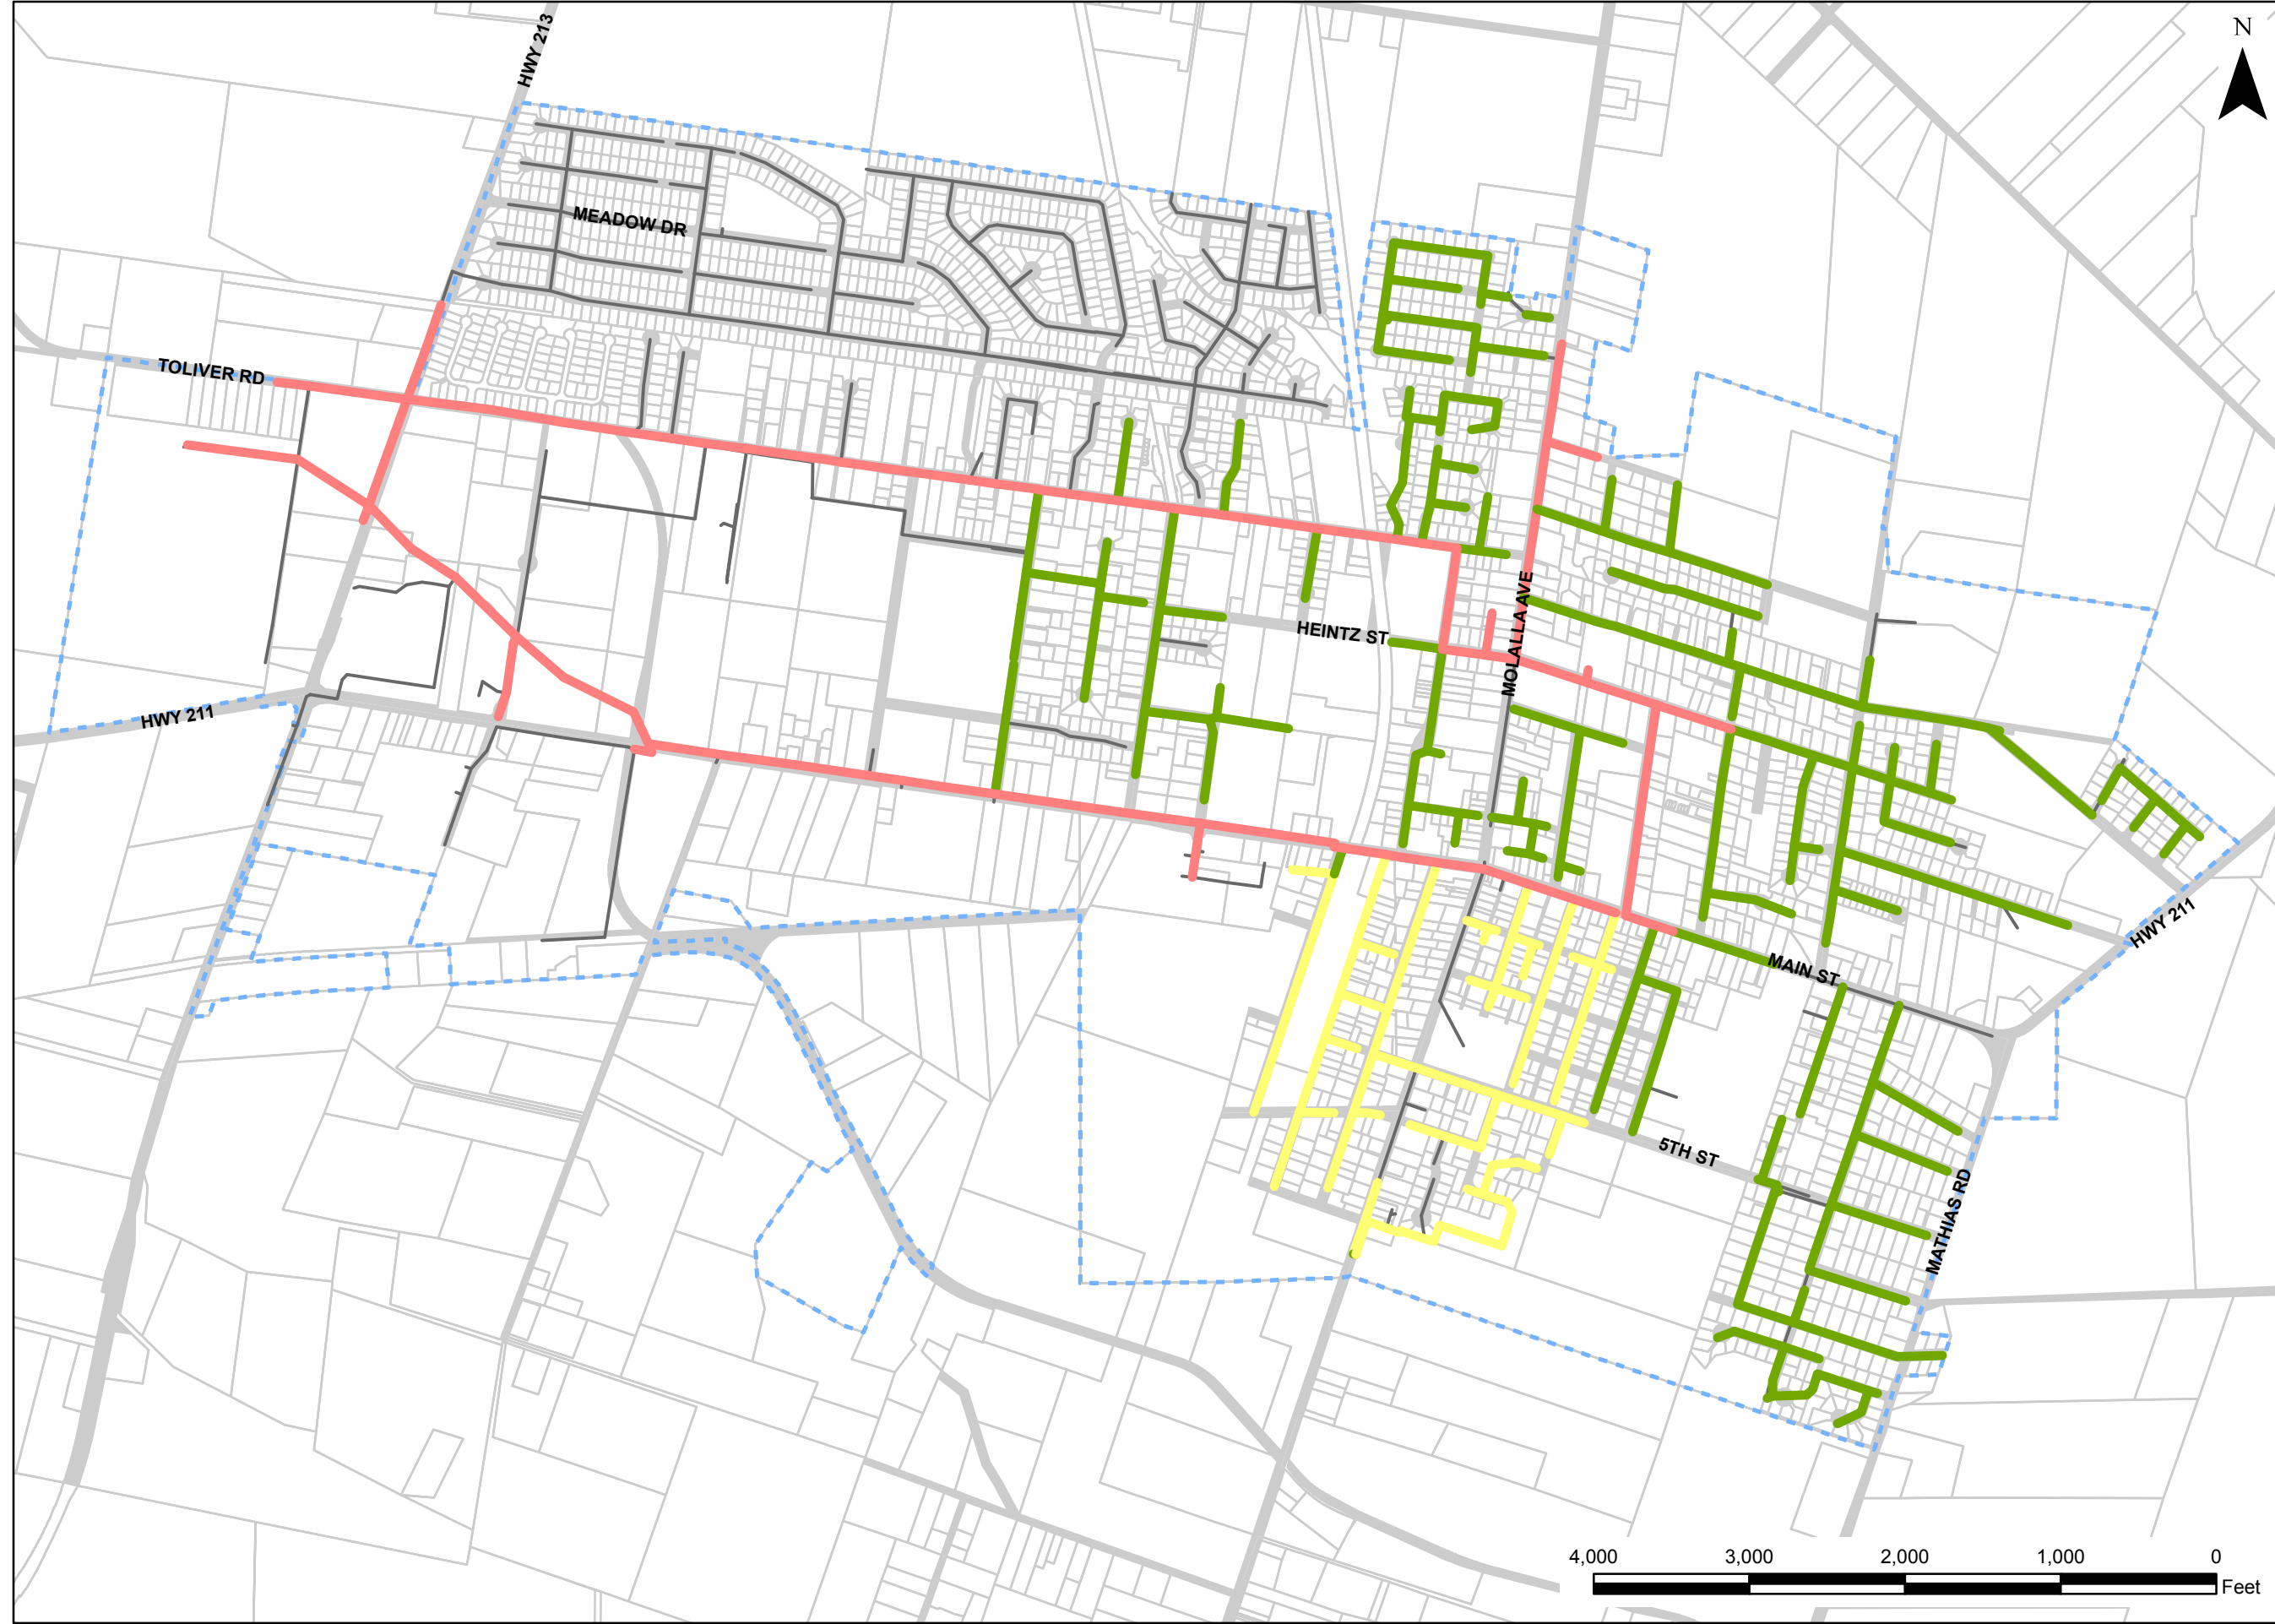
**Appendix B:**  
Modified Sewer Video Map

| Project/Task | Description & Information |
|---|---|
| System Assessment | With the change in staffing at the Director level, a review of the work to date identified issues related to cleaning and inspecting the sewer trunk along Toliver Road. The amount of I&I flowing into the trunk line made it impossible to video this line and determine its condition. Cleaning and video inspection efforts were refocused on the upper reaches of the Toliver and Bear Creek basin to identify repair needs that would allow the City to effectively reduce the I&I within these basins. A reduction in I&I would then allow the City to clean and video the Toliver and Bear Creek trunk lines at a future date. A map showing revised cleaning and inspection priorities has been provided in the Appendix B. Additional lines are drawn in light yellow and the removed lines are drawn in light red. |

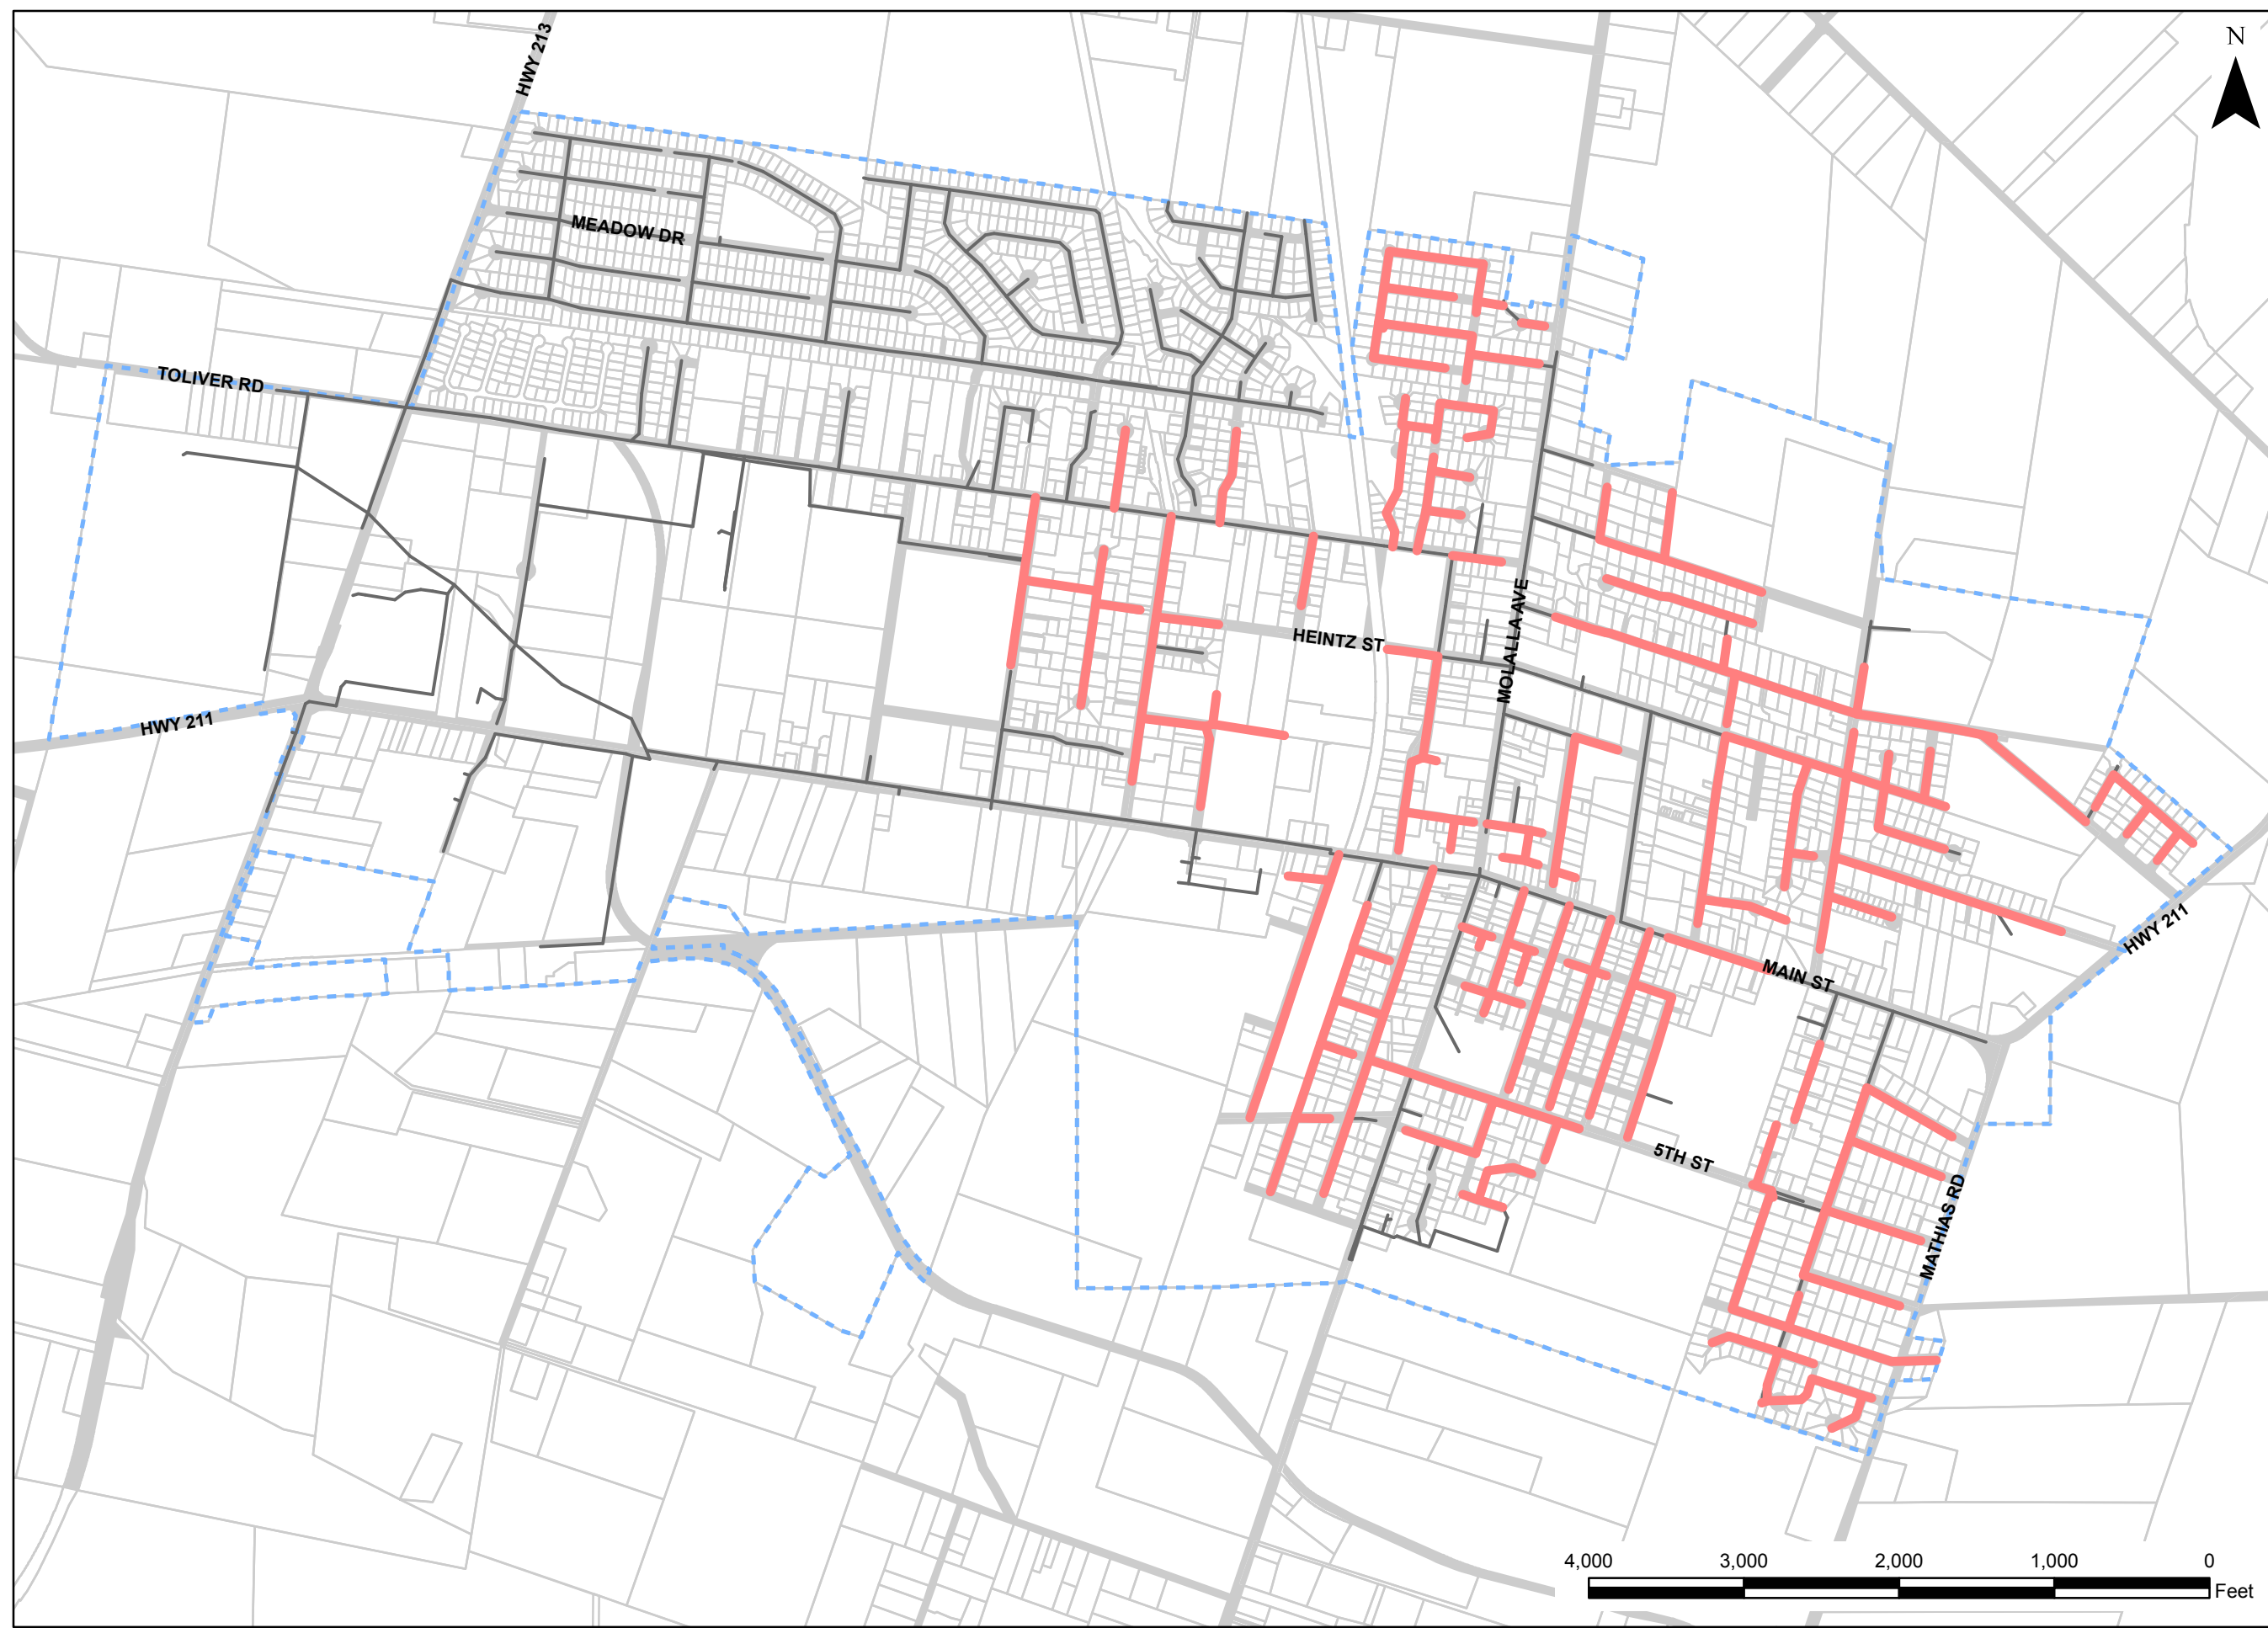
**Appendix C:**  
Sanitary Mains Cleaned

| Project/Task | Description & Information |
|---|---|
| Sewer Line Cleaning | To prepare for CCTV inspection work, City crews began an aggressive sewer line cleaning program in the month of January 2016. To date, 65,790 linear feet of sewer line has been cleaned. A map showing the lines cleaned to date has been provided in the Appendix C. |

Total Inspected Lines:  
65,790 LFT

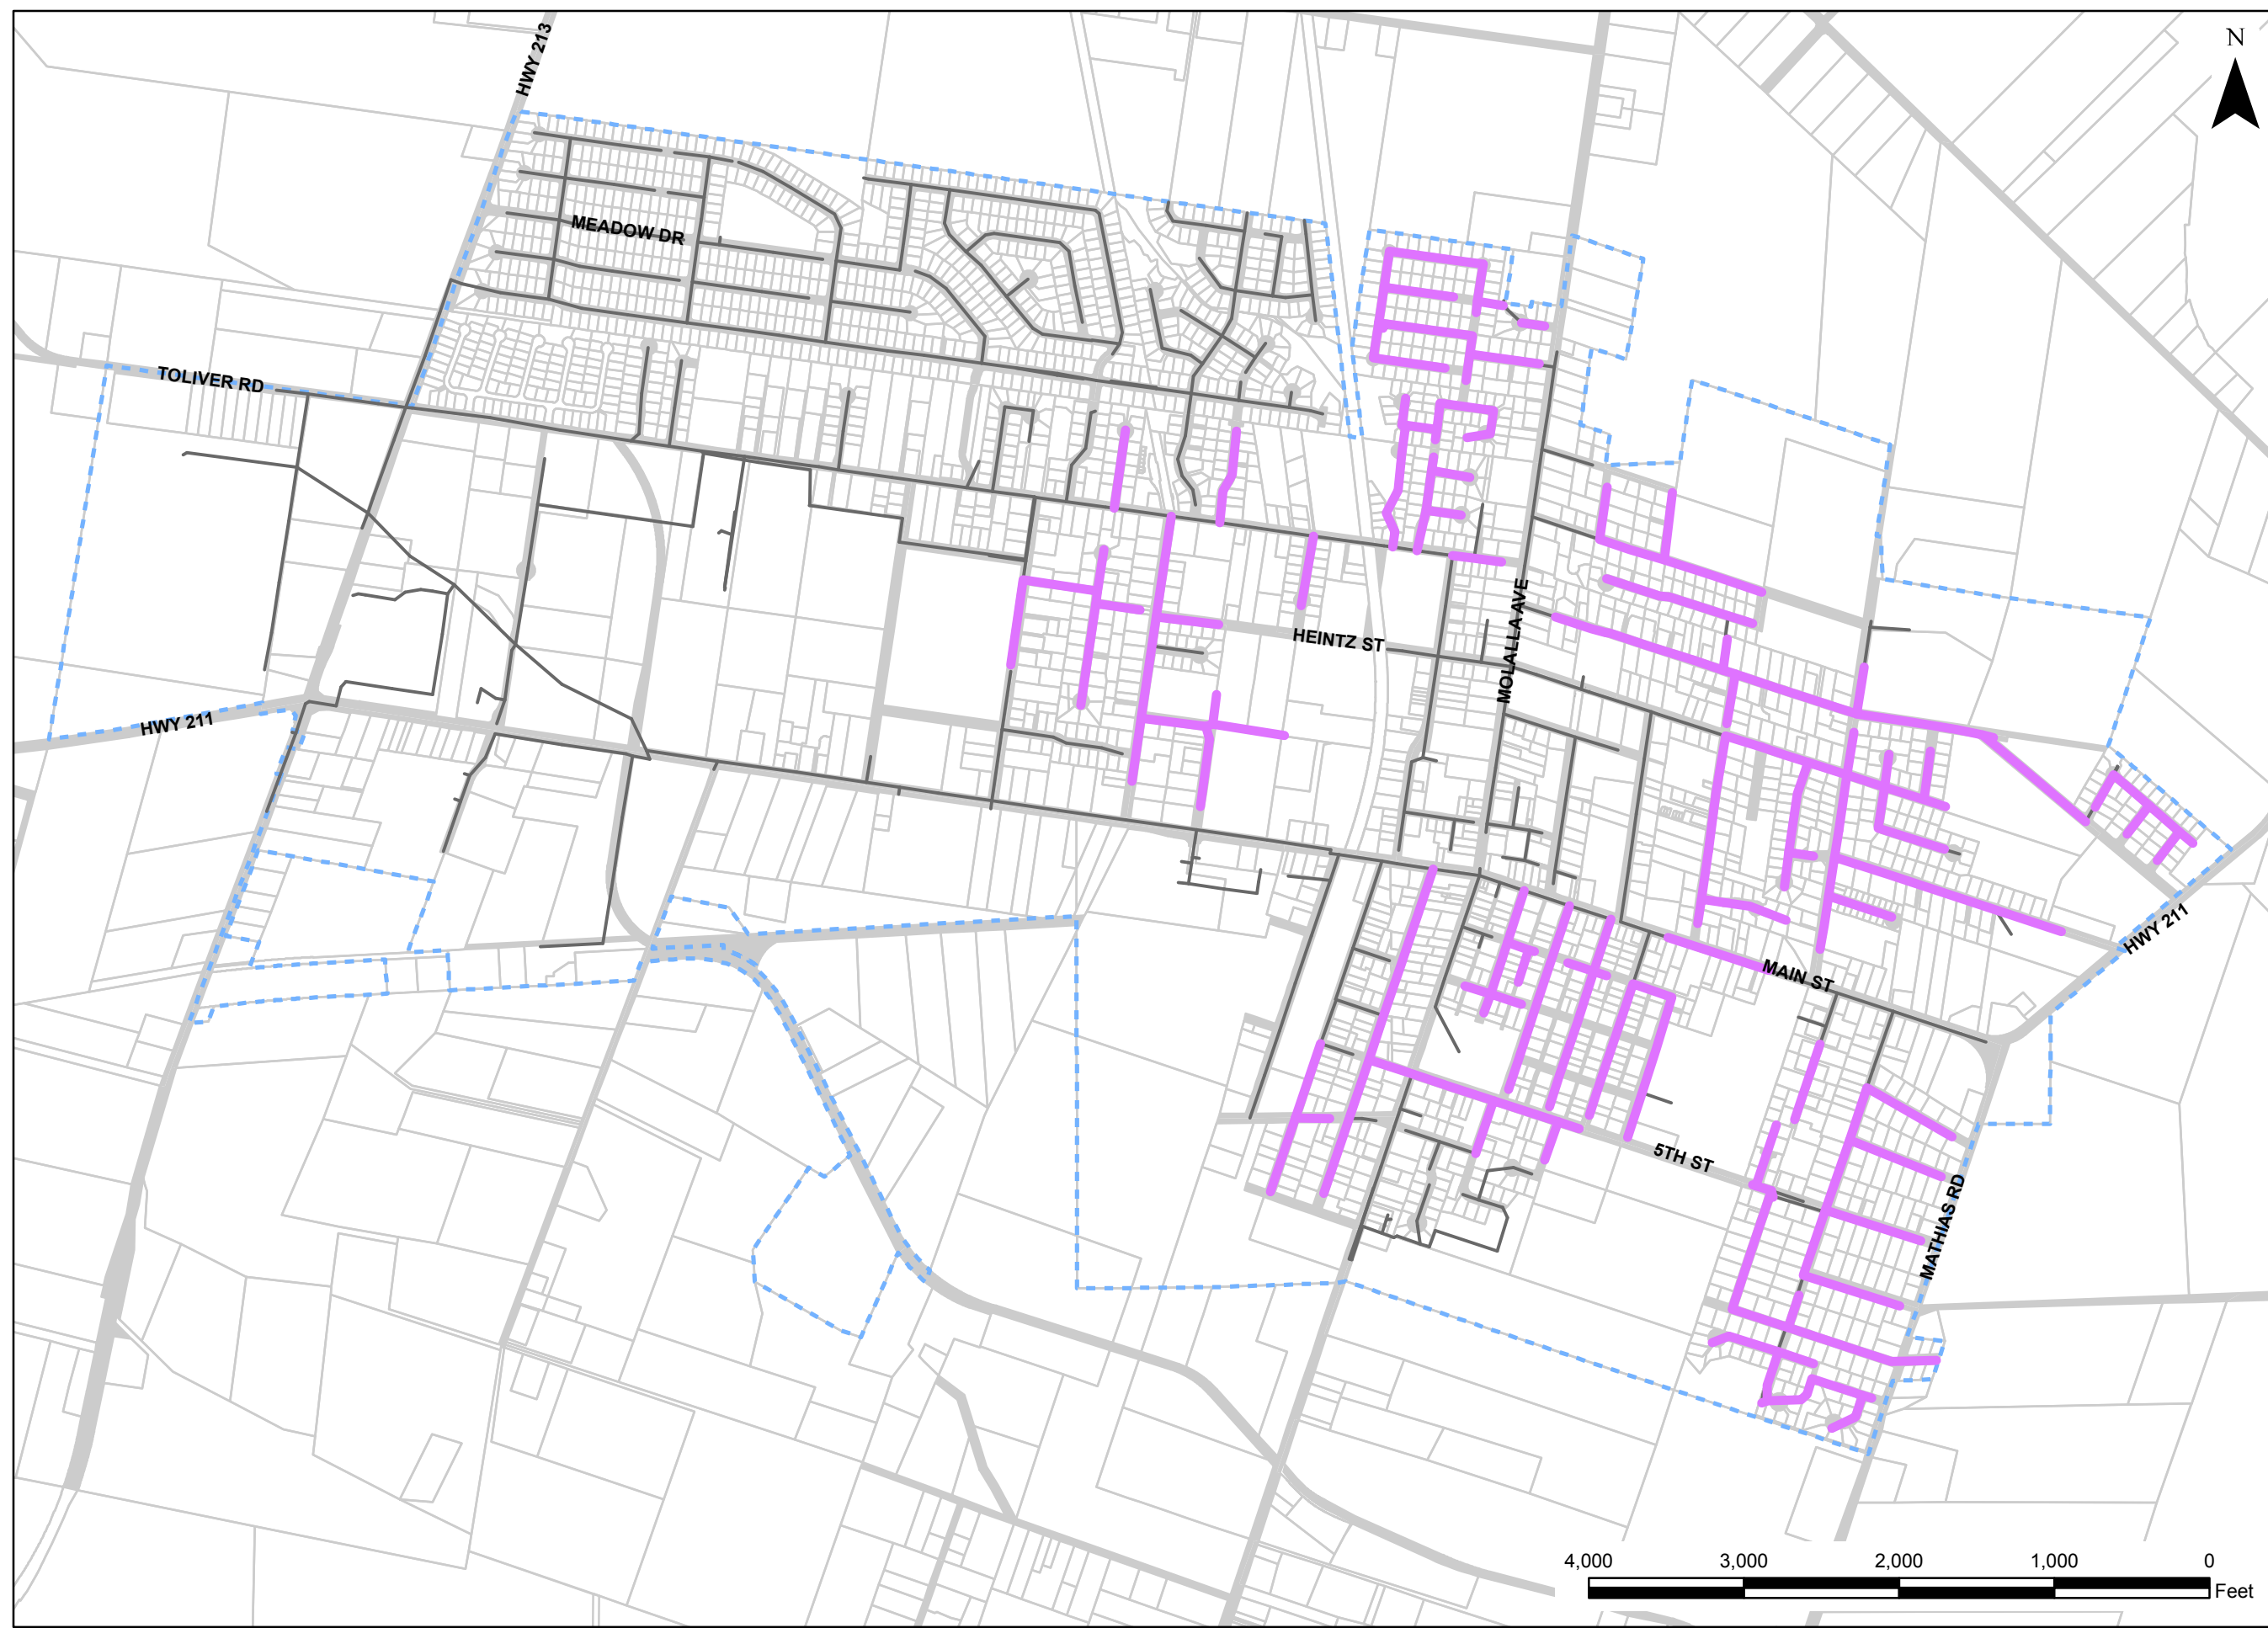
**Appendix D:**  
*Sanitary Mains Inspected*

| Project/Task | Description & Information |
|---|---|
| CCTV Inspections | As sewer lines were cleaned, that information was relayed to Pacific INT-R-TEK to video inspect each cleaned line and report on the condition of the sanitary sewer lines. To date, the CCTV crew has inspected 55,011 linear feet of pipe. As Pacific INT-R-TEK completes its inspections and reporting, the City will begin prioritizing and budgeting areas for repair and replacement of compromised lines. A map showing lines inspected to date has been provided in the Appendix D. |

Total Inspected Lines:  
55,011 LFT
