Public Works Department

RE: 2017 ANNUAL INFLOW & INFILTRATION REPORT

This report provides an annual summary of the actions the City of Molalla has taken for the 2017 calendar year in accordance with City's Inflow and Infiltration Assessment and Reduction Plan and NPDES Permit No. 101514.

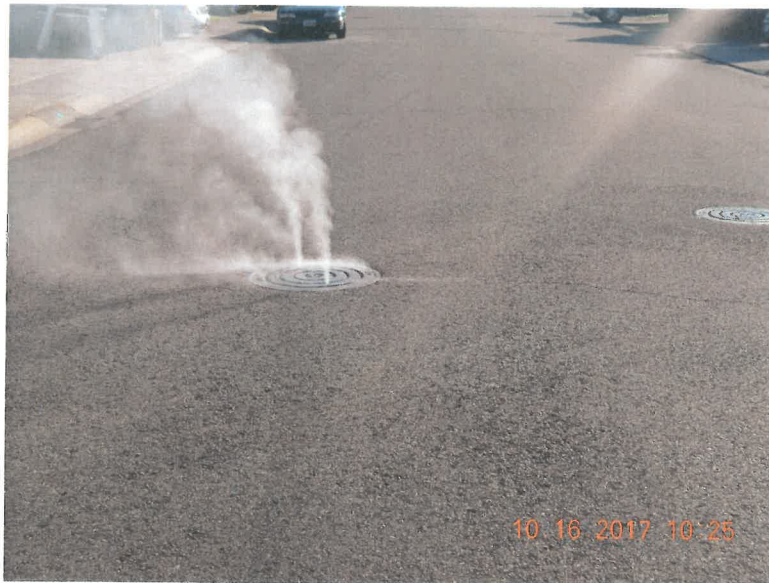
- Smoke coming from crack in road next to the manhole

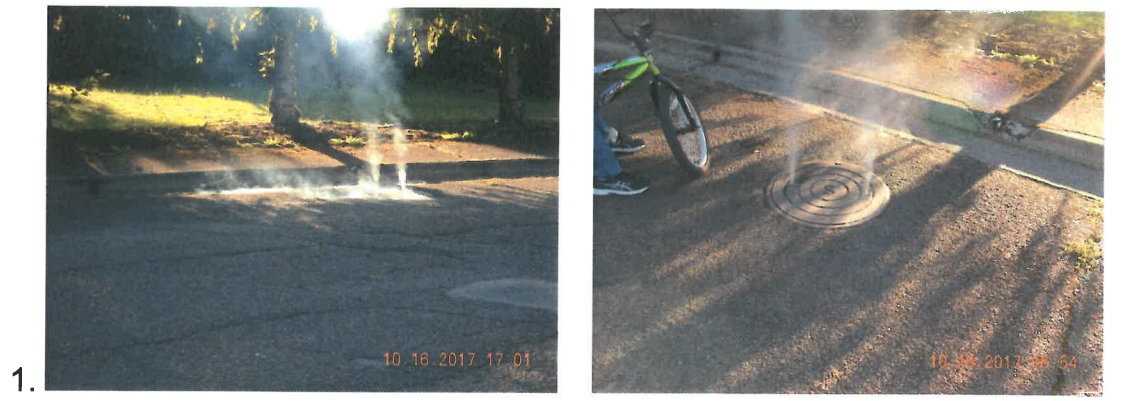
- Smoke leaky out around the rim of the manhole, the cracks in the road around the manhole and along the joint between the ac pavement and concrete gutter
-
-
-
-

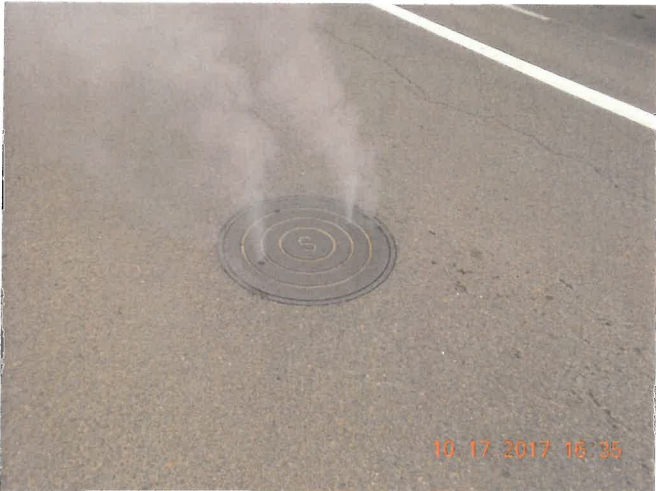
- Smoke leaking around rim of manhole
-
-
-
-
-

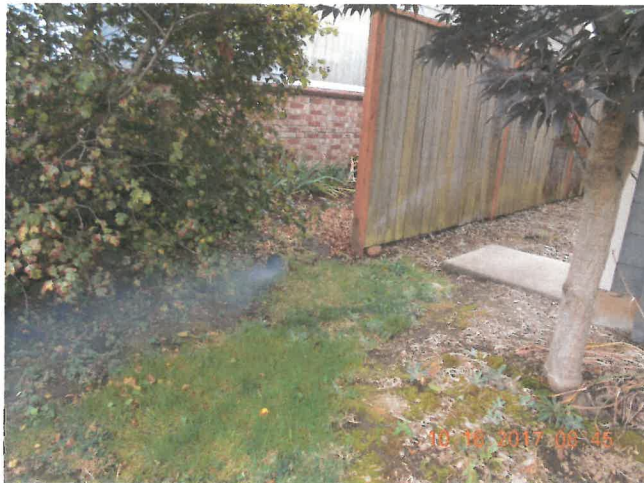
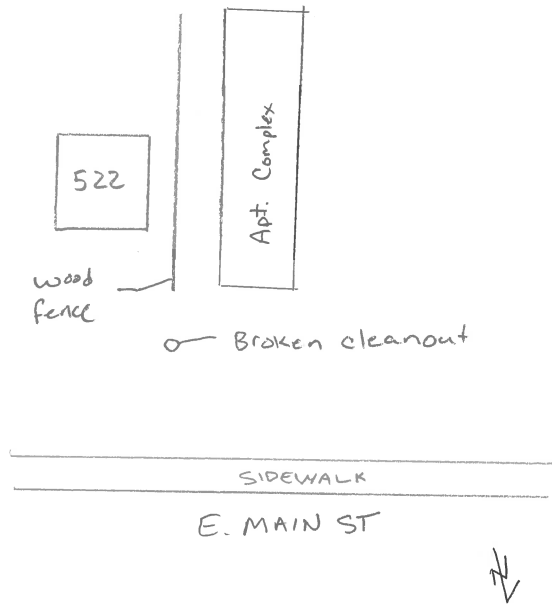
- Smoke coming out of broken cleanout
-
-
-
-
-

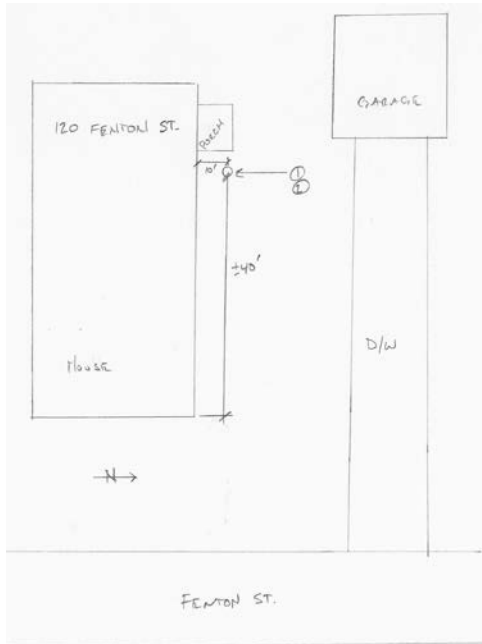
- Smoke from cleanout area. It appears the area is currently under repair/construction.
-
-
-
-
-

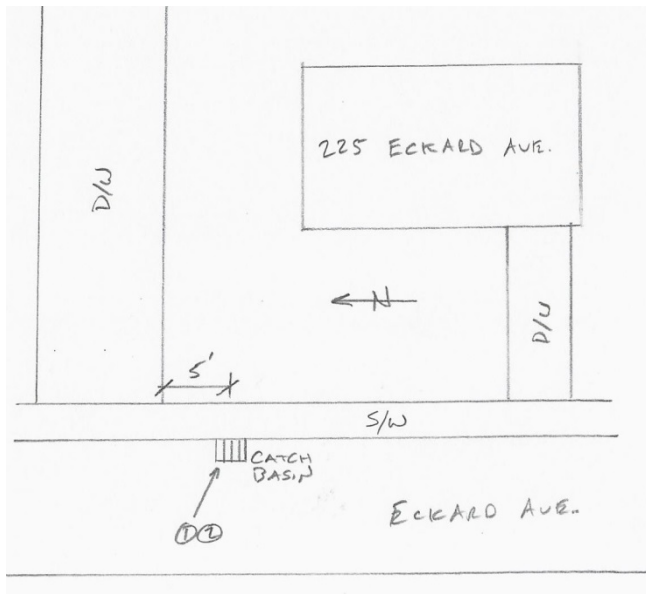
- Smoke coming from catch basin and crack in the concrete curb behind the catch basin on the east side of Eckerd Ave, approximately 75' south of manhole TL_A_21.

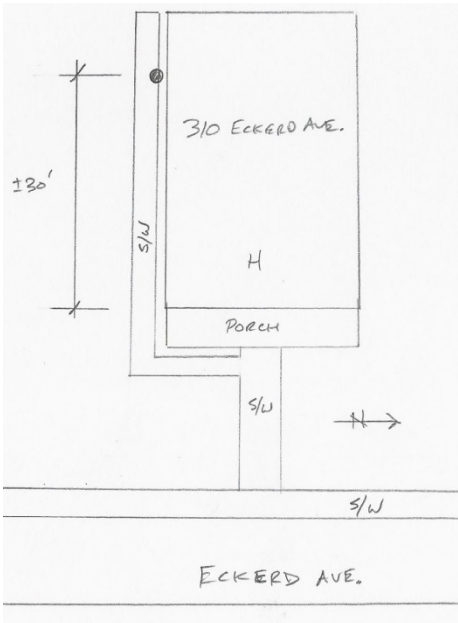
- Smoke from cleanout area. Could not confirm if the cap was broken or missing.
-
-
-
-
-

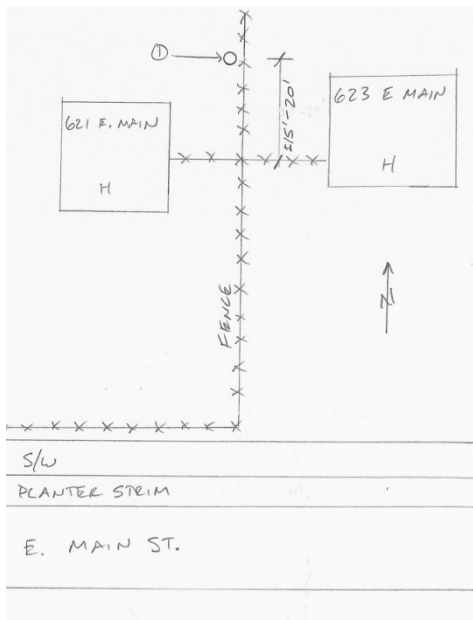
- Smoke from fence line, between backyards of 621 and 623 Main St.
- Could not confirm broken or uncovered cleanout.
-
-
-

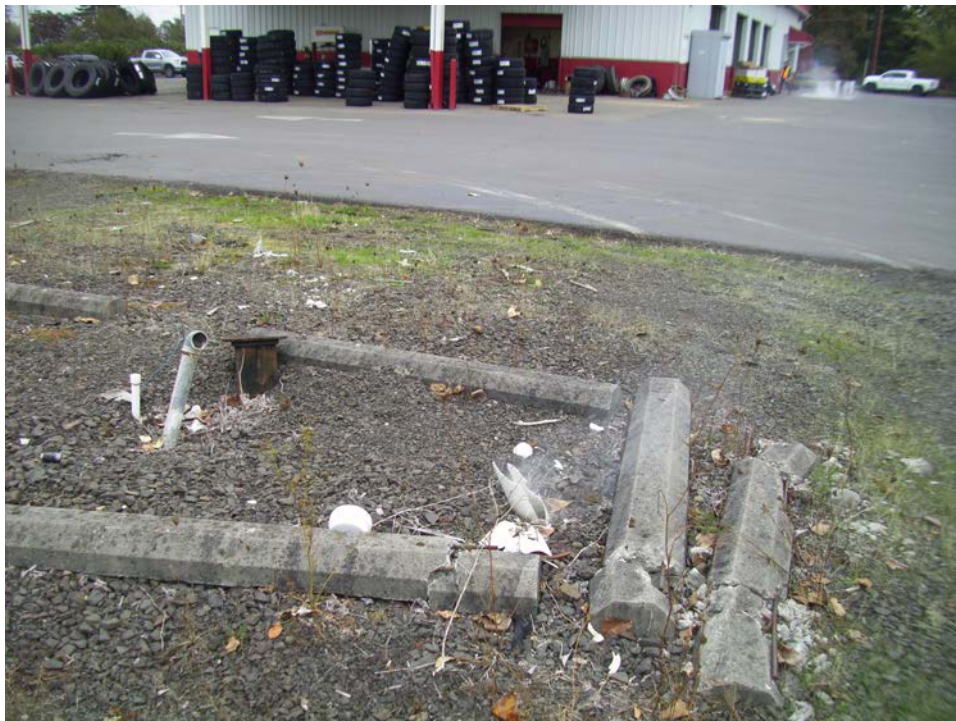
- Broken cleanout pipe.
-
-
-
-

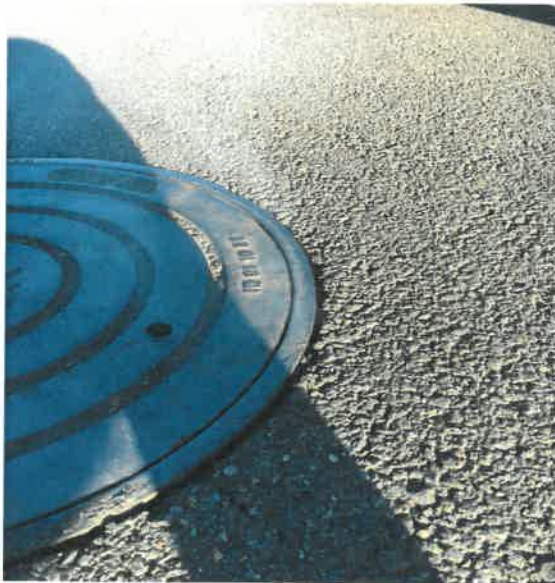
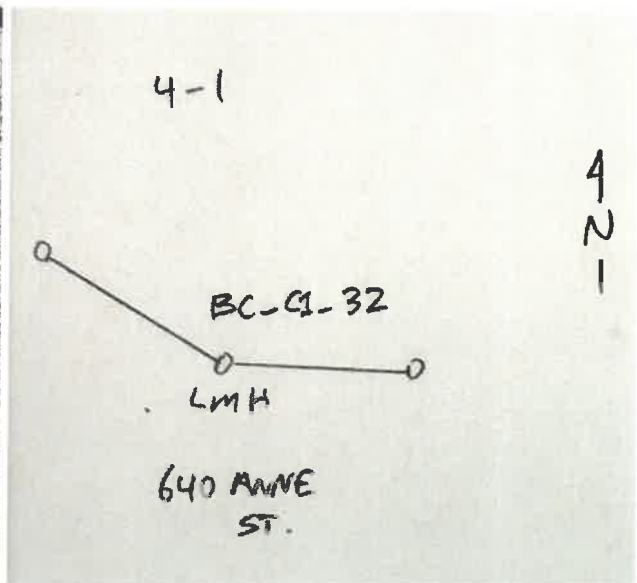
- Leaking around manhole rim.
-
-
-
-

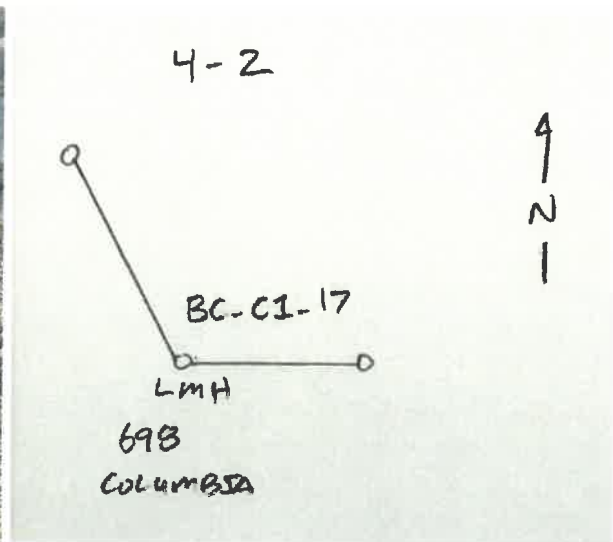
- Leaking around manhole rim.
-
-
-
-
-

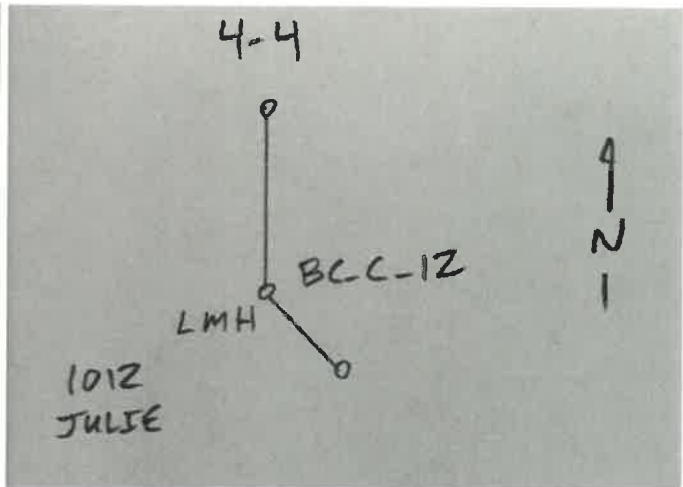
- Leaking around manhole rim.
-
-
-
-
-
