**Public Works Department**

**RE: 2018 ANNUAL INFLOW & INFILTRATION REPORT**

This report provides an annual summary of some of the more important I/I reduction actions the City of Molalla has taken for the 2018 calendar year, in accordance with City's Inflow and Infiltration Assessment and Reduction Plan and NPDES Permit No. 101514.

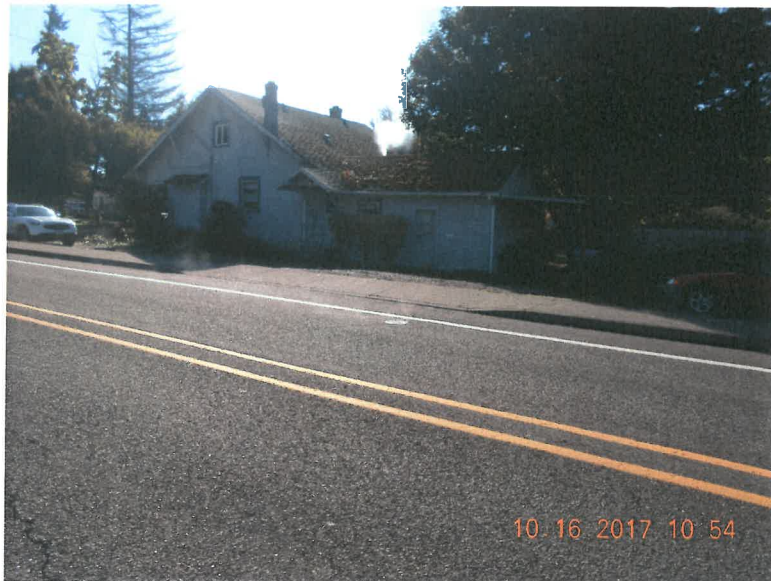
- Smoke coming from around the rim of the cleanout
- \_\_\_\_\_
- \_\_\_\_\_
- \_\_\_\_\_
- \_\_\_\_\_
- \_\_\_\_\_

Repaired on WO#908

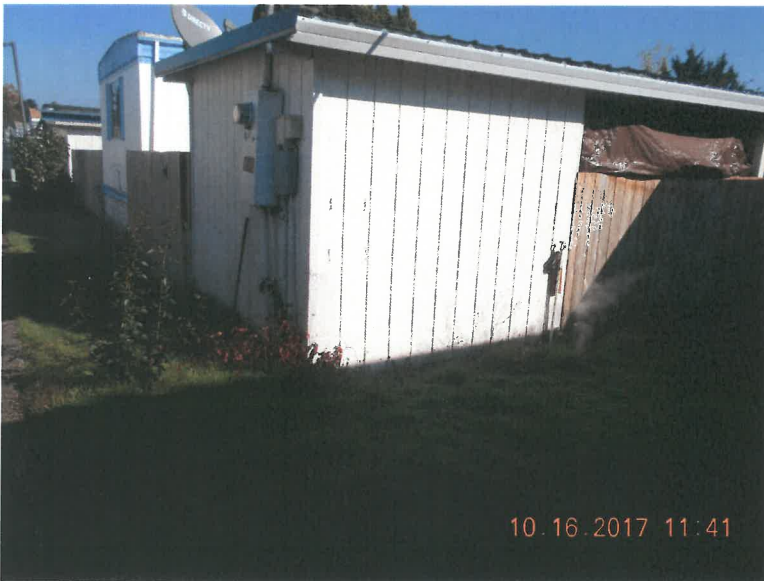
- Located at Unit #723 of Twin Firs Mobile Home Park
- Smoke coming from open cleanout, located behind the shed
- Smoke coming out of broken cleanout cap on the side of the shed
- 
-

Repaired on WO#908

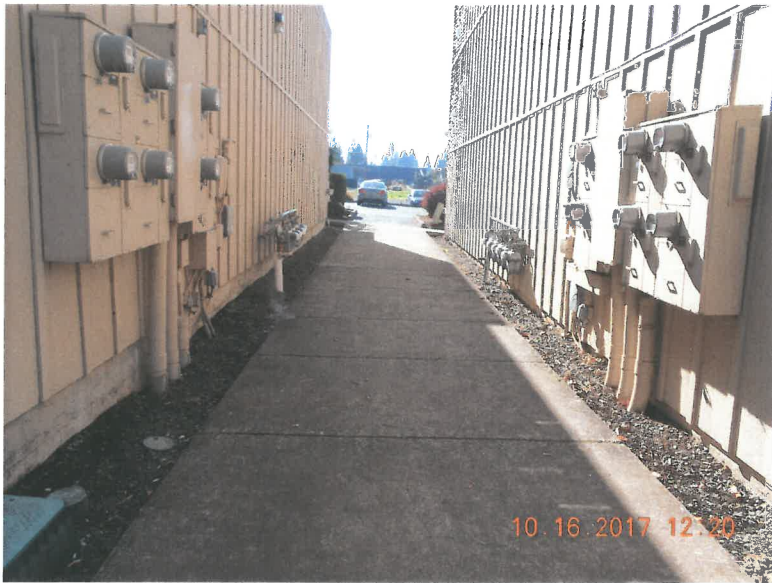
- Smoke coming from cleanout cap,
- Located in the sidewalk along the west wall of building 270 N. Molalla (Just In video)
- 
- 
-

Repaired on WO#908

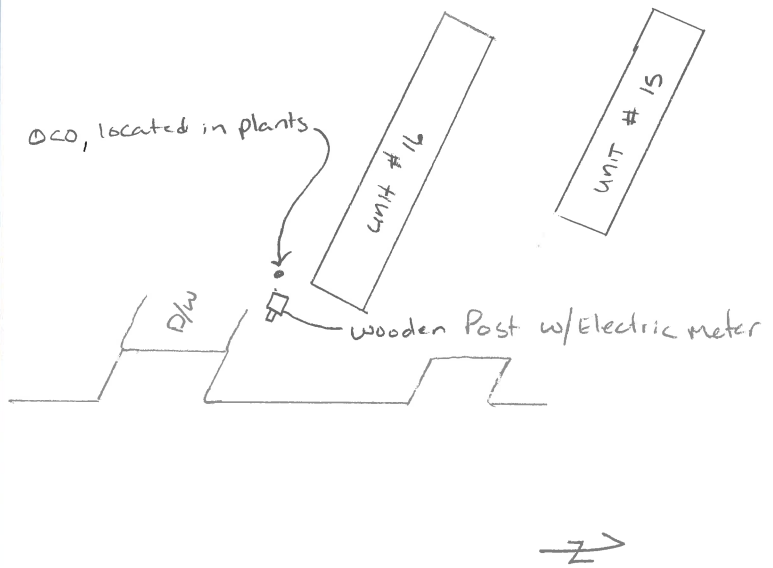
- Smoke coming from open cleanout with no cap
- Located in Molalla Mobile Manor
- 
- 
-

Repaired on WO#908

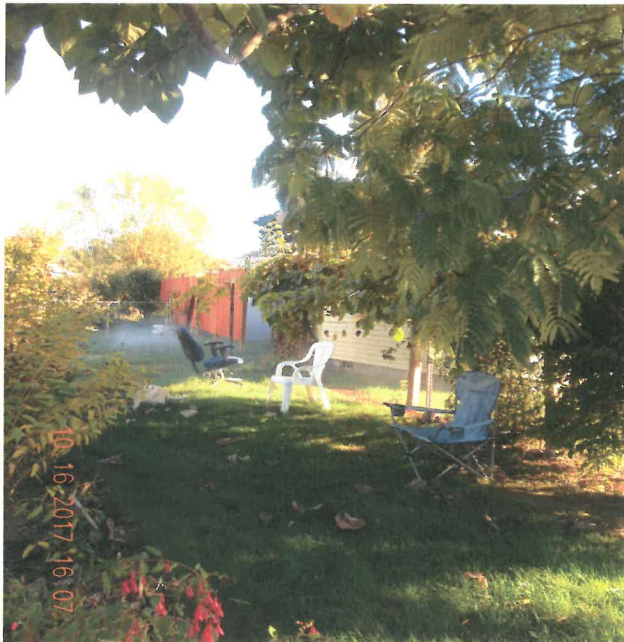
- Smoke coming behind the fence, could not identify the source.
- 
- 
- 
- 
-

Repaired on WO#908

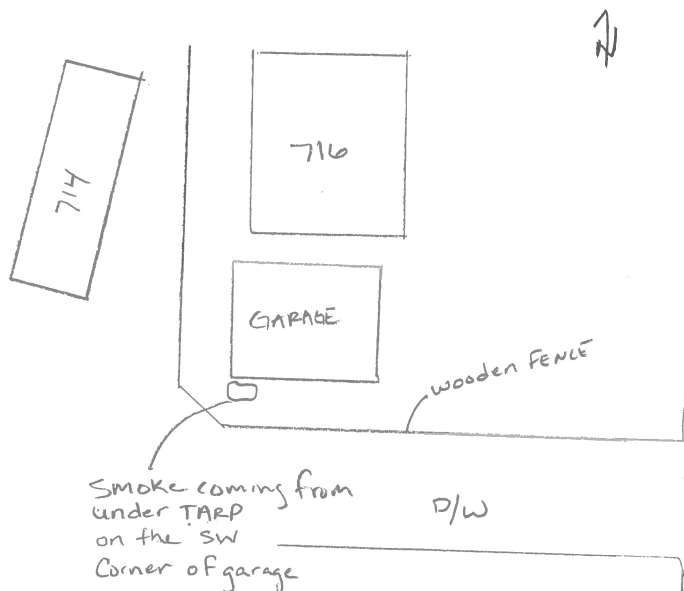
- Smoke coming out from under the tarp on the southwest corner of the garage
- 
- 
- 
- 
-

Repaired on WO#956

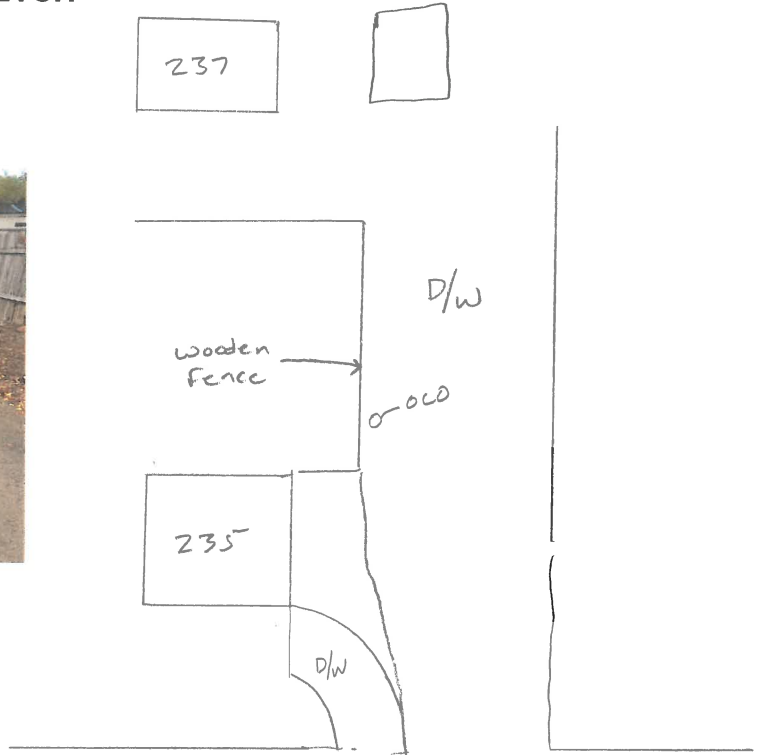
- Smoke coming out of cleanout with no cap
- 
- 
- 
- 
-

Repaired on WO#956

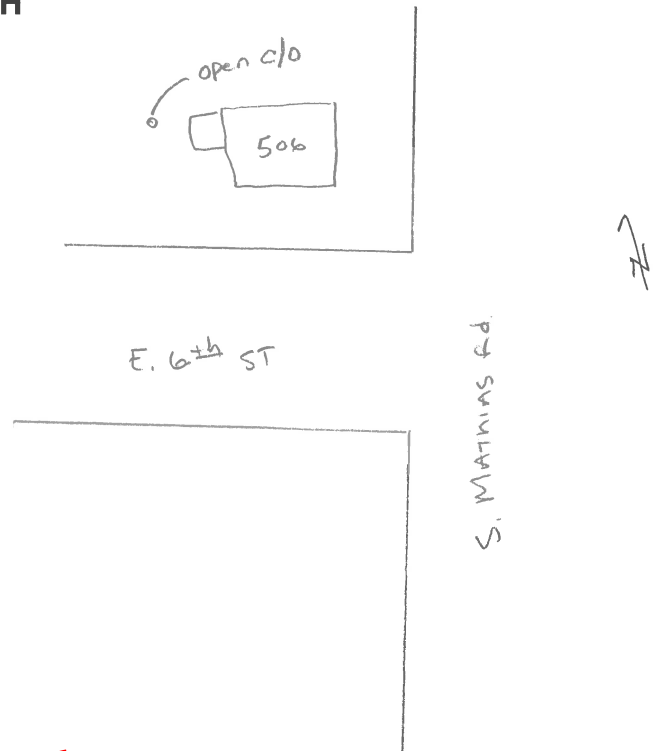
- Smoke coming out of cleanout with no cap
- 
- 
- 
- 
-

Repaired on WO#956

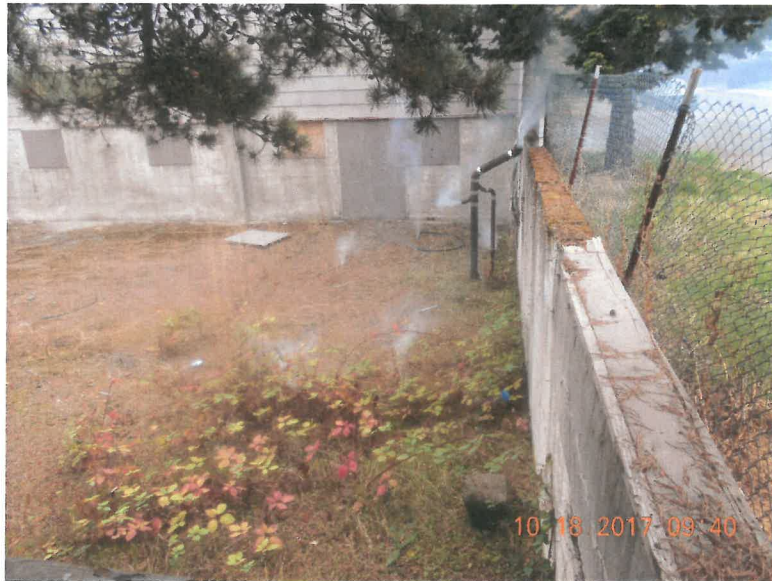
- Vacant lot - has multiple open pipes and multiple area where smoke was coming from the ground.
- \_\_\_\_\_
- \_\_\_\_\_
- \_\_\_\_\_
- \_\_\_\_\_
- \_\_\_\_\_

Repaired on WO#1038

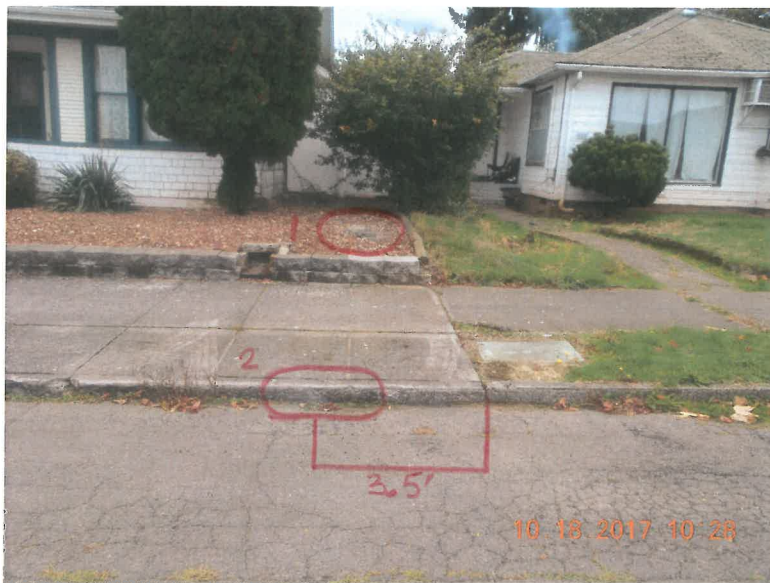
- Smoke coming out of open cleanout with chunks of concrete covering it up. Smoke coming out at the joint of the AC pavement and the curb.
- 
- 
- 
-

1. Smoke from open cleanout
2. Smoke from joint between road and curb,

Repaired on WO#1038

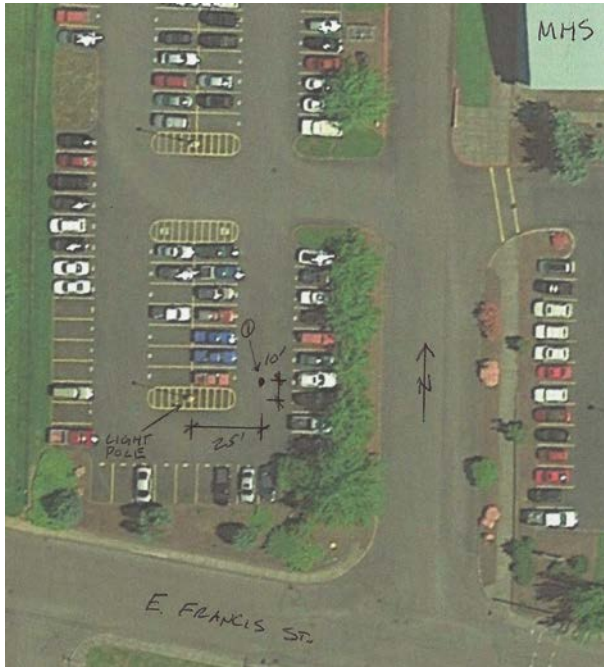
- Smoke coming from cleanout in the southwest parking lot of Molalla High School.
- 
- 
- 
-

Repaired on WO#1384

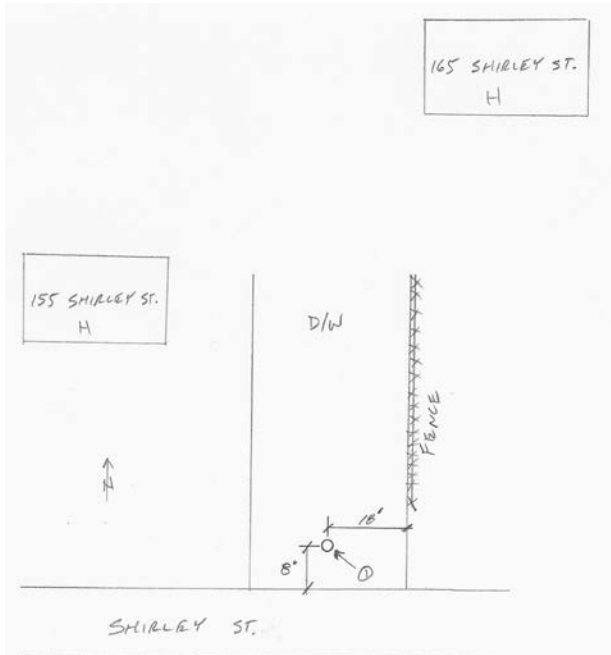
- Smoke coming from cleanout in the driveway serving flag lots at 165 Shirley St.
- 
- 
- 
- 
-

Repaired on WO#1384

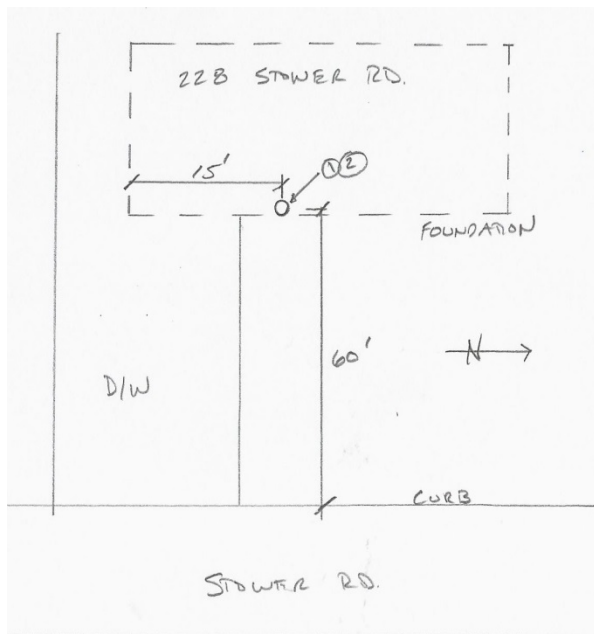
- House has been removed. Smoke from uncovered sewer connection in foundation.
- 
- 
- 
-

Repaired on WO#1529

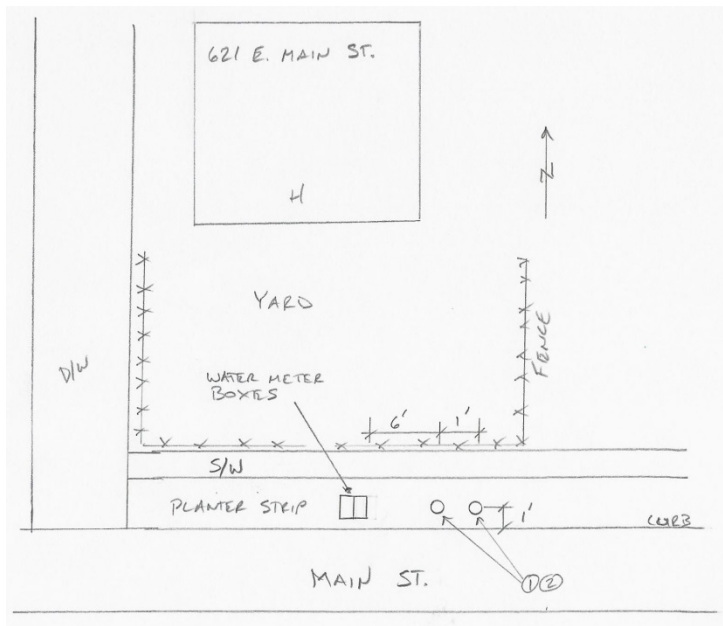
- Smoke from two, adjacent cleanout covers, in beauty strip grass in front of 621 Main St.
- 
- 
- 
-

Repaired on WO#3150

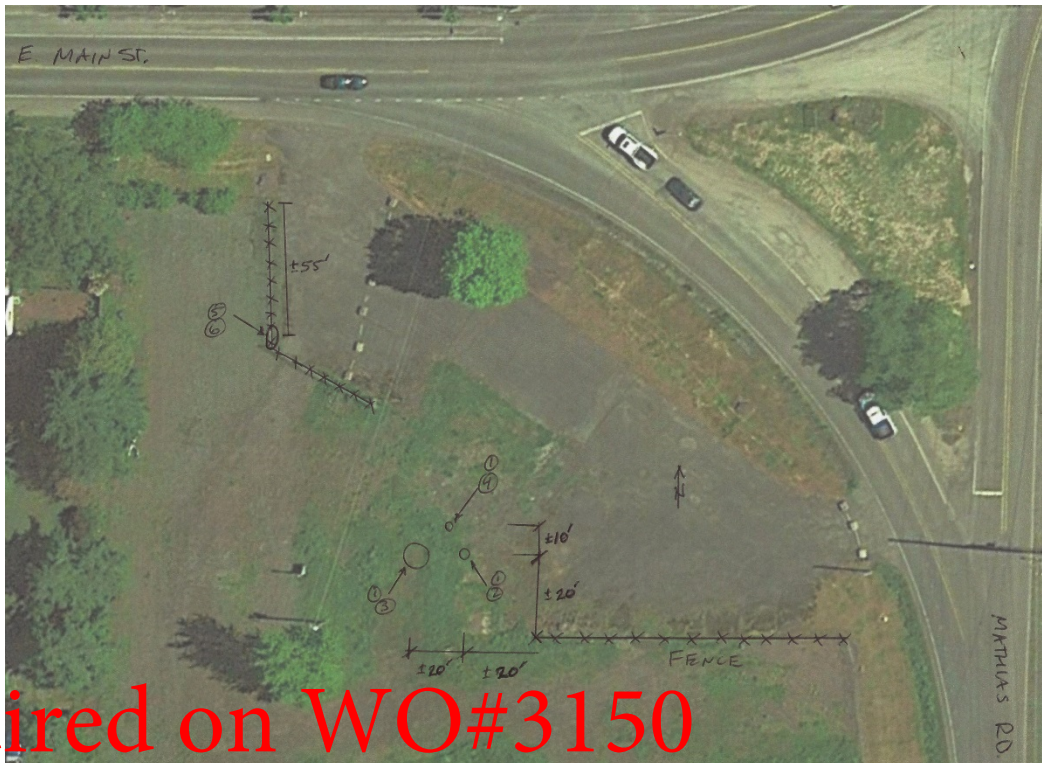
Molalla Smoke Testing  
Report No. 2-56  
812 E. Main St.

- See aerial for picture locations.
- No. 2 – Cleanout covered with concrete block and open stub out pipe.
- No. 3 – Smoke from gravel area covering broken service lateral.
- No. 5/6 – Smoke from fence line. Possible broken service lateral under fence line.

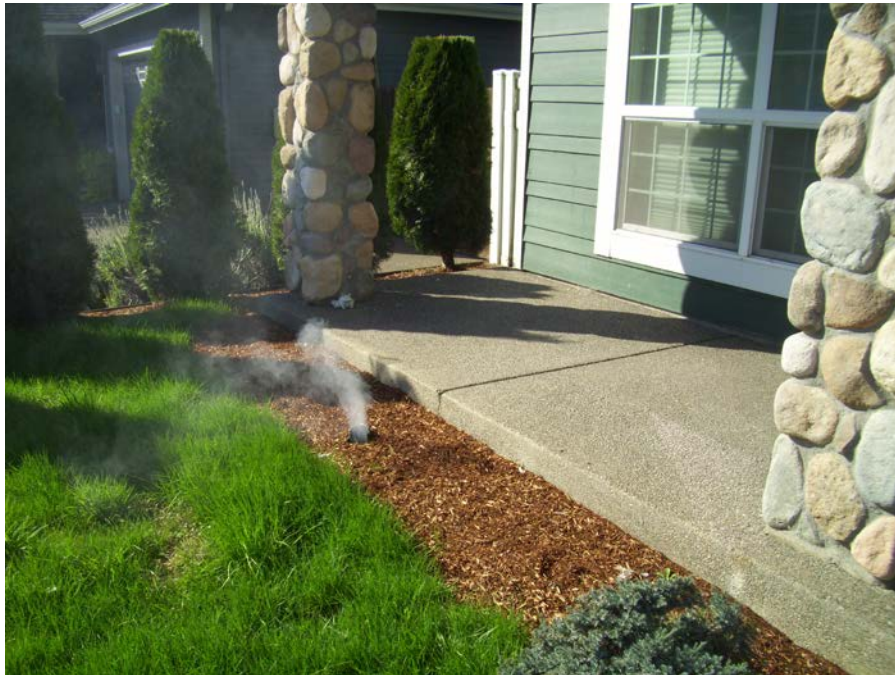
- Cleanout has broken pipe and missing lid.
- 
- 
- 
-

Repaired on WO#3150

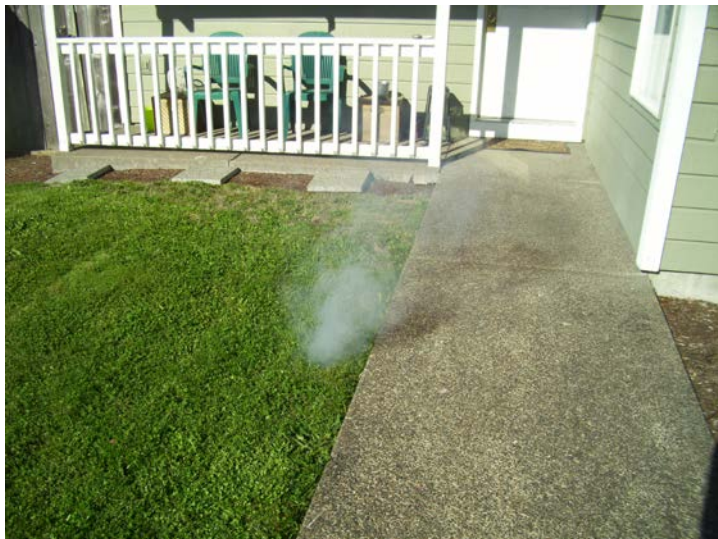
- Cleanout does not have lid.
- 
- 
- 
-

Repaired on WO#3150

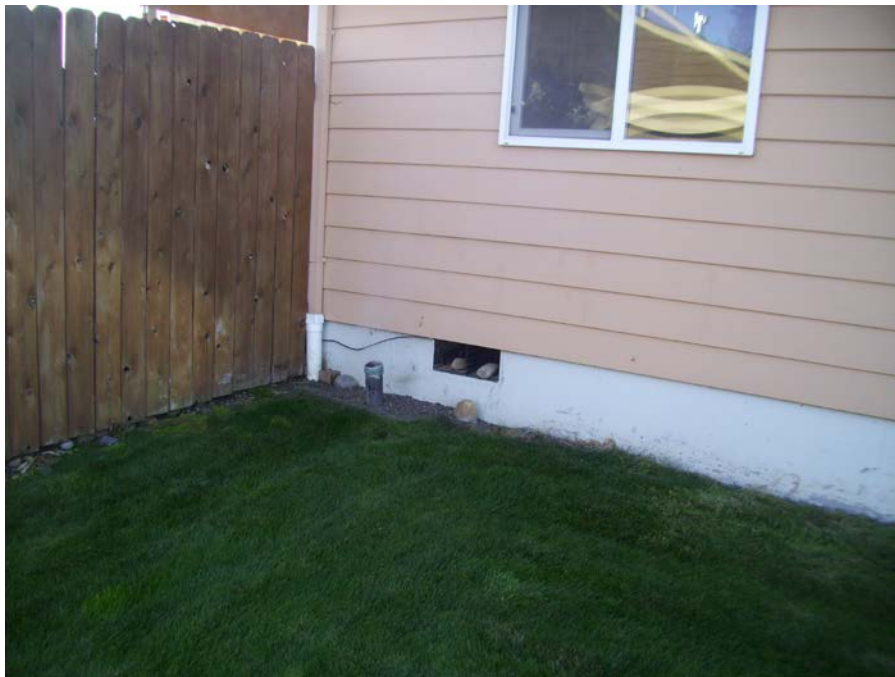
- Above grade cleanout does not have lid.
- 
- 
- 
-

Repaired on WO#3224

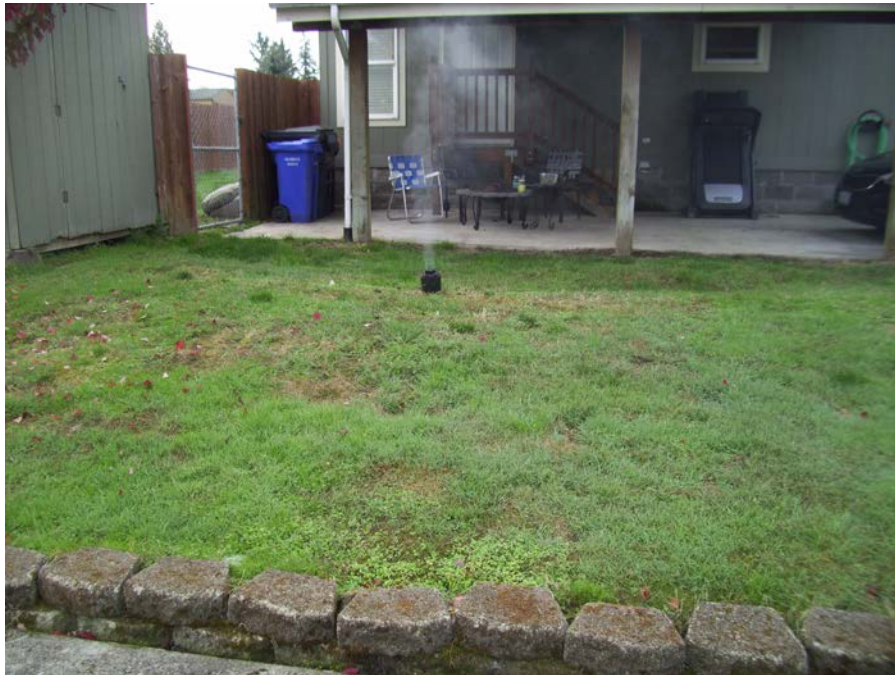
- Above grade cleanout lid has holes drilled in top.
- 
- 
- 
-

Repaired on WO#3224

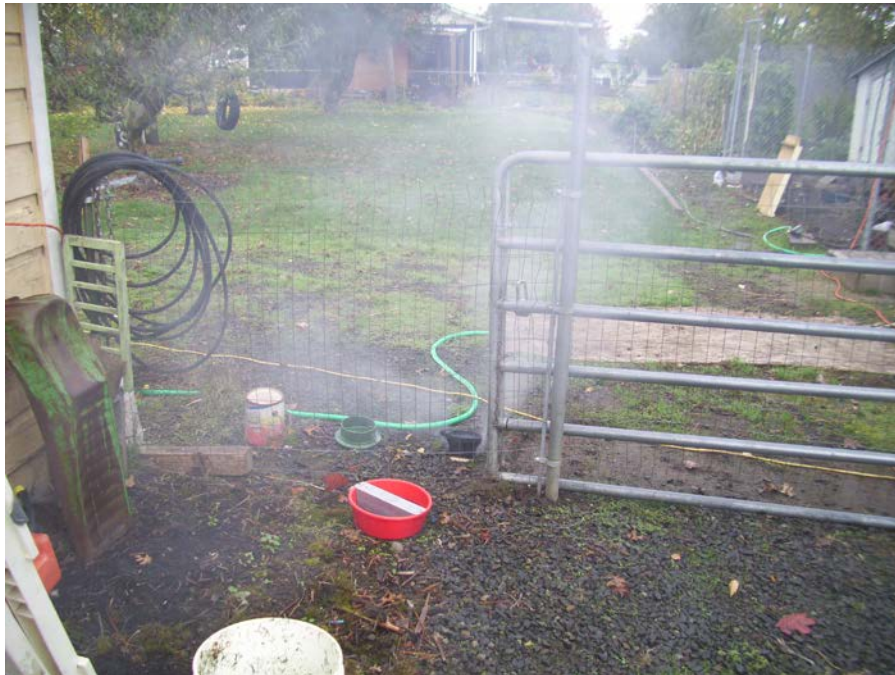
- Cleanout has grated lid.
- 
- 
- 
-

Repaired on WO#3224

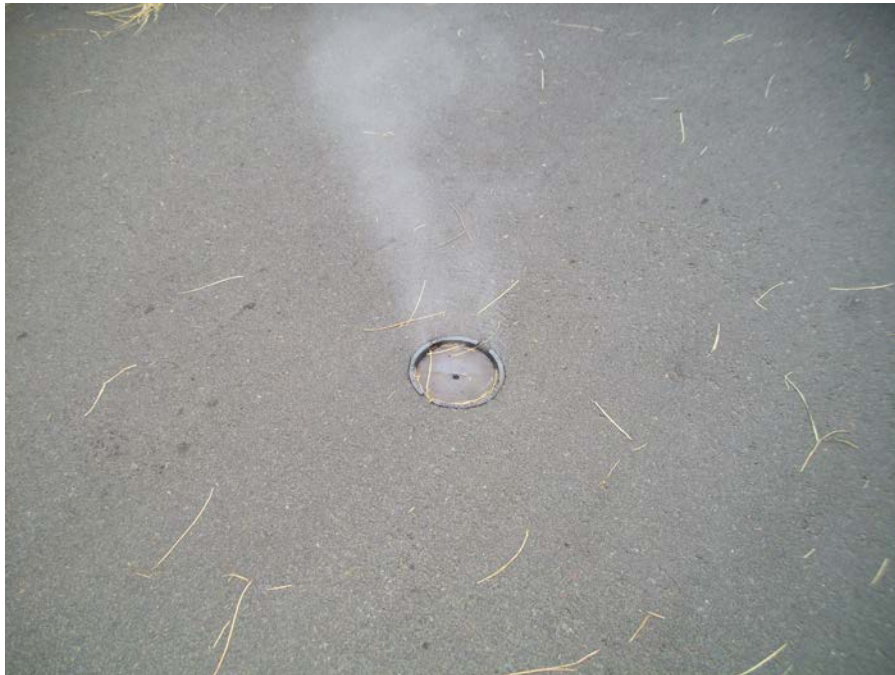
- Cleanout lid recessed below pavement grade. Smoke coming from sides of lid and center.
- 
- 
- 
-

Repaired on WO#3224

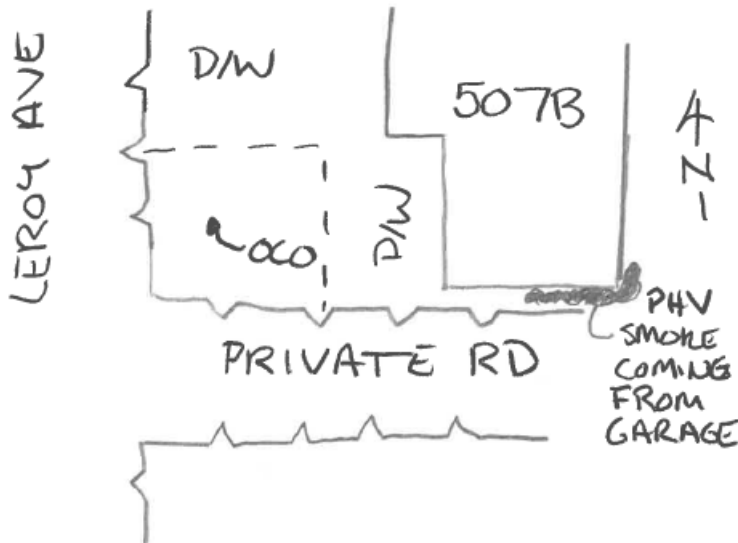
- OCO (509 Leroy Ave): Cleanout had cast iron lid but was smoking from sides in yard.
- PHV (507B Leroy Ave): Garage off of house 507B had smoke coming from underneath.
- 
- 
-

Repaired on WO#3224

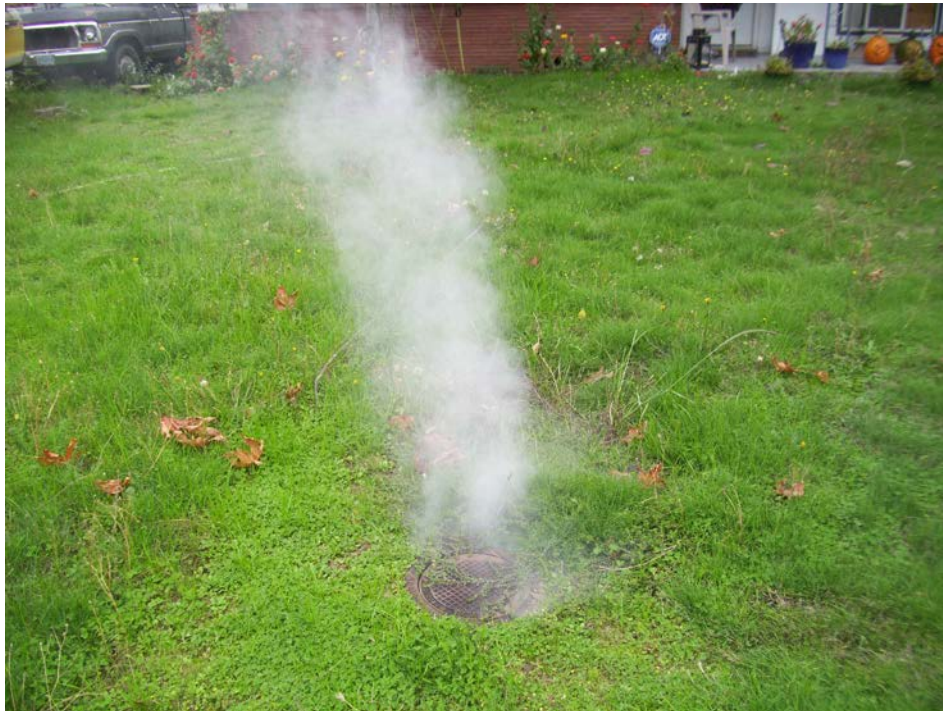
- Cleanout smoking around cast iron lid. Plastic cleanout cap behind cast iron lid also smoking.
- 
- 
- 
-

Repaired on WO#3445

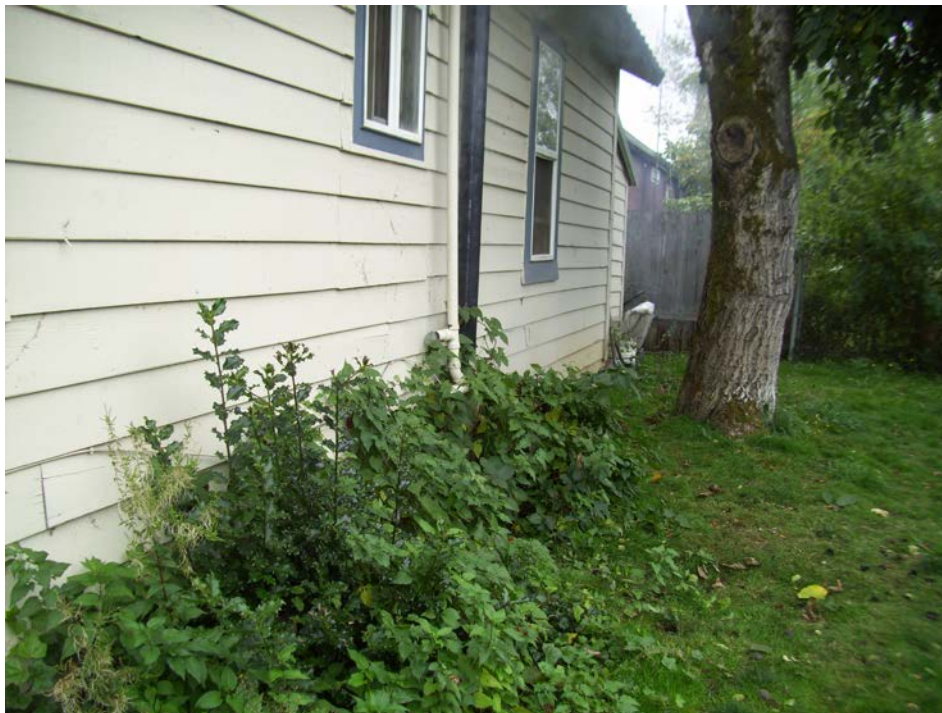
- OCO (Apartment No. 9): Smoke coming from cleanout pipe at ground level in brush.
- PHV (Apartment No. 3): Smoke coming from bathroom sink.
- 
- 
-

Repaired on WO#3445

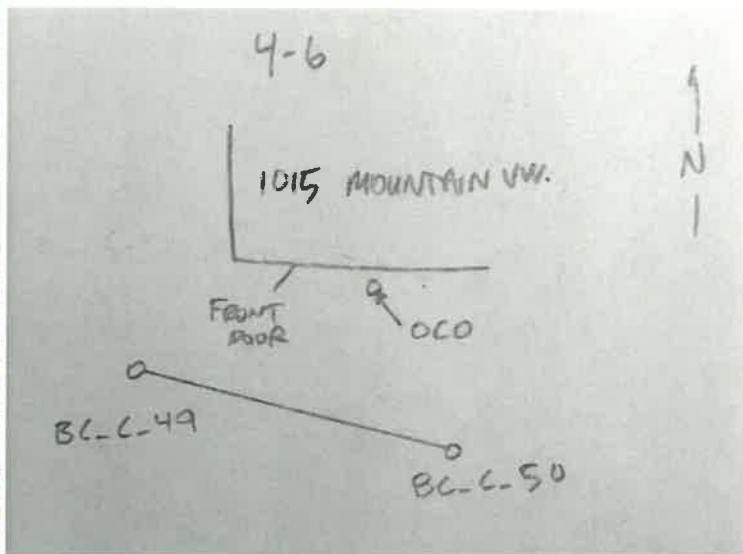
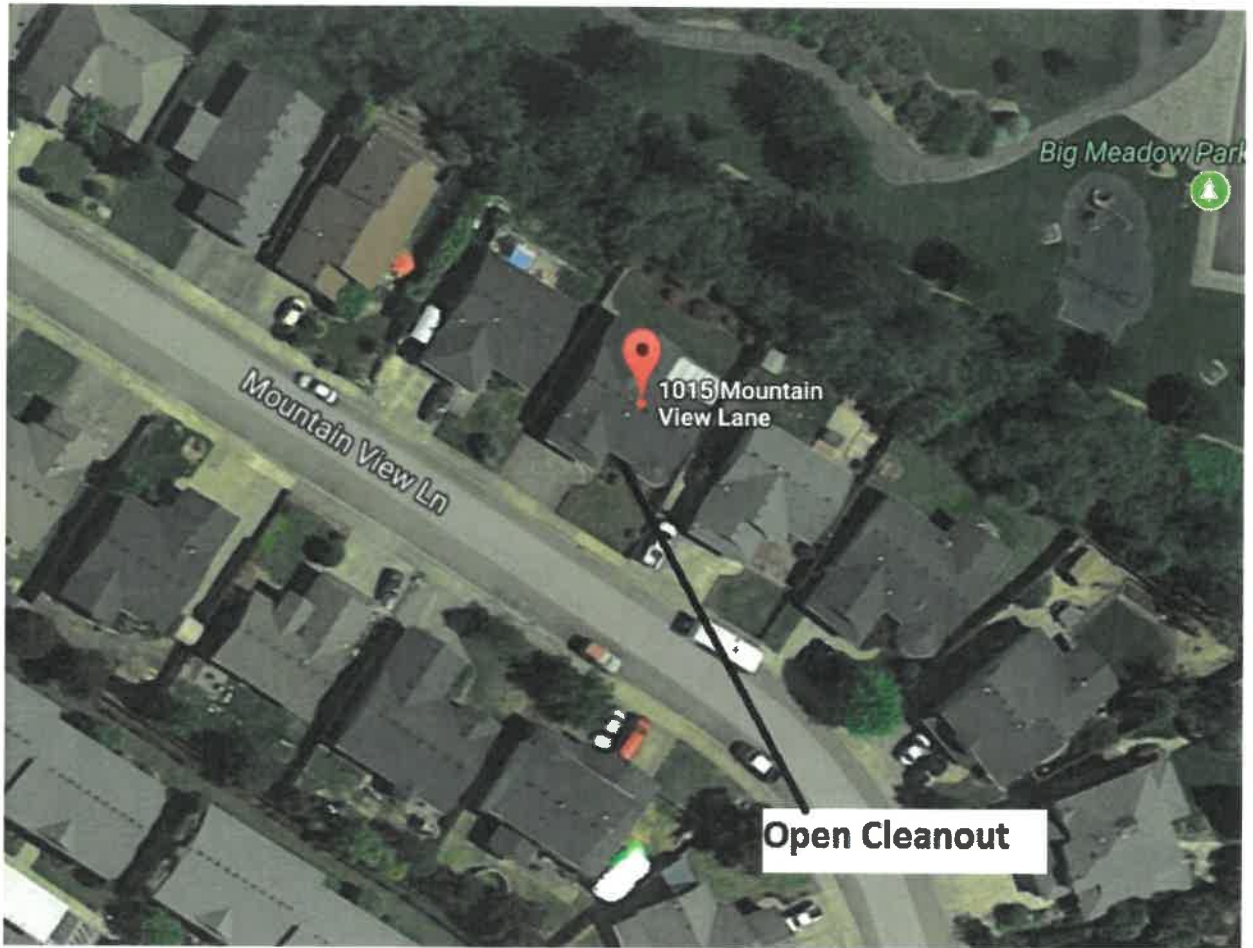
- Open cleanout located immediately to the right of the front door. Right next to hose reel.
- Also refer to aerial on following page.

Repaired on WO#3515

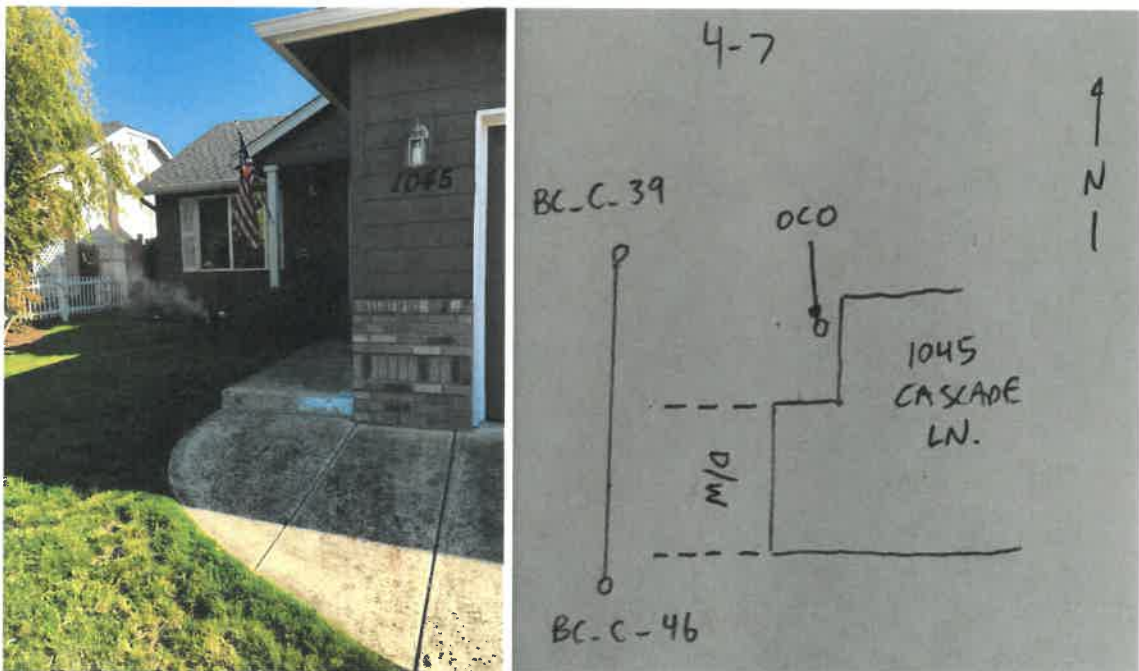
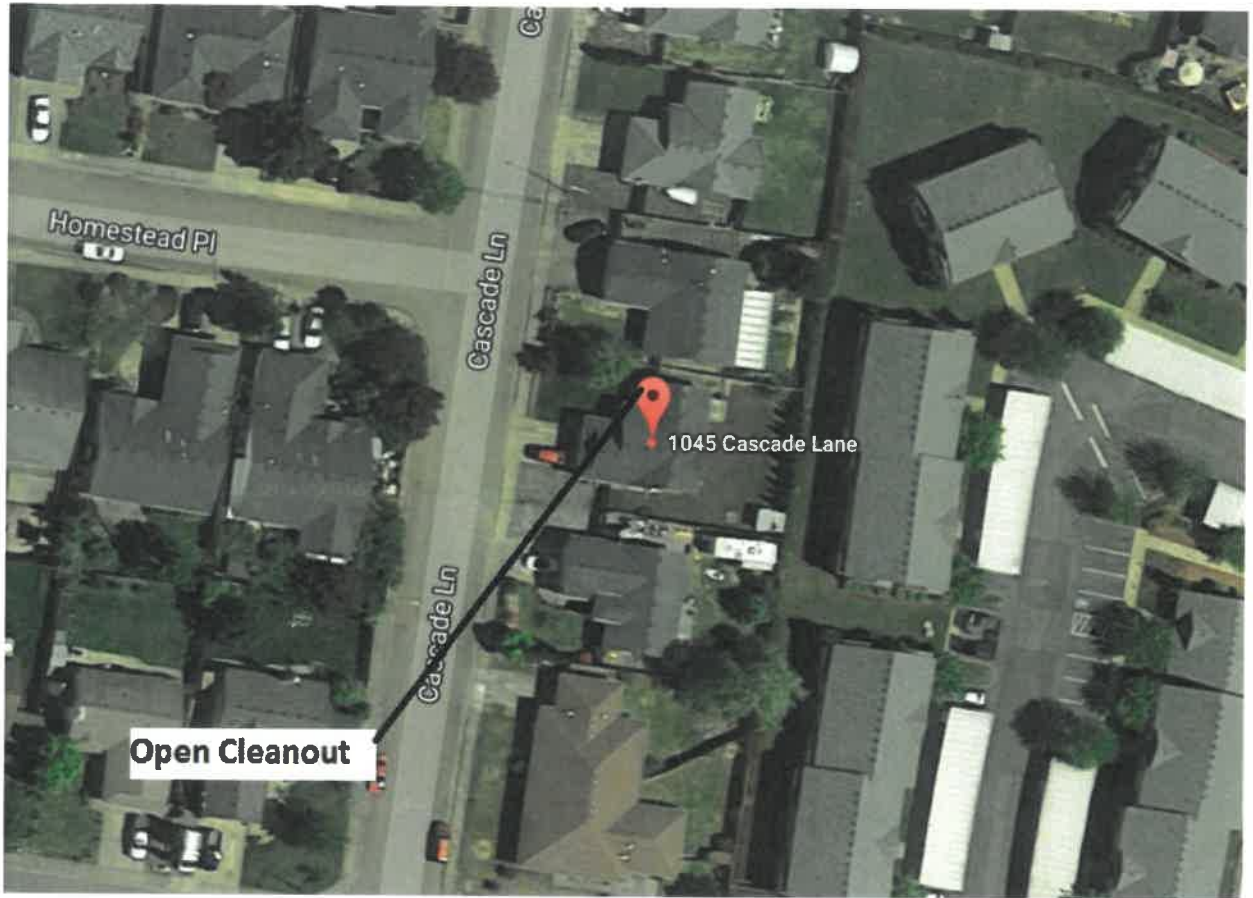
- Open cleanout located about 10 ft to the left of the front door. Right in front of the front window.
- Also refer to aerial on following page.
- 
- 
-

Repaired on WO#3515

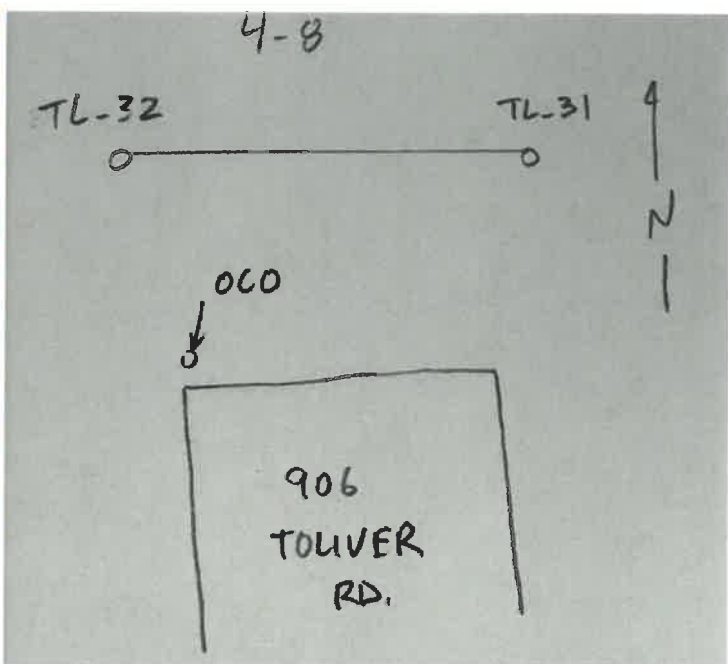
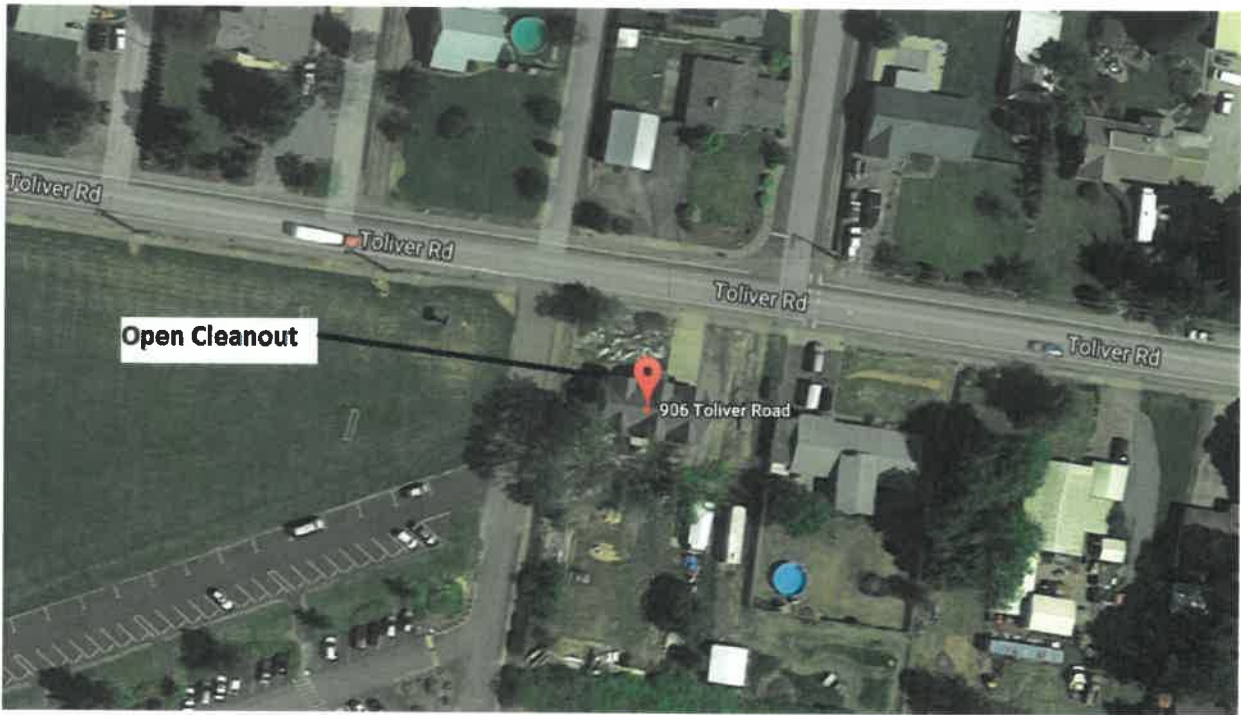
- Open cleanout. House was undergoing some landscaping and upgrades. Open cleanout may only be temporary.
- Also refer to aerial on following page.
- \_\_\_\_\_
- \_\_\_\_\_
- \_\_\_\_\_

**Repaired on WO#3515**

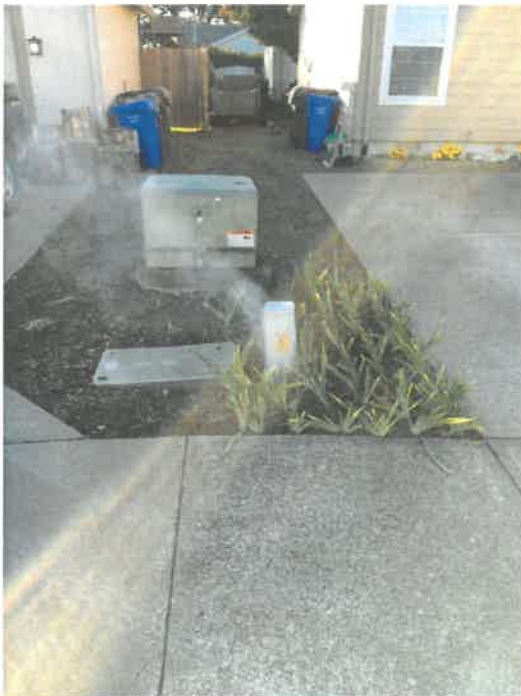
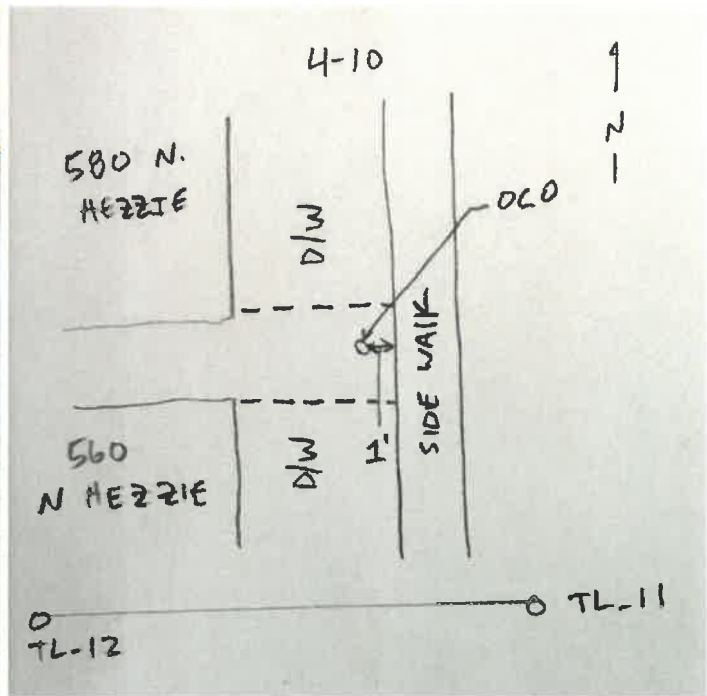
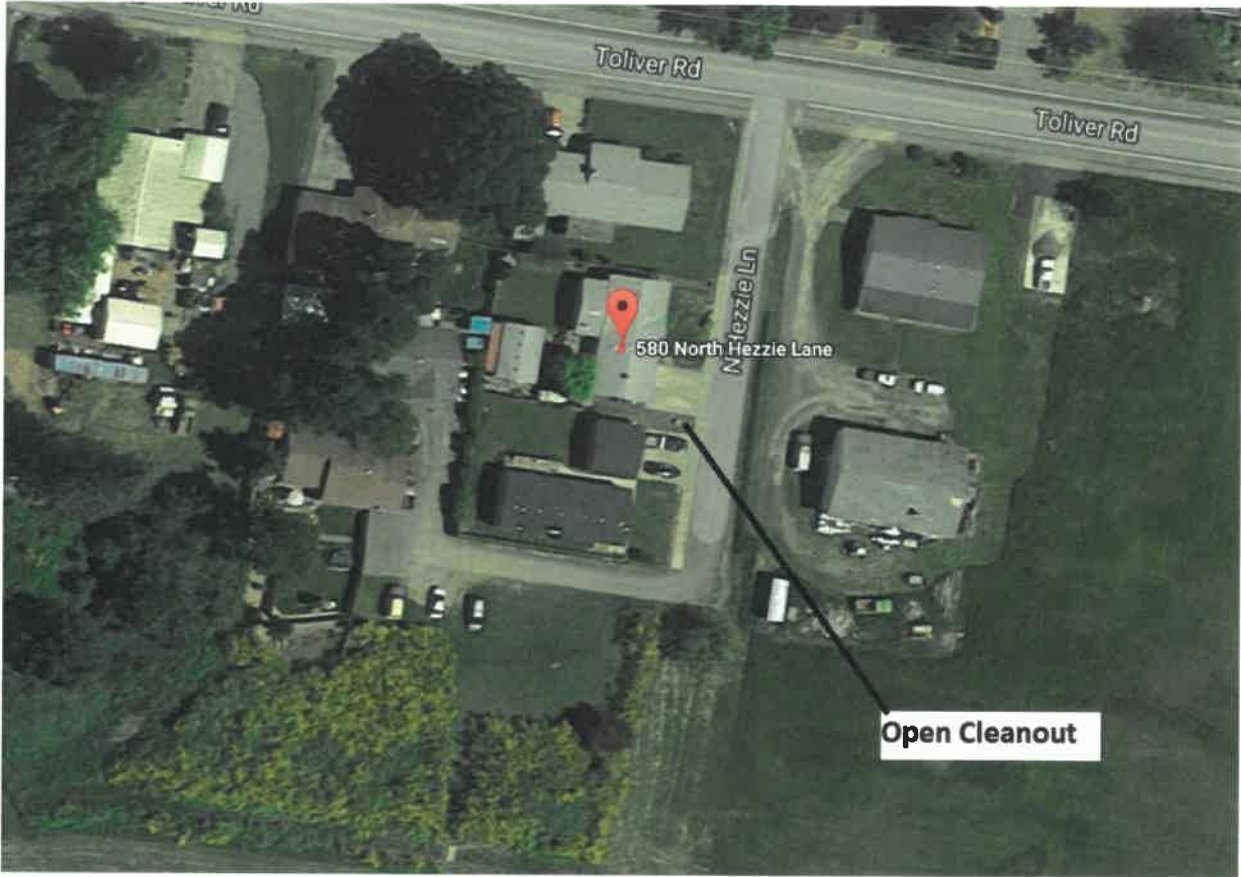
- Open cleanout adjacent to electrical box, in between driveways.
- Also refer to aerial on following page.
- 
- 
-

Repaired on WO#3515

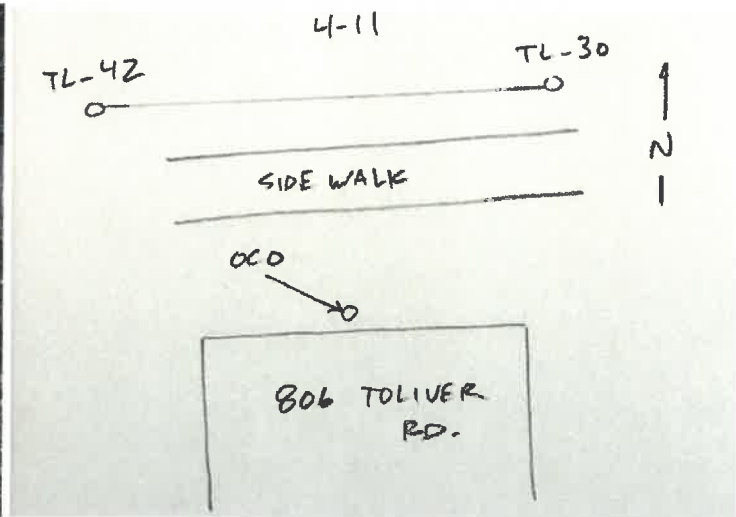
- Open cleanout located to the right of the front porch.
- 
- 
- 
- 
-

Repaired on WO#3515

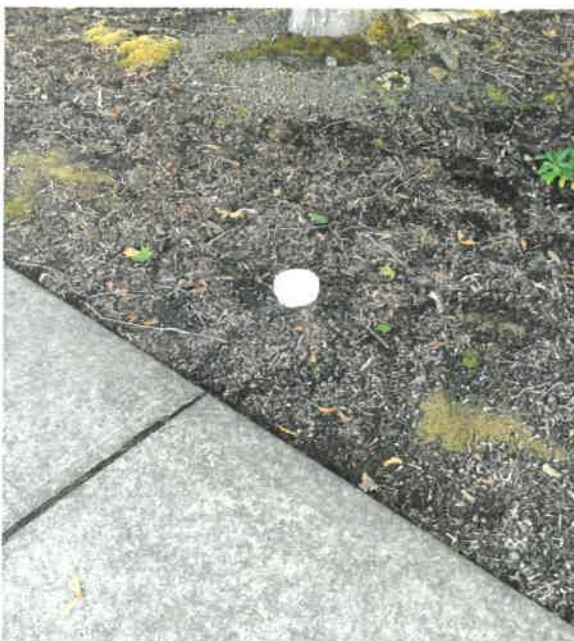
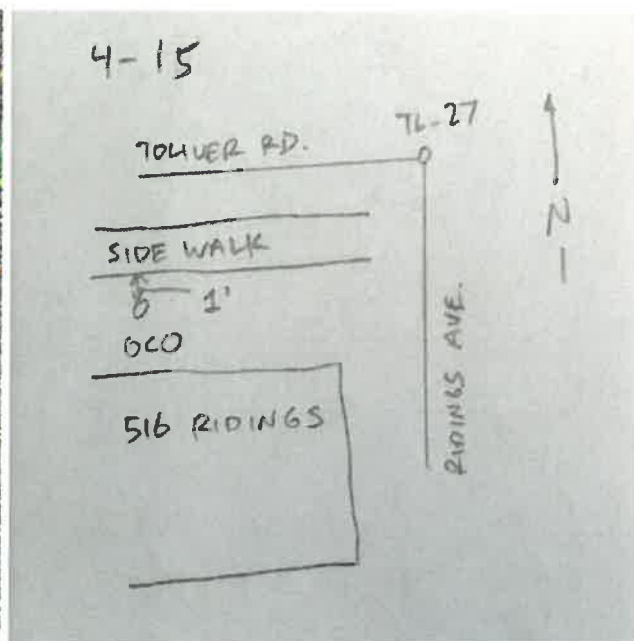
- Open cleanout west of side walk. Exposed pipe was cracked.
- 
- 
- 
- 
-

Repaired on WO#3515

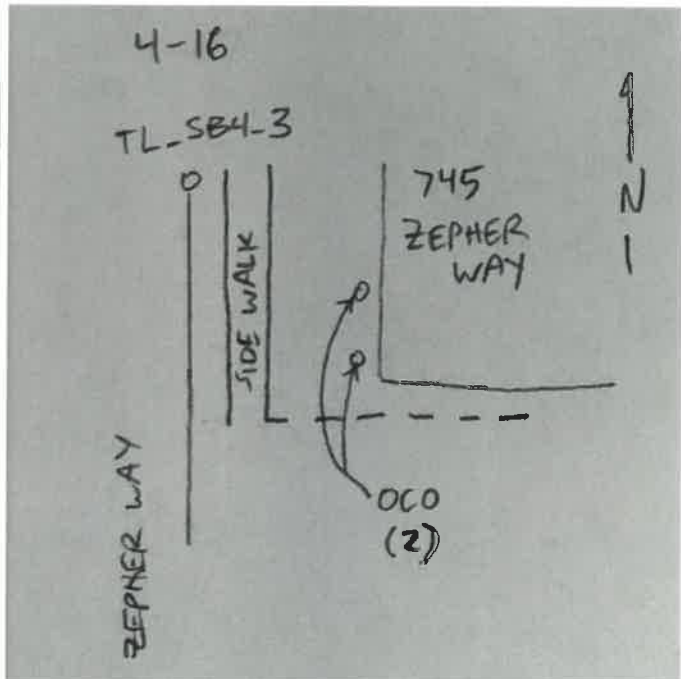
- Two open cleanouts located approximately two and five feet from north side of drive way.
- 
- 
- 
- 
-

Repaired on WO#3515

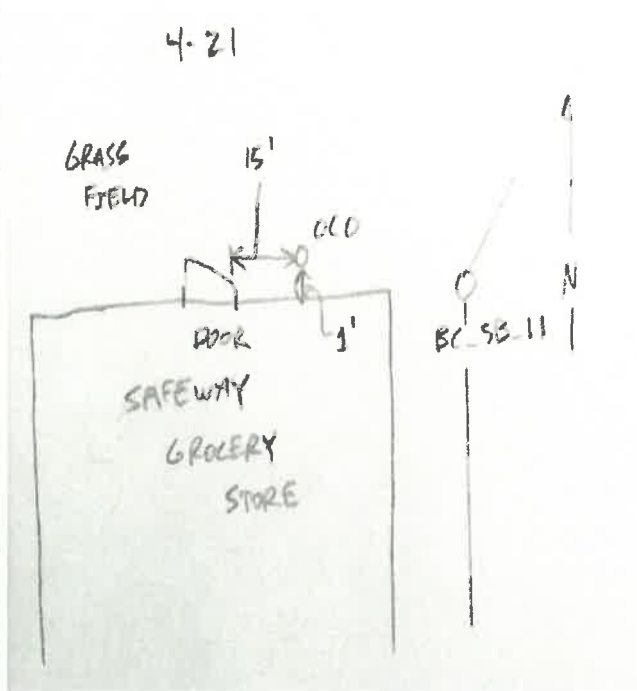
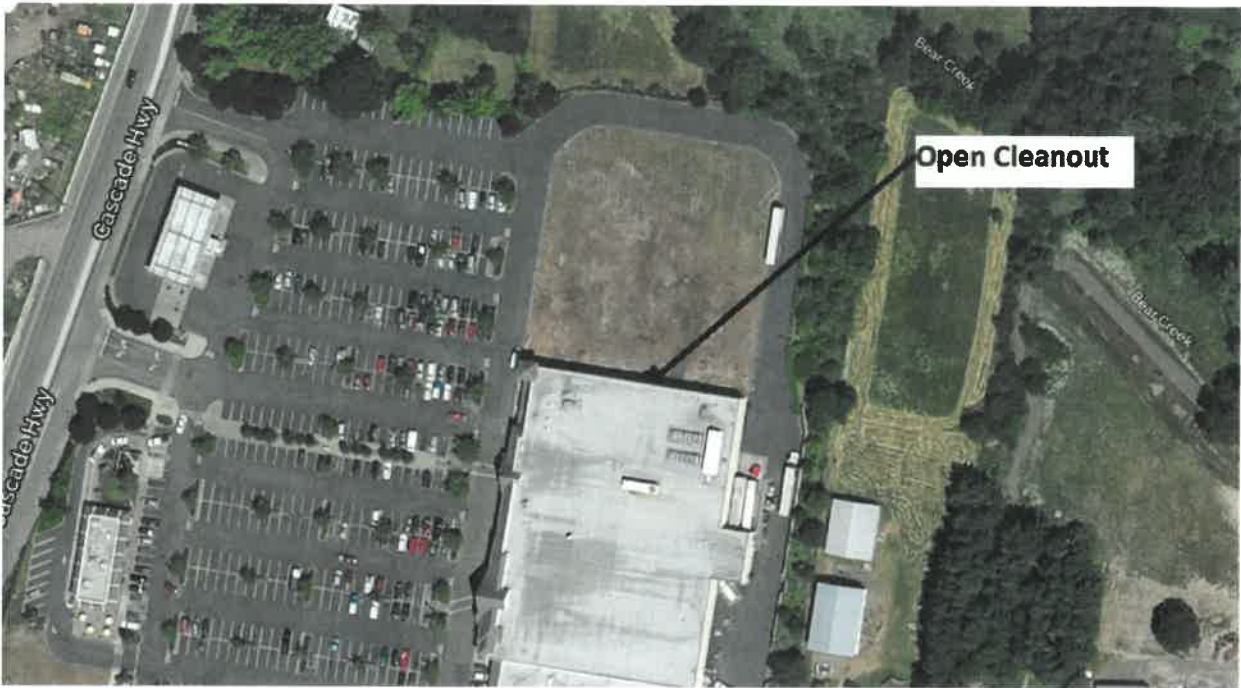
- There was an open cleanout to the north of the Safeway building. The pipe is a few inches below ground level, and probably receives quite a bit of inflow.
- Also refer to aerial on following page.
- 
- 
-

Repaired on WO#3515
