**Public Works Department**

**RE: 2018 ANNUAL INFLOW & INFILTRATION REPORT**

This report provides an annual summary of some of the more important I/I reduction actions the City of Molalla has taken for the 2018 calendar year, in accordance with City's Inflow and Infiltration Assessment and Reduction Plan and NPDES Permit No. 101514.

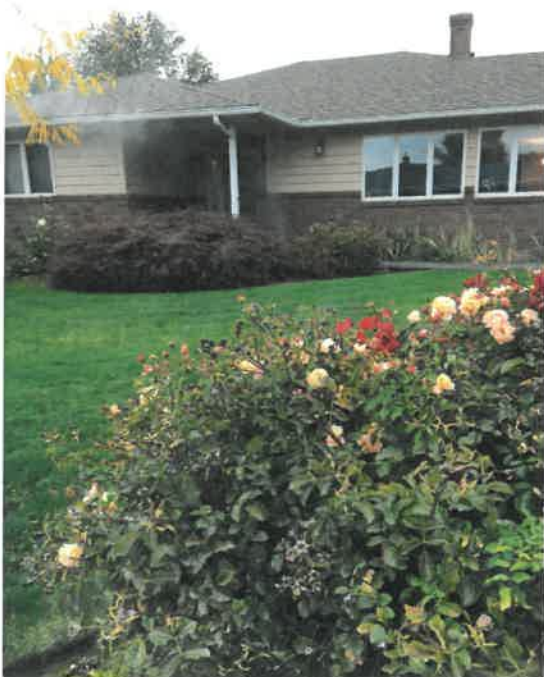
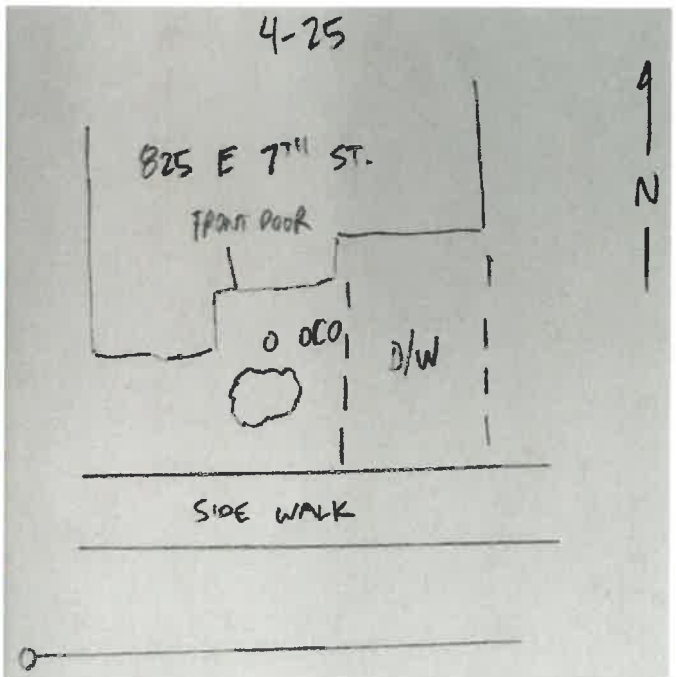
- Open cleanout located immediately to the right of the front door.
- 
- 
- 
- 
-

Repaired on WO#3515

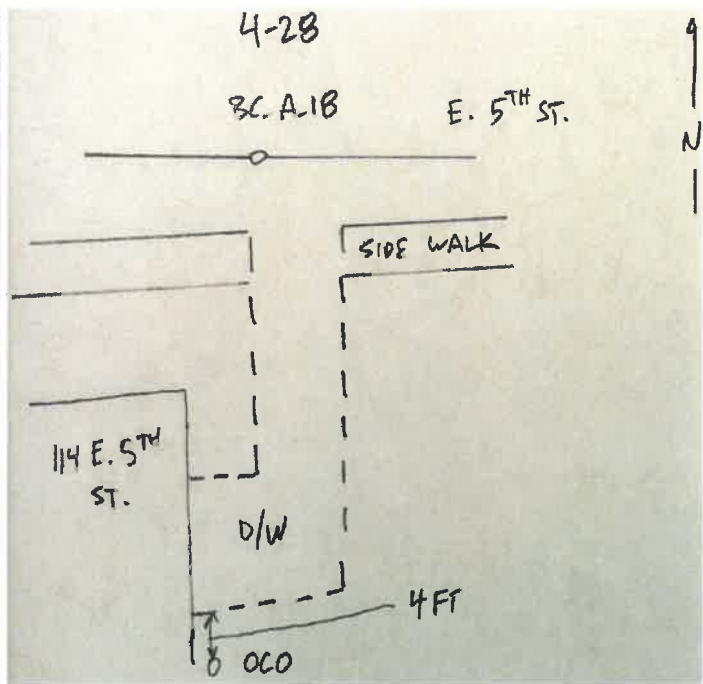
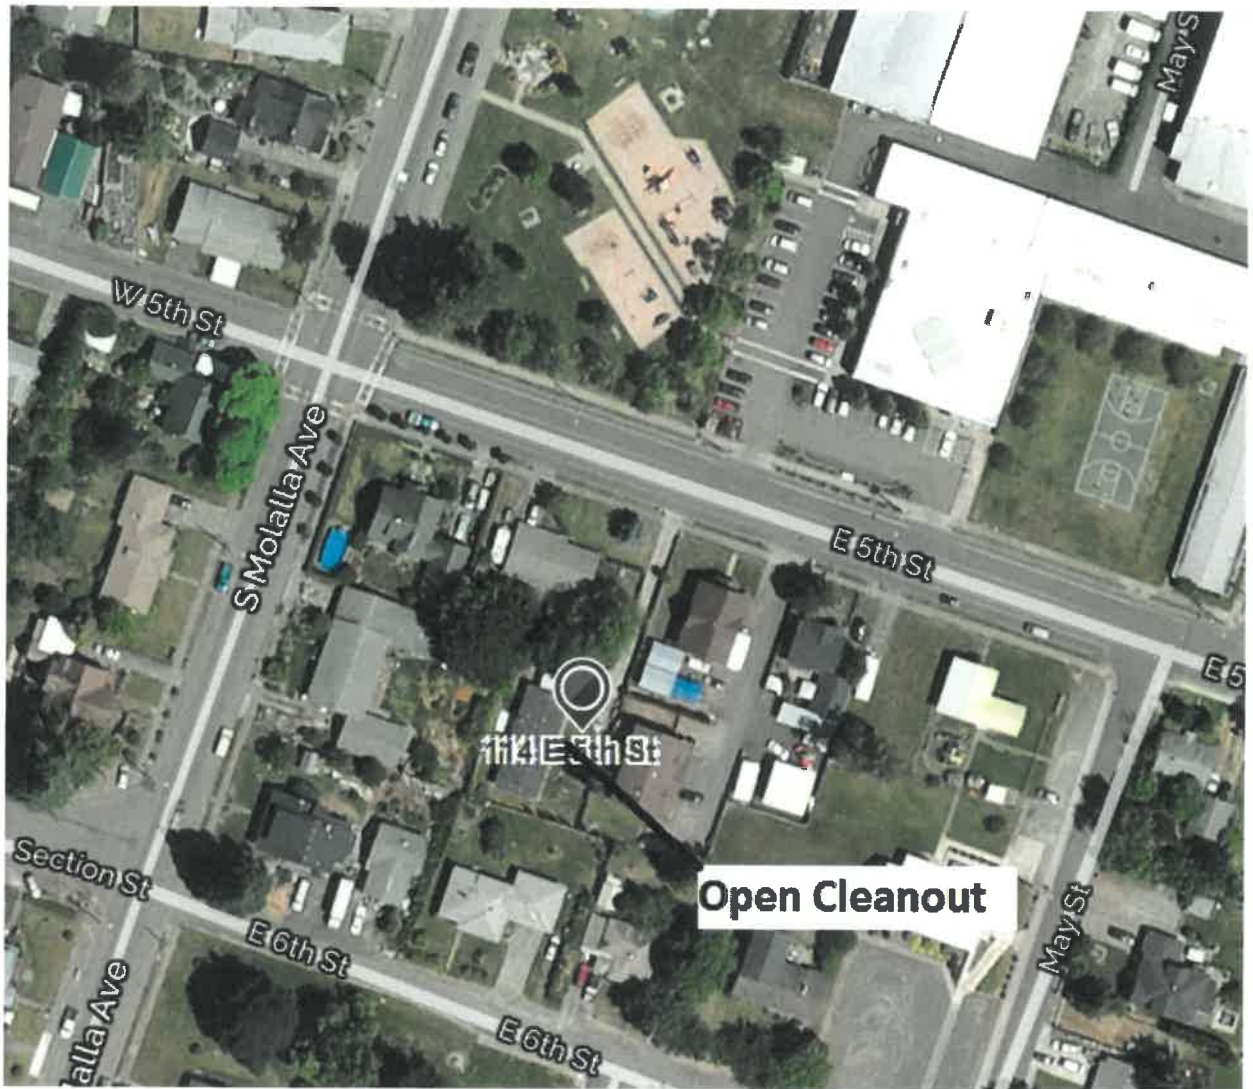
- Open cleanout located south of the concrete drive way, and just north of the electric meter.
- Also refer to aerial on following page.
- 
- 
-

Repaired on WO#3858

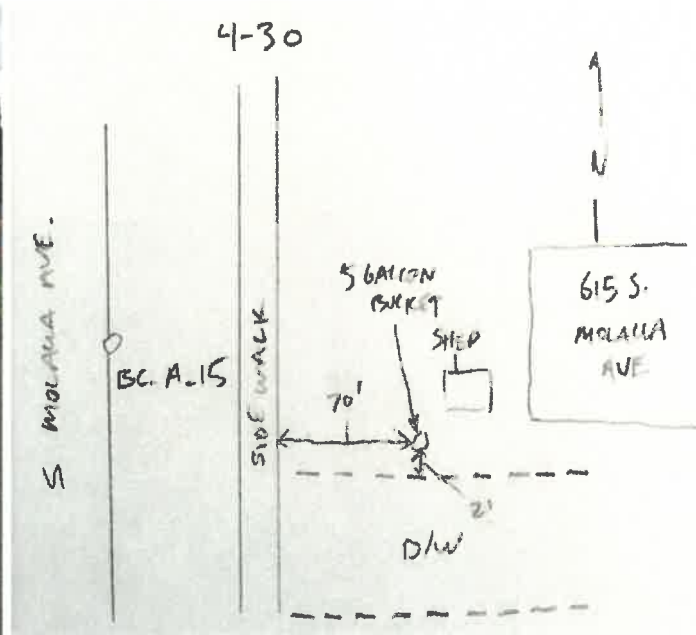
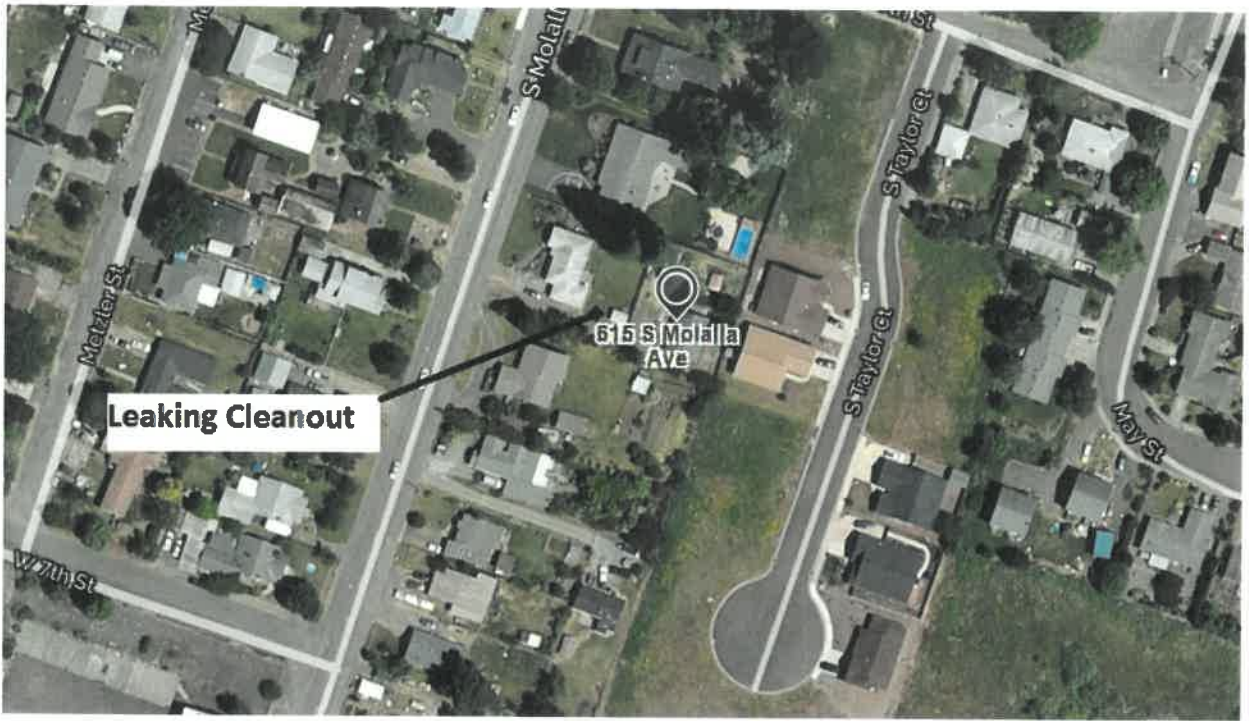
- Open cleanout is located to the north of the drive way. Suspected cleanout has 5 gallon bucket and concrete footing located above it. Smoke exited rapidly.
- Also refer to aerial on following page.
- 
- 
-

Repaired on WO#3858

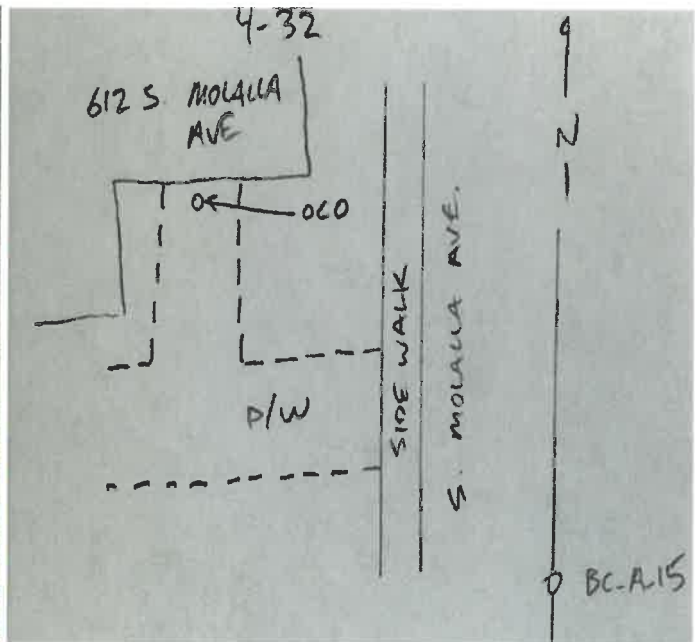
- Open cleanout located north of the driveway, immediately adjacent to the house.
- \_\_\_\_\_
- \_\_\_\_\_
- \_\_\_\_\_
- \_\_\_\_\_
- \_\_\_\_\_

Repaired on WO#3858

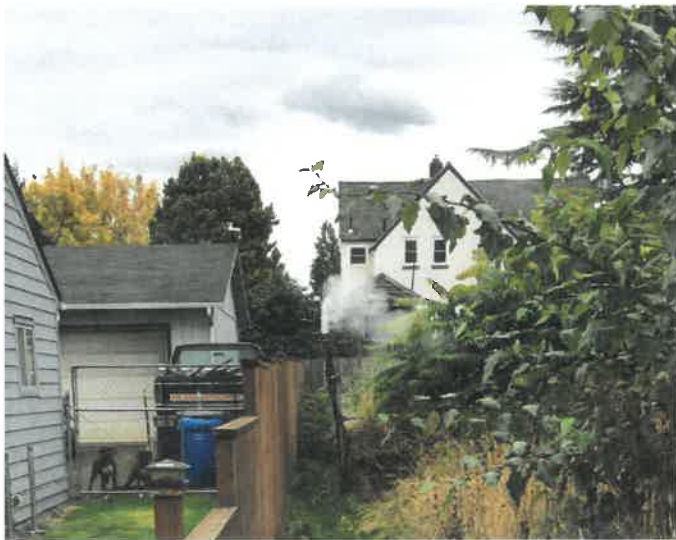
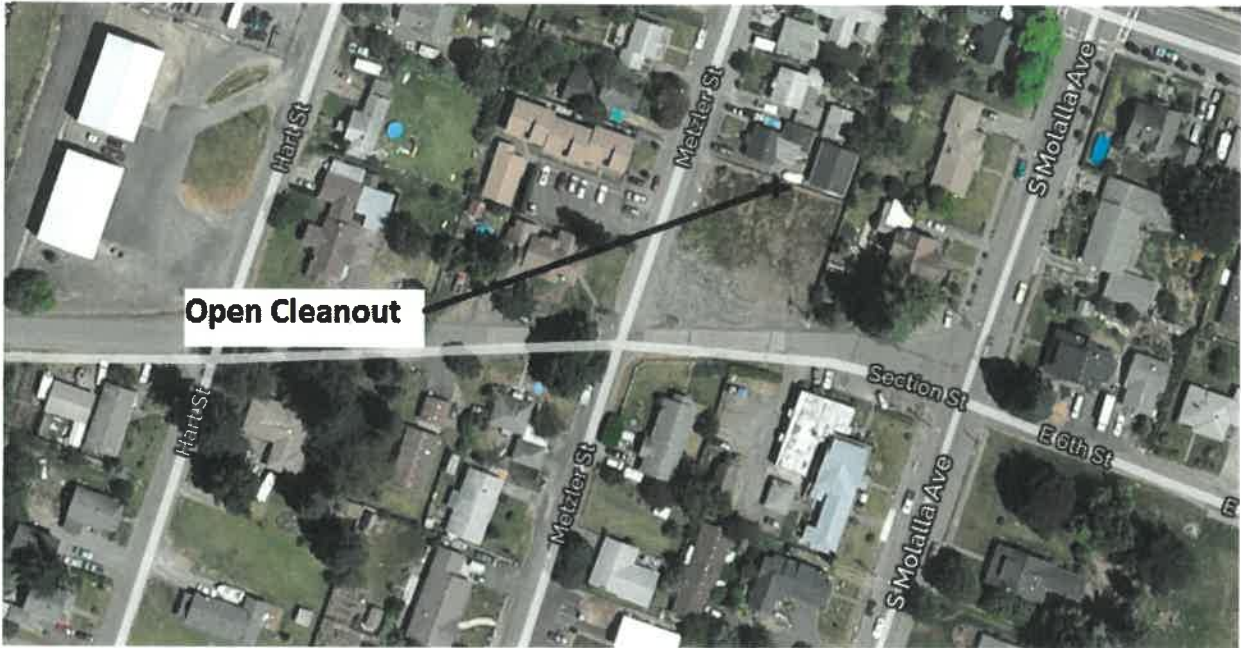
- Open cleanout located to the south of the fence. Pipe extends approximately six feet into the air. Property is an abandoned house.
- Also refer to aerial on following page.
- 
- 
-

Repaired on WO#3858
