# CITY OF MOLALLA

## SMOKE TESTING REPORT

OCTOBER 2018

**Project No. 100.26**

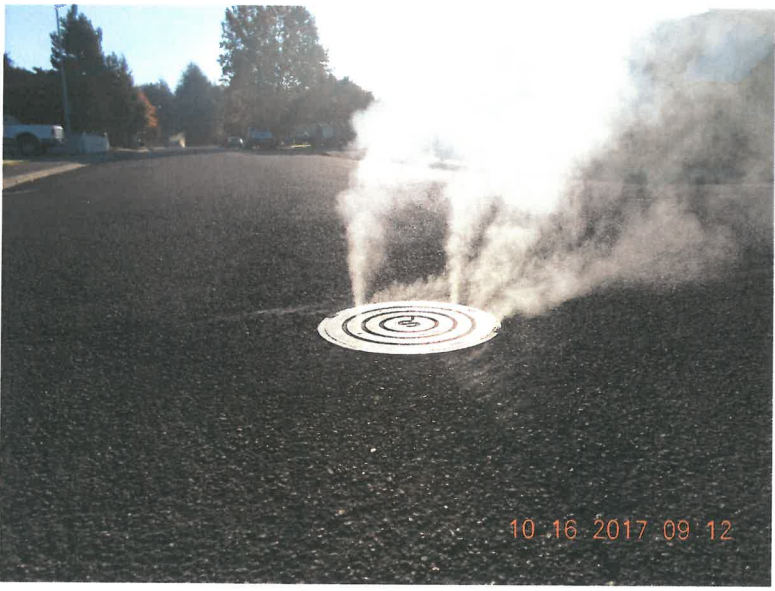
- Smoke coming from around the ring and the cracks in the road next to the manhole.
- 
- 
- 
- 
-

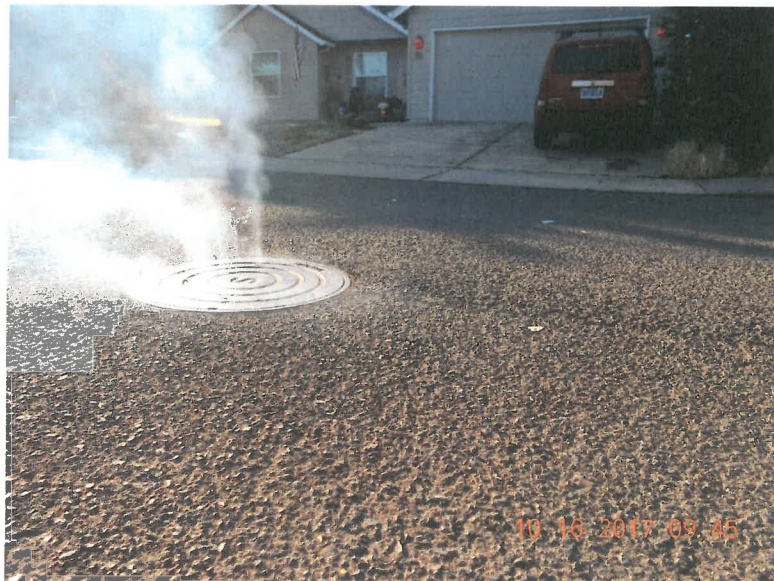
- Smoke coming from around the ring and the cracks in the road next to the manhole.
- \_\_\_\_\_
- \_\_\_\_\_
- \_\_\_\_\_
- \_\_\_\_\_
- \_\_\_\_\_

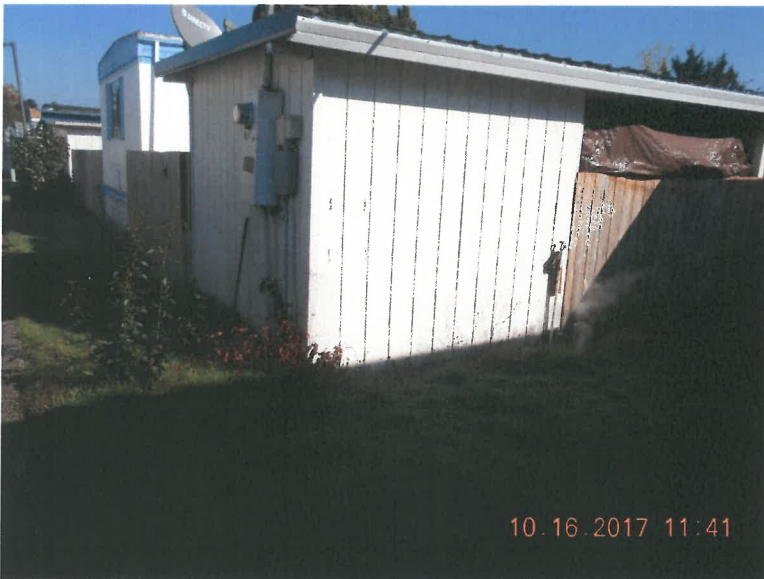
- Located at Unit #723 of Twin Firs Mobile Home Park
- Smoke coming from open cleanout, located behind the shed
- Smoke coming out of broken cleanout cap on the side of the shed
- 
-

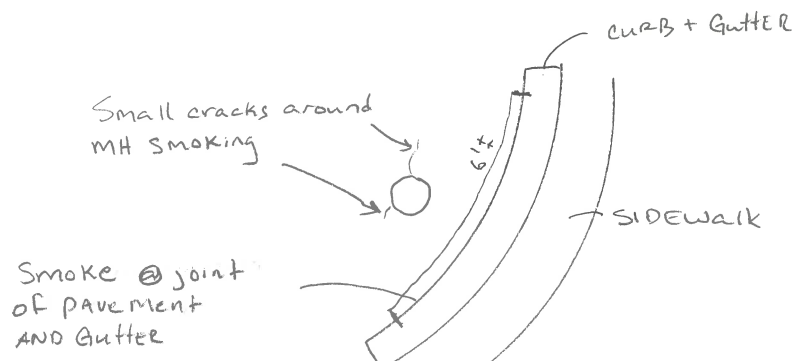
- Smoke leaky out around the rim of the manhole, the cracks in the road around the manhole and along the joint between the ac pavement and concrete gutter
- 
- 
- 
-

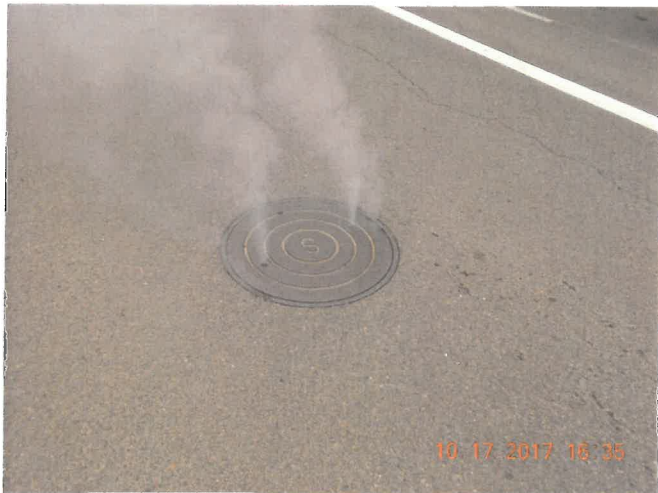
- Smoke leaking around rim of manhole
- 
- 
- 
- 
-

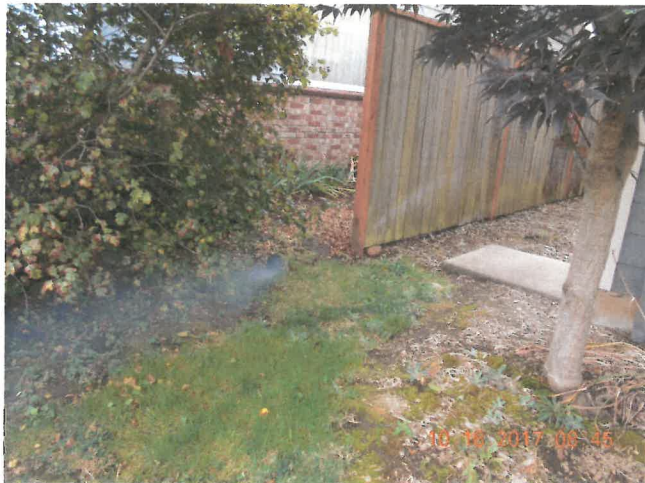
- Smoke coming out of broken cleanout
- 
- 
- 
- 
-

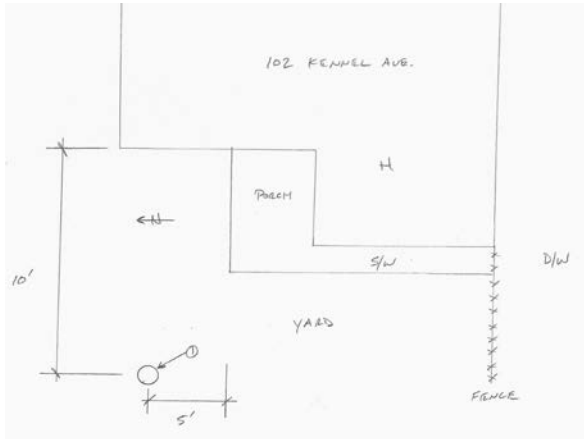
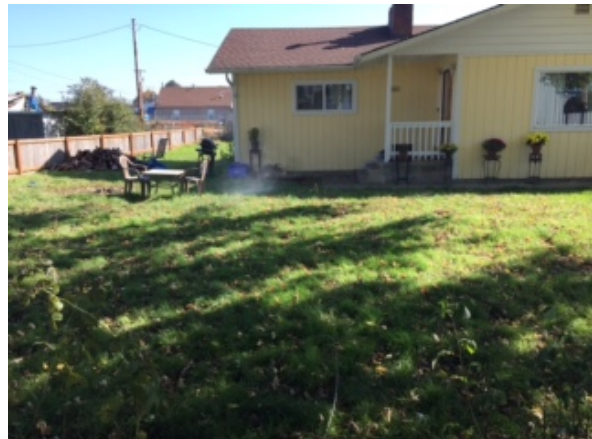
- Broken sewer cleanout cap in front yard.
- 
- 
- 
-

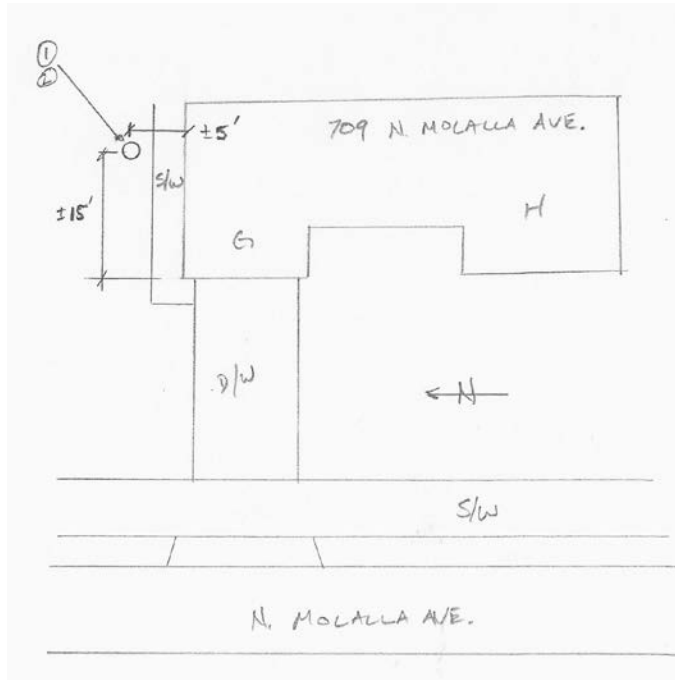
- Broken cleanout cap on north side of garage, adjacent to concrete sidewalk.
- 
- 
- 
- 
-

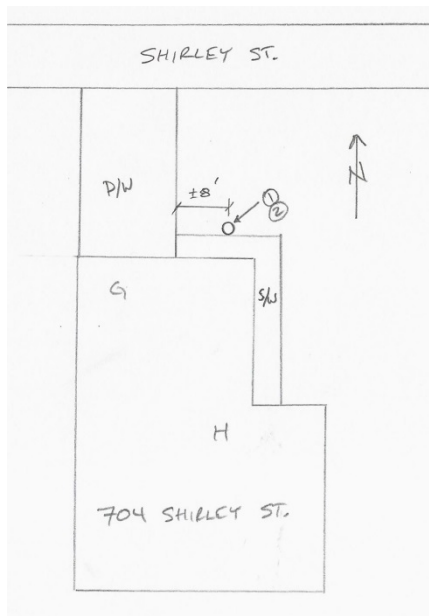
- .Smoke from broken cleanout cap, located next to concrete walkway, under planter.
- 
- 
- 
-

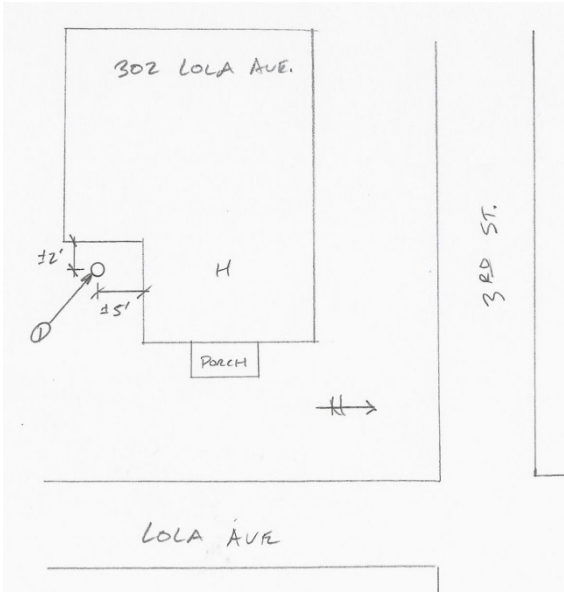
- Smoke from cleanout area. Could not confirm if the cap was broken or missing.
- 
- 
- 
-

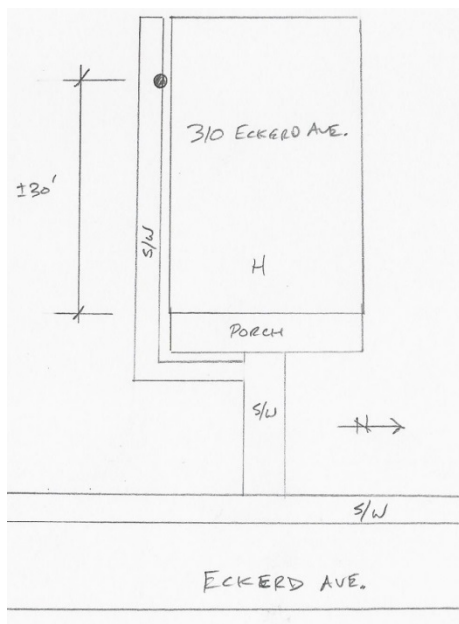
- Smoke from cleanout area. Could not confirm if the cap was broken or missing.
- 
- 
- 
-

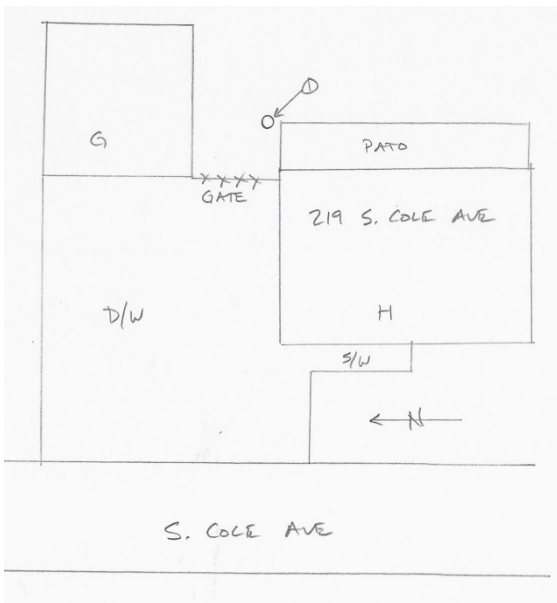
- Smoke from cleanout area. Could not confirm broken or missing cleanout cap.
- 
- 
- 
- 
-

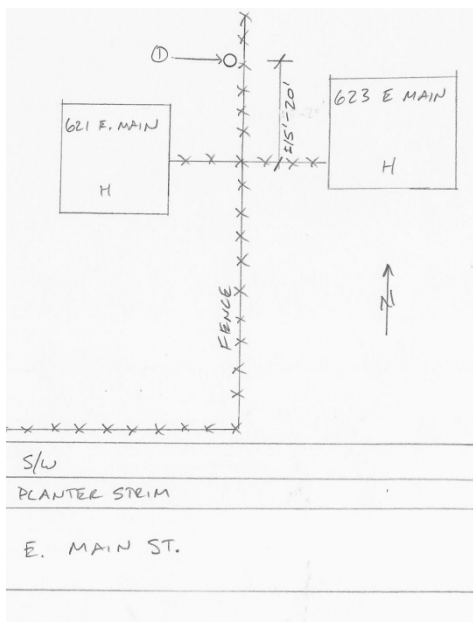
- Smoke from fence line, between backyards of 621 and 623 Main St.
- Could not confirm broken or uncovered cleanout.
- 
- 
-

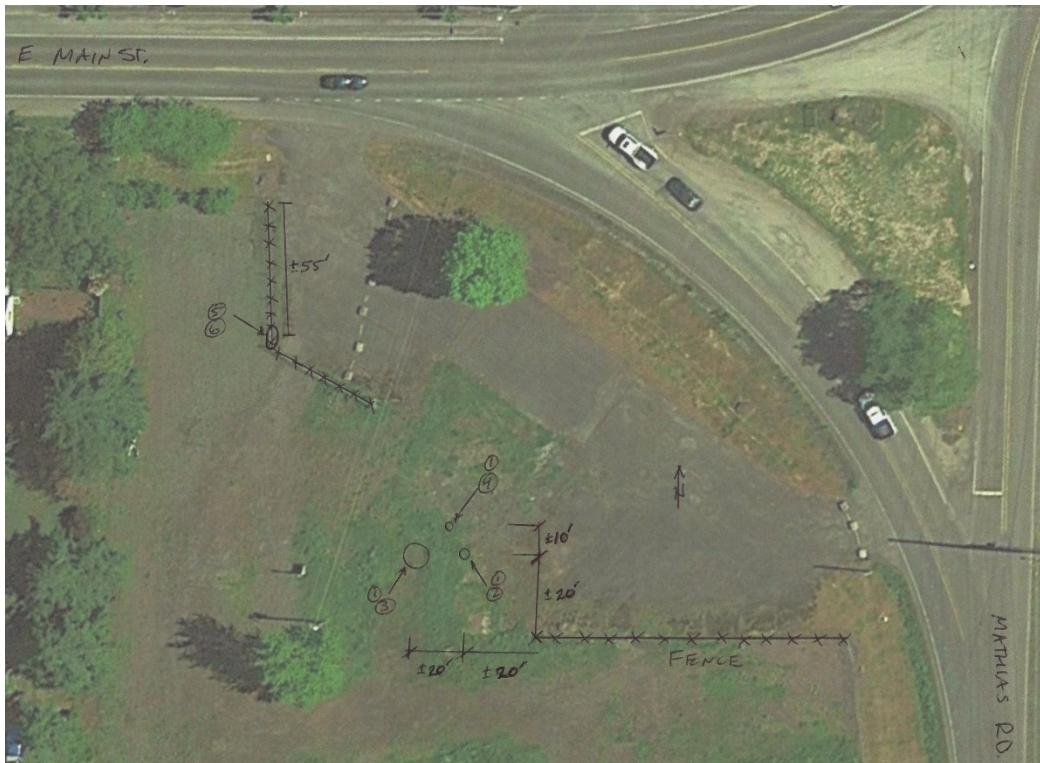
- See aerial for picture locations.
- No. 2 – Cleanout covered with concrete block and open stub out pipe.
- No. 3 – Smoke from gravel area covering broken service lateral.
- No. 5/6 – Smoke from fence line. Possible broken service lateral under fence line.

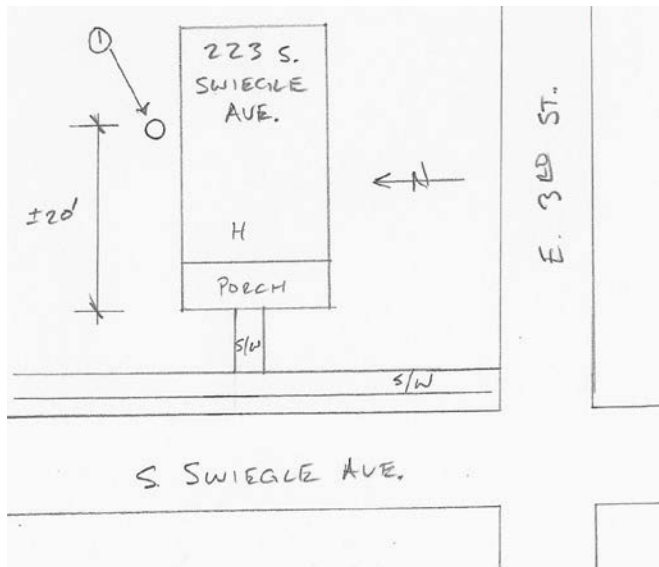
- Smoke from cleanout area on north side of house. Could not confirm broken or missing cap.
- 
- 
- 
- 
-

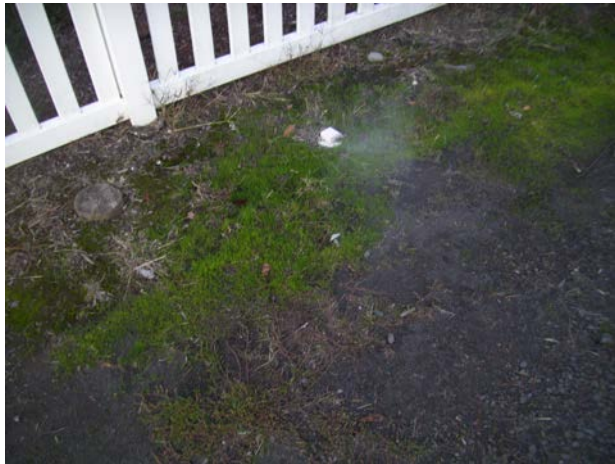
- Broken cleanout lid.
- 
- 
- 
-

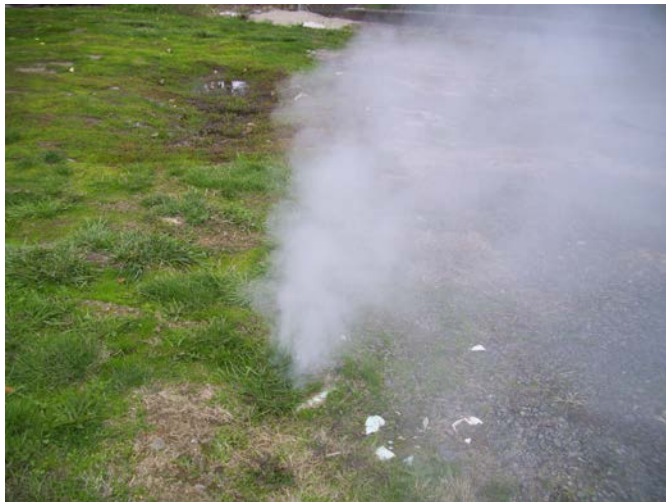
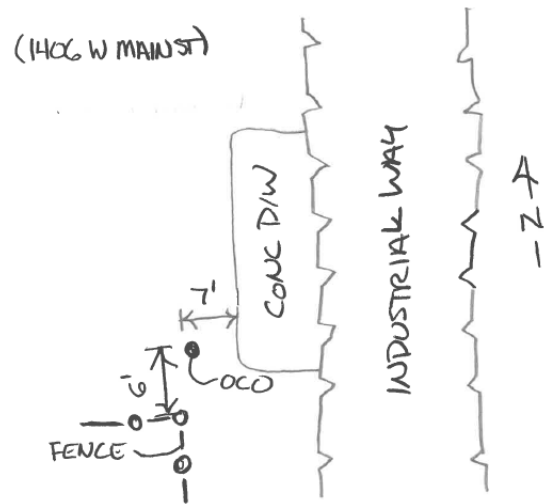
- Cleanout pipe broken at surface.
- 
- 
- 
- 
-

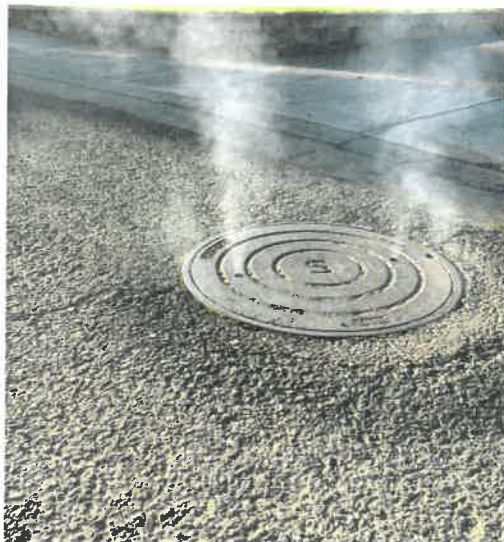
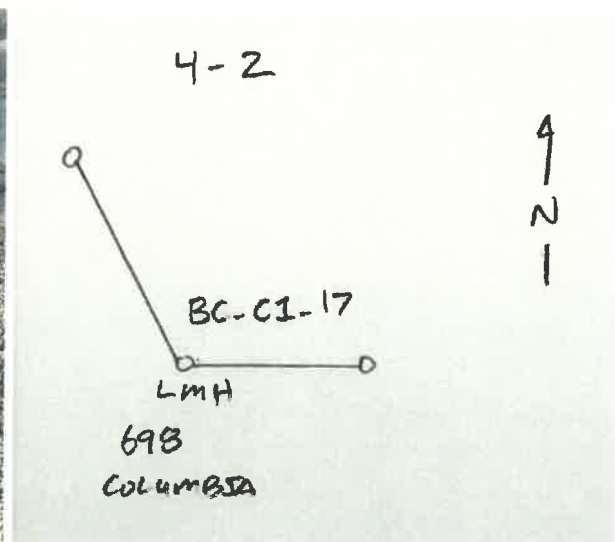
- Leaking around manhole rim.
- 
- 
- 
- 
-

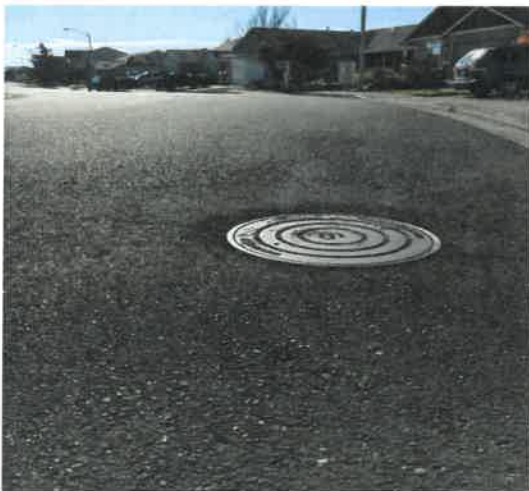
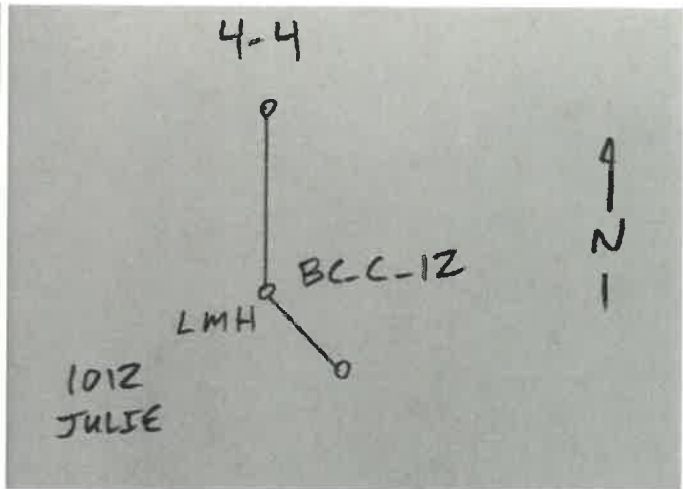
- Leaking around manhole rim.
- 
- 
- 
- 
-

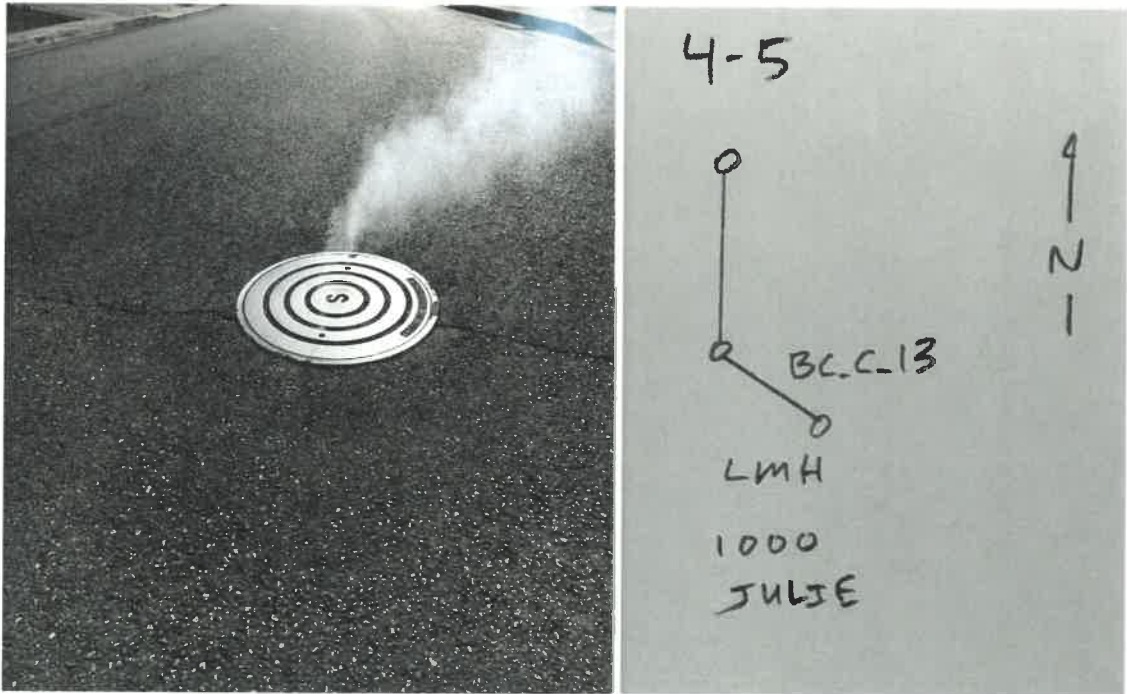
- Leaking around manhole rim and surrounding cracks in asphalt.
- \_\_\_\_\_
- \_\_\_\_\_
- \_\_\_\_\_
- \_\_\_\_\_

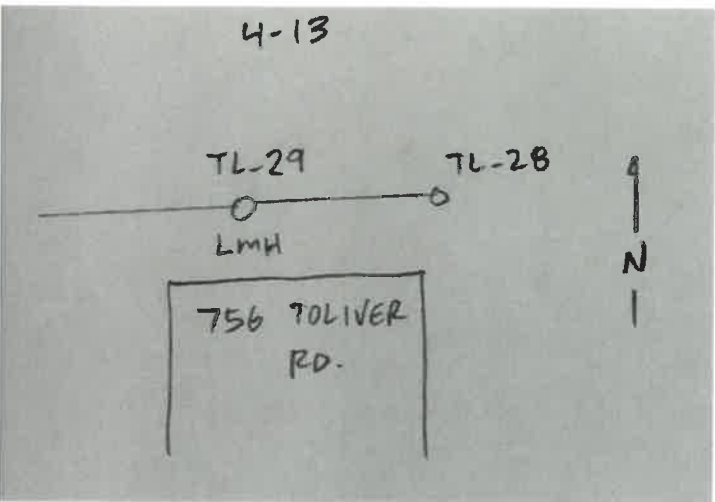
- Manhole was leaking around rim and surrounding cracks around manhole.
- \_\_\_\_\_
- \_\_\_\_\_
- \_\_\_\_\_
- \_\_\_\_\_
- \_\_\_\_\_

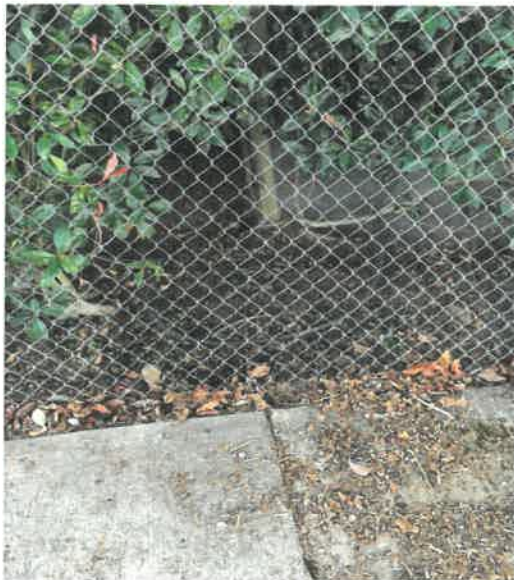
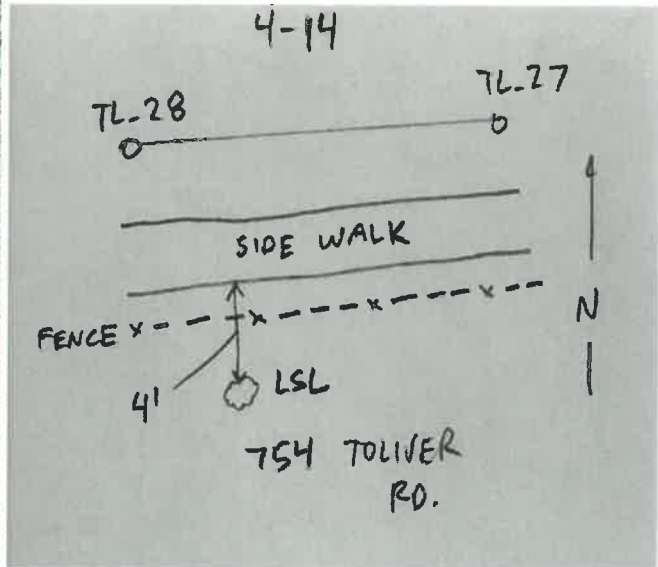
- Service lateral was leaking significantly immediately south of chain link fence. With brush, it was difficult to see, but there was a large amount of smoke, and the area was recessed.
- Also refer to aerial on following page.
- \_\_\_\_\_
- \_\_\_\_\_
- \_\_\_\_\_
- \_\_\_\_\_

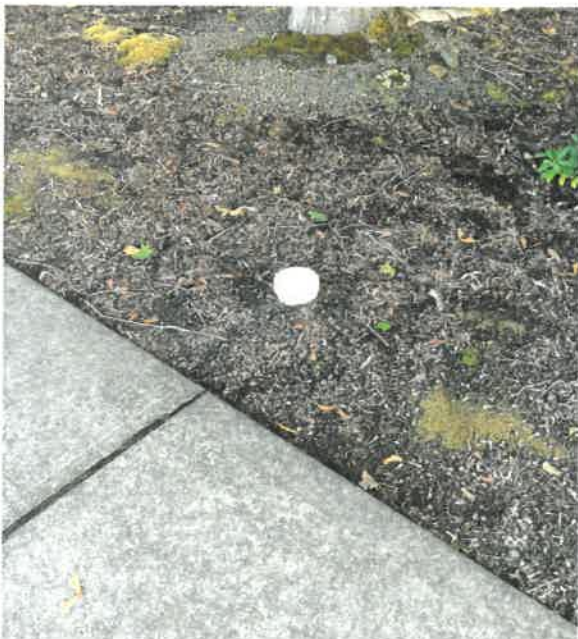
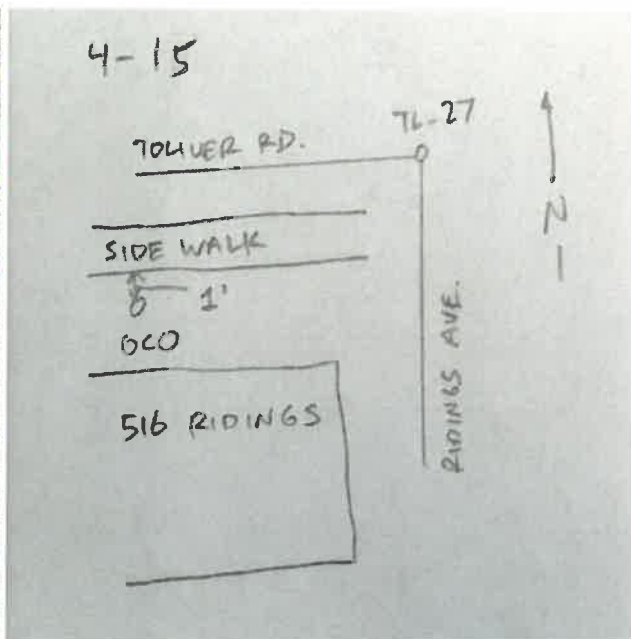
- Open cleanout west of side walk. Exposed pipe was cracked.
- 
- 
- 
- 
-

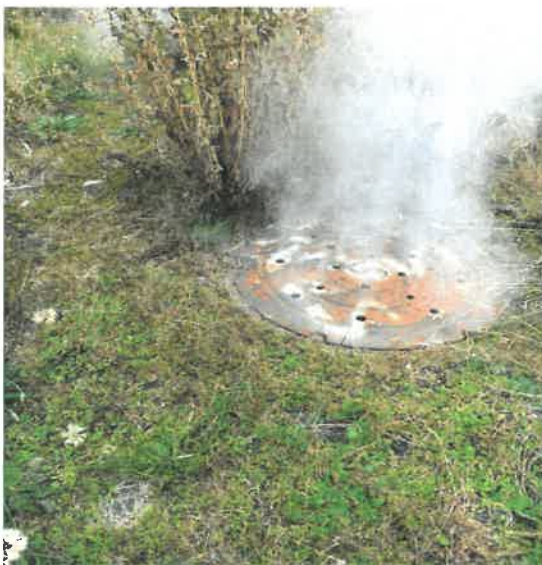
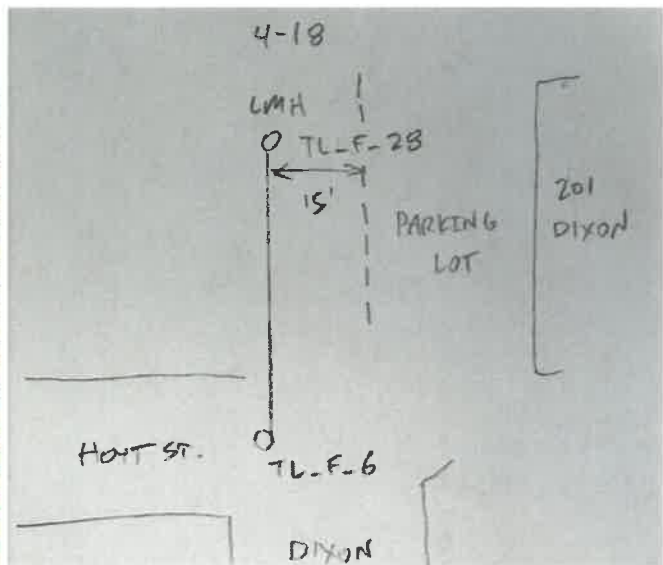
- Manhole located to the west of the parking lot was leaking into surrounding soil.
- Also refer to the aerial on the following page.
- 
- 
-

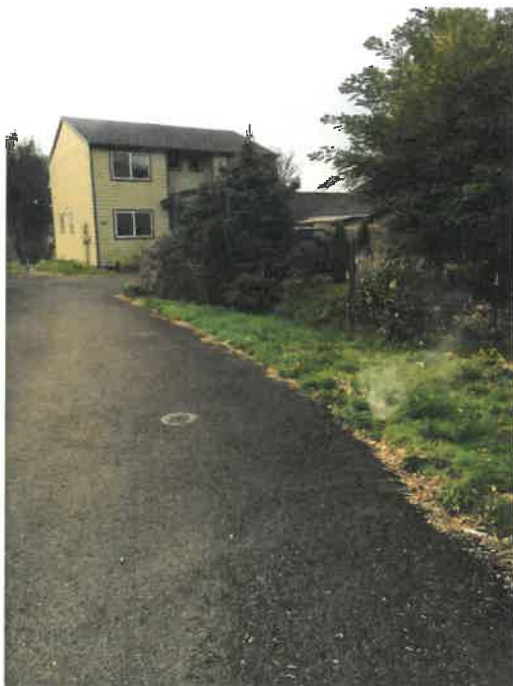
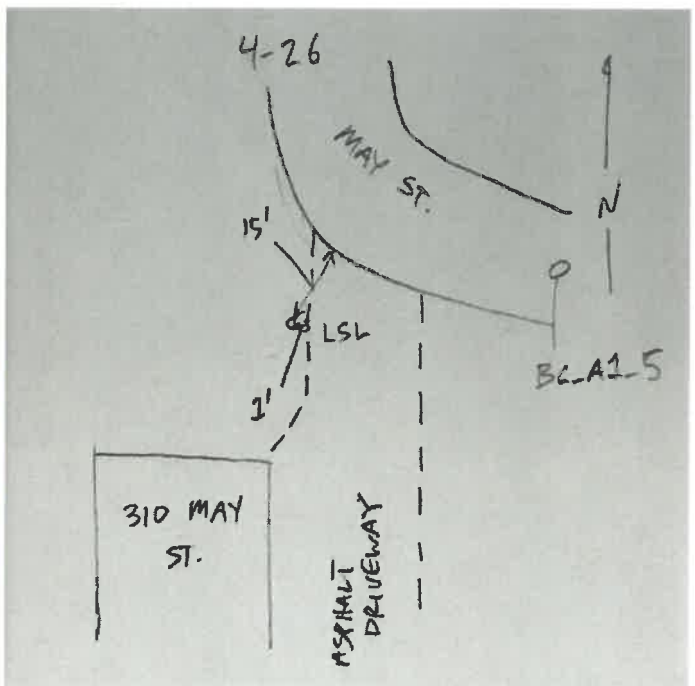
- Service lateral was leaking to the west of the drive way, approximately 15 ft from May Street.
- Also refer to aerial on following page.
- 
- 
-

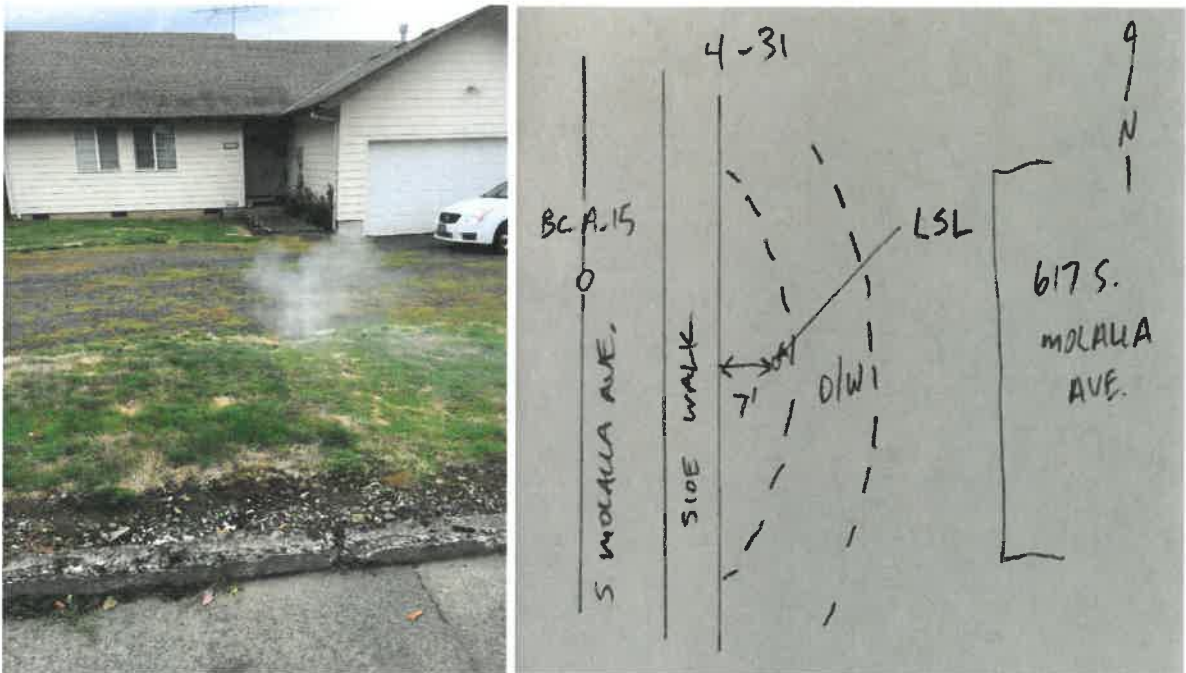
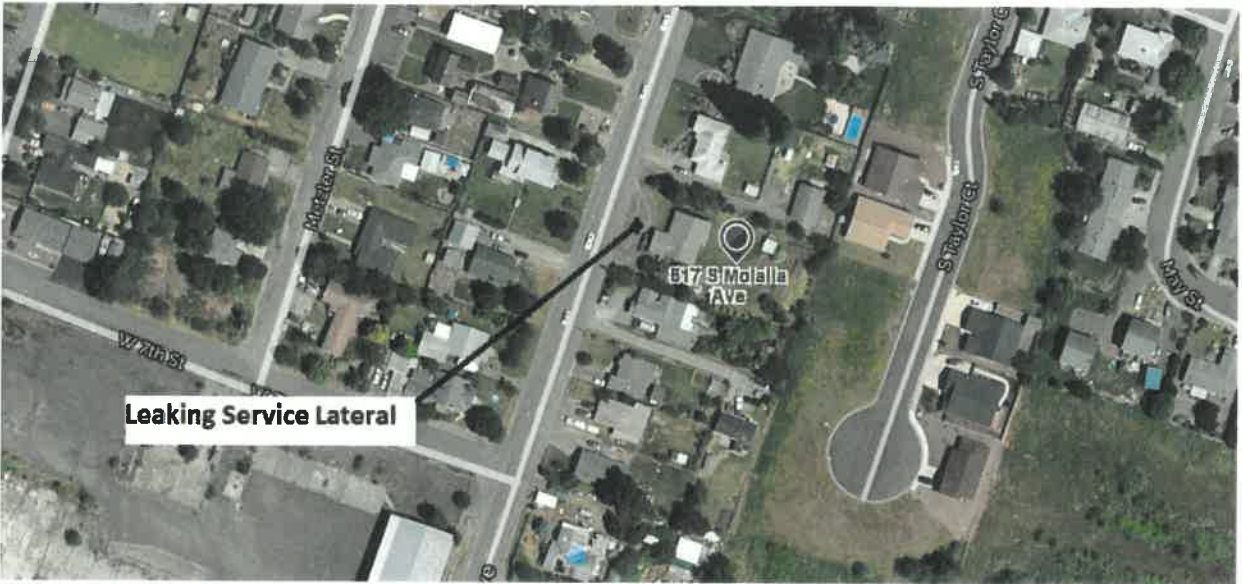
- Leaking service lateral or open cleanout located on western edge of gravel drive way. Smoke exited significantly.
- Also refer to aerial on following page.
- 
- 
-
