PROJECT NAME City of Molalla
WWFCSMP

WASTEWATER FACILITY AND COLLECTION SYSTEM MASTER PLAN VOLUME 1

AUGUST 2018

The Dyer Partnership Engineers & Planners, Inc.

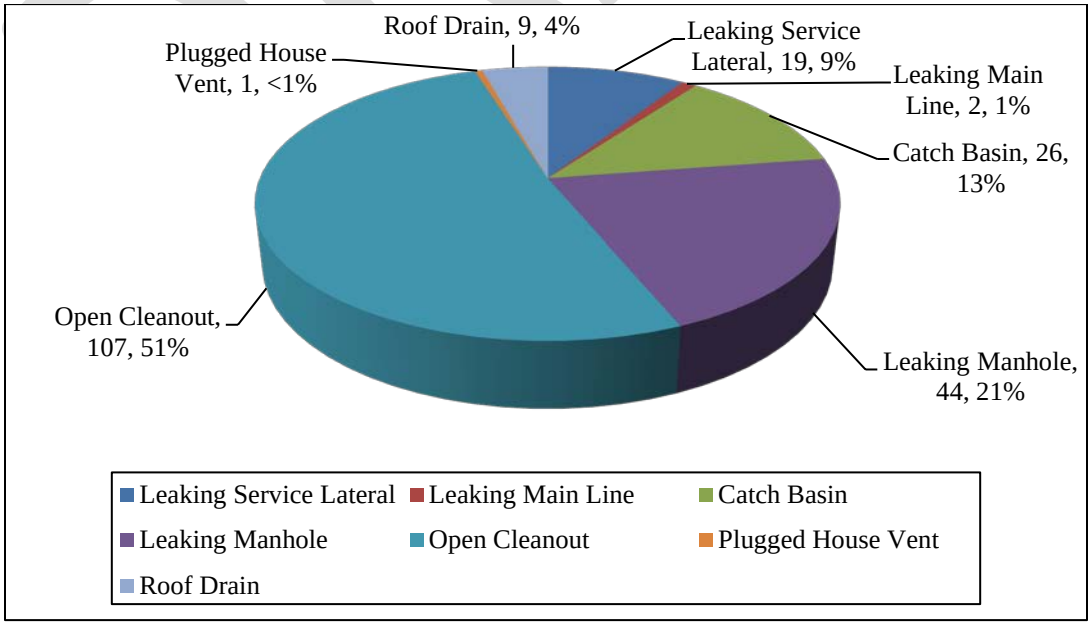
FIGURE 2.1.1
SMOKE TESTING RESULTS SUMMARY
NUMBER OF VIOLATIONS BY TYPE

Table 2.1.1 lists the type and number of deficiencies that were indicated by the presence of smoke. Figure 2.1.1 illustrates the number and percentage of type of deficiency. Figures 2.1.2 and 2.1.3, located at the end of this section, are maps of the City's collection system, which show the sewer lines that were tested, the location of each deficiency discovered, and which manholes were smoked. Table 2.1.2 provides a reference to each of these individual deficiency reports according to the type of deficiency. A table of the smoke testing report number and its associated deficiency is included in Appendix A.

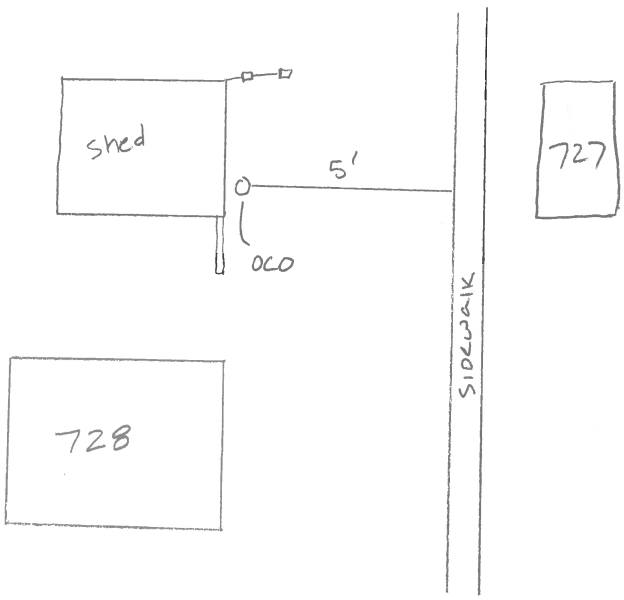
- Located at Unit #728 of Twin Firs Mobile Home Park
- Smoke coming from open cleanout, located behind the shed
-
-
-

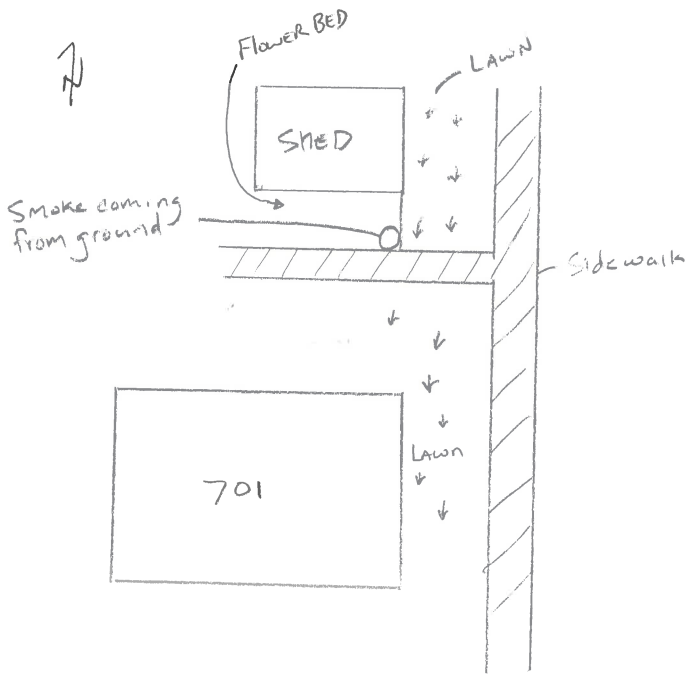
- Located at Unit #701 of Twin Firs Mobile Home Park
- Smoke coming from ground in the flower bed, next the shed.
-
-
-

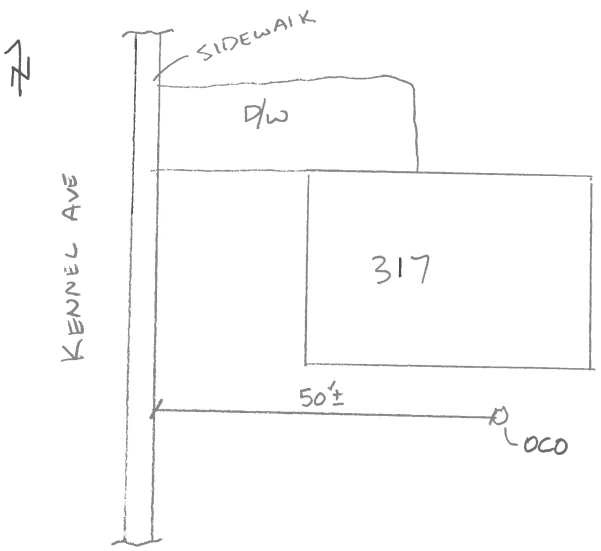
- Smoke coming from open cleanout
-
-
-
-

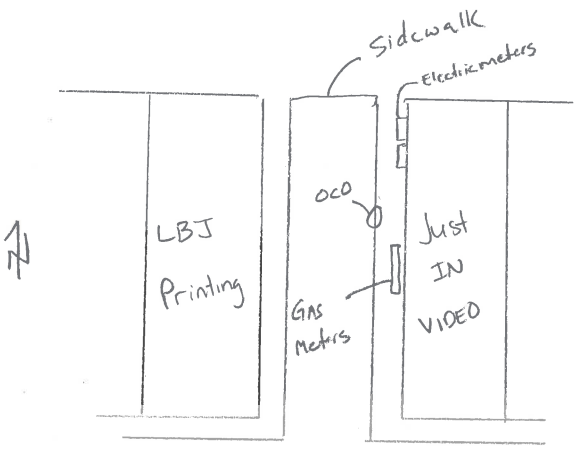
- Smoke coming from cleanout cap,
- Located in the sidewalk along the west wall of building 270 N. Molalla (Just In video)
-
-
-

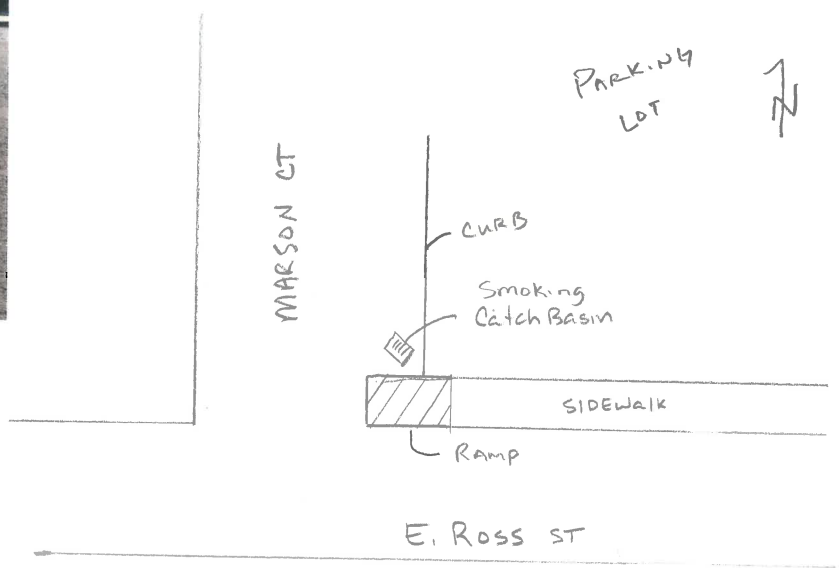
- Smoke coming from catch basin
- Located in the northeast corner of intersection of E. Ross Street & Marson Court, on the north side of the asphalt ramp.
-
-
-

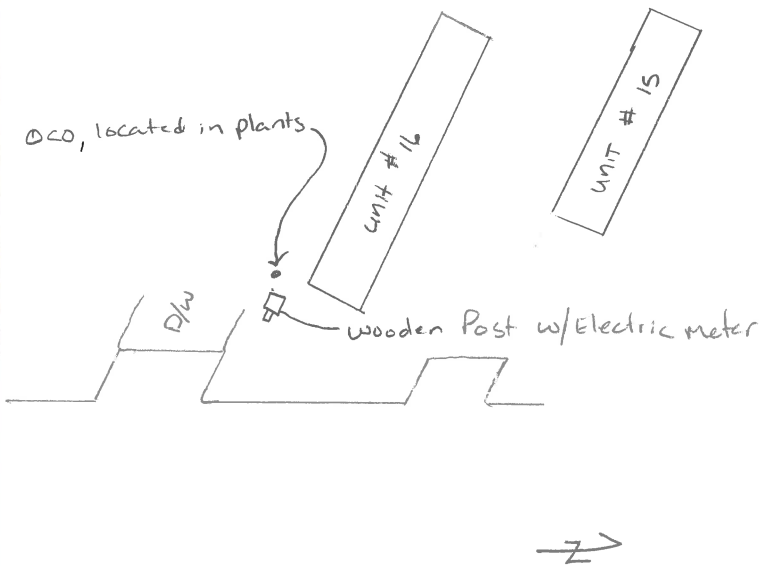
- Smoke coming from open cleanout with no cap
- Located in Molalla Mobile Manor
-
-
-

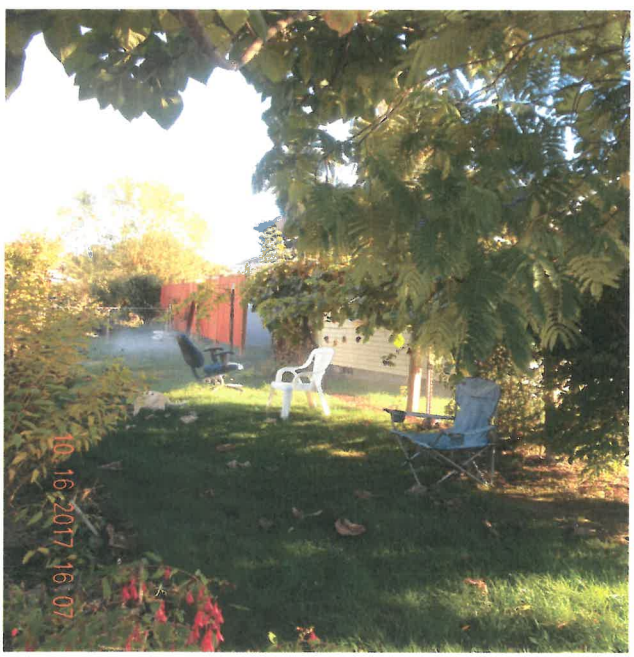
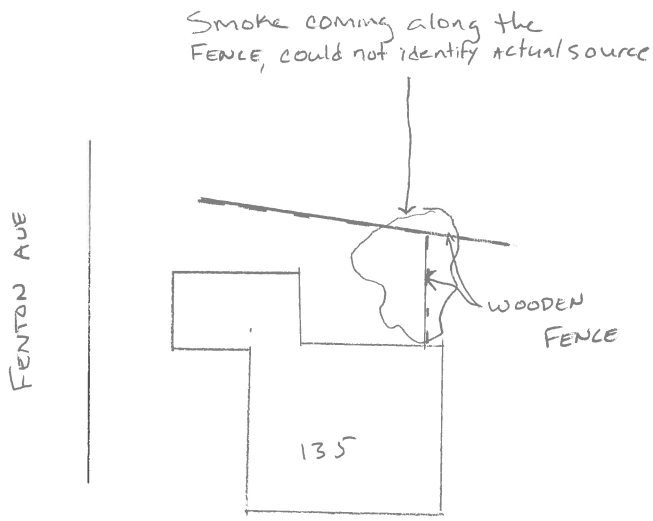
- Smoke coming behind the fence, could not identify the source.
-
-
-
-

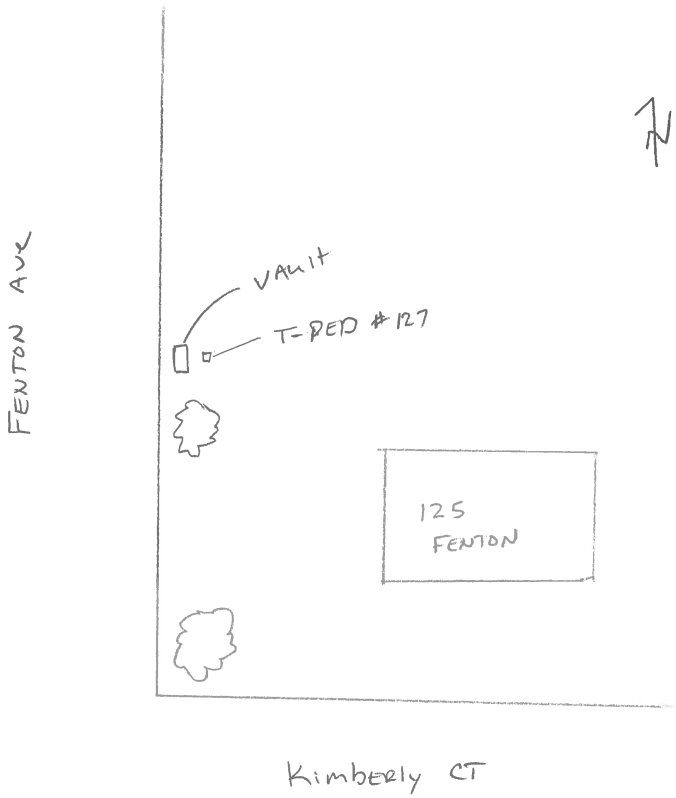
- Smoke coming out of communication box located in front of telephone pedestal #127
-
-
-
-

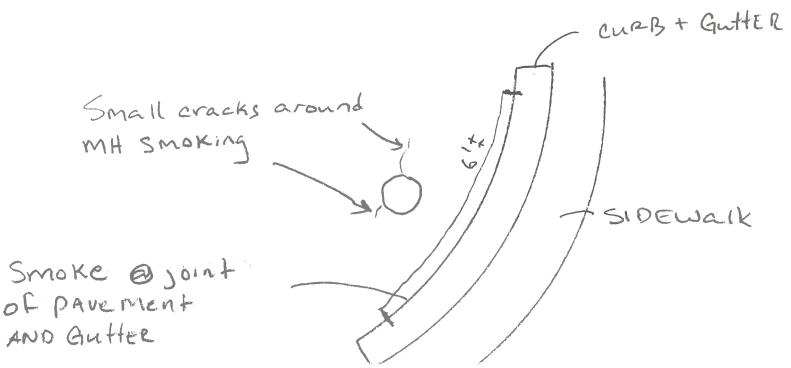
- Smoke leaky out around the rim of the manhole, the cracks in the road around the manhole and along the joint between the ac pavement and concrete gutter
-
-
-
-

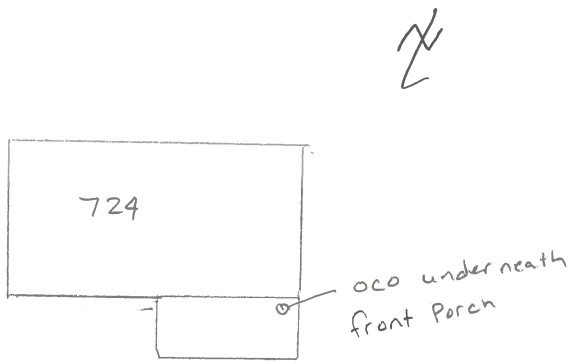
- Smoke coming out of open clean located under the front deck.
-
-
-
-

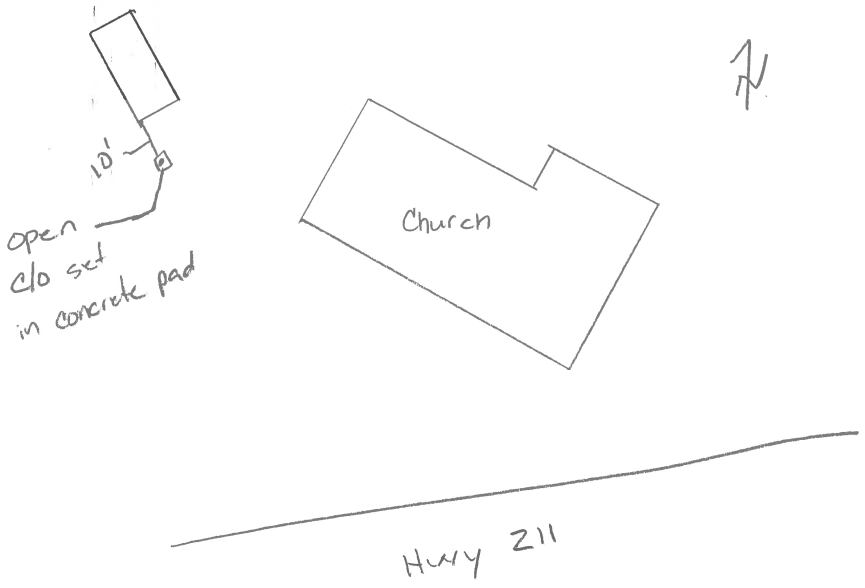
- Smoke coming out of open cleanout next to shop T@ Church of the Nazarene
-
-
-
-

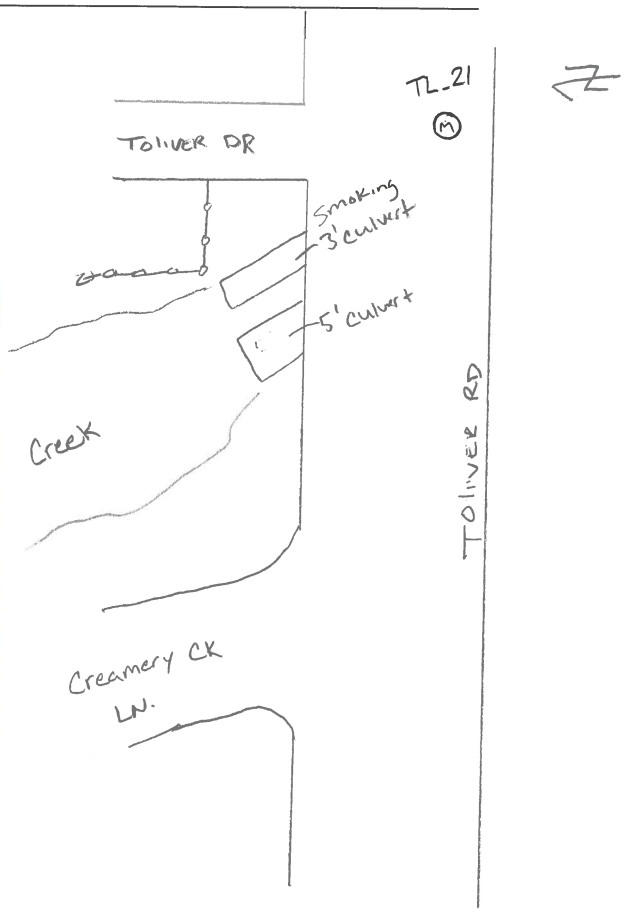
- Smoke coming out of the 36" diameter culvert. Smoke machine was set up on MH TL_21
-
-
-
-

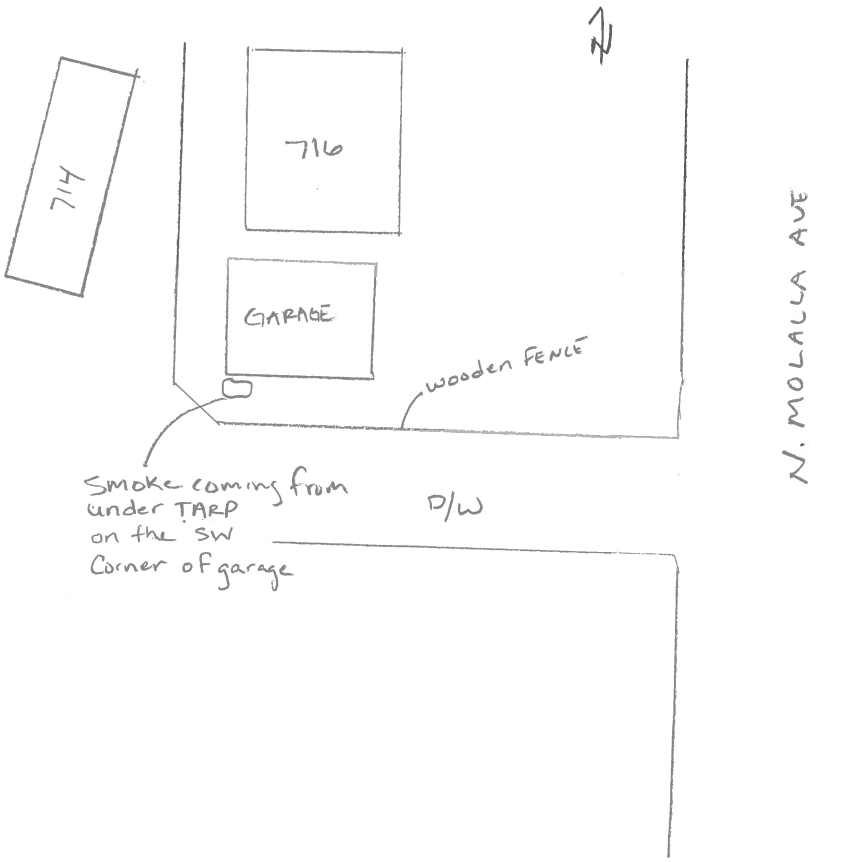
- Smoke coming out from under the tarp on the southwest corner of the garage
-
-
-
-

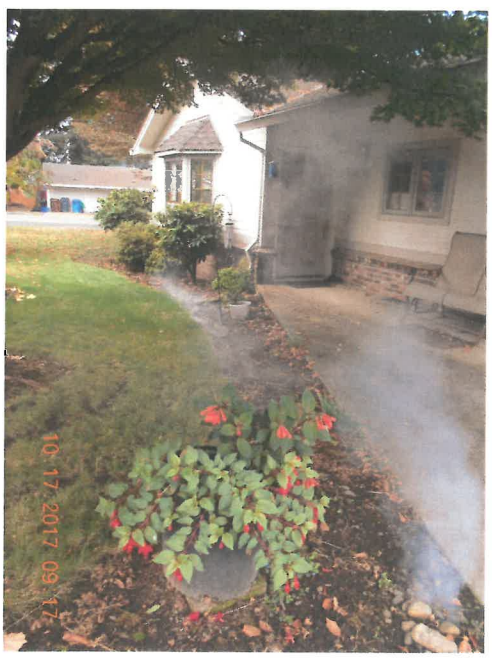
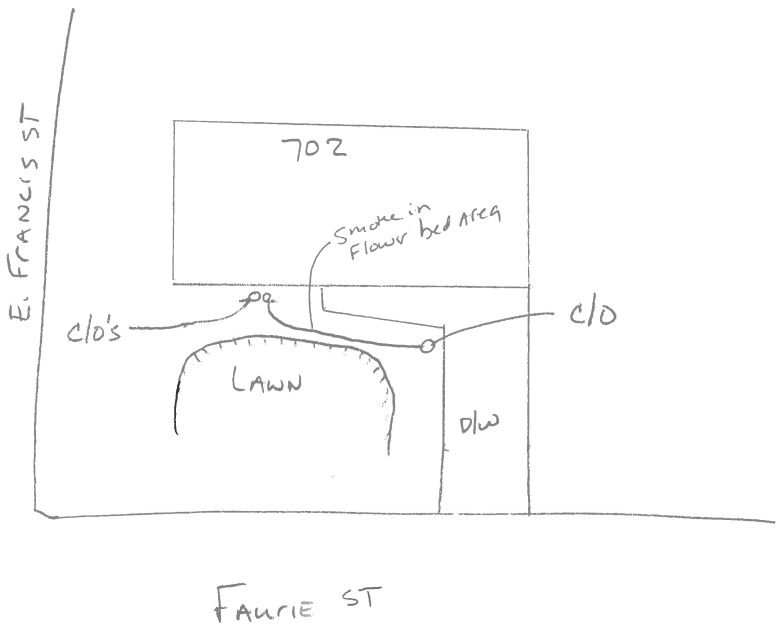
- Smoke coming out from cleanout with rocks over it and along the lateral to another cleanout located close to the house. The lateral follows the edge of the grass.
-
-
-
-

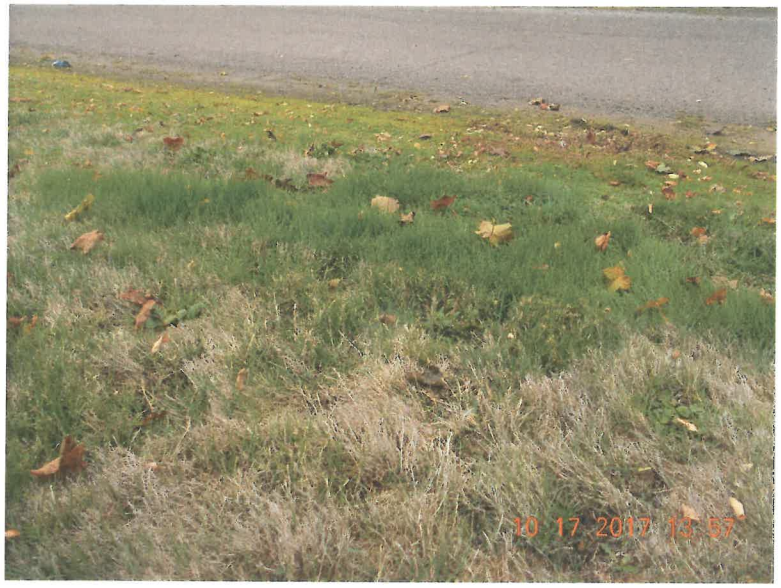
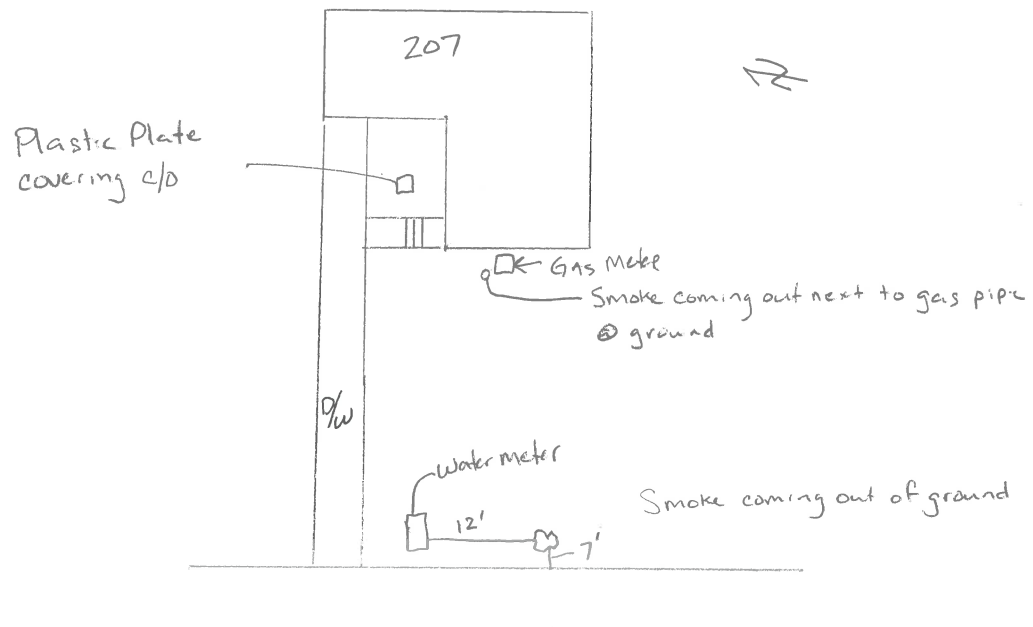
No.	Description
1	OCO
2	LSL – smoke coming from ground
3	Smoke coming from ground

- Resident has a plastic plate fastened down over the cleanout, smoke coming out of the ground near the road and the gas meter
-
-
-
-

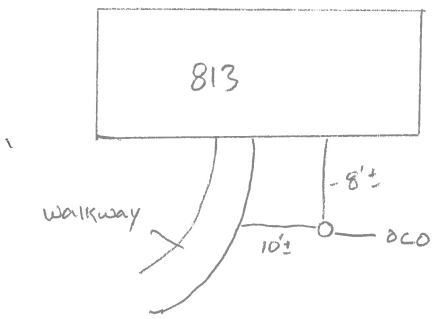
- Smoke coming out of cleanout
-
-
-
-

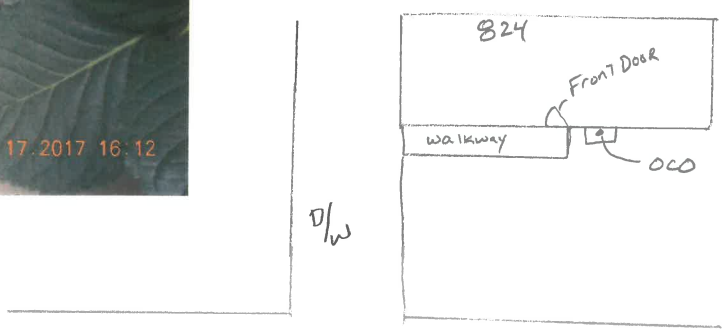
- Smoke coming out of cleanout, located in recessed house vent
-
-
-
-

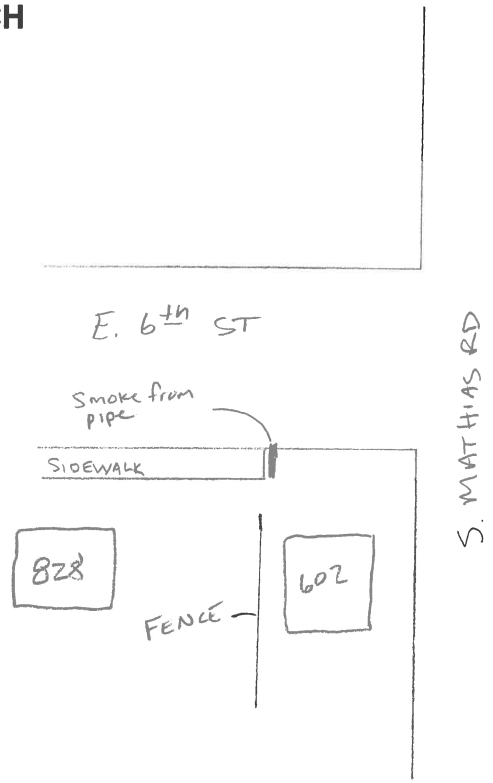
- Smoke coming out of drain located in the sidewalk
-
-
-
-

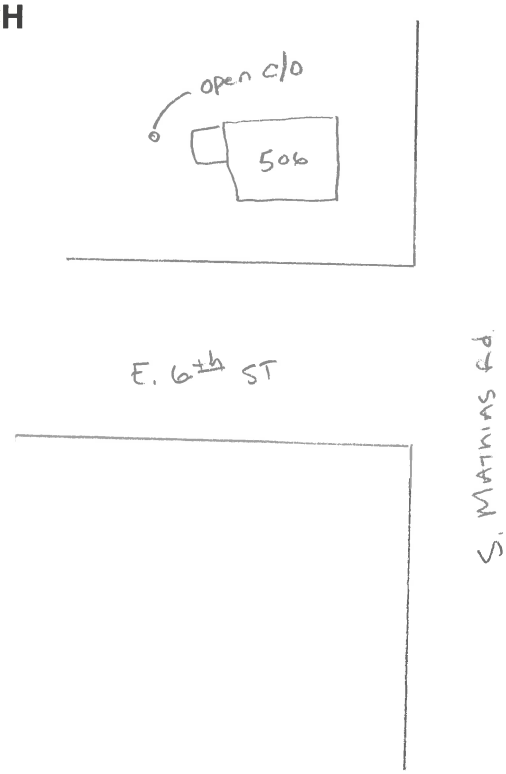
- Smoke coming out of cleanout with no cap
-
-
-
-

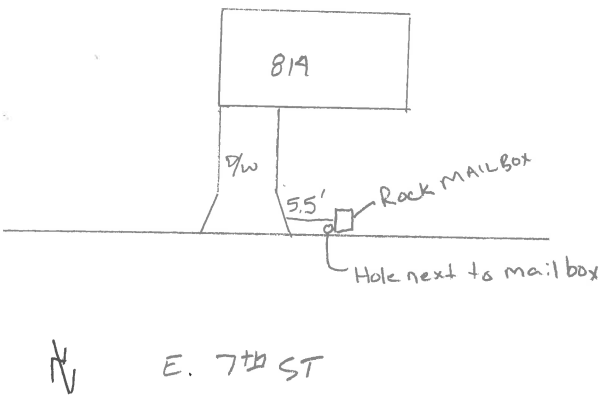
- Smoke coming out of hole in the ground next to the mailbox
-
-
-
-

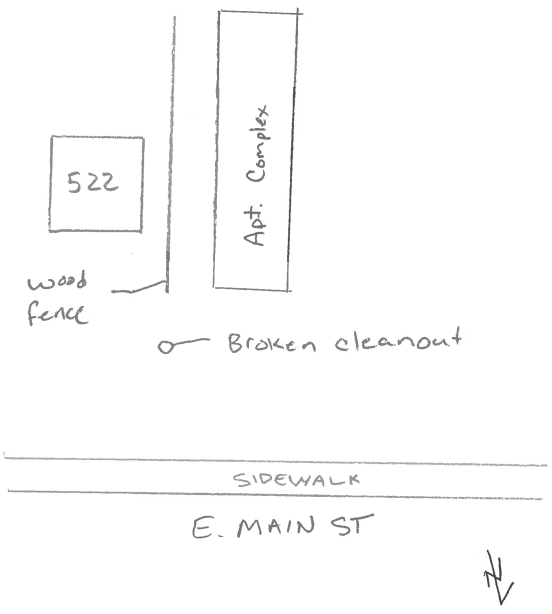
- Smoke coming out of broken cleanout
-
-
-
-

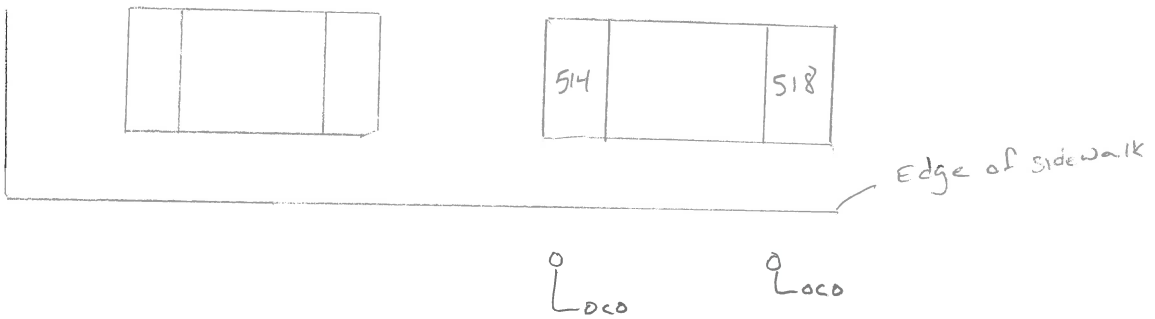
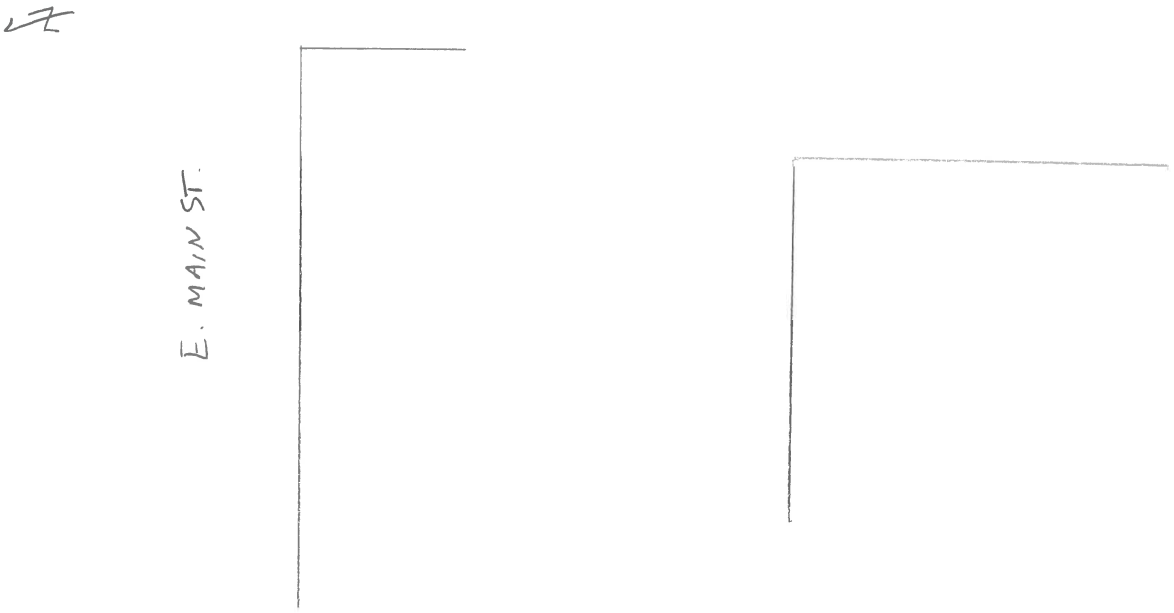
TESTING CODE			PHOTOGRAPHS	
LSL	=	Leaking Service Lateral	No.	Description
LML	=	Leaking Main Line	1	OCO for Unit #514
CB	=	Catch Basin	2	OCO for Unit #518
LMH	=	Leaking Manhole		
OCO	=	Open Cleanout		
PHV	=	Plugged House Vent		
RD	=	Roof Drain

- Smoke coming out of cleanout cap for both units
-
-
-
-

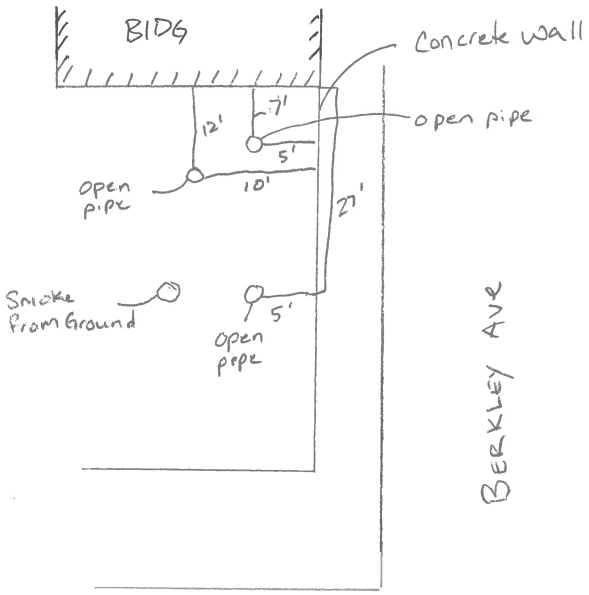
- Vacant lot - has multiple open pipes and multiple area where smoke was coming from the ground.
-
-
-
-

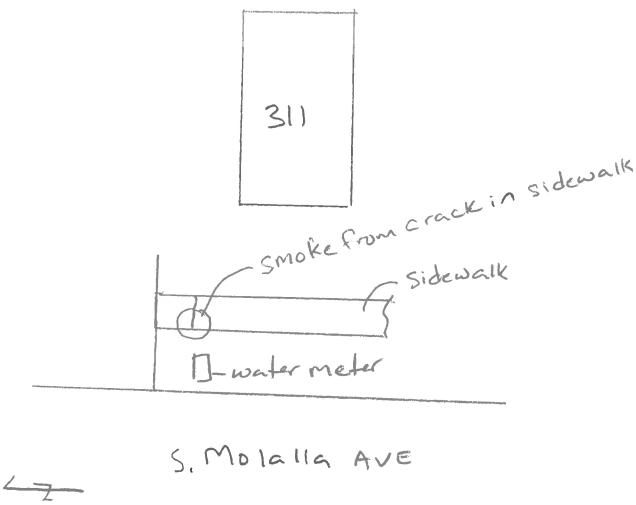
- Smoke coming out of the joint in the concrete sidewalk
-
-
-
-

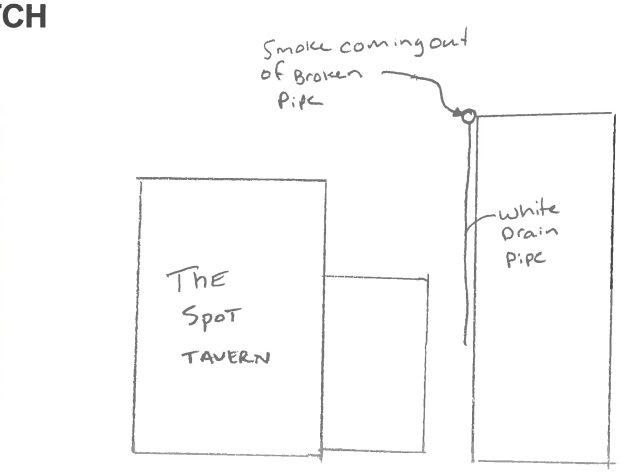
- 4" white drain pipe located on the north side of the building. Smoke coming out of the pipe at the northeast corner of the building. Hole in the pipe.
-
-
-
-

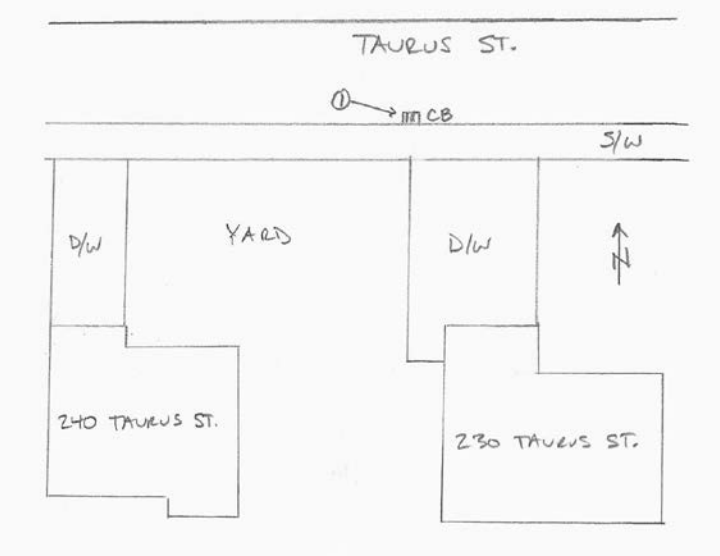
- Catch Basin on the south side of Taurus St., in front of 230 & 240 Taurus St.
-
-
-
-

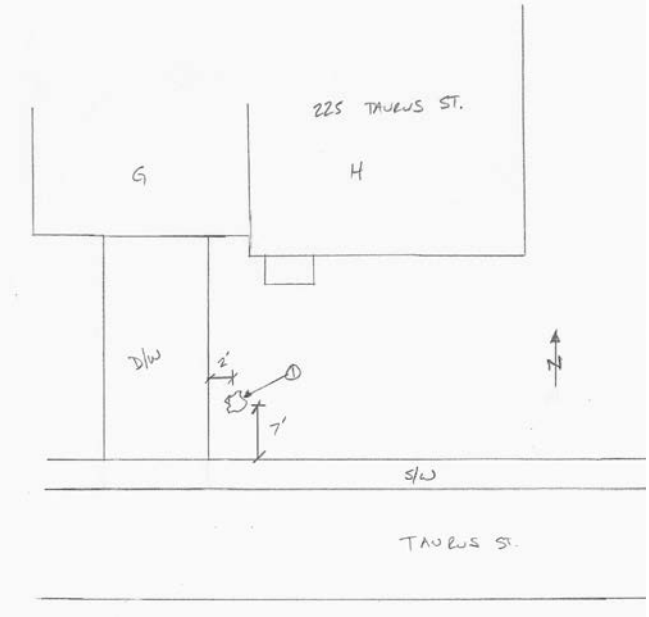
- Smoke in front yard, just east of driveway edge. No cleanout found in area of smoke.
-
-
-
-

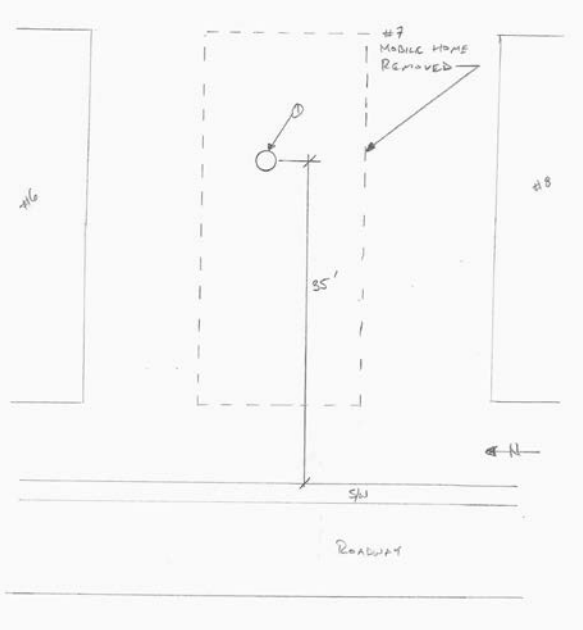
- Mobile home has been removed from Lot #7. Sewer connection wasn't capped and covered with plywood.
-
-
-
-

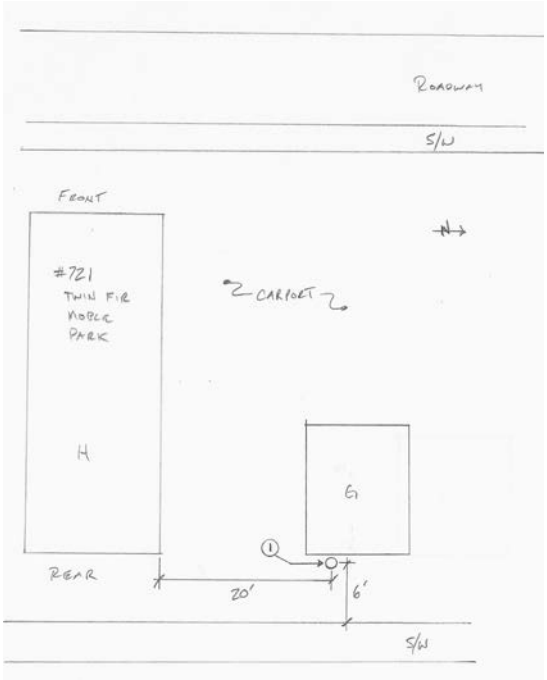
- Open sewer connection/cleanout behind garage.
-
-
-
-

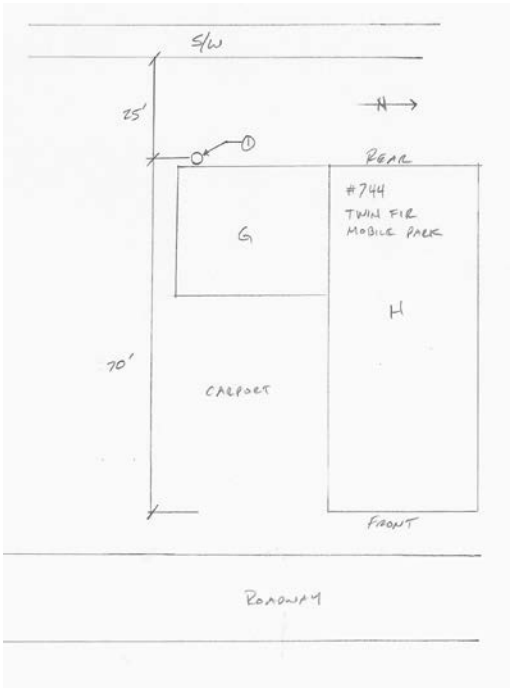
- Broken sewer cleanout cap behind garage.
-
-
-
-

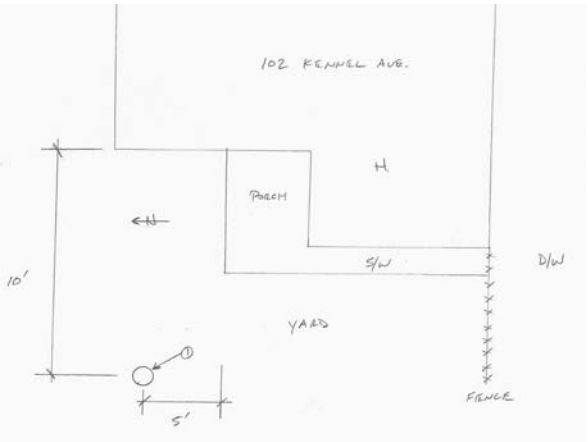
- Broken sewer cleanout cap in front yard.
-
-
-
-

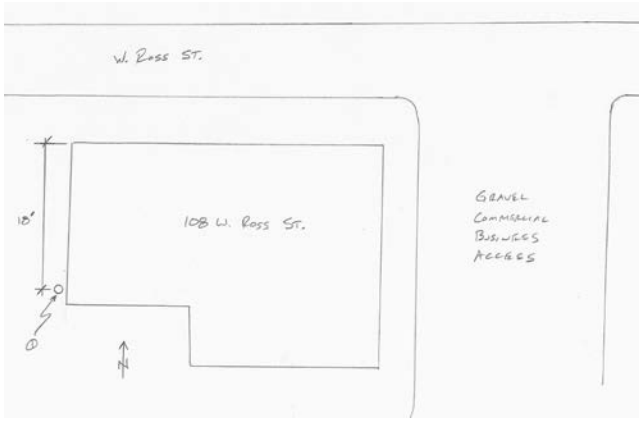
- Cleanout without cap. Covered with cinder block.
-
-
-
-

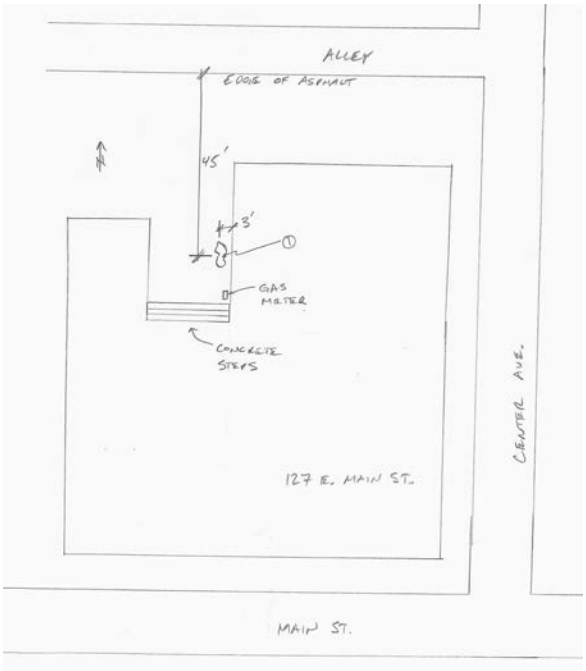
- Smoking through the gravel. No sign of a cleanout in the area but possibly buried.
-
-
-
-

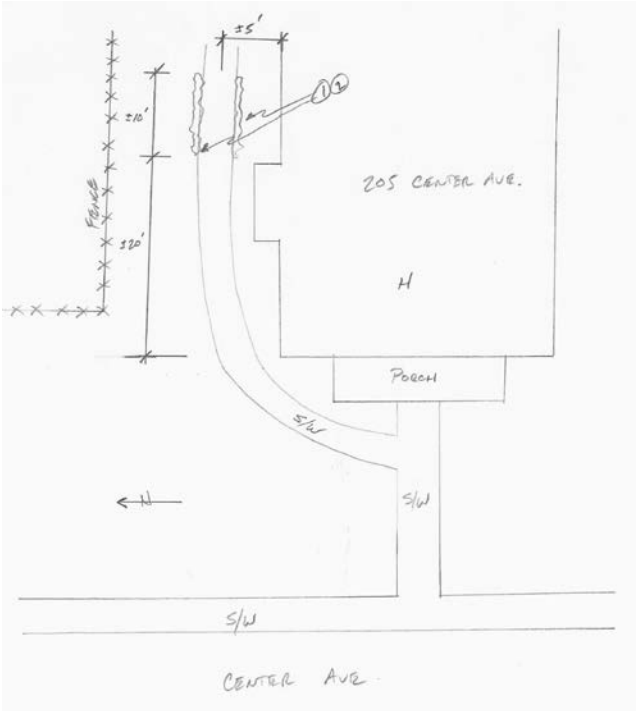
- A 10' section of concrete walkway on the north side of the residence had smoke coming up on both sides of the walk.
-
-
-
-

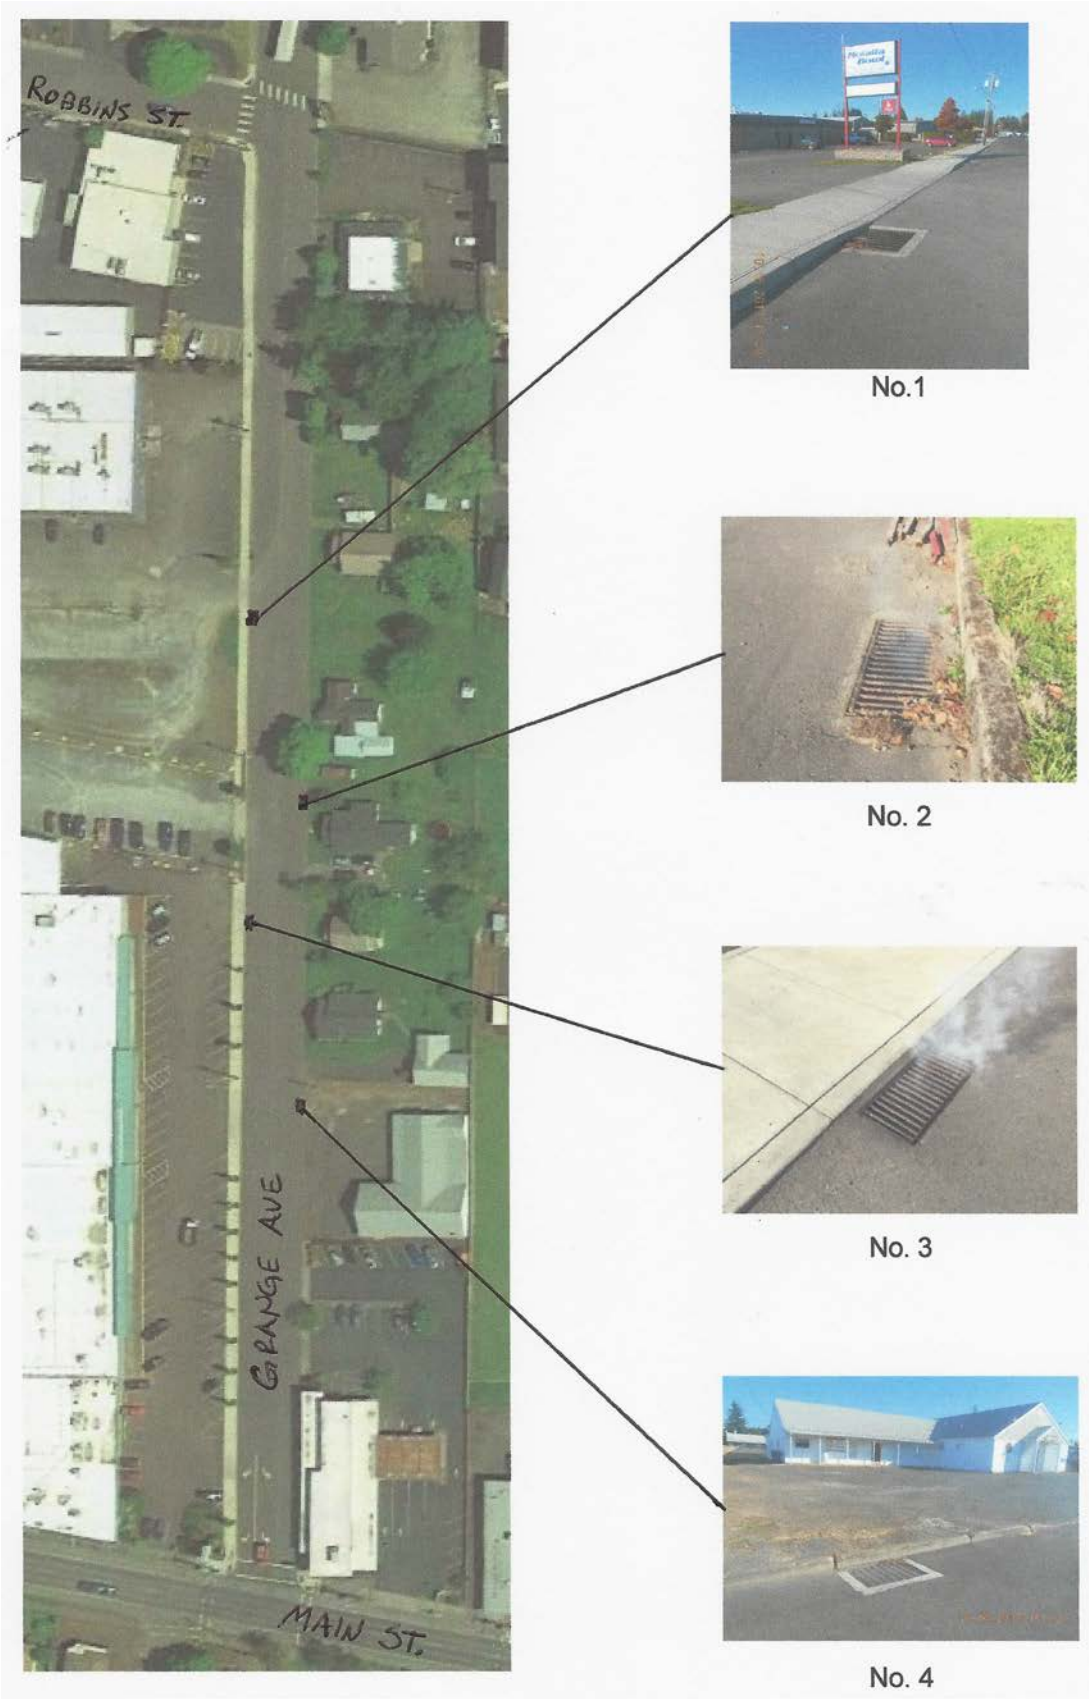
No.	Description
1	Near 150 Grange Ave. – west side of road
2	Near 139 Grange Ave. – east side of road
3	Near 122 Grange Ave. – west side of road
4	Near 127 Grange Ave. – east side of road

- Smoke was coming from the city storm system catch basins on Grange Ave.
- See attached aerial for catch basin locations and pictures.
-
-
-

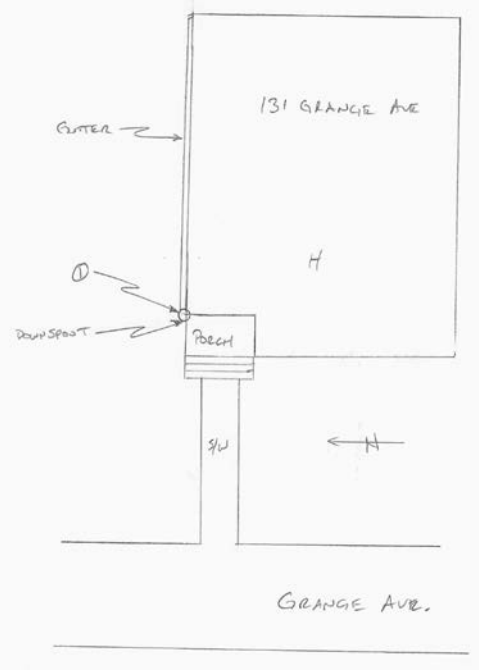
- Smoke coming from gutter/downspout on northwest corner of house.
-
-
-
-

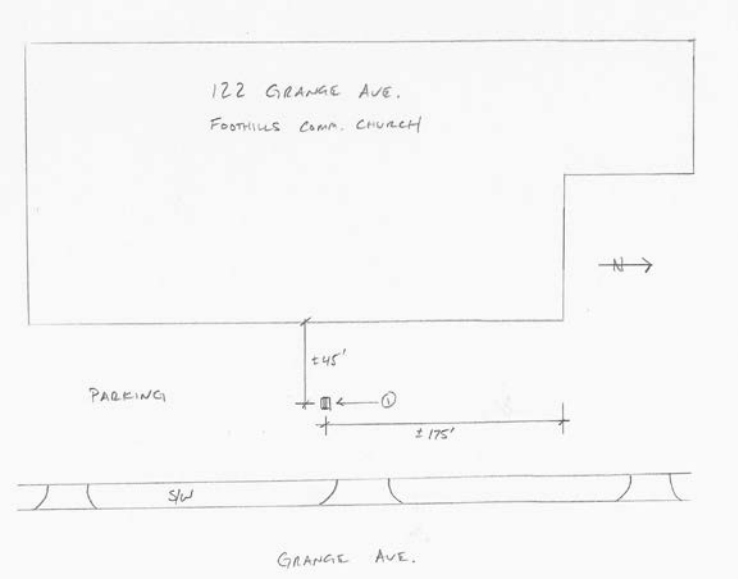
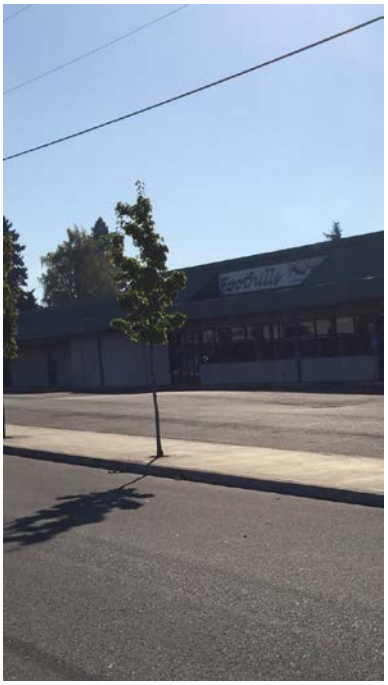
- Small amount of smoke coming from the parking lot catch basin.
-
-
-
-

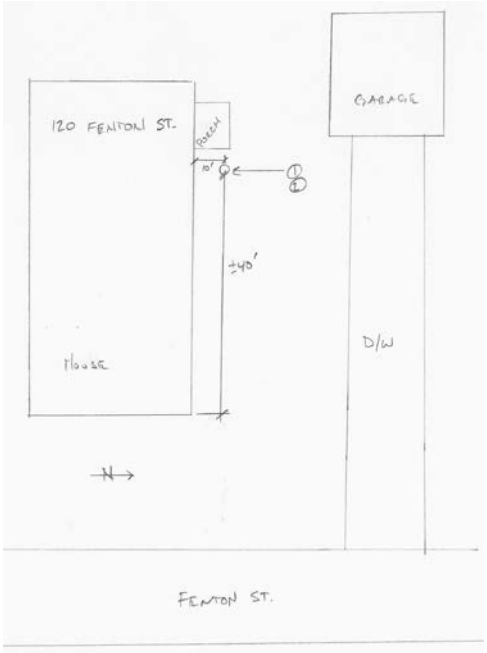
- Smoke from cleanout area. It appears the area is currently under repair/construction.
-
-
-
-

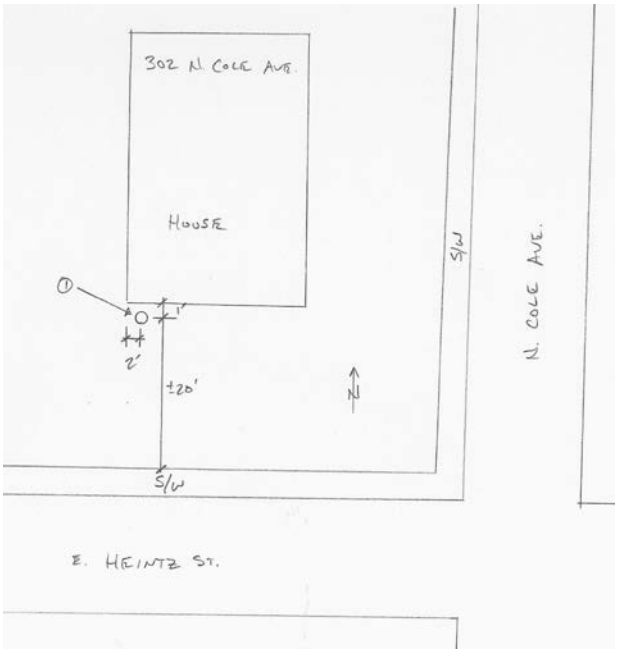
TESTING CODE			PHOTOGRAPHS	
LSL	=	Leaking Service Lateral	No.	Description
LML	=	Leaking Main Line	1	Smoke from broken cleanout cap
CB	=	Catch Basin		
LMH	=	Leaking Manhole		
OCO	**=**	**Open Cleanout**		
PHV	=	Plugged House Vent		
RD	=	Roof Drain

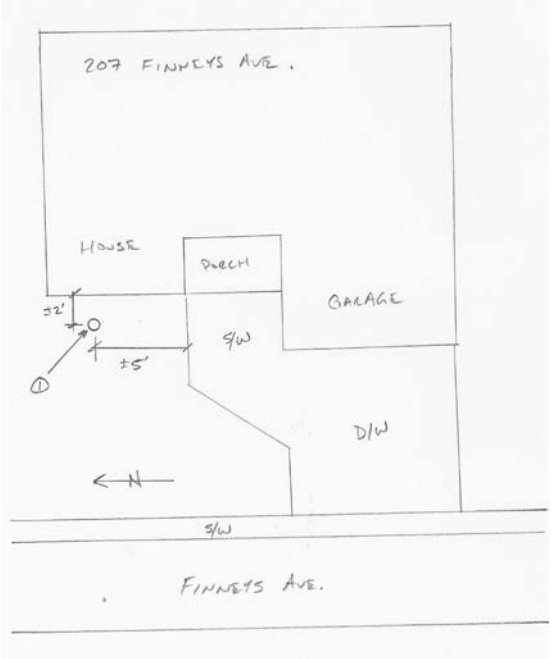
No.	Description
1	Smoke from broken cleanout cap

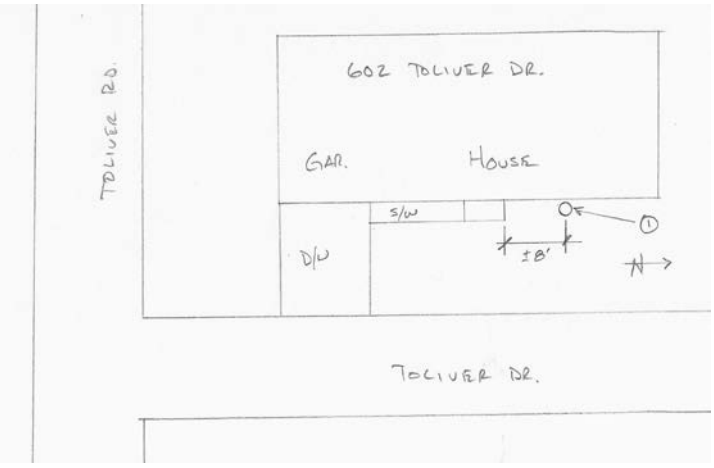
TESTING CODE			PHOTOGRAPHS	
LSL	=	Leaking Service Lateral	No.	Description
LML	=	Leaking Main Line	1	Smoke from broken cleanout cap
CB	=	Catch Basin		
LMH	=	Leaking Manhole		
OCO	**=**	**Open Cleanout**		
PHV	=	Plugged House Vent		
RD	=	Roof Drain

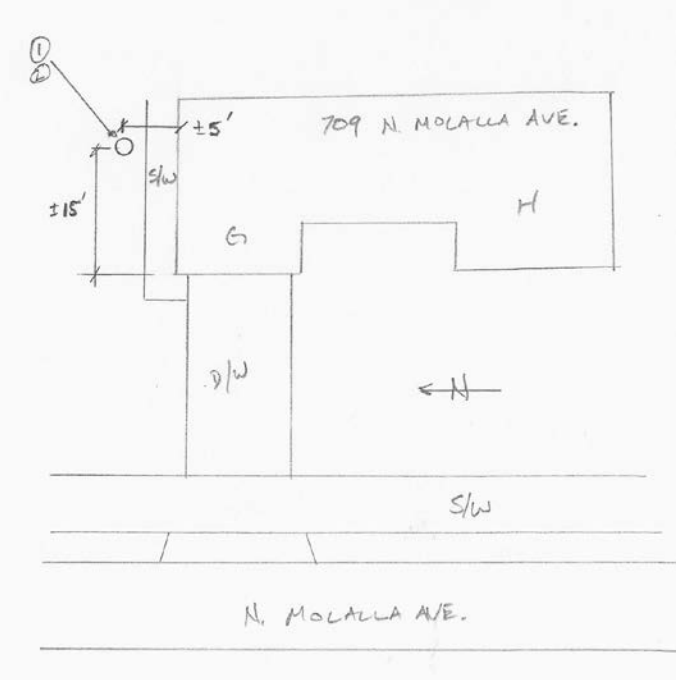
- Broken cleanout cap on north side of garage, adjacent to concrete sidewalk.
-
-
-
-

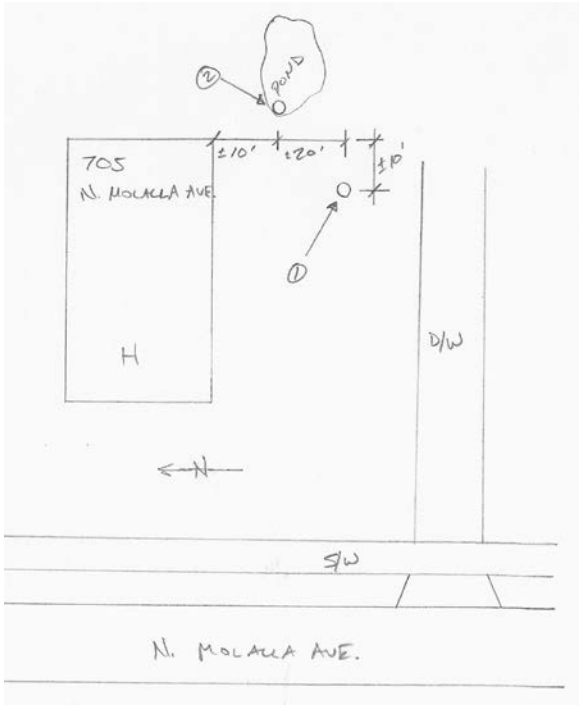
- Broken cleanout cap on south side of house, between house and driveway.
- Smoke from landscape pond overflow pipe. Pond is southeast of house.
-
-
-

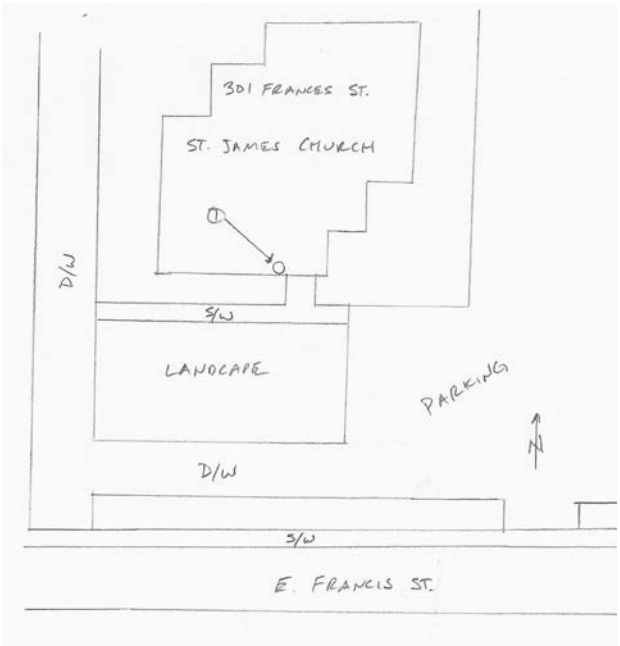
- Smoke coming from gutter on the south side of the main church building.
-
-
-
-

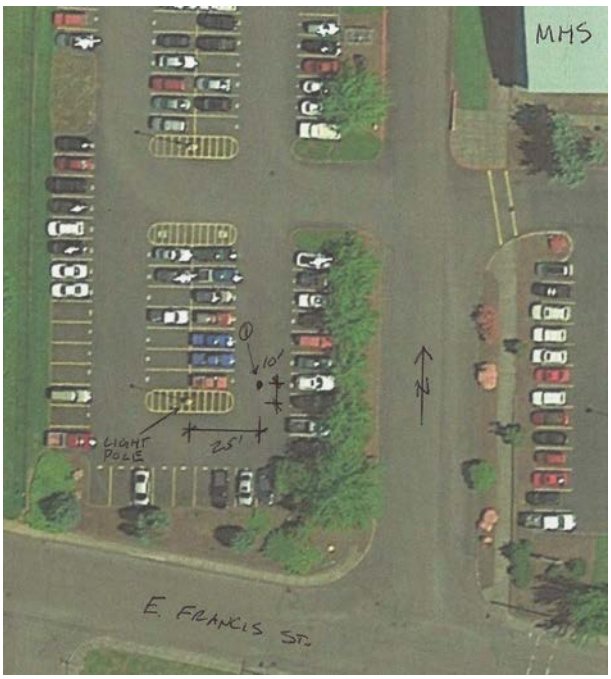
- Smoke coming from cleanout in the southwest parking lot of Molalla High School.
-
-
-
-
