PROJECT NAME City of Molalla
WWFCSMP

WASTEWATER FACILITY AND COLLECTION SYSTEM MASTER PLAN VOLUME 1

AUGUST 2018

The Dyer Partnership Engineers & Planners, Inc.

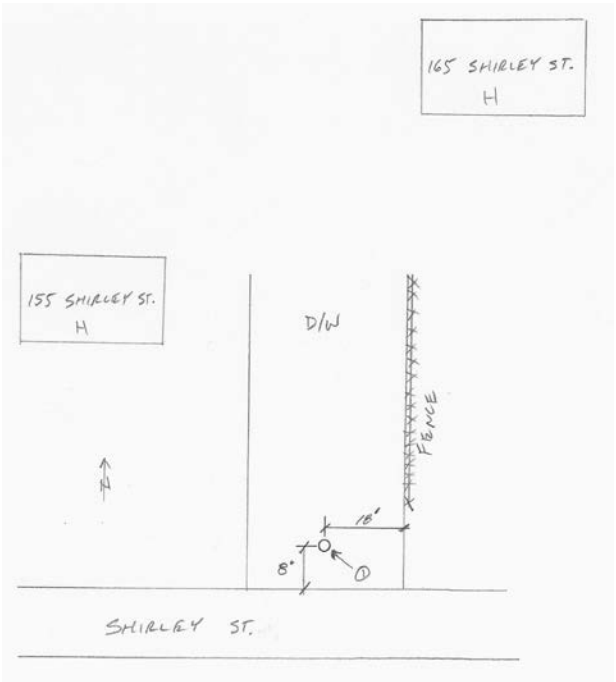
TESTING CODE			PHOTOGRAPHS	
LSL	=	Leaking Service Lateral	No.	Description
LML	=	Leaking Main Line	1	Smoke from driveway cleanout
CB	=	Catch Basin		
LMH	=	Leaking Manhole		
OCO	**=**	**Open Cleanout**		
PHV	=	Plugged House Vent		
RD	=	Roof Drain

- Smoke coming from cleanout in the driveway serving flag lots at 165 Shirley St.
-
-
-
-

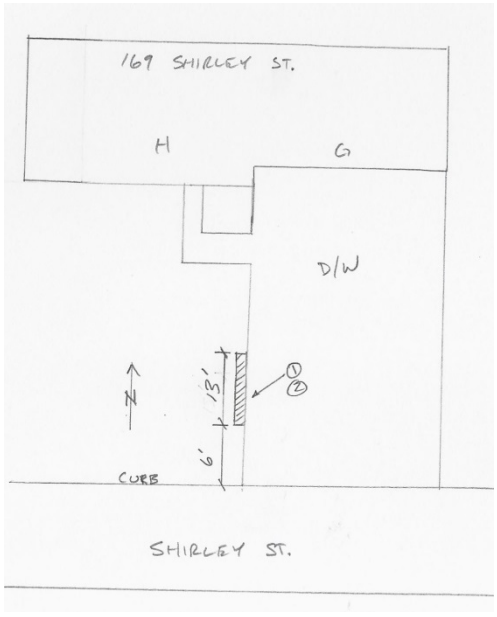
- .Smoke coming up from a 13' section of the driveway edge.
-
-
-
-

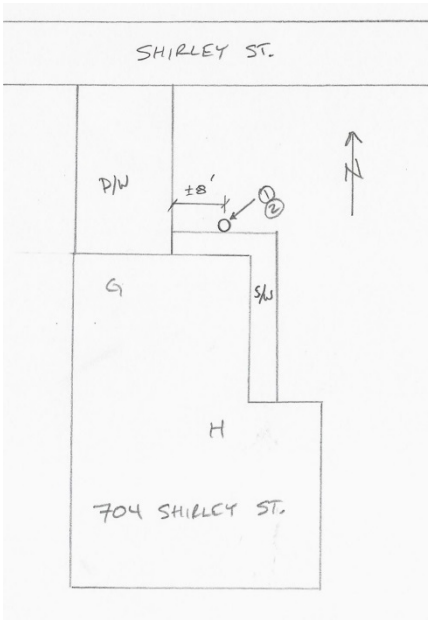
- .Smoke from broken cleanout cap, located next to concrete walkway, under planter.
-
-
-
-

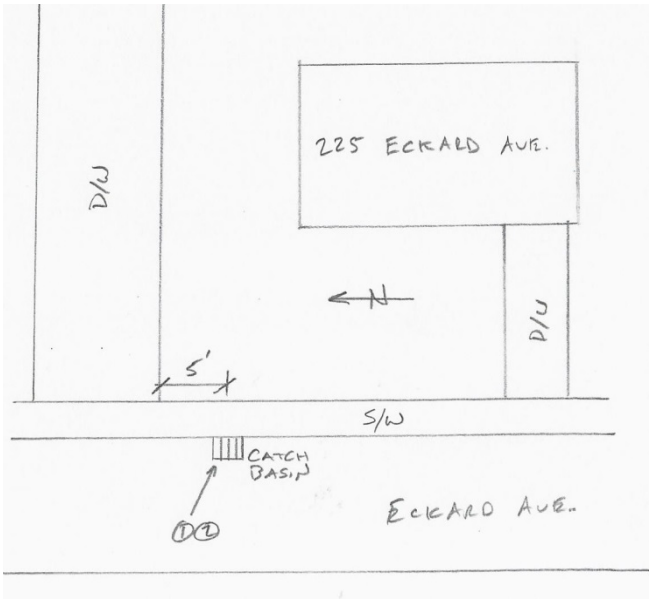
- Smoke coming from catch basin and crack in the concrete curb behind the catch basin on the east side of Eckerd Ave, approximately 75' south of manhole TL_A_21.
-
-
-
-

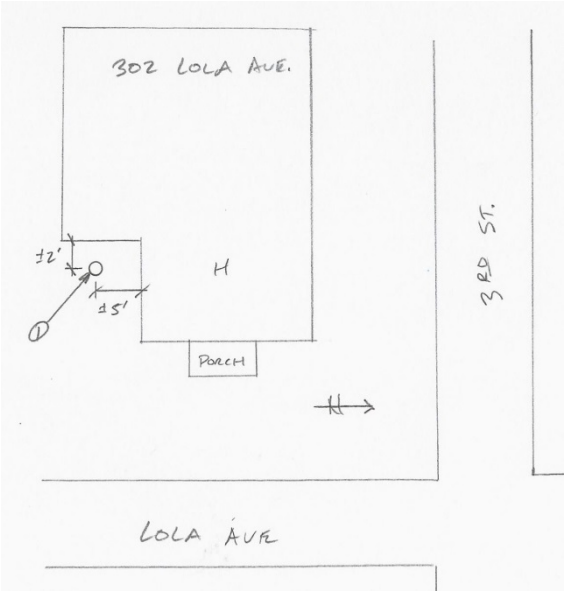
- Smoke from cleanout area. Could not confirm if the cap was broken or missing.
-
-
-
-

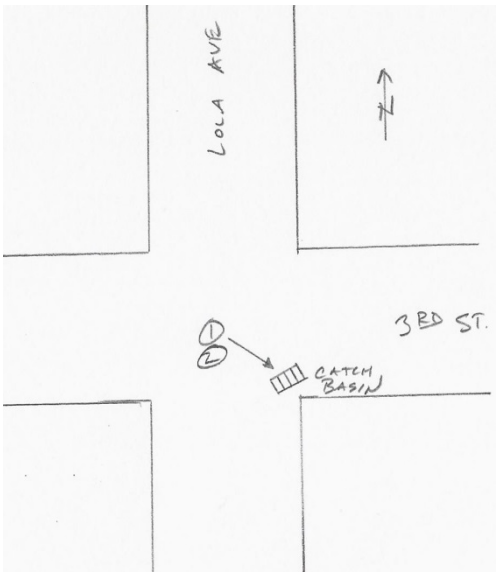
- Smoke from CB at the south east corner of Lola Ave. and 3rd St. intersection, with smoke machine setup on manhole TL_A_19.
-
-
-
-

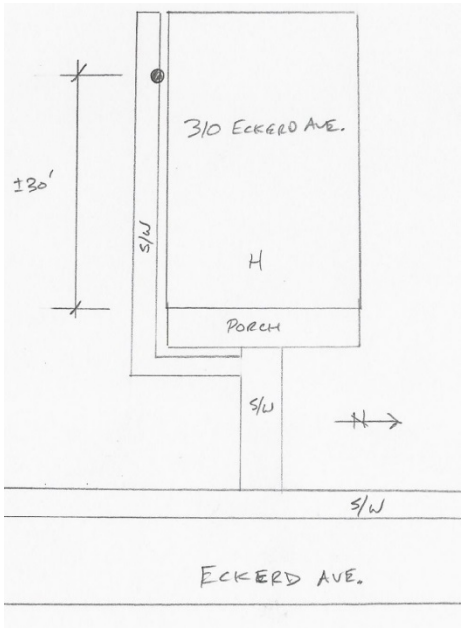
- Smoke from cleanout area. Could not confirm if the cap was broken or missing.
-
-
-
-

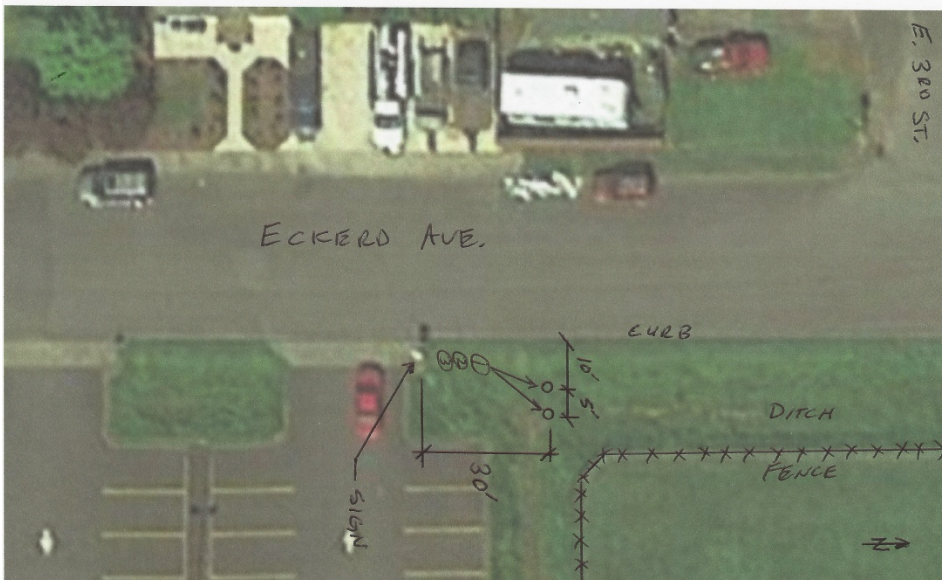
- Smoke from ditch running north/south on east side of Eckerd Ave. Smoke was near the northwest corner of the football field parking lot.
- See attached for pictures.
-
-
-

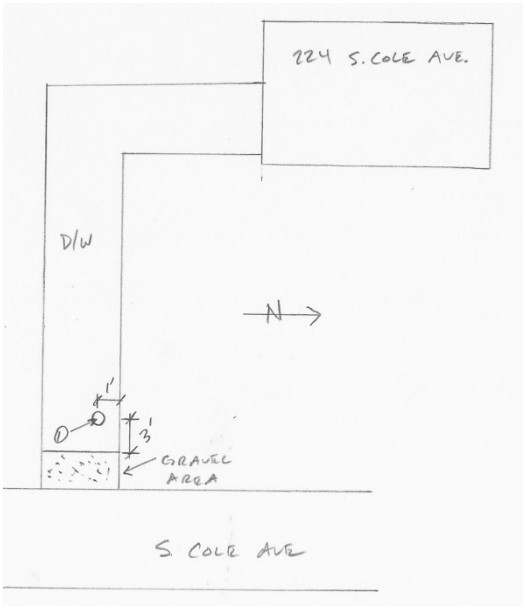
- Smoke from cleanout in flag lot driveway.
-
-
-
-

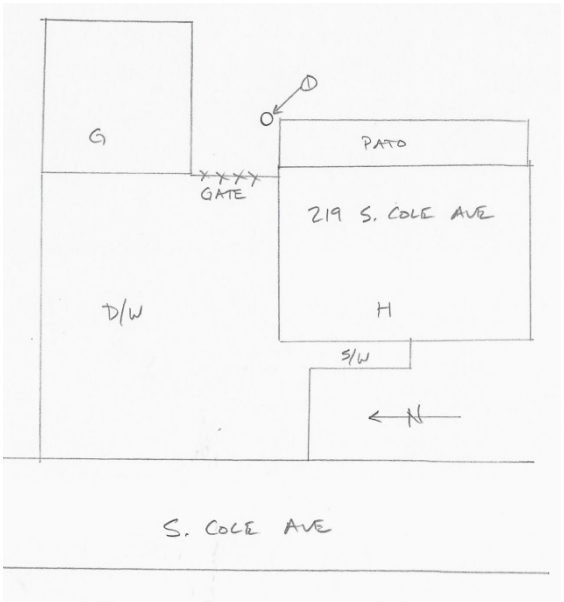
- Smoke from cleanout area. Could not confirm broken or missing cleanout cap.
-
-
-
-

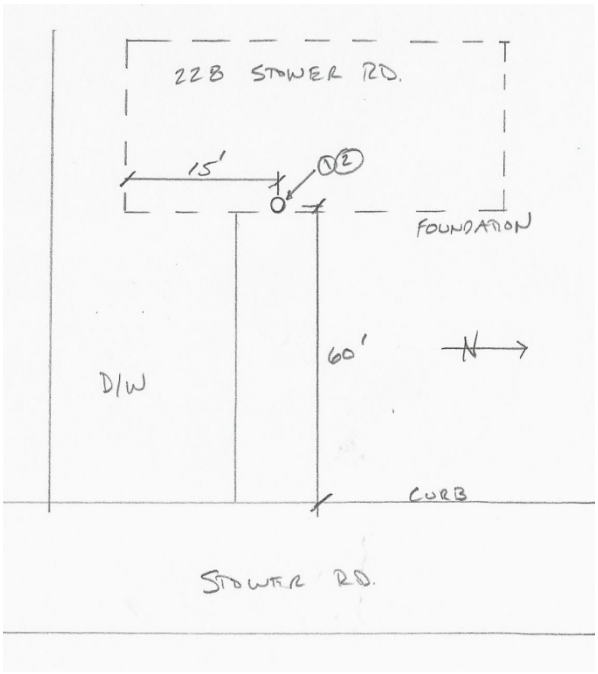
- House has been removed. Smoke from uncovered sewer connection in foundation.
-
-
-
-

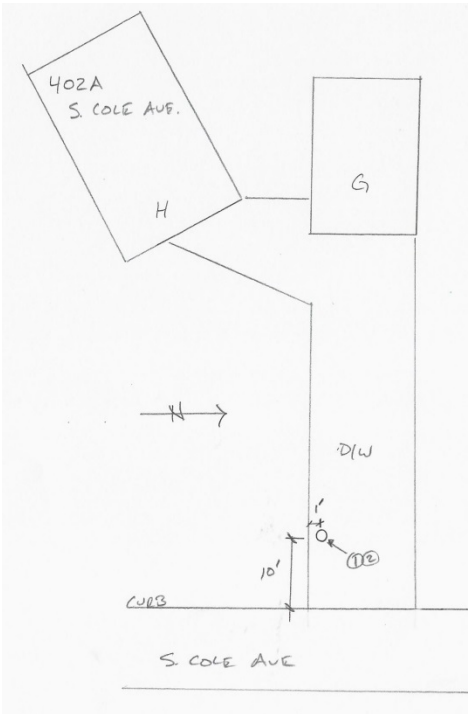
- Smoke from driveway cleanout cover on south side of driveway.
- Smoke is also coming up from edge of asphalt, adjacent to the cleanout cover.
-
-
-

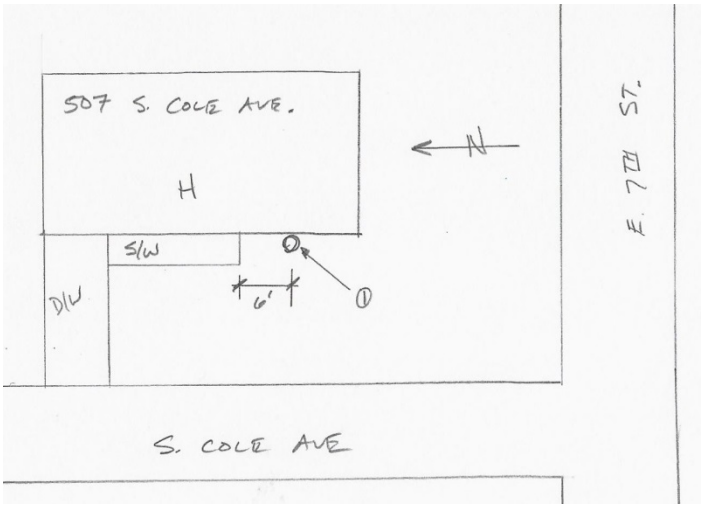
- Smoke from open cleanout, south of front porch, adjacent to front of house.
-
-
-
-

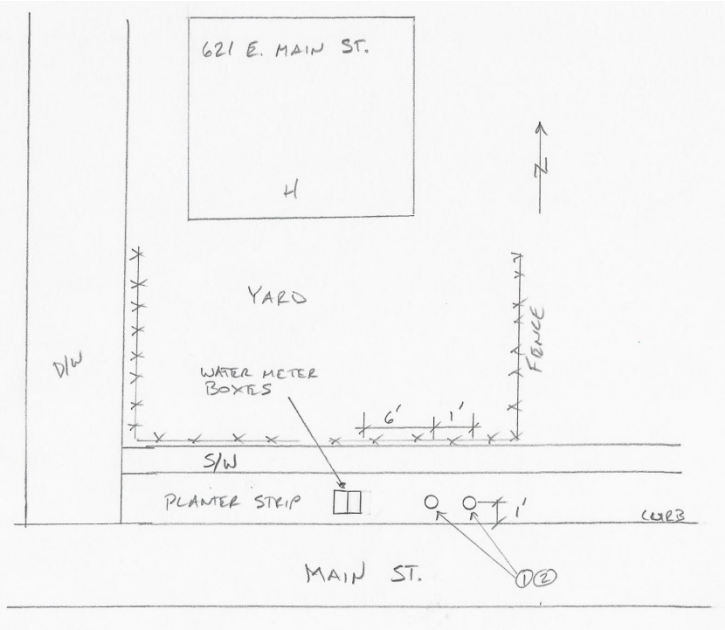
- Smoke from two, adjacent cleanout covers, in beauty strip grass in front of 621 Main St.
-
-
-
-

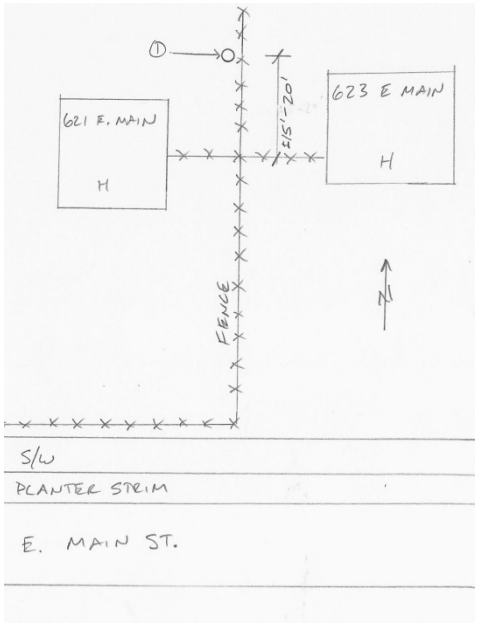
- Smoke from fence line, between backyards of 621 and 623 Main St.
- Could not confirm broken or uncovered cleanout.
-
-
-

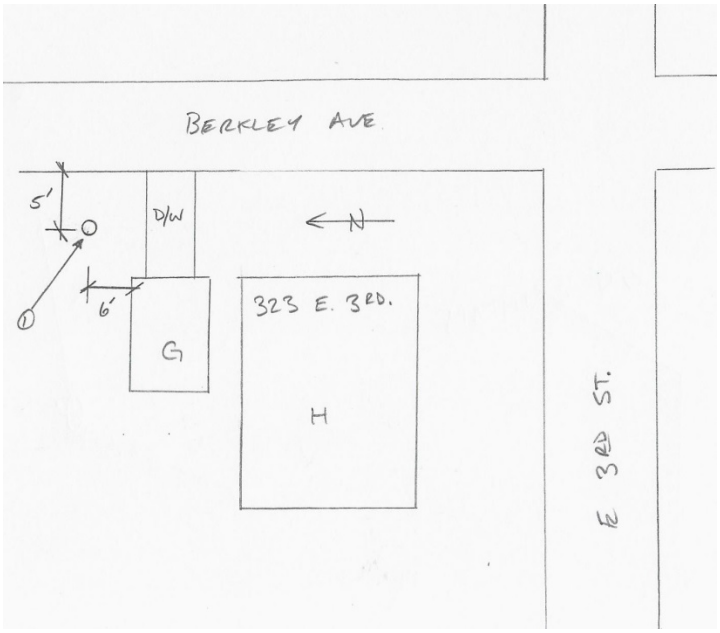
- Broken cleanout cap, located in gravel area under trailer.
-
-
-
-

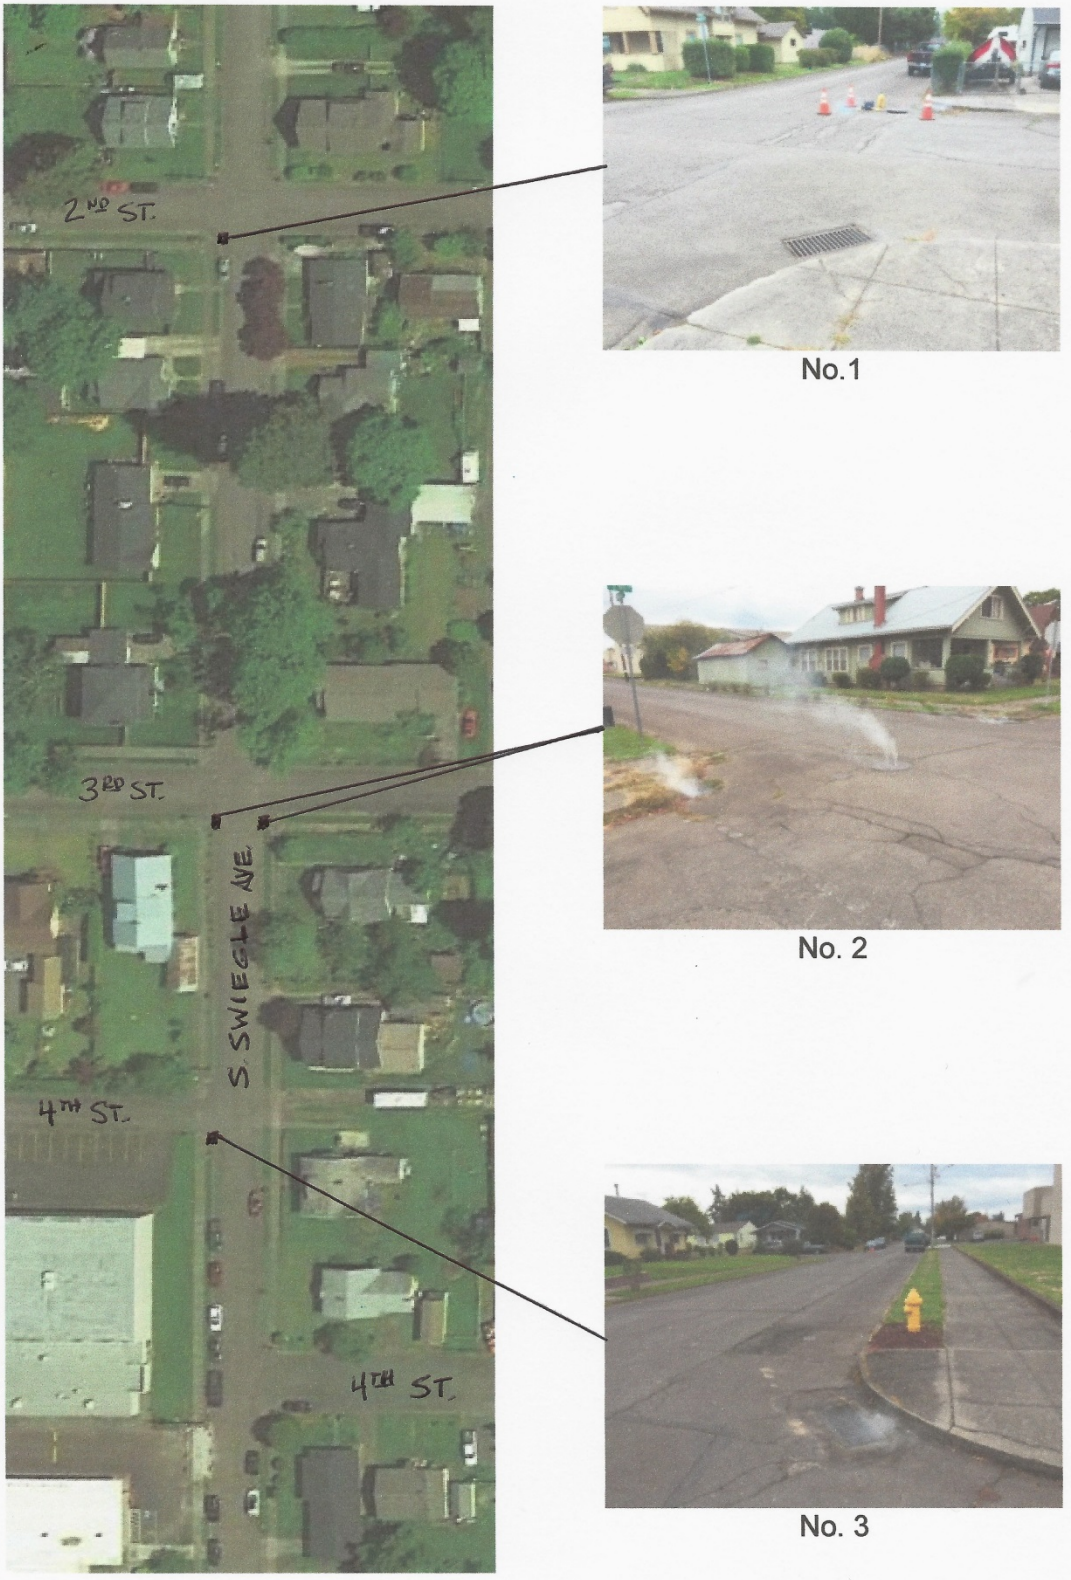
No.	Description
1	Smoke from CB – 2nd & Swiegle Ave.
2	Smoke from CB – 3rd & Swiegle Ave.
3	Smoke from CB – 4th & Swiegle Ave.

- See attached aerial for pictures and locations.
- Storm system manholes on Swiegle Ave., adjacent to catch basins, were also smoking.
-
-
-

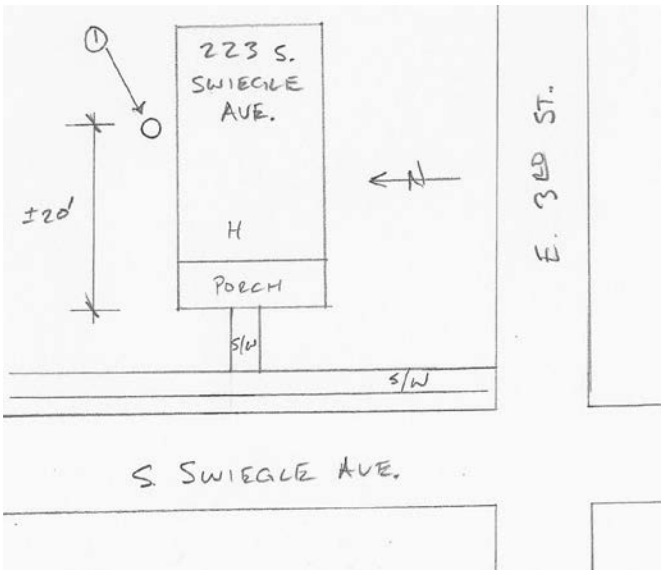
- Smoke from cleanout area on north side of house. Could not confirm broken or missing cap.
-
-
-
-

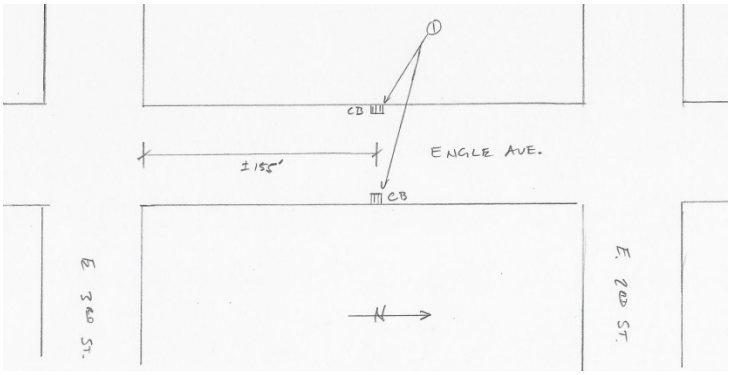
- Smoke from catch basins on east and west side of Engle Ave., between 2nd and 3rd Streets.
-
-
-
-

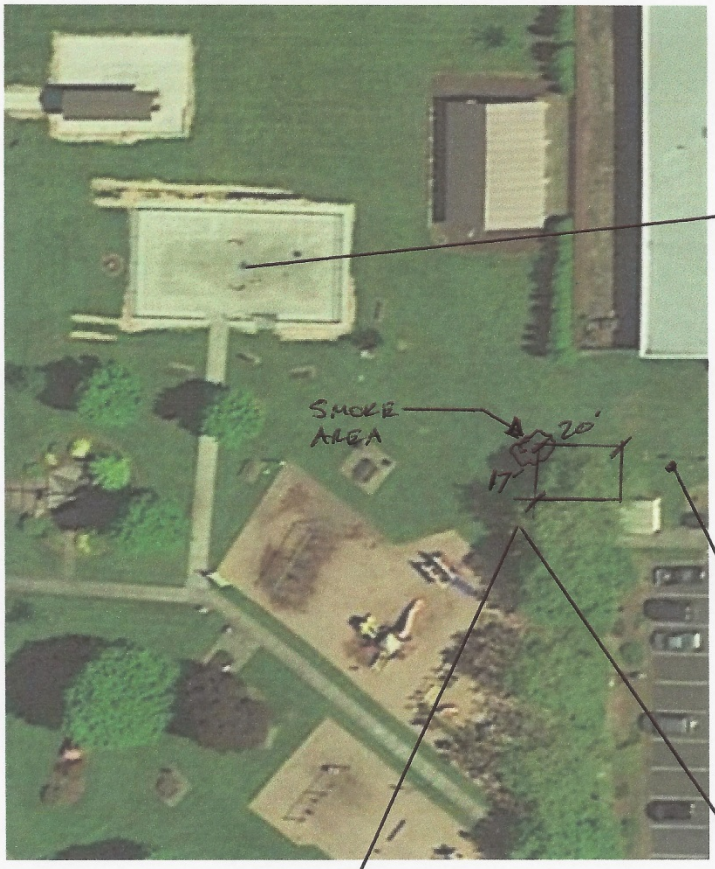
No.	Description
1	Smoke from splash pad drain
2	Smoke from broken clean out cap
3	Smoke from lawn area
4	Smoke from lawn area

- See attached aerial for locations.
- Picture No. 1 – Smoke coming up from the new splash pad play area drain.
- Picture No. 3 & 4 – Approximate10 sq. ft. area in the lawn was smoking. No cleanout found. Assumed to be broken sewer lateral or main. 20' north and 17' west of northwest bathroom corner.
-
-

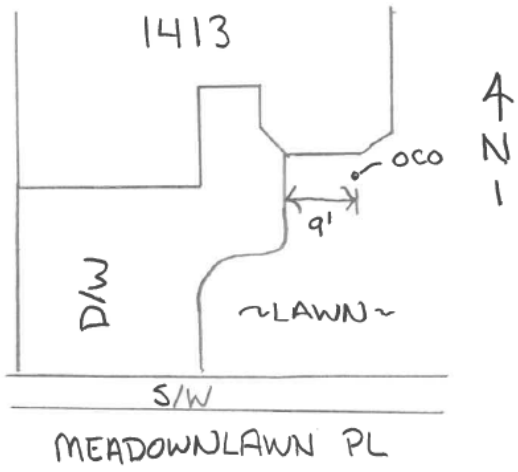
- Cleanout has broken lid.
-
-
-
-

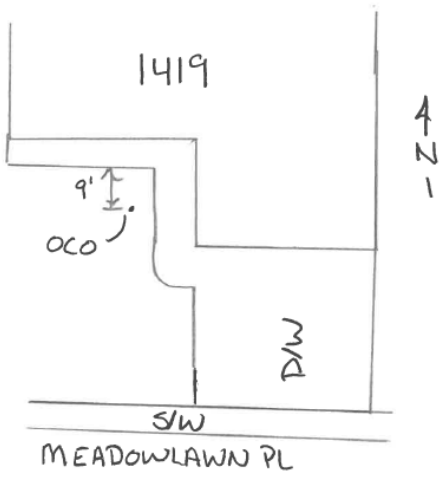
- Cleanout does not have lid.
-
-
-
-

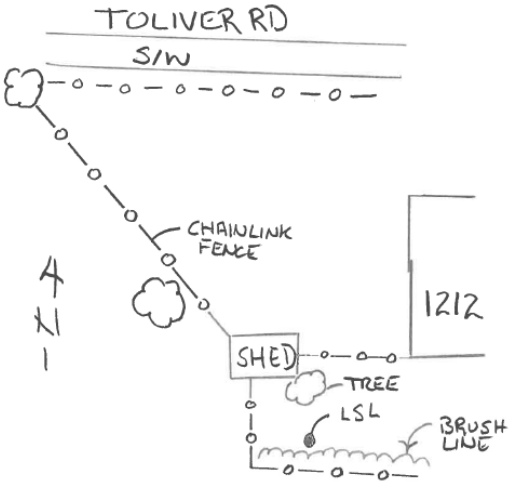
- Could not confirm (Private property).
-
-
-
-

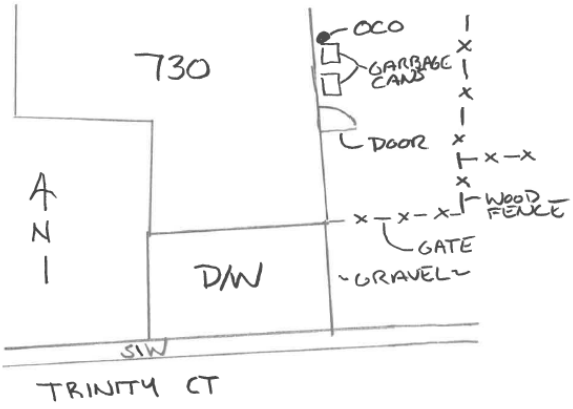
- Behind gate. Could not confirm (Private property).
-
-
-
-

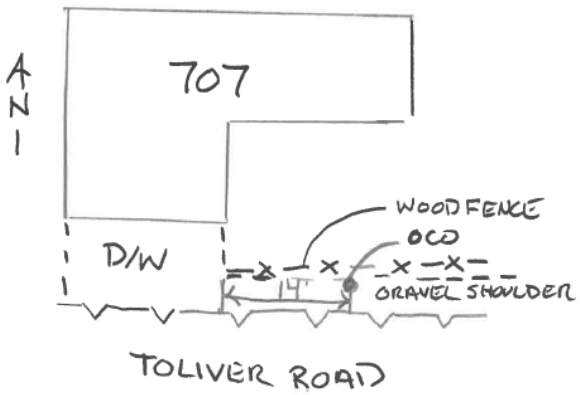
- Broken cleanout lid.
-
-
-
-

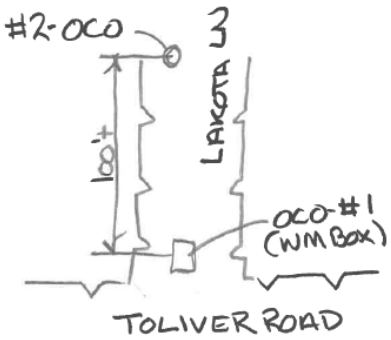
TESTING CODE			PHOTOGRAPHS	
LSL	=	Leaking Service Lateral	No.	Description
LML	=	Leaking Main Line	1	Open Cleanout
CB	=	Catch Basin	2	Open Cleanout
LMH	=	Leaking Manhole		
OCO	**=**	**Open Cleanout**		
PHV	=	Plugged House Vent		
RD	=	Roof Drain

- Photo 1: Water meter lid smoking below grade.
- Photo 2: Smoke around cleanout lid and cracks in pavement.
-
-
-

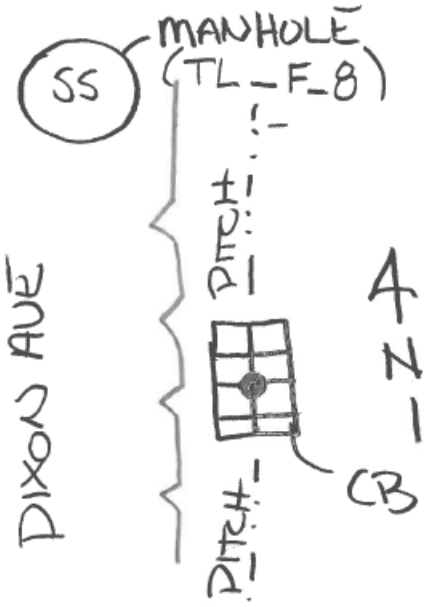
- Smoke coming from catch basin.
-
-
-
-

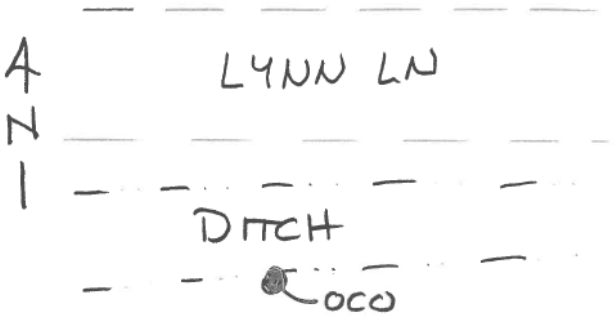
- Cleanout pipe broken next to ditch.
-
-
-
-

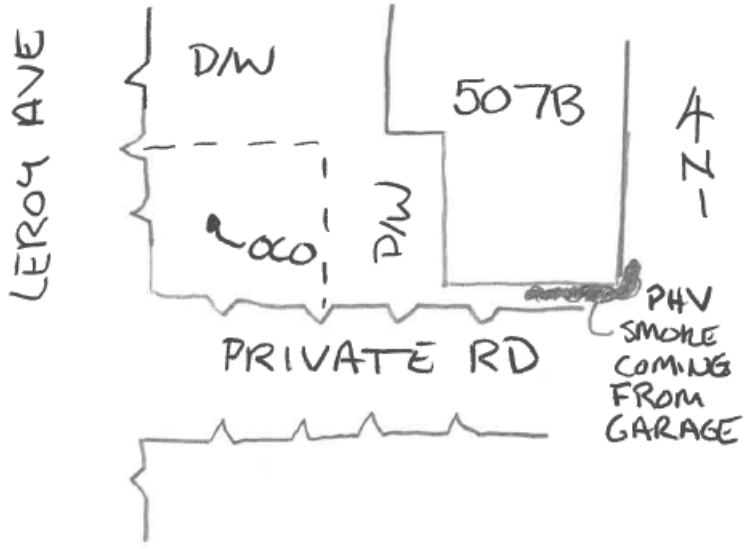
- OCO (509 Leroy Ave): Cleanout had cast iron lid but was smoking from sides in yard.
- PHV (507B Leroy Ave): Garage off of house 507B had smoke coming from underneath.
-
-
-

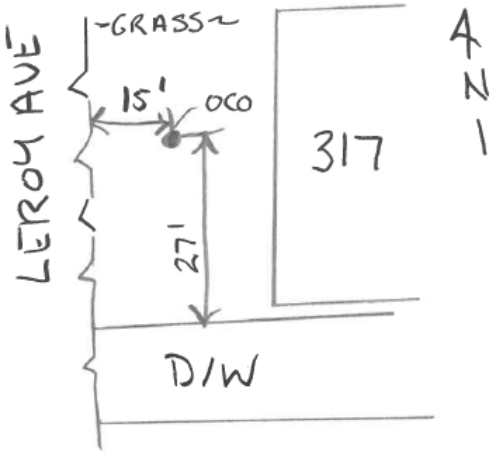
- Cleanout with cast iron lid smoking from sides of lid in yard.
-
-
-
-

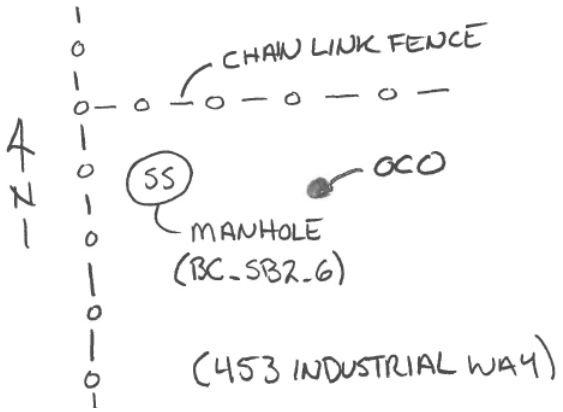
- Smoke coming from ground at base of cleanout riser pipe.
-
-
-
-

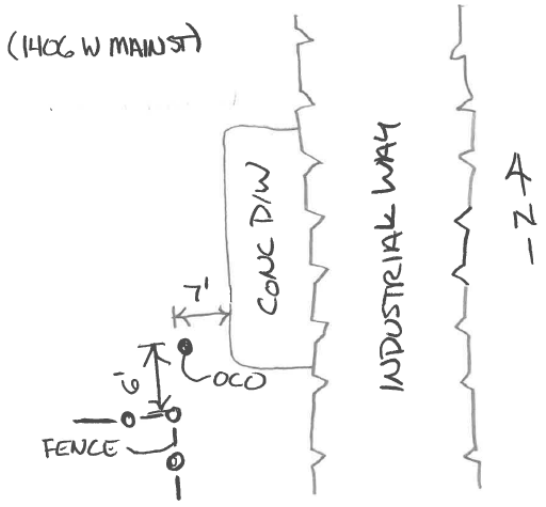
- Cleanout pipe broken at surface.
-
-
-
-

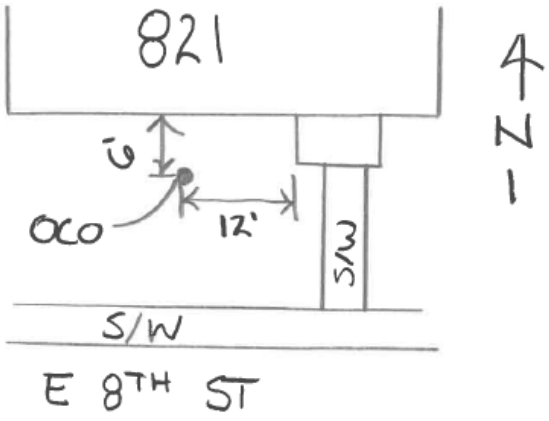
- Cleanout has grated lid.
-
-
-
-

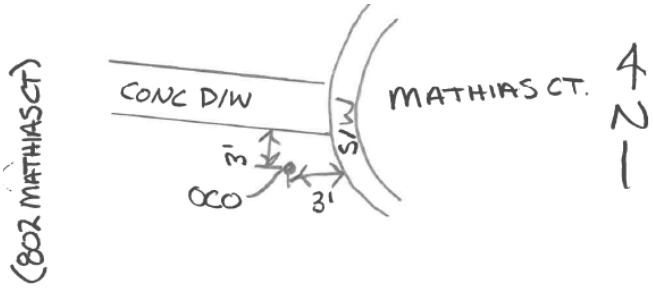
- Cleanout does not have cap.
-
-
-
-

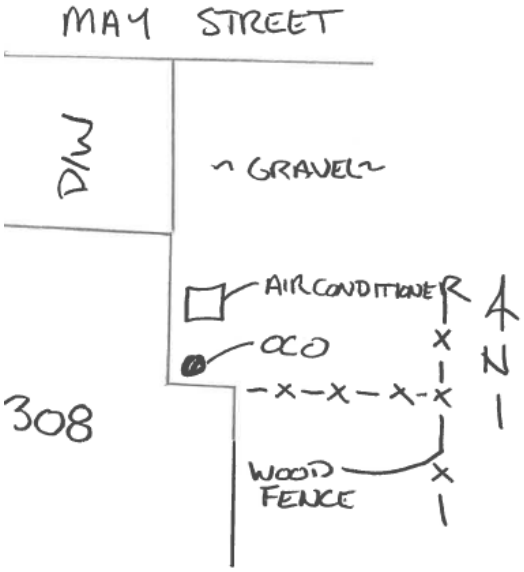
- Could not identify source of smoke.
-
-
-
-

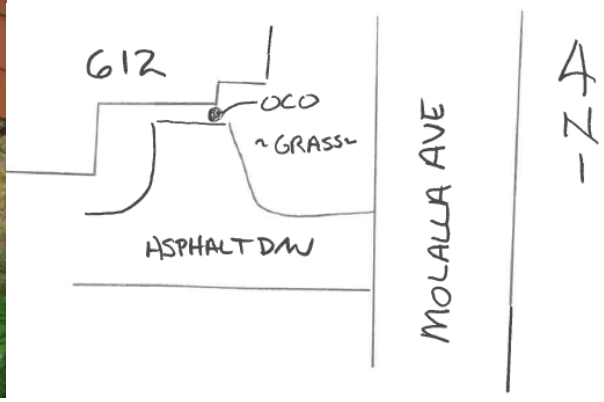
- Cleanout does not have cap.
-
-
-
-

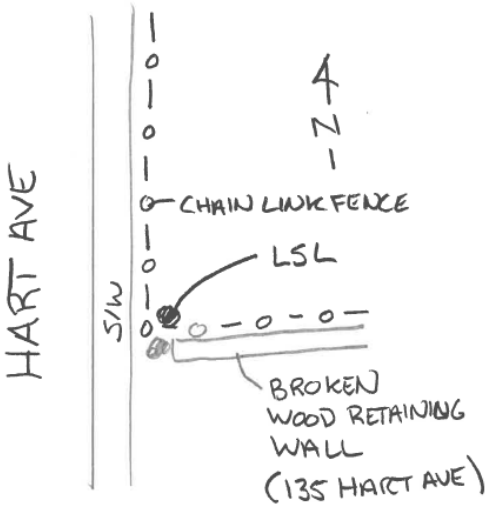
- Smoke coming from under bricks, rock, and old retaining wall.
-
-
-
-

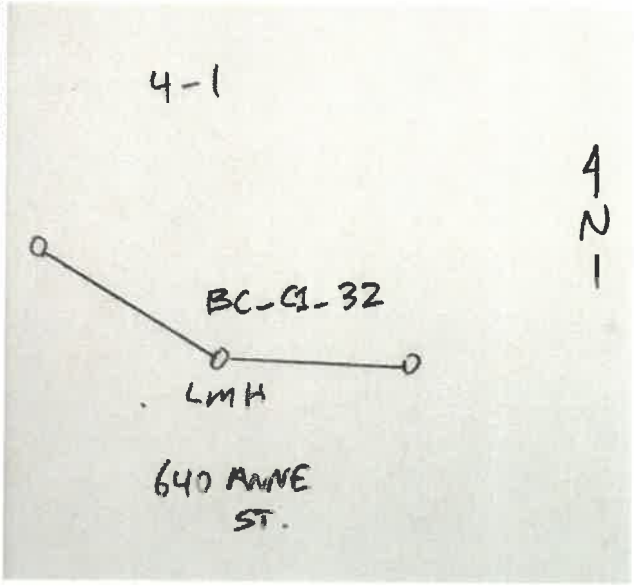
- Leaking around manhole rim.
-
-
-
-

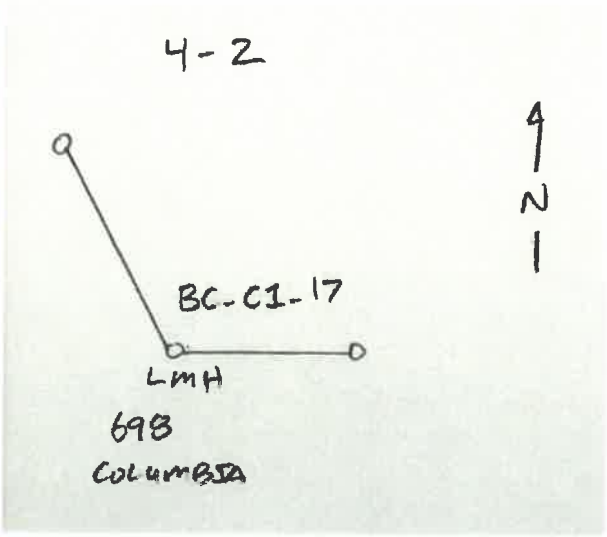
- Leaking around manhole rim.
-
-
-
-

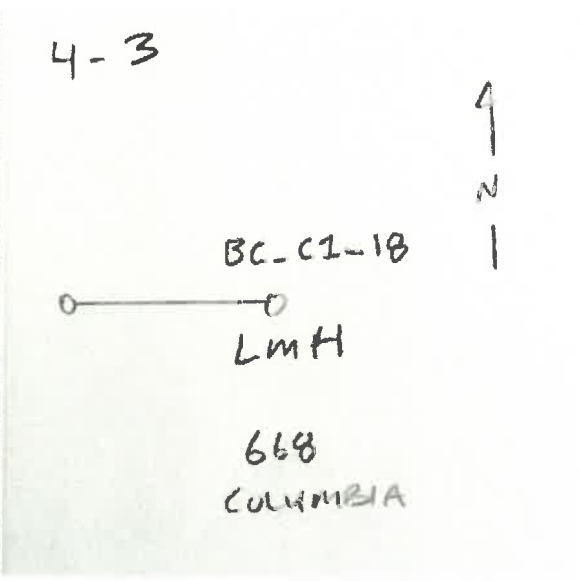
- Leaking around manhole rim.
-
-
-
-

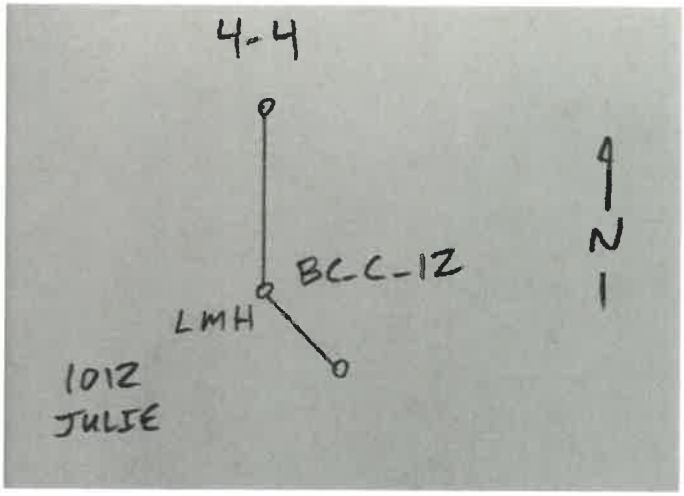
- Leaking around manhole rim.
-
-
-
-

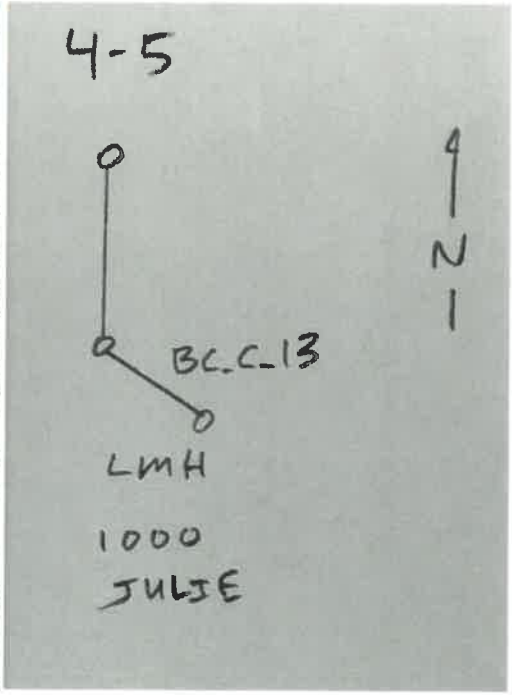
- Leaking around manhole rim and surrounding cracks in asphalt.
-
-
-
-

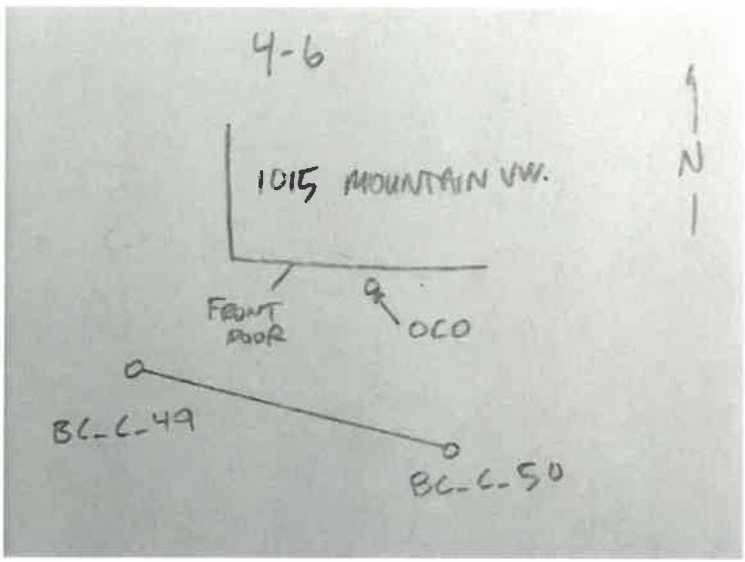
- Open cleanout located immediately to the right of the front door. Right next to hose reel.
- Also refer to aerial on following page.
-
-
-

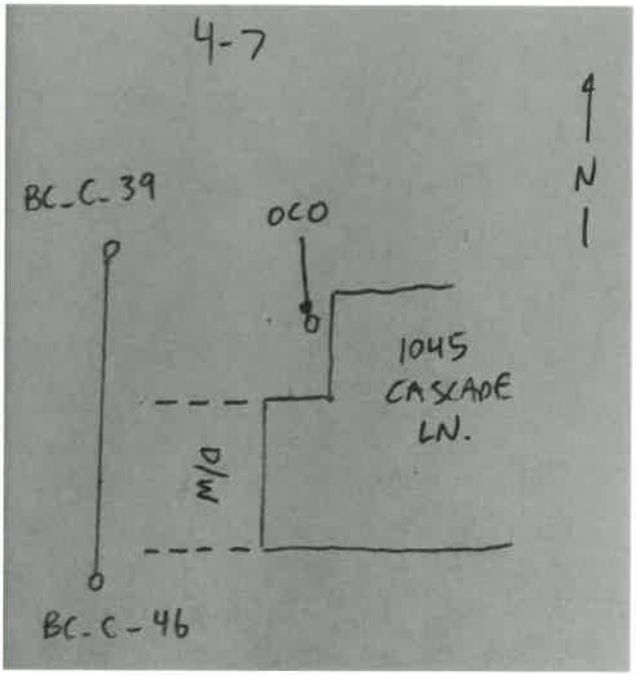
- Open cleanout located about 10 ft to the left of the front door. Right in front of the front window.
- Also refer to aerial on following page.
-
-
-

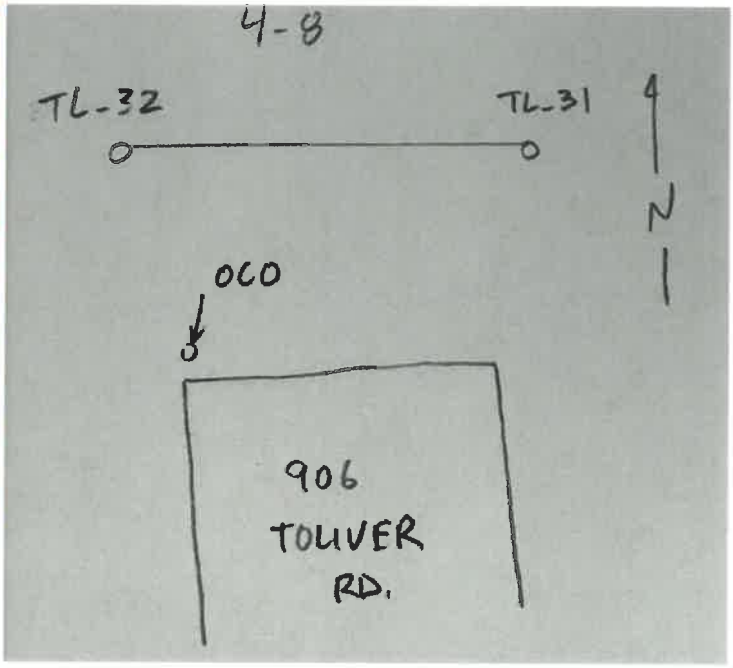
- Open cleanout. House was undergoing some landscaping and upgrades. Open cleanout may only be temporary.
- Also refer to aerial on following page.
-
-
-

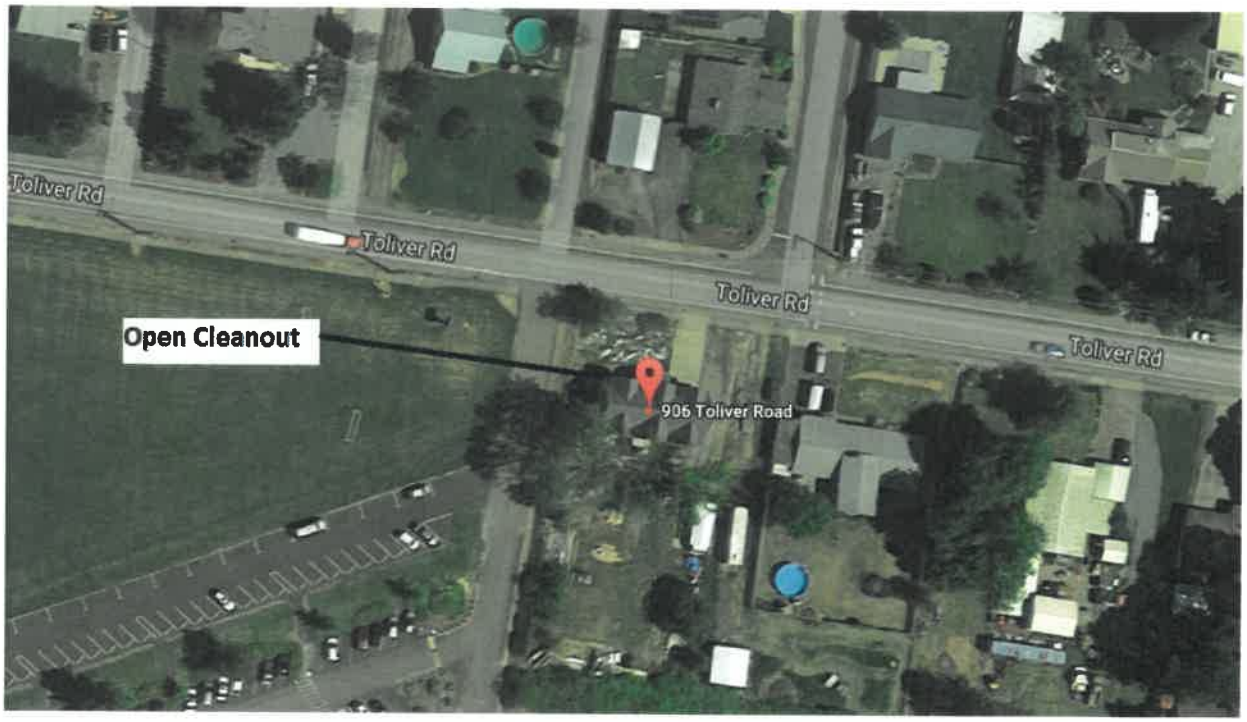
Toliver Rd
Toliver Rd
Toliver Rd
Toliver Rd
Toliver Rd
Open Cleanout
906 Toliver Road

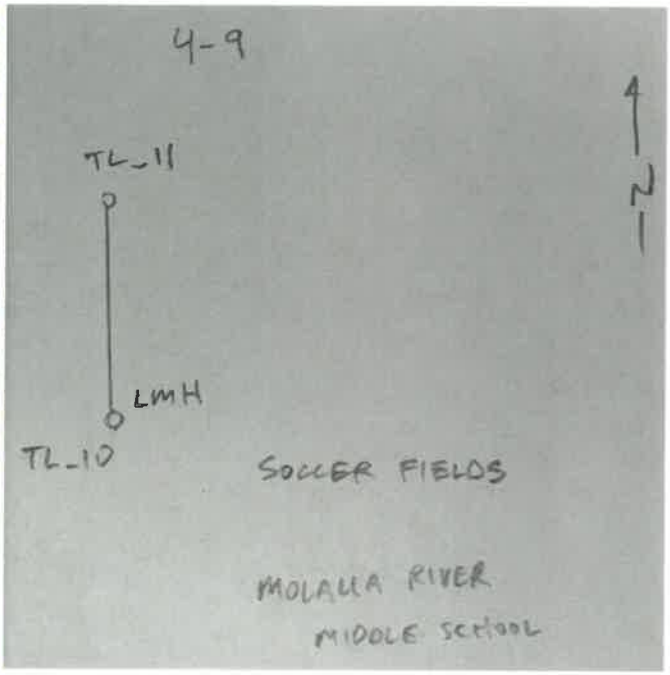
- Manhole was located at perimeter of soccer field. Manhole was leaking significantly around adjacent soil.
- Also refer to aerial on following page.
-
-
-

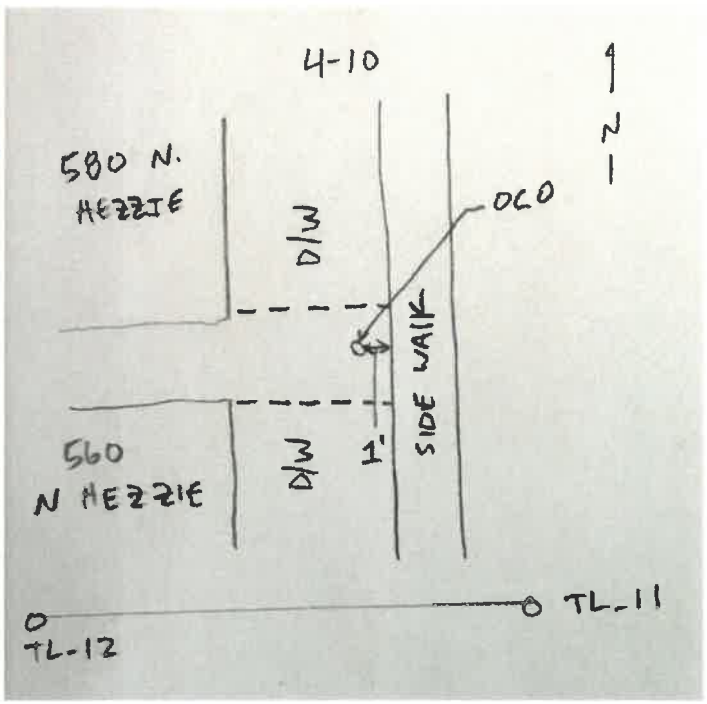
- Open cleanout adjacent to electrical box, in between driveways.
- Also refer to aerial on following page.
-
-
-

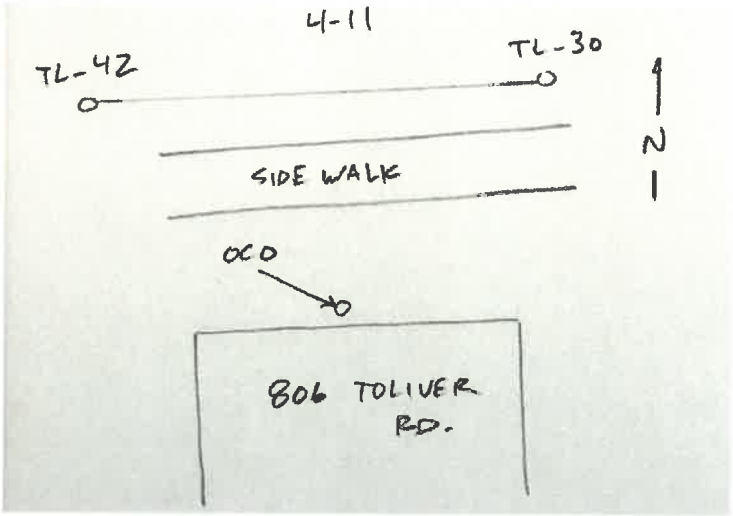
- Open cleanout located to the right of the front porch.

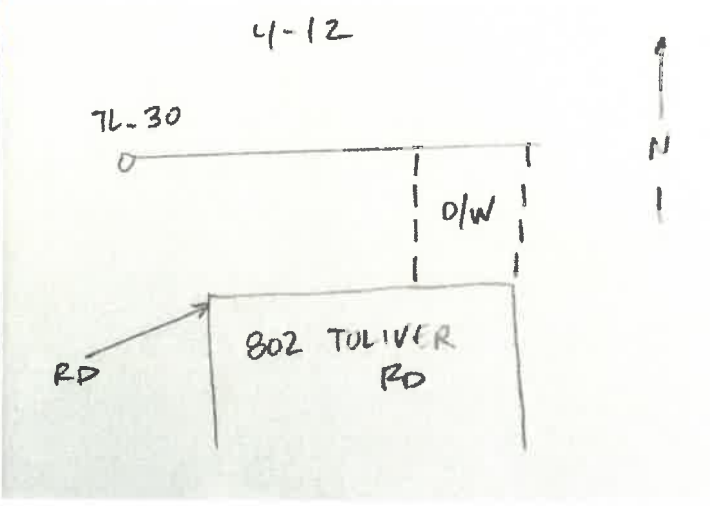
- Roof drain connected on northwest corner of house.
- Also refer to aerial on following page.
-
-
-

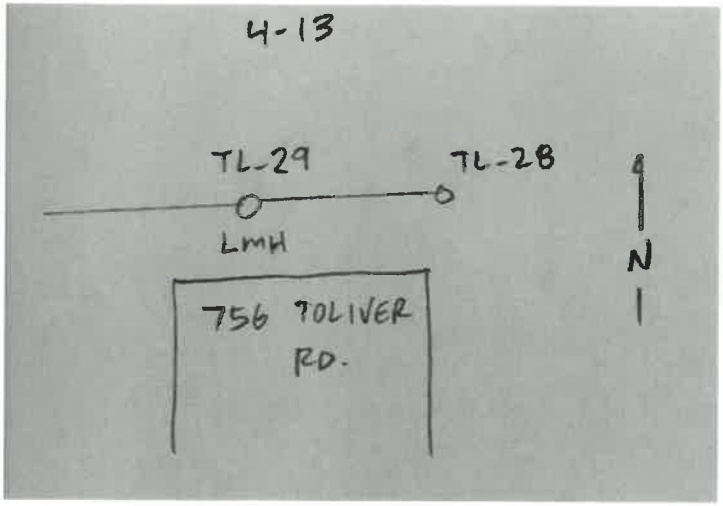
- Manhole was leaking around rim and surrounding cracks around manhole.
-
-
-
-

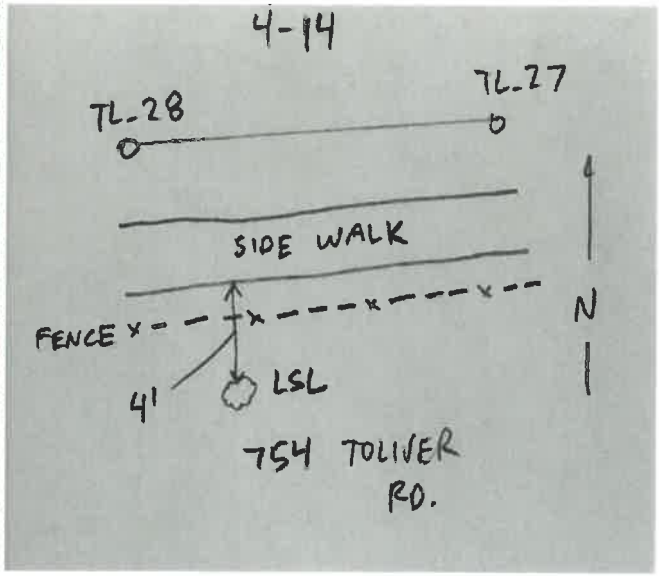
- Service lateral was leaking significantly immediately south of chain link fence. With brush, it was difficult to see, but there was a large amount of smoke, and the area was recessed.
- Also refer to aerial on following page.
-
-
-

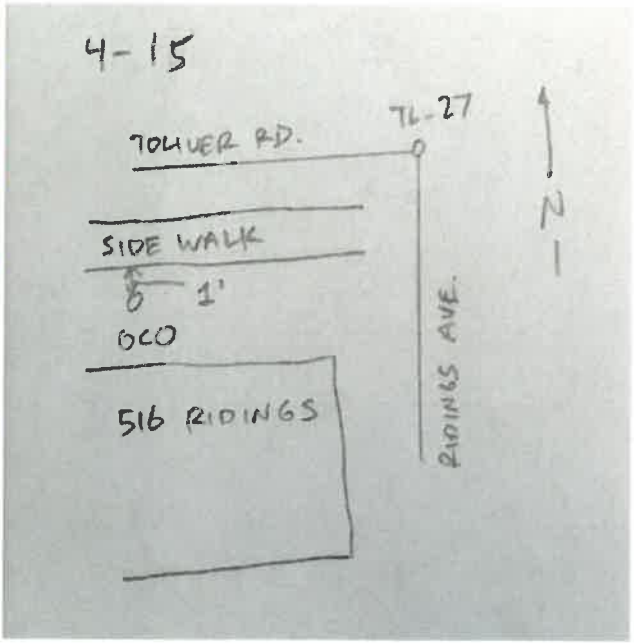
- Open cleanout west of side walk. Exposed pipe was cracked.
-
-
-
-

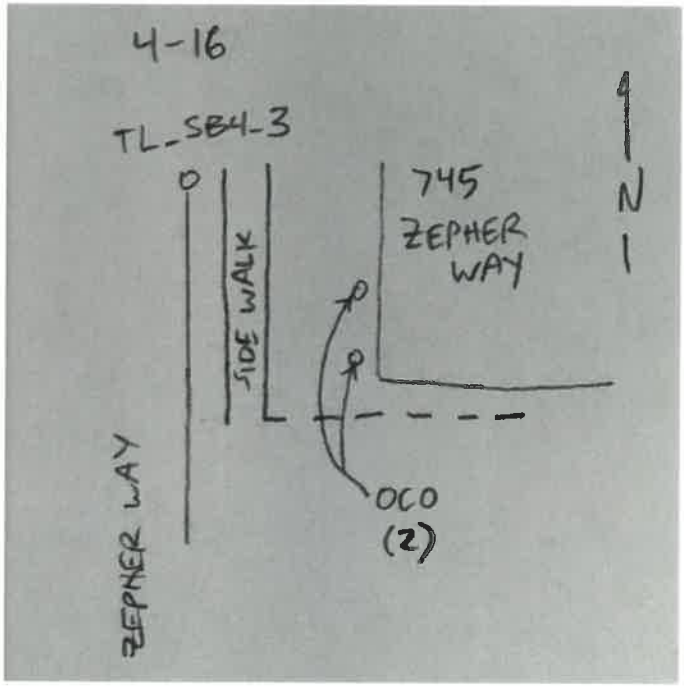
- Two open cleanouts located approximately two and five feet from north side of drive way.
-
-
-
-

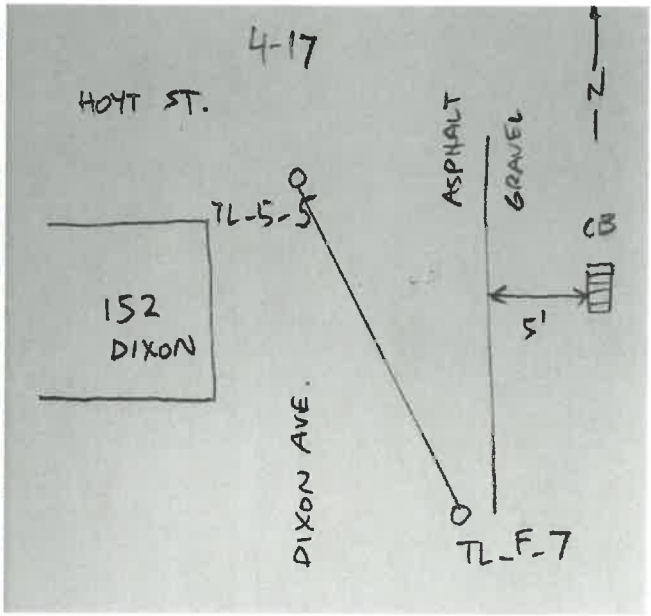
- Catch basin is tied into the sewer system. Catch basin is located in roadway ditch.
- Also refer to aerial on following page.
-
-
-

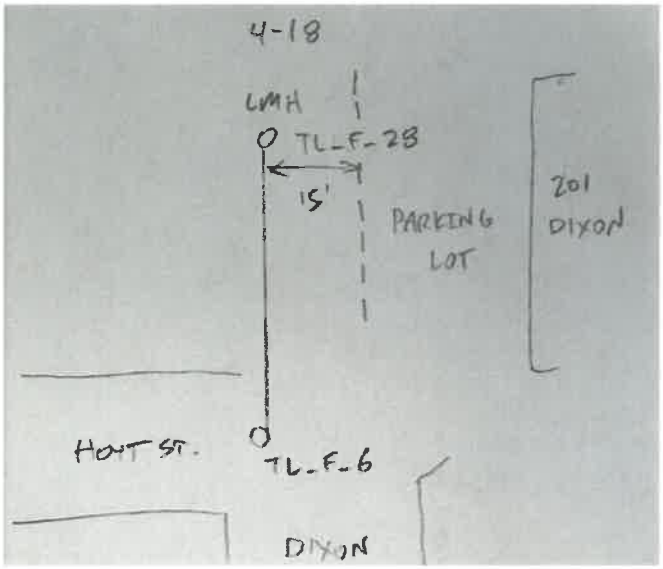
- Manhole located to the west of the parking lot was leaking into surrounding soil.
- Also refer to the aerial on the following page.
-
-
-

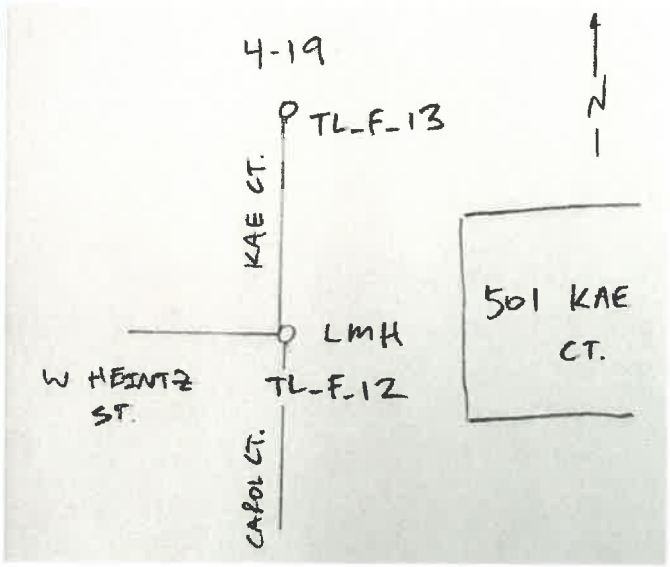
- We set up the smoke machine on this manhole and smoke exited from cracks in adjacent asphalt.
-
-
-
-
