PROJECT NAME City of Molalla
WWFCSMP

WASTEWATER FACILITY AND COLLECTION SYSTEM MASTER PLAN VOLUME 1

AUGUST 2018

The Dyer Partnership Engineers & Planners, Inc.

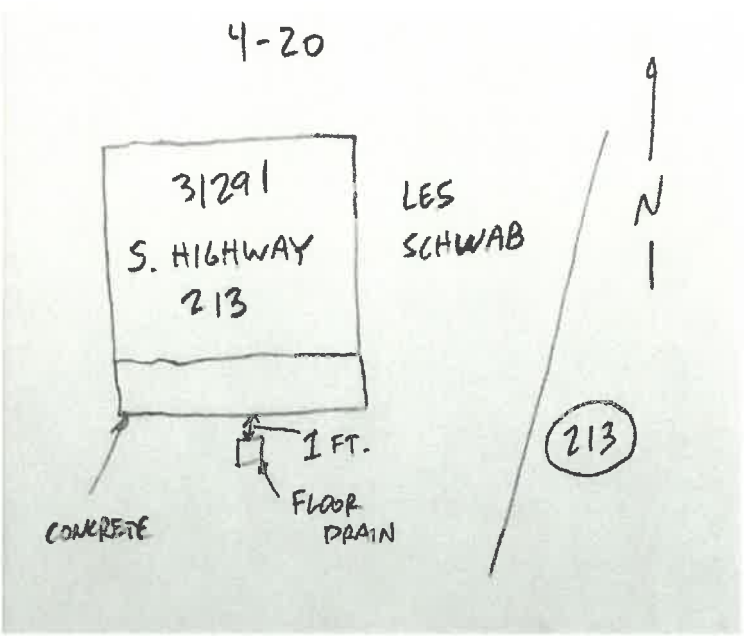
- All of the floor drains in Les Schwab are connected to the gravity sewer mains. Smoke exited throughout floor drains.
- Picture is showing location where all of the floor drains are connected, to the south of the building.
- Also refer to aerial on following page.
-
-

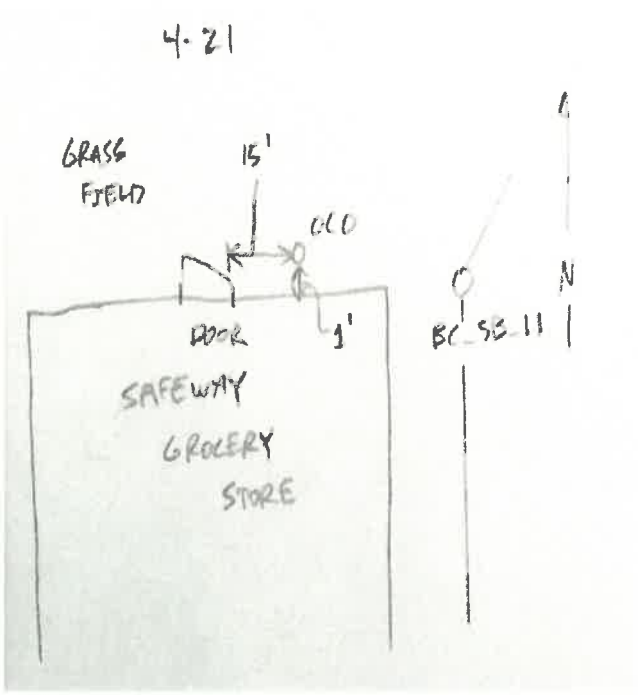
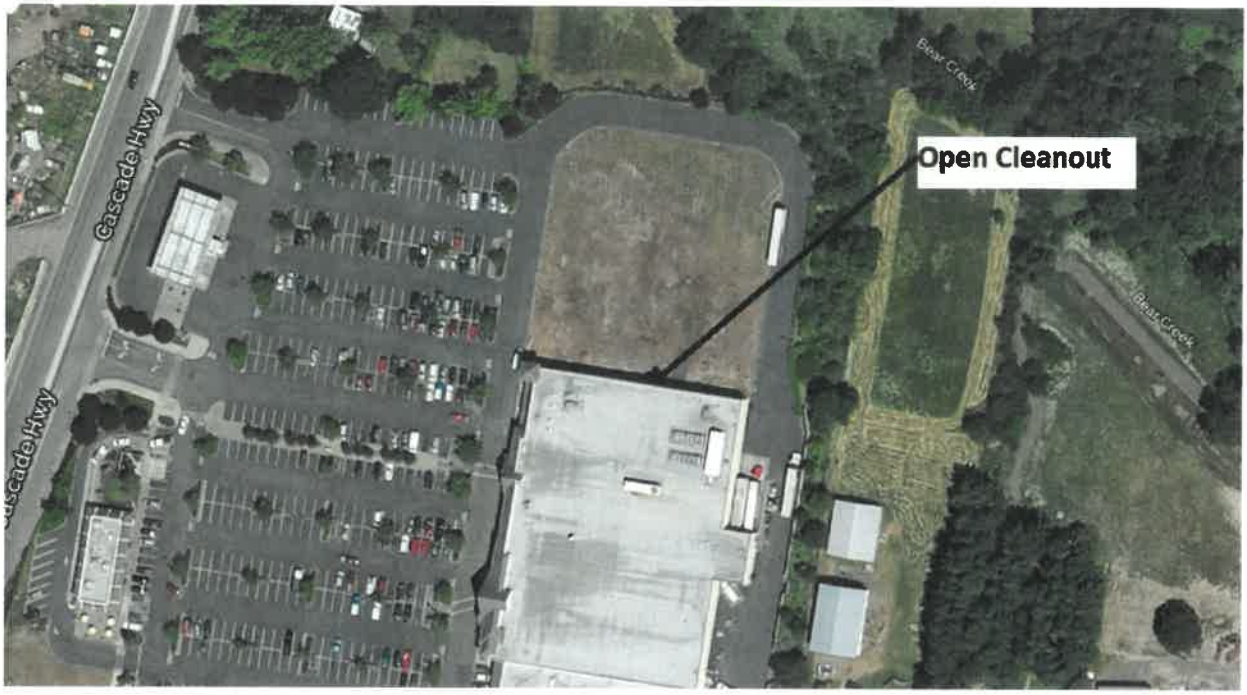
- There was an open cleanout to the north of the Safeway building. The pipe is a few inches below ground level, and probably receives quite a bit of inflow.
- Also refer to aerial on following page.
-
-
-

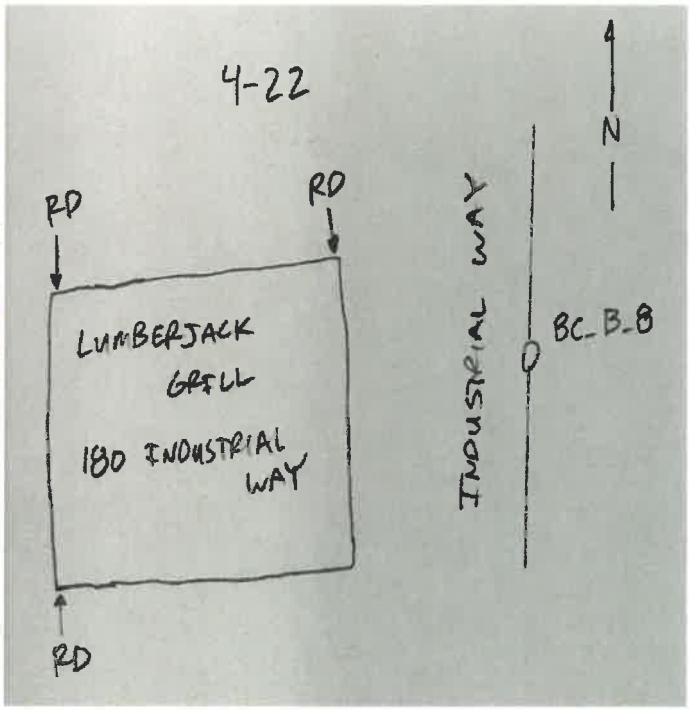
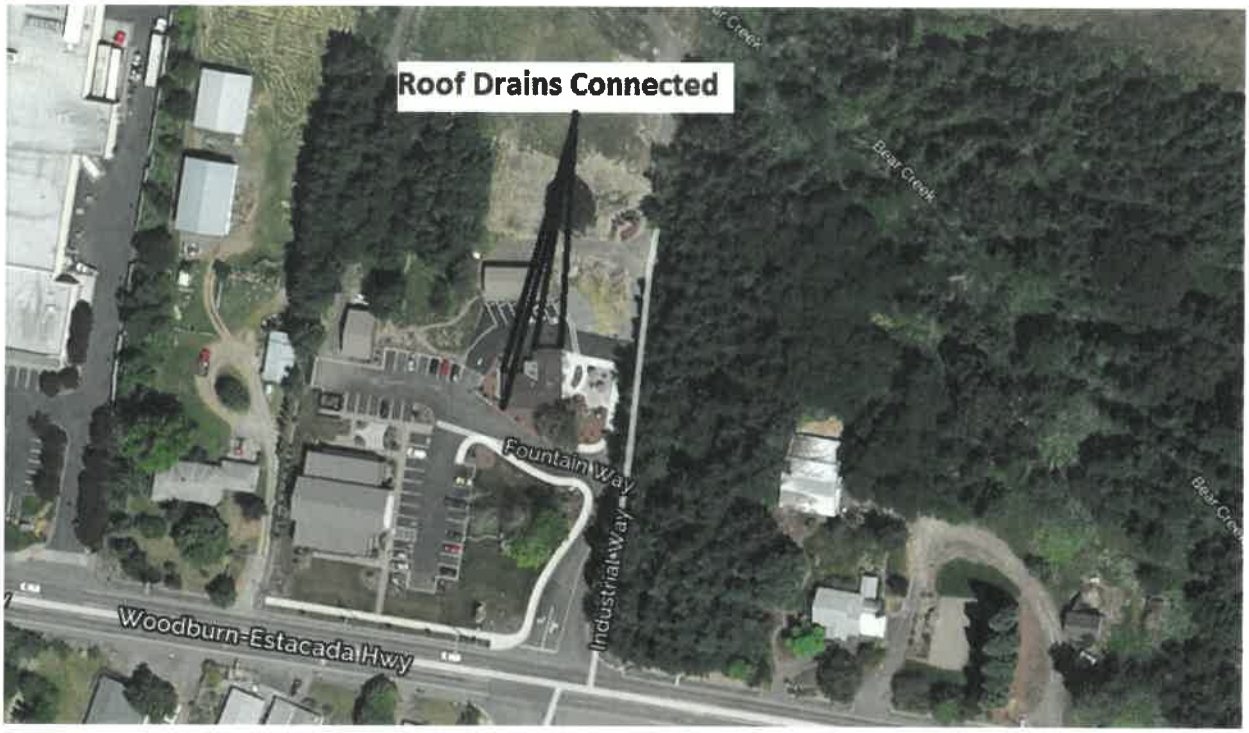
- The roof drains on the Lumberjack Restaurant are all connected to the sewer system. The roof drains to the north and south of the building are all connected. Photo shows drains connected to the north.
- Also refer to aerial on following page.
-
-
-

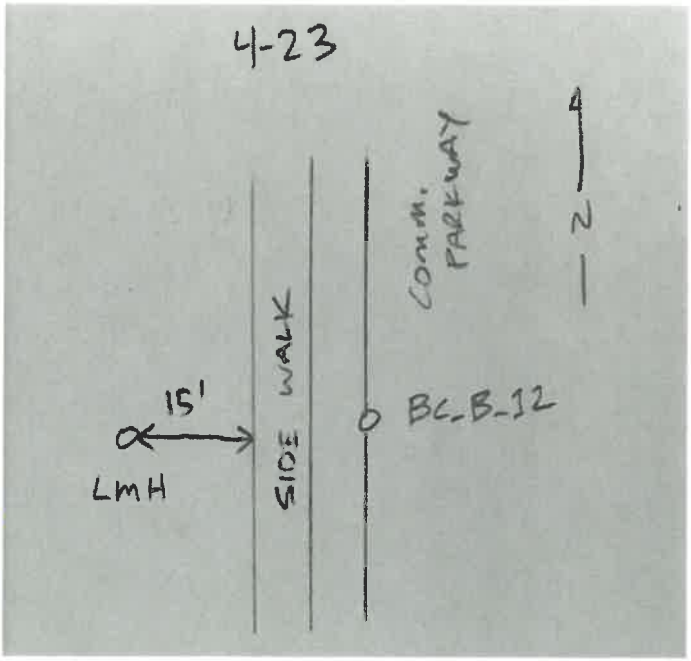
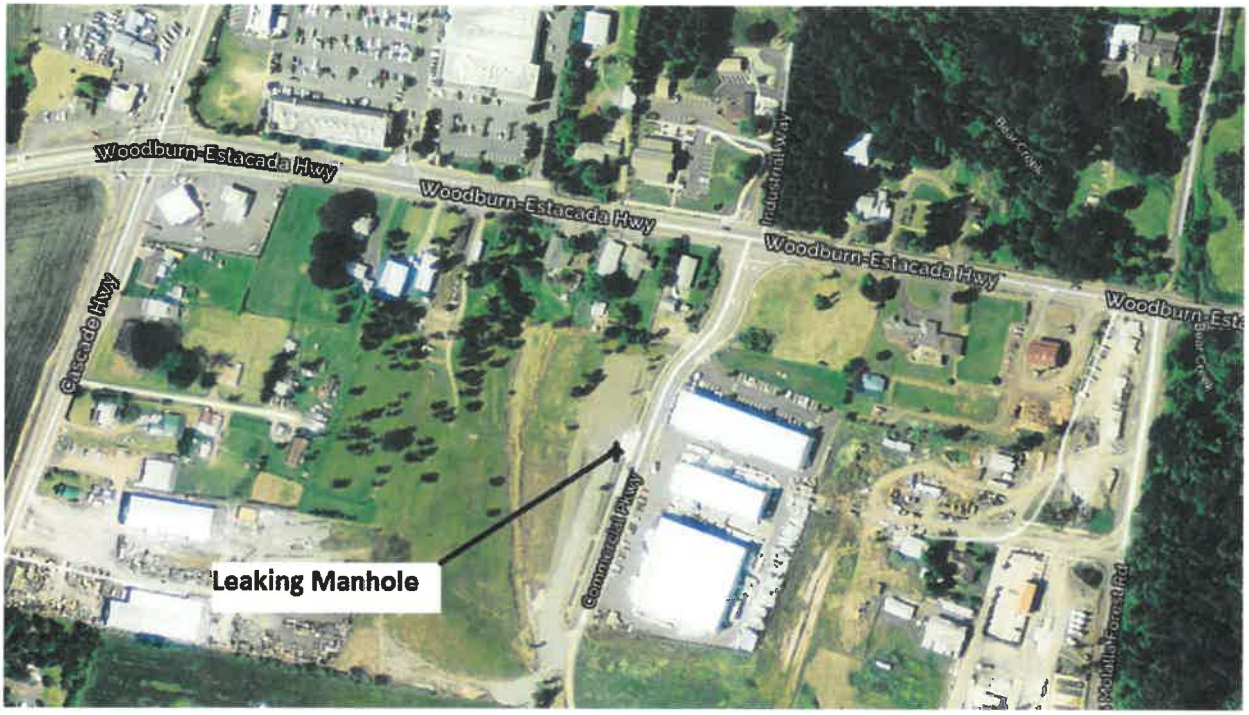
- Manhole was unmarked and located approximately 15ft to the west of the sidewalk, due west of BC_B_12. Smoke exited from around manhole.
- Also refer to aerial on following page.
-
-
-

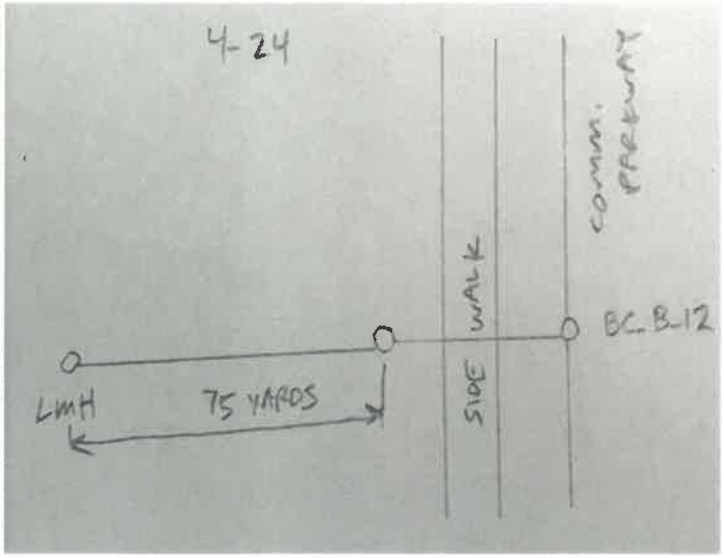
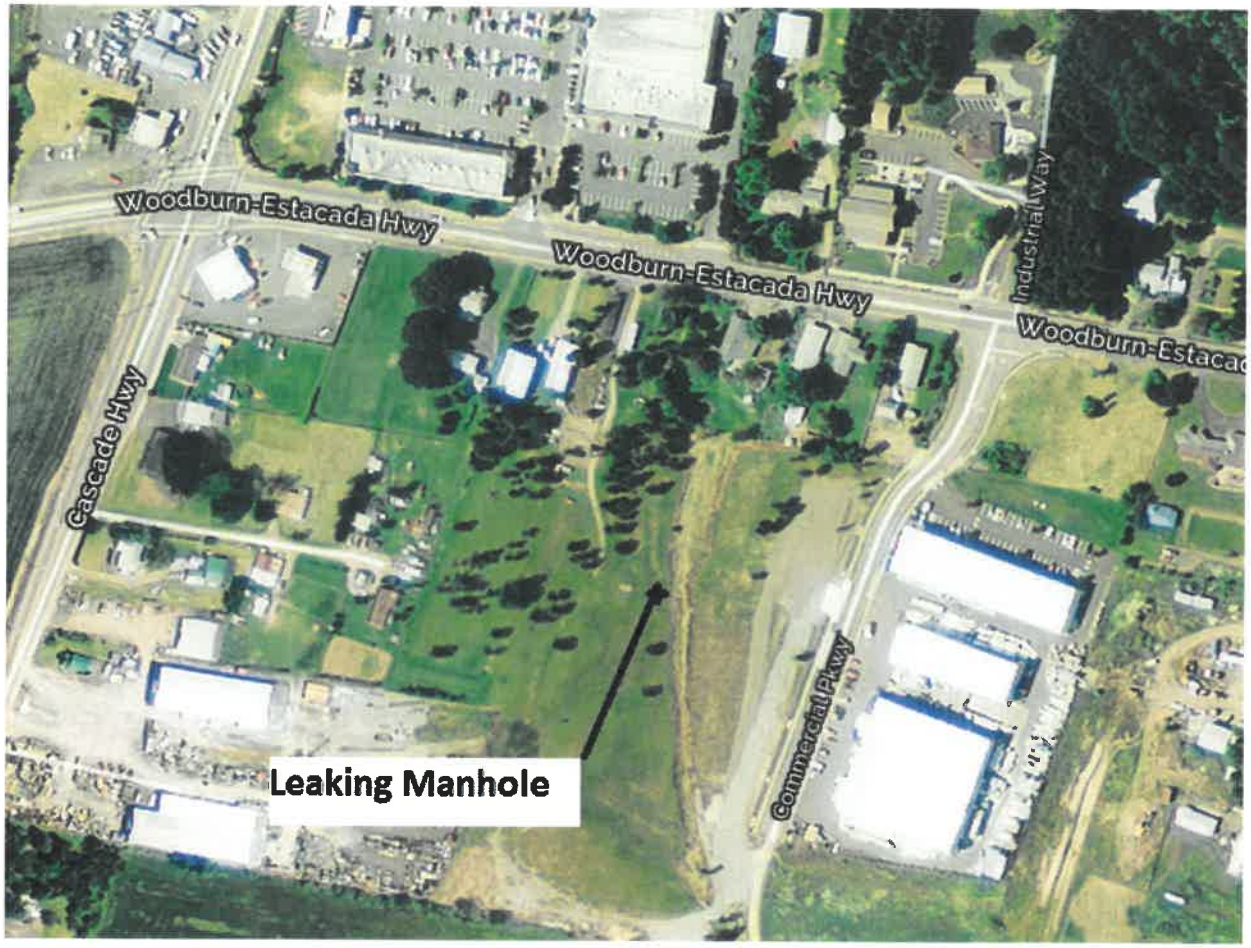
- Manhole was unmarked and located approximately 75 yards to the west of the sidewalk, due west of BC_B_12. Smoke exited from around manhole. Manhole is located in field.
- Also refer to aerial on following page.
-
-
-

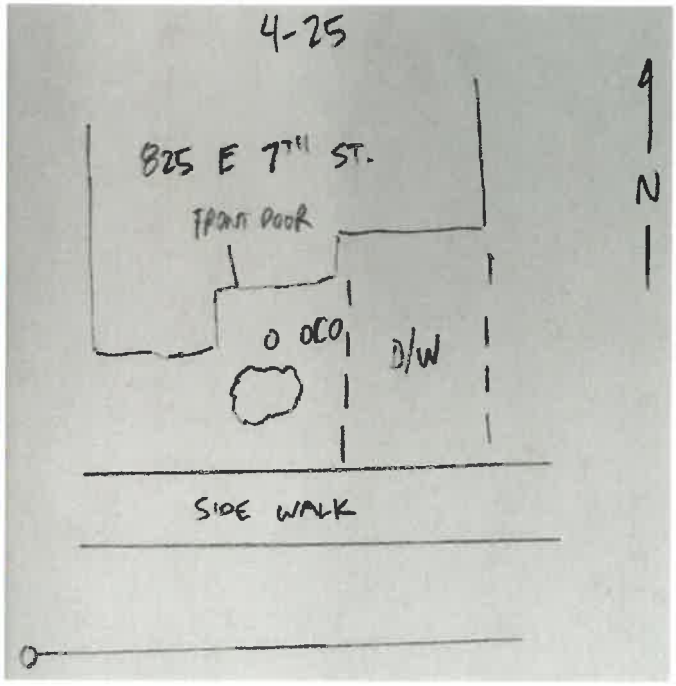
- Open cleanout located immediately to the right of the front door.
-
-
-
-

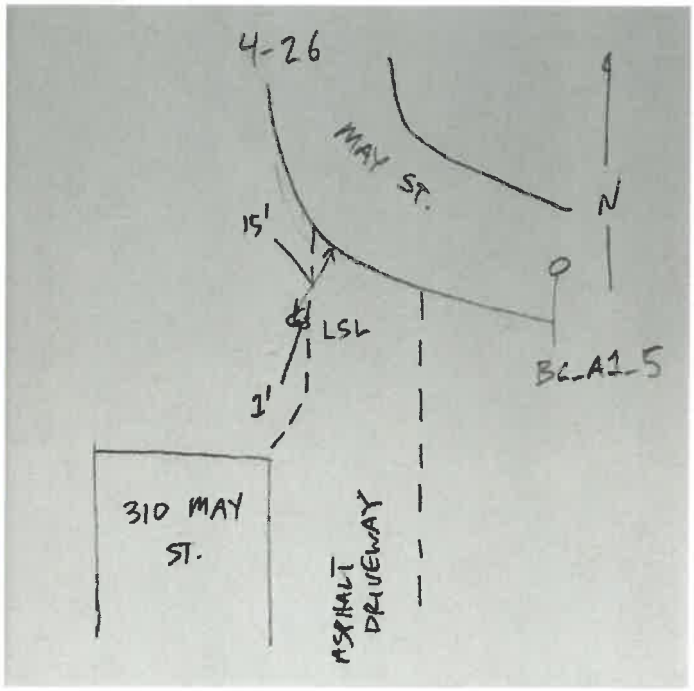
- Service lateral was leaking to the west of the drive way, approximately 15 ft from May Street.
- Also refer to aerial on following page.
-
-
-

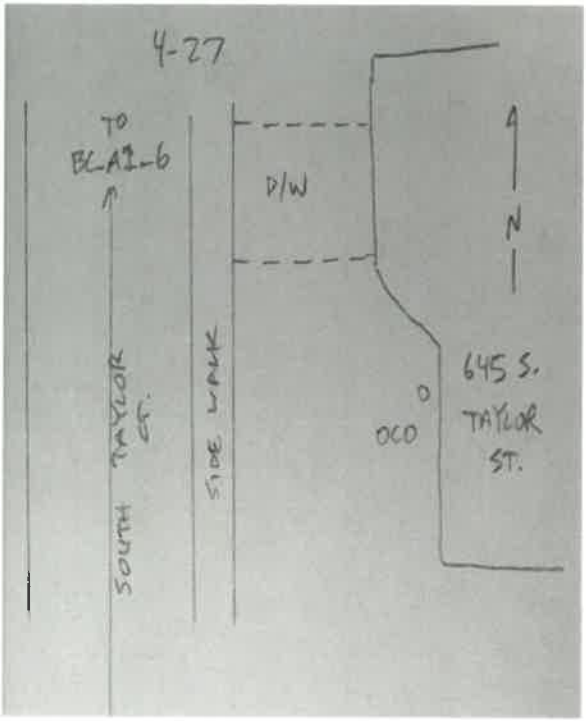
- Open cleanout located immediately to the right of the walk way, in the flower patches. It was leaking around the cleanout, suggesting something deficient underground.
-
-
-
-

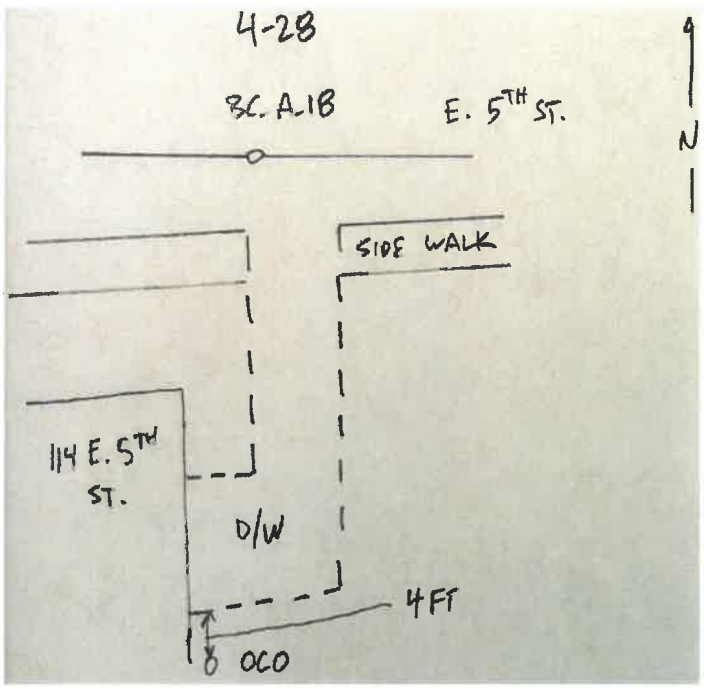
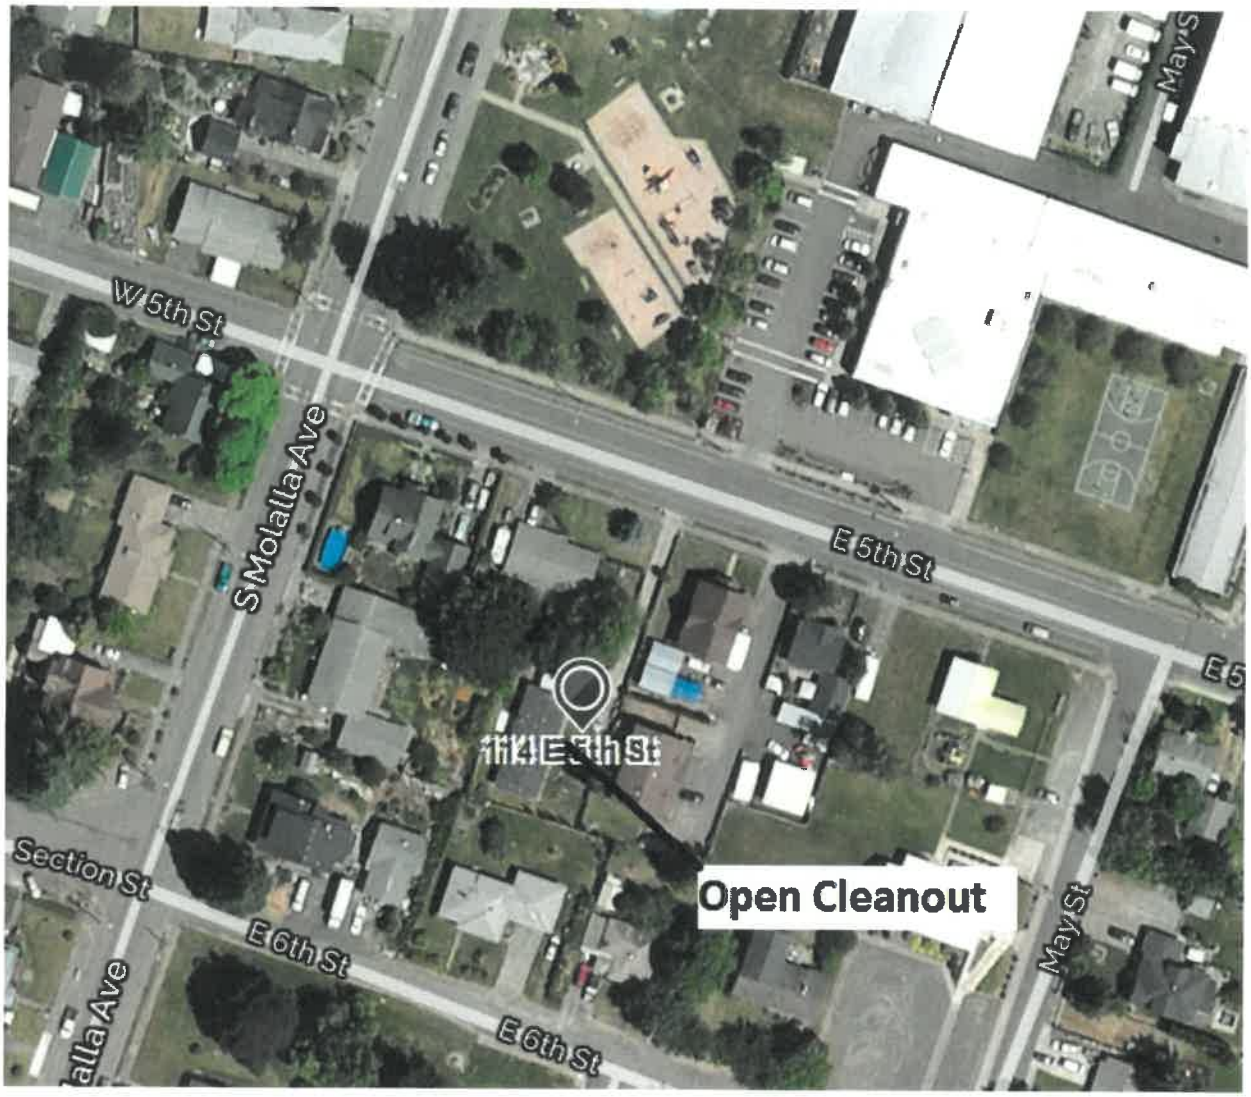
- Open cleanout located south of the concrete drive way, and just north of the electric meter.
- Also refer to aerial on following page.
-
-
-

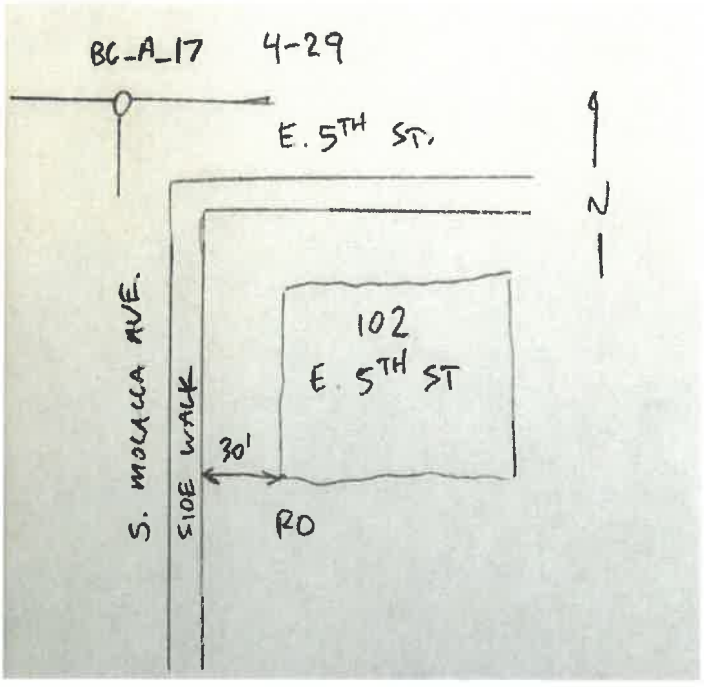
- The roof drain was connected to the sewer system. The drain on the southwest corner of the house was smoking.
- Also refer to aerial on following page.
-
-
-

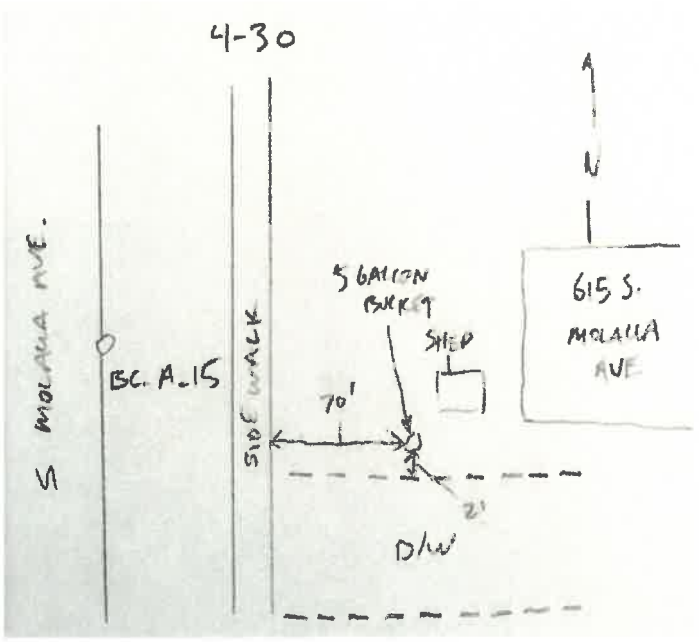
- Open cleanout is located to the north of the drive way. Suspected cleanout has 5 gallon bucket and concrete footing located above it. Smoke exited rapidly.
- Also refer to aerial on following page.
-
-
-

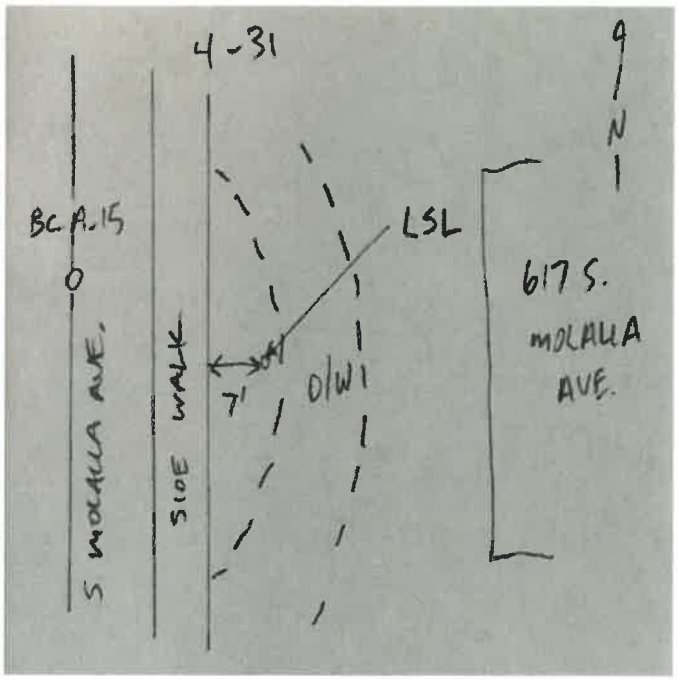
- Leaking service lateral or open cleanout located on western edge of gravel drive way. Smoke exited significantly.
- Also refer to aerial on following page.
-
-
-

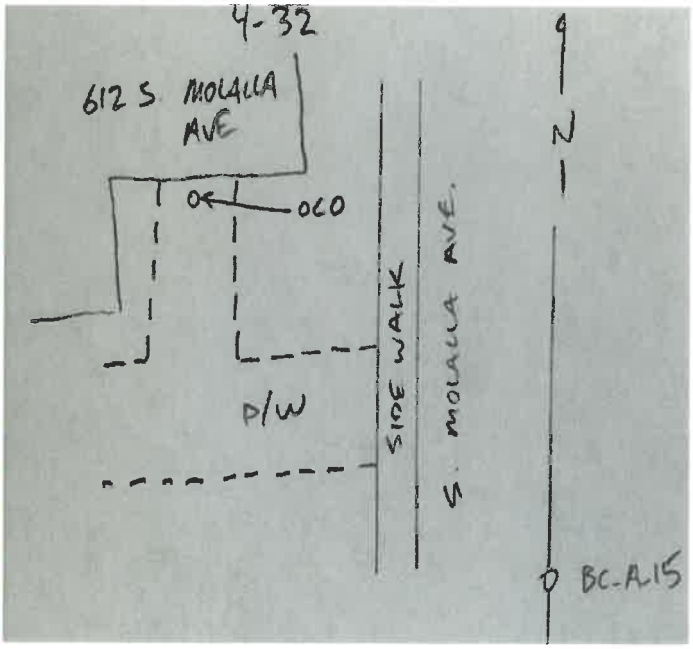
- Open cleanout located north of the driveway, immediately adjacent to the house.
-
-
-
-

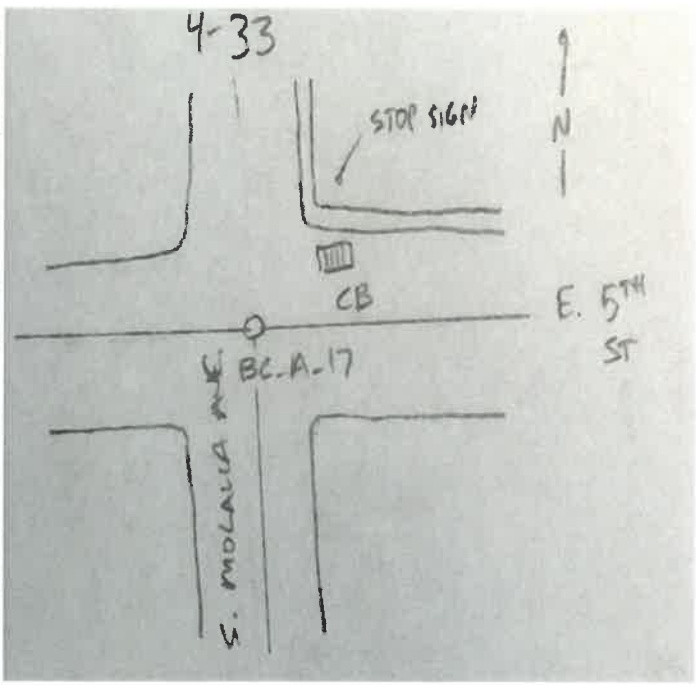
- Catch basin was only lightly smoking, but it is connected to the sewer system. It's the catch basin located in the northeast of the intersection of East 5th and South Molalla.
- It's hard to tell from the picture that it's smoking. It was light.
- Also refer to aerial on following page.
-
-

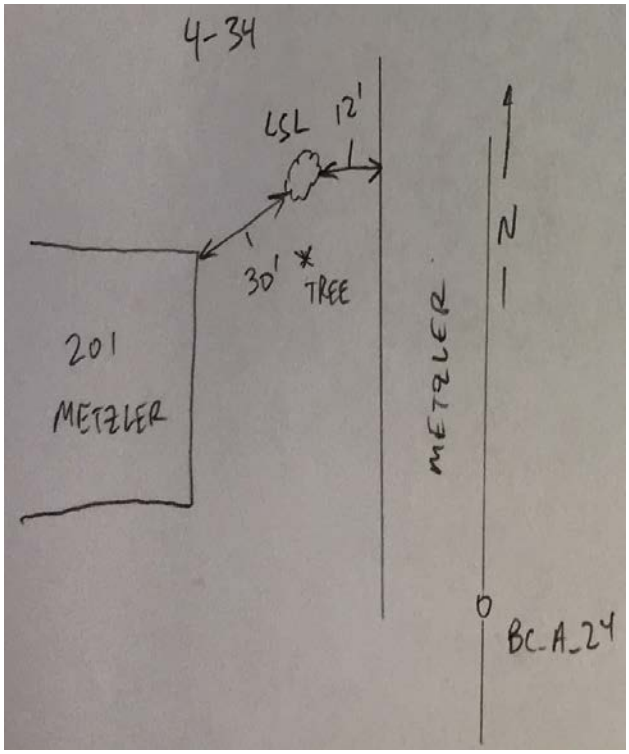
- Leaking service lateral located to the north of a small tree.
- Also refer to aerial on following page.
-
-
-

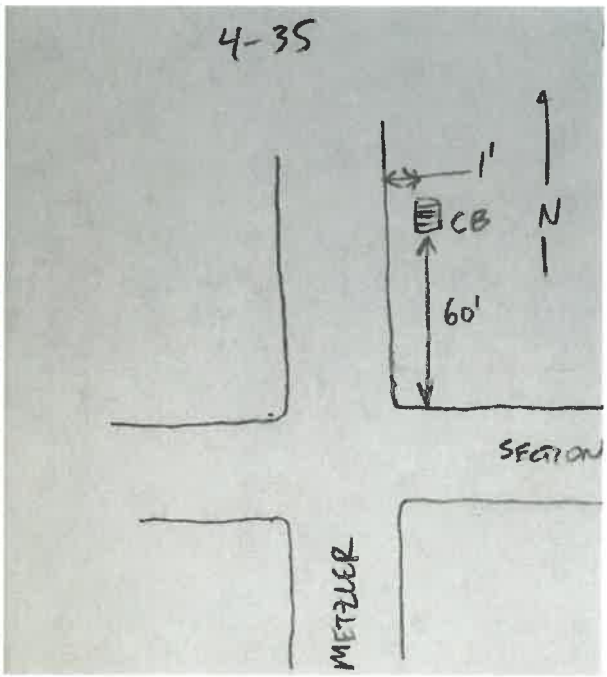
- Catch basin is located underneath the black car. Smoke was rapidly existing from catch basin.
- Also refer to aerial on following page.
-
-
-

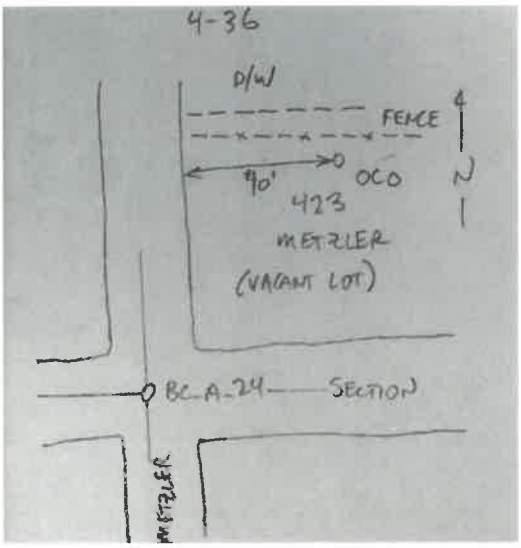
- Open cleanout located to the south of the fence. Pipe extends approximately six feet into the air. Property is an abandoned house.
- Also refer to aerial on following page.
-
-
-
