# CITY OF MOLALLA

## SMOKE TESTING REPORT

OCTOBER 2017

**Project No. 100.26**

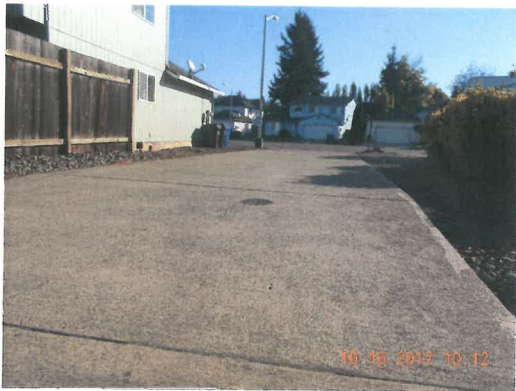
- Located in concrete driveway for 120 Toliver Ct.
- Smoke coming from cleanout cap, Did not open to verify actual issue
- 
- 
-

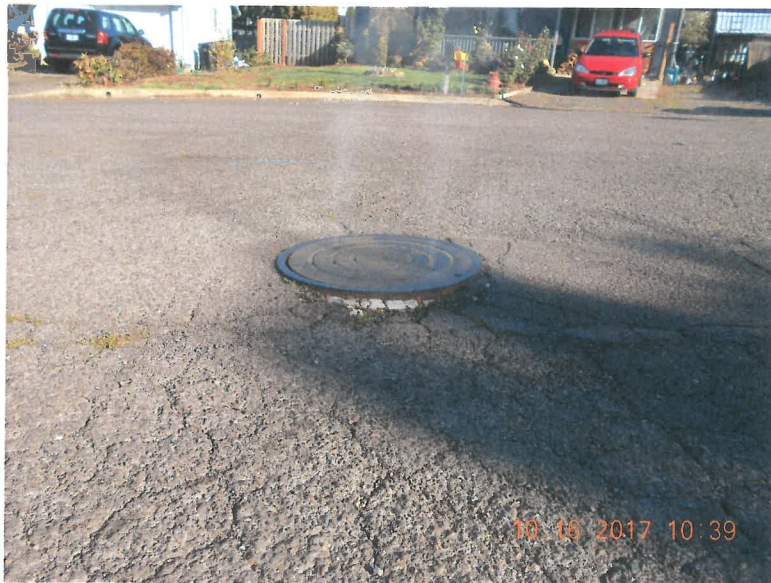
- Smoke coming from around the rim of the manhole
- 
- 
- 
-

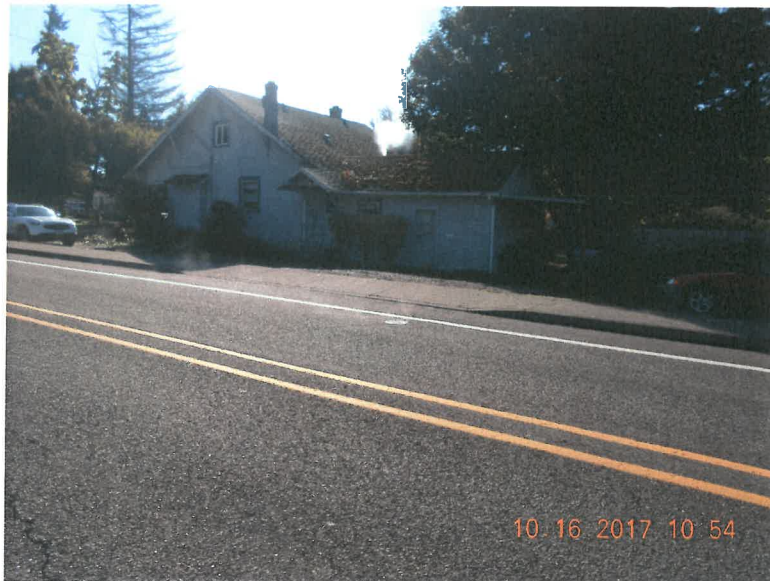
- Smoke coming from around the rim of the cleanout
- \_\_\_\_\_
- \_\_\_\_\_
- \_\_\_\_\_
- \_\_\_\_\_
- \_\_\_\_\_

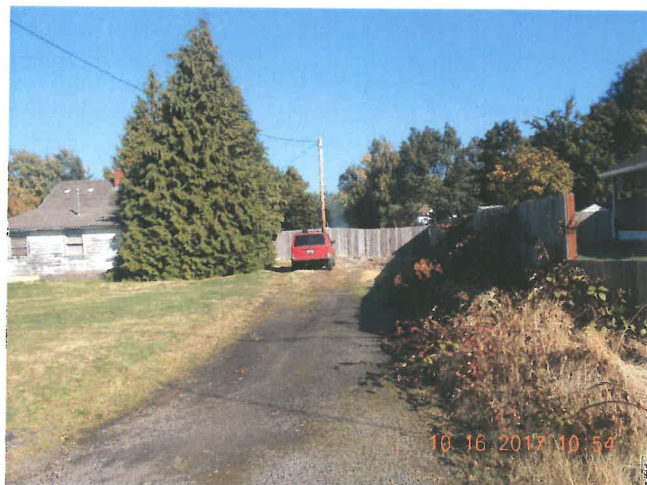
- Smoke coming from behind wooden fence, could not gain access to verify issue
- There was an exposed section of PVC pipe at the fence.
- 
- 
-

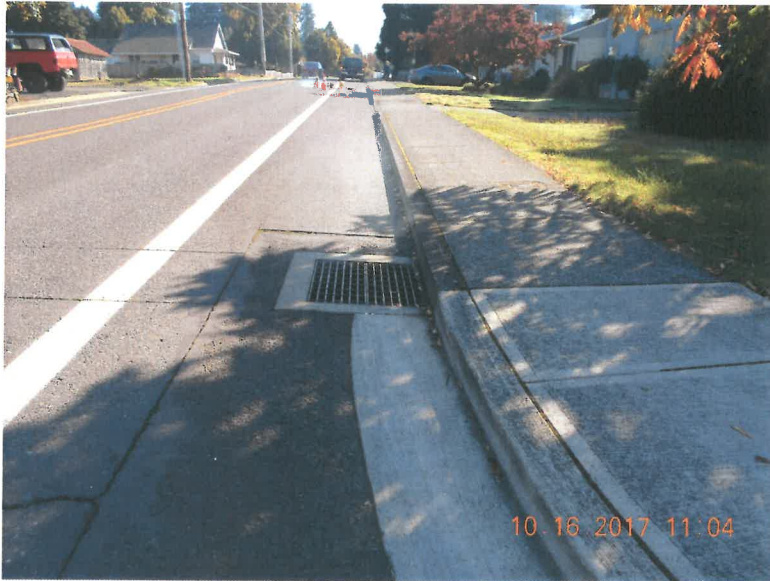
- Smoke coming from catch basin.
- Looking east on Toliver Rd from Kennel Ave.
- 
- 
-

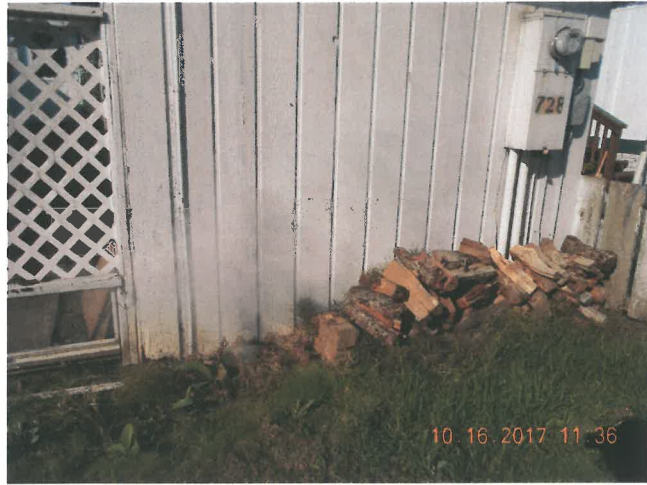
- Located at Unit #728 of Twin Firs Mobile Home Park
- Smoke coming from open cleanout, located behind the shed
- 
- 
-

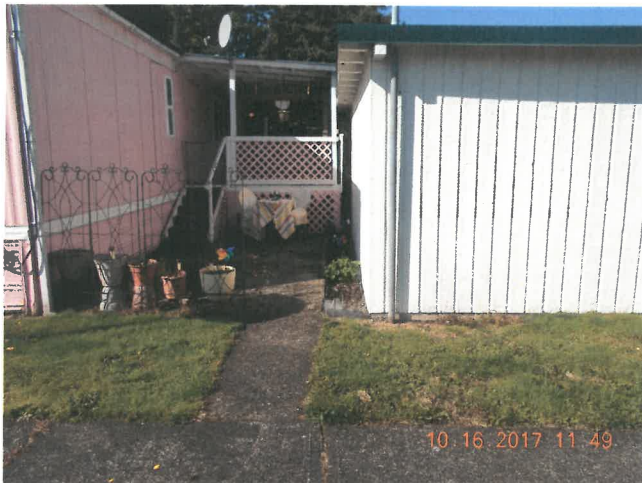
- Located at Unit #701 of Twin Firs Mobile Home Park
- Smoke coming from ground in the flower bed, next the shed.
- 
- 
-

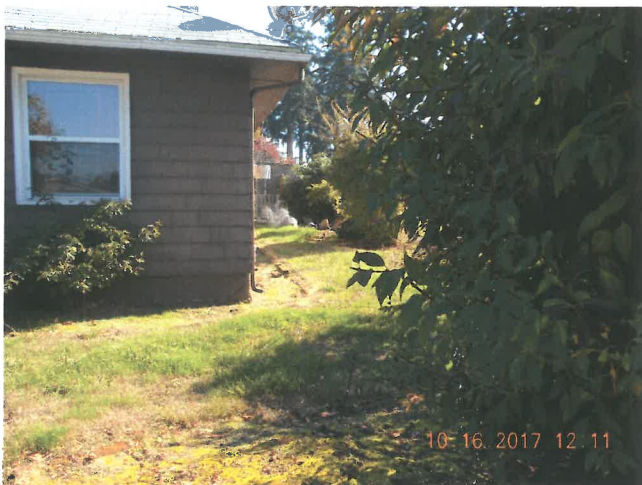
- Smoke coming from open cleanout
- 
- 
- 
- 
-

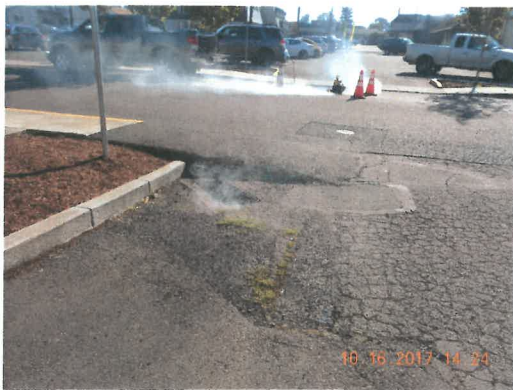
- Smoke coming from catch basin
- Located in the northeast corner of intersection of E. Ross Street & Marson Court, on the north side of the asphalt ramp.
- 
- 
-

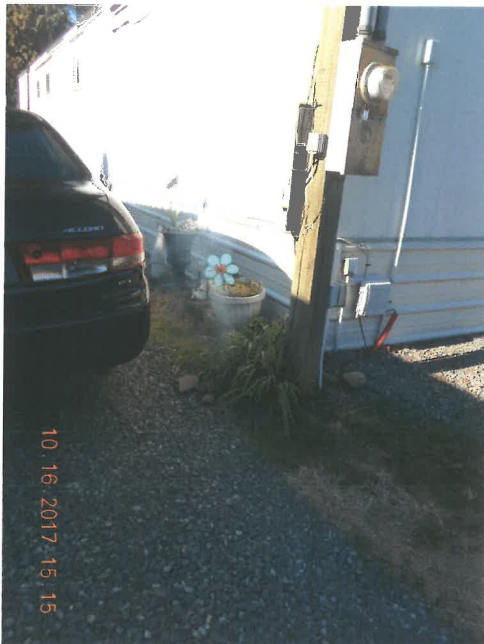
- Smoke coming from open cleanout with no cap
- Located in Molalla Mobile Manor
- 
- 
-

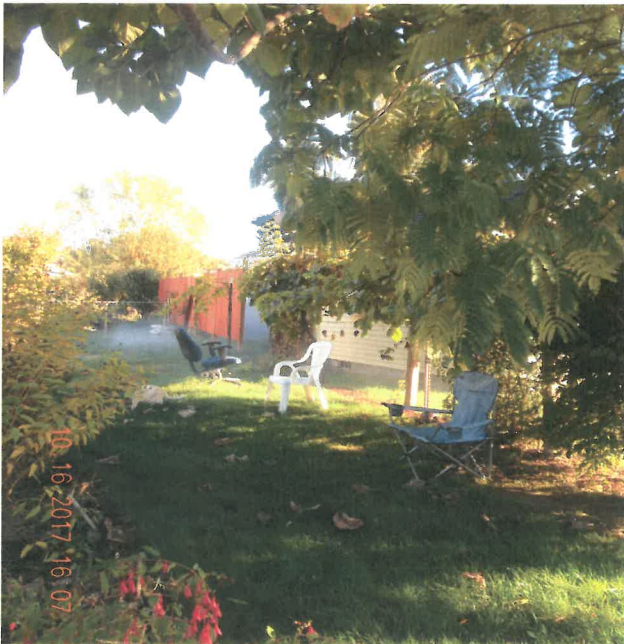
- Smoke coming behind the fence, could not identify the source.
- 
- 
- 
- 
-

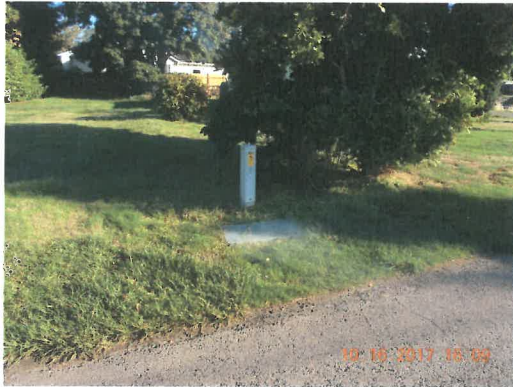
- 1-18. Smoke was exiting from a communication box located in front of telephone pedestal #127.
- 3-28. Smoke was exiting from a vault in the parking lot west of car wash.
- 4-20. Floor drains at Les Schwab Tire Center were connected to the gravity sewer.

- Smoke coming out of communication box located in front of telephone pedestal #127
- 
- 
- 
-

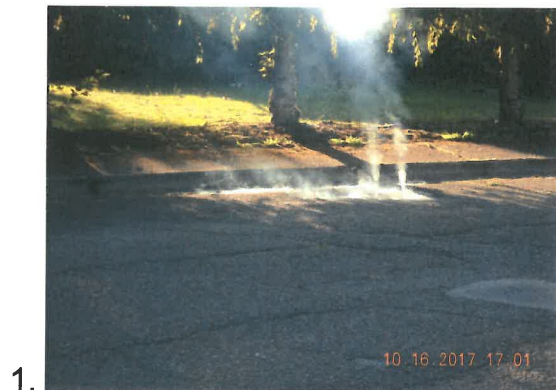
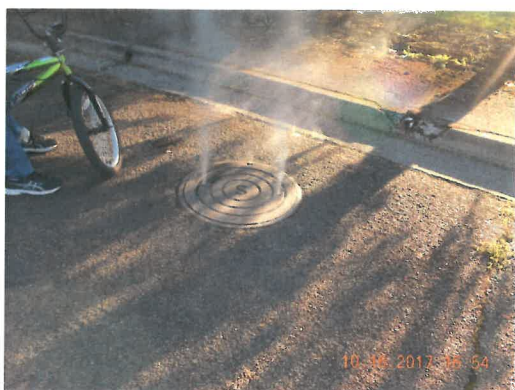
- Smoke leaky out around the rim of the manhole, the cracks in the road around the manhole and along the joint between the ac pavement and concrete gutter
- 
- 
- 
-

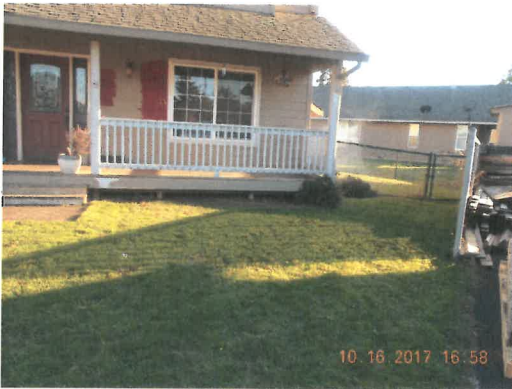
- Smoke coming out of open clean located under the front deck.
- 
- 
- 
- 
-

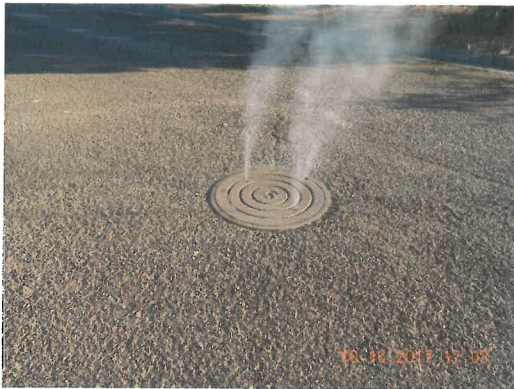
- Smoke leaking slightly around the rim of the manhole
- 
- 
- 
-

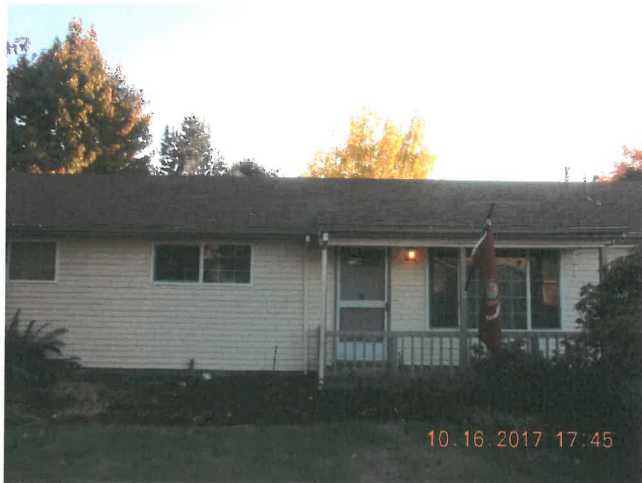
- Smoke coming out of gutter by front porch.
- 
- 
- 
- 
-

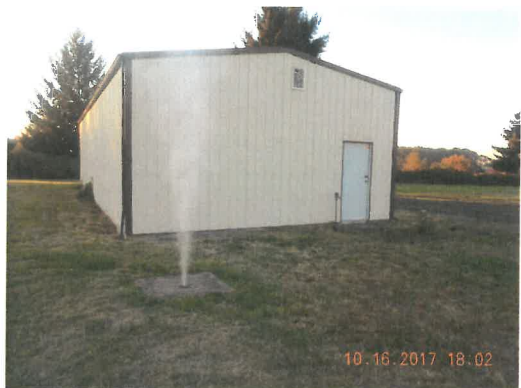
- Smoke coming out of open cleanout next to shop T@ Church of the Nazarene
- 
- 
- 
- 
-

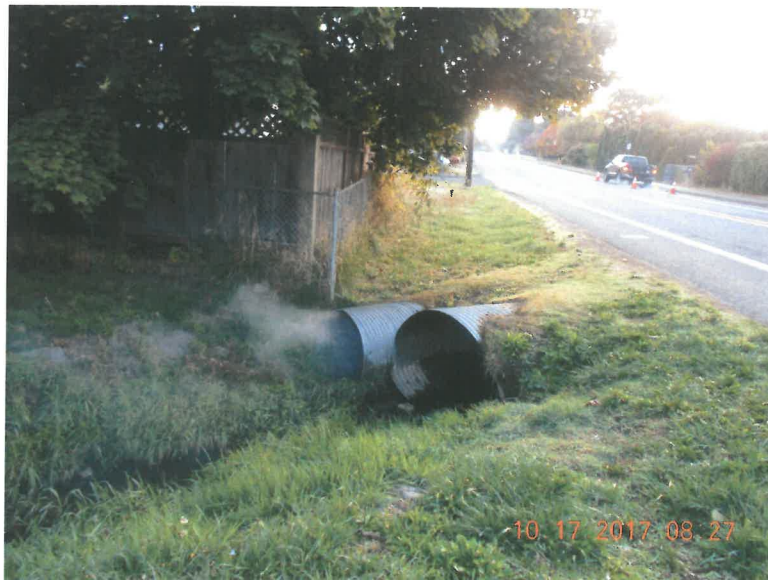
- Smoke coming out of the 36" diameter culvert. Smoke machine was set up on MH TL 21
- 
- 
- 
- 
-

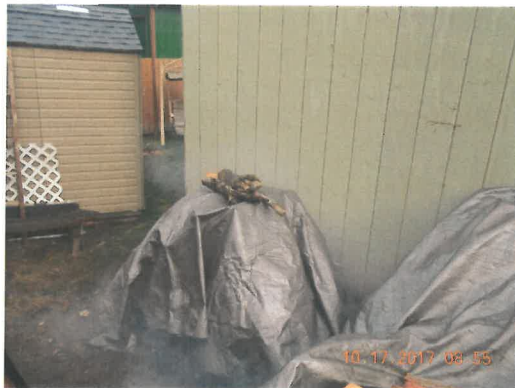
- Smoke coming out from under the tarp on the southwest corner of the garage
- 
- 
- 
- 
-

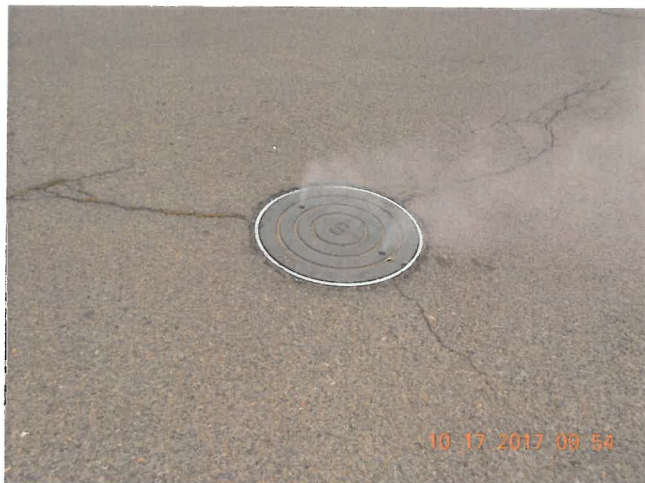
- Smoke coming out from around rim of manhole
- 
- 
- 
-

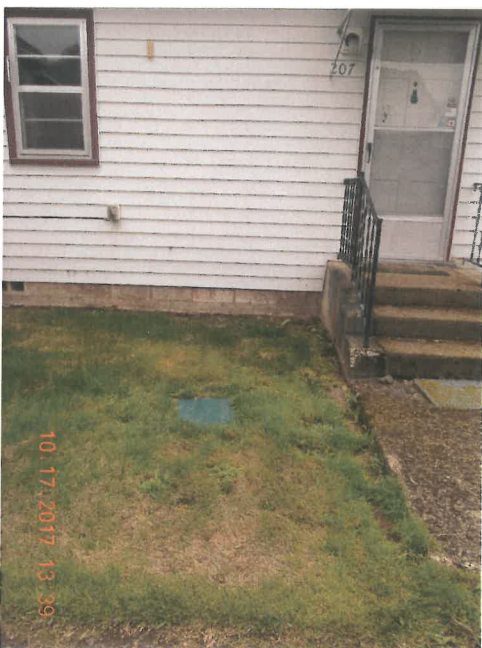
- Resident has a plastic plate fastened down over the cleanout, smoke coming out of the ground near the road and the gas meter
- 
- 
- 
-

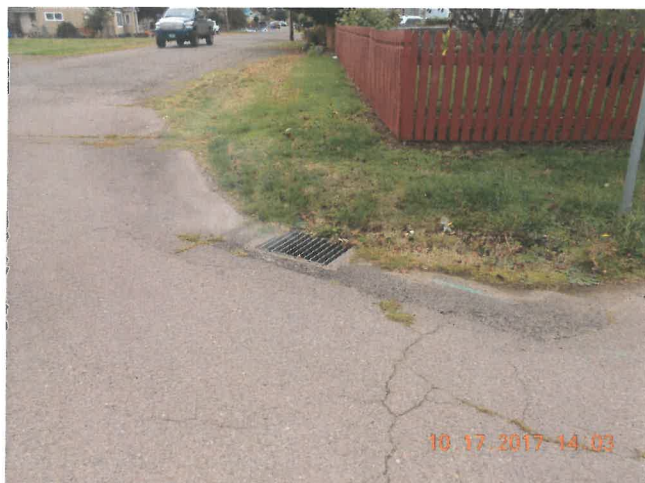
- Smoke coming out of catch basin on the southwest corner of Lola Ave and E. 2<sup>nd</sup> St.
- 
- 
- 
-

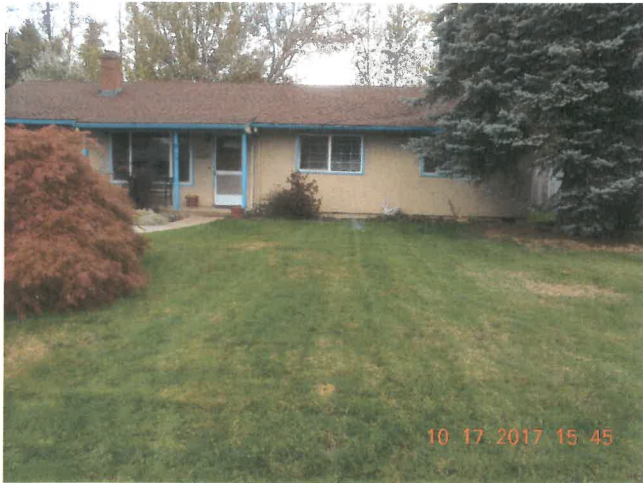
- Smoke coming out of cleanout
- 
- 
- 
- 
-

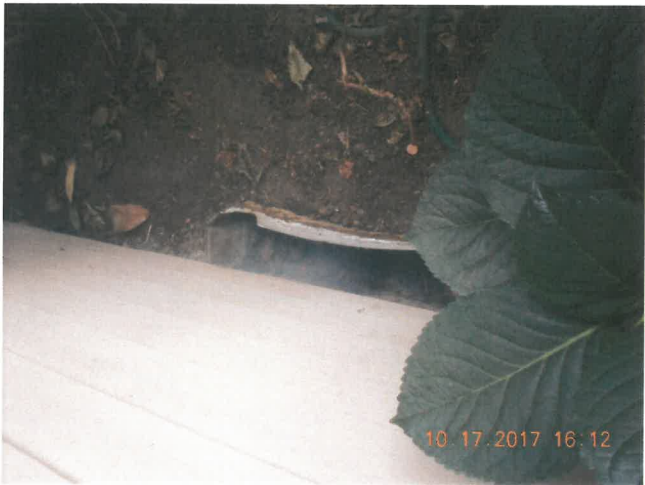
- Smoke coming out of cleanout, located in recessed house vent
- 
- 
- 
- 
-

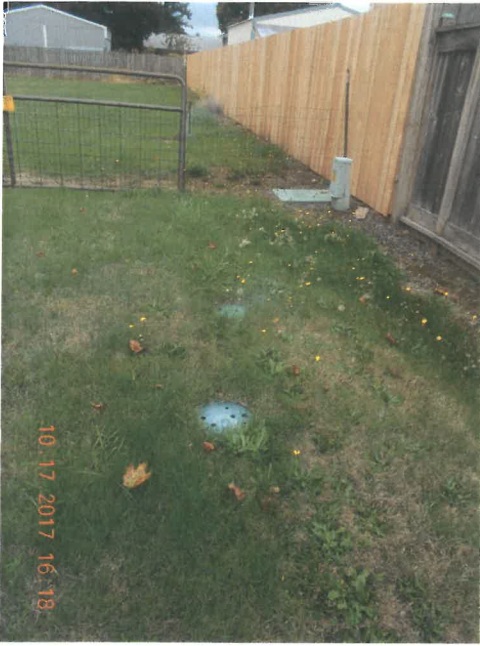
- 1. Smoke leaking around cleanout cap
- 2. Smoke coming out of irrigation valve box
- 3. Smoke coming out of cleanout with no cap
- 
-

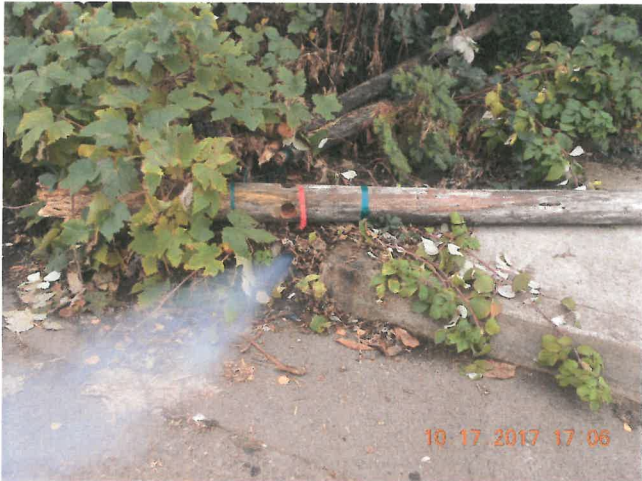
- Smoke coming out of drain located in the sidewalk
- \_\_\_\_\_
- \_\_\_\_\_
- \_\_\_\_\_
- \_\_\_\_\_
- \_\_\_\_\_

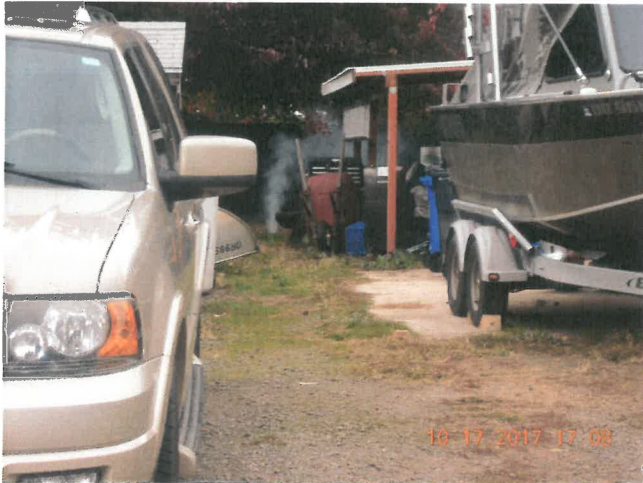
- Smoke coming out of cleanout with no cap
- 
- 
- 
- 
-

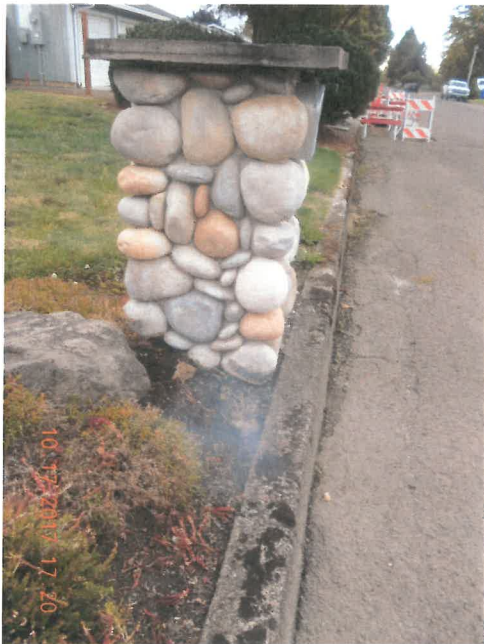
- Smoke coming out of hole in the ground next to the mailbox
- 
- 
- 
- 
-

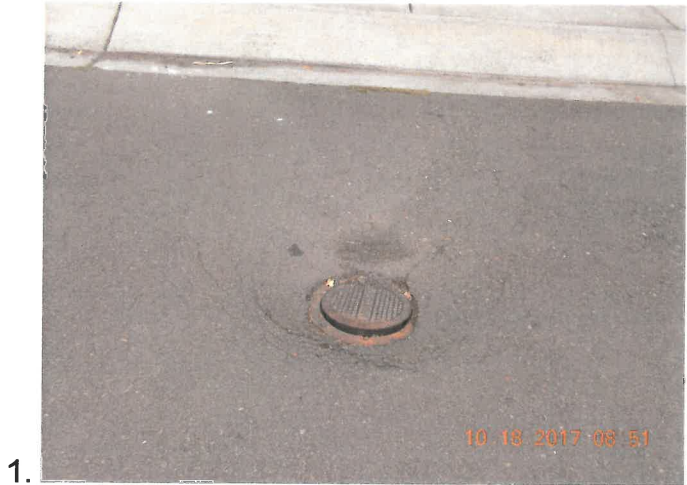
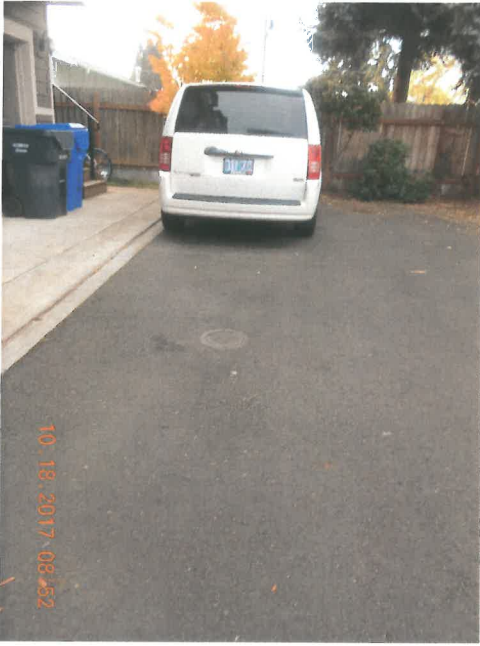
- Smoke coming out of cleanout cap for both units
- 
- 
- 
- 
-

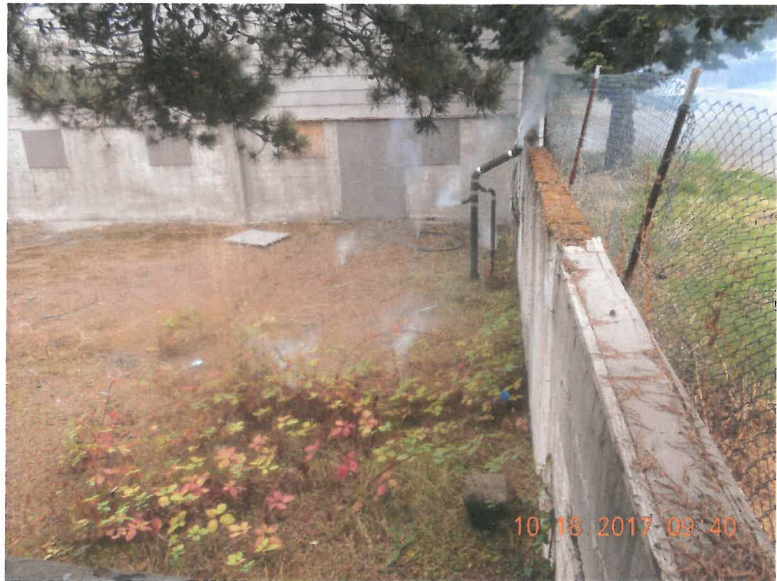
- Vacant lot - has multiple open pipes and multiple area where smoke was coming from the ground.
- 
- 
- 
- 
-

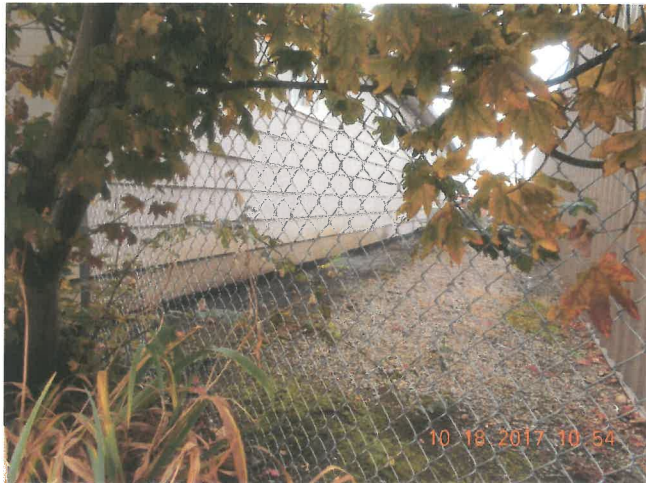
- Smoke coming out next the building, could not identify the source
- \_\_\_\_\_
- \_\_\_\_\_
- \_\_\_\_\_
- \_\_\_\_\_
- \_\_\_\_\_

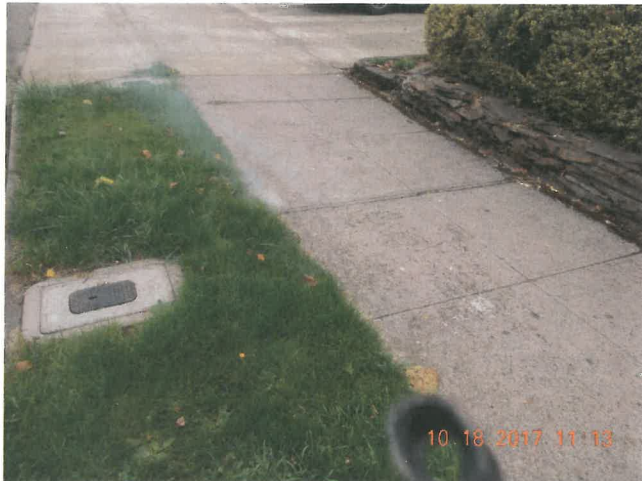
- Smoke coming out of the joint in the concrete sidewalk
- 
- 
- 
- 
-

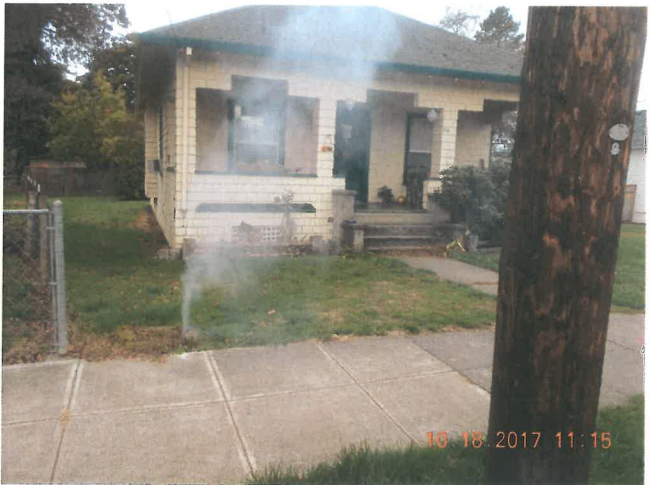
- Smoke coming out of open cleanout, no cap
- 
- 
- 
-

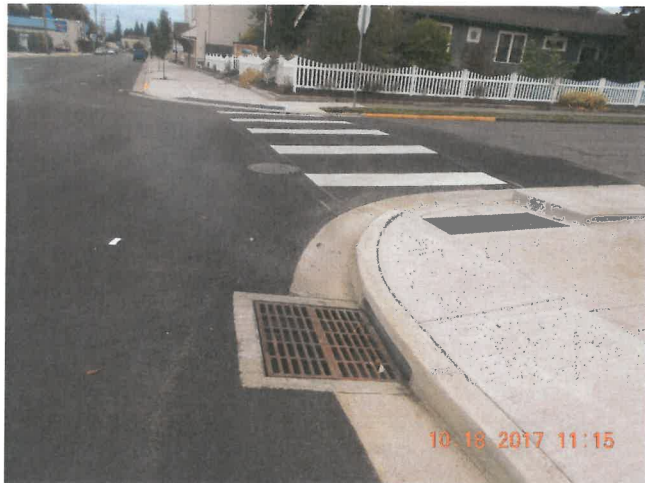
- Smoke coming out of catch basin, located on the southeast corner of the intersection
- 
- 
- 
-

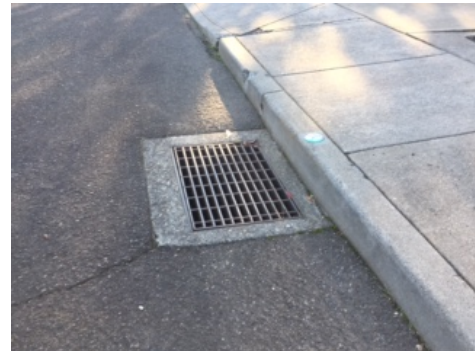
- Catch Basin on the south side of Taurus St., in front of 230 & 240 Taurus St.
- 
- 
- 
-

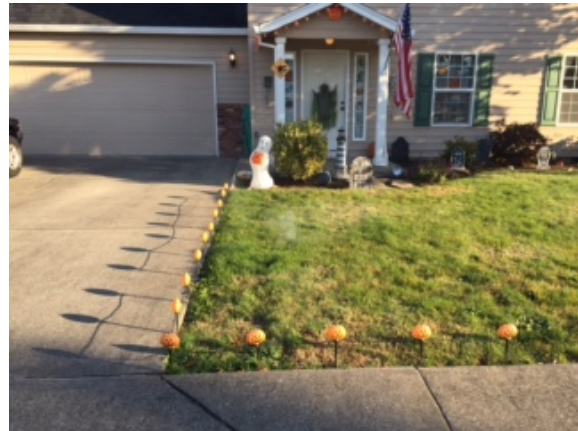
- Smoke in front yard, just east of driveway edge. No cleanout found in area of smoke.
- 
- 
- 
- 
-

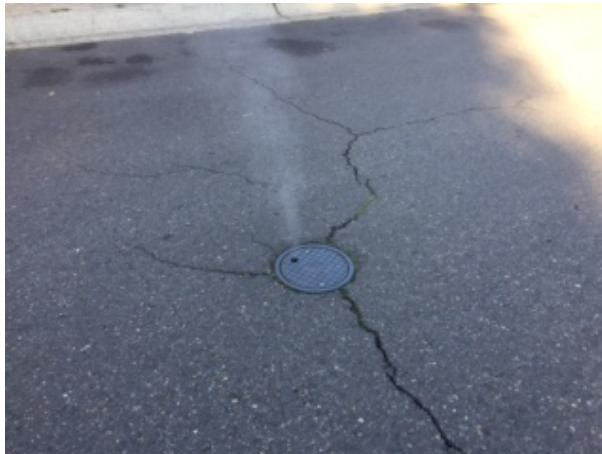
- Mainline cleanout on Toliver Dr., +/-65' south of manhole TL\_E\_6.
- 
- 
- 
-

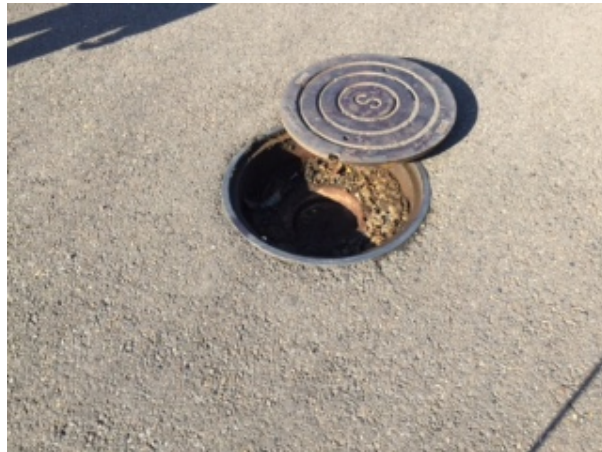
- Mainline cleanout on Hauser Ct., +/-185' north of manhole TL\_E\_3.
- 
- 
- 
-

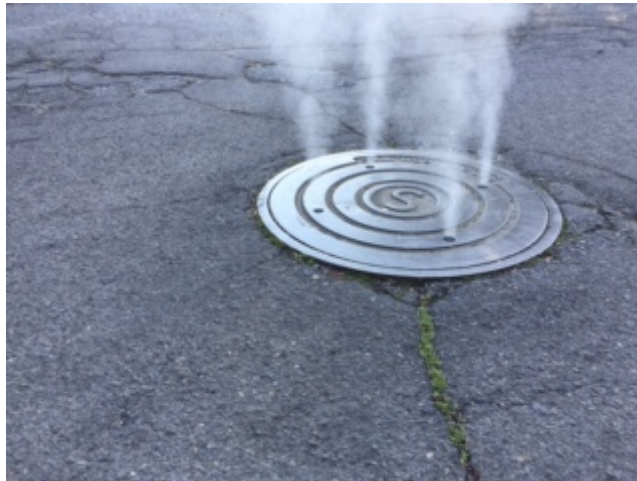
- Smoke was coming up from exterior of manhole TL\_SB1\_3 rim.
- 
- 
- 
-

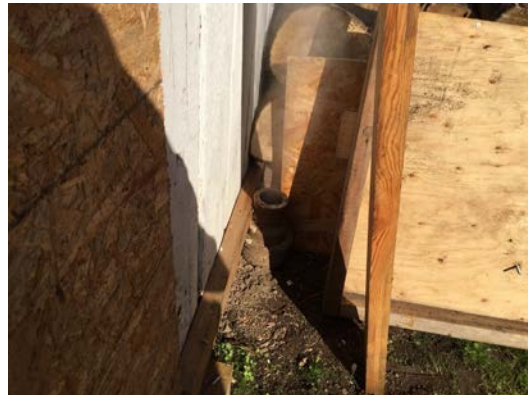
- Open sewer connection/cleanout behind garage.
- 
- 
- 
- 
-

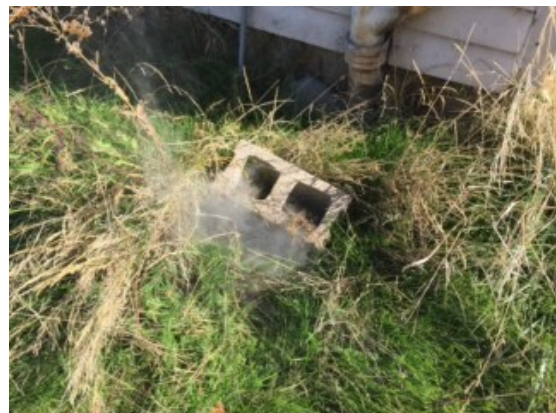
- Cleanout without cap. Covered with cinder block.
- 
- 
- 
- 
-

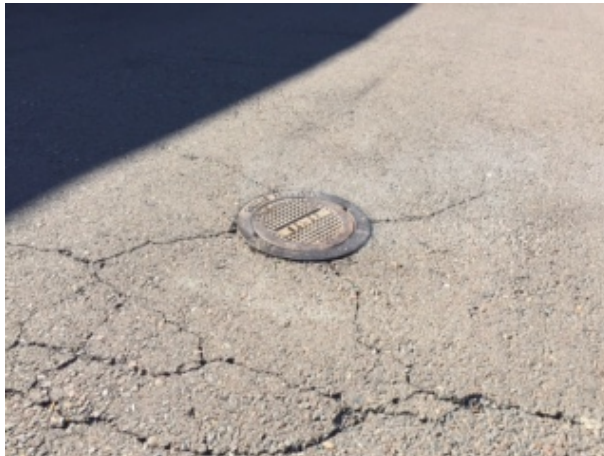
- Smoke from cleanout located 80' east of manhole TL\_D\_12.
- 
- 
- 
- 
-

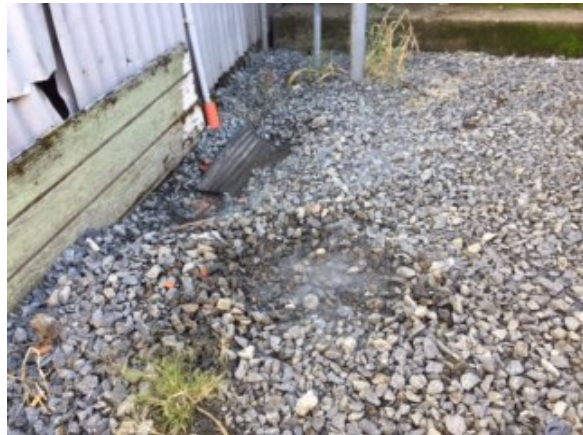
- Smoking through the gravel. No sign of a cleanout in the area but possibly buried.
- 
- 
- 
- 
-

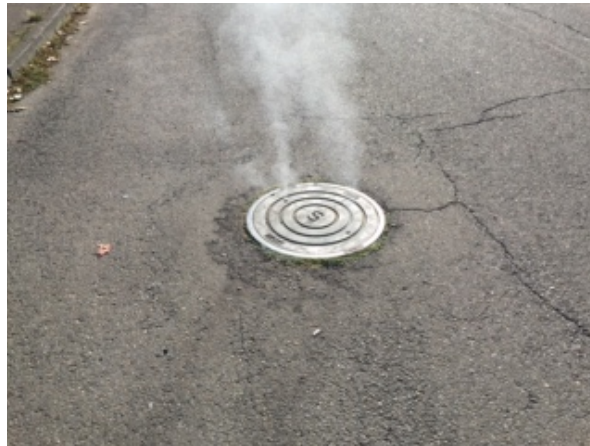
- Smoke coming up from exterior of manhole TL\_D\_3.
- 
- 
- 
-

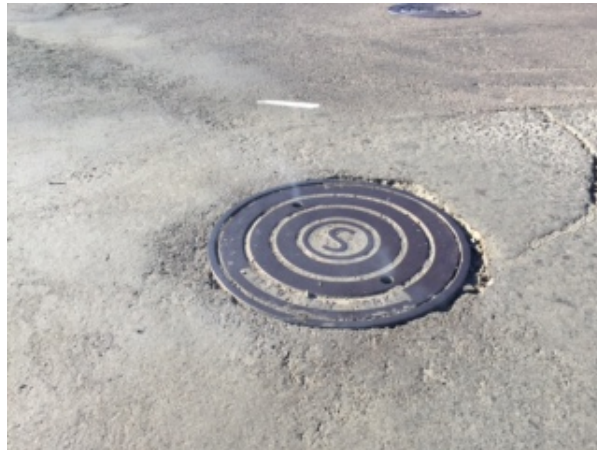
- Smoke coming up from exterior of manhole TL \_2.
- 
- 
- 
- 
-

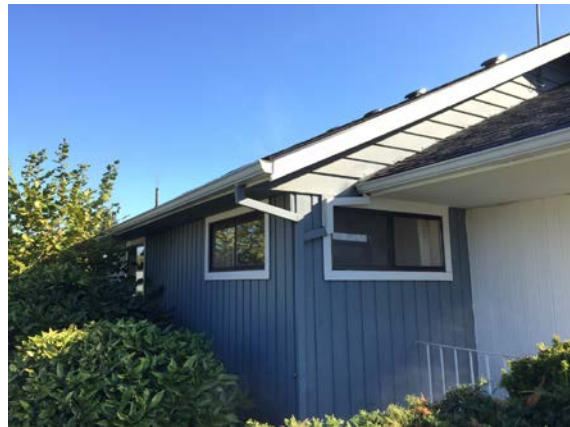
- Smoke coming from gutter/downspout on northwest corner of house.
- 
- 
- 
- 
-

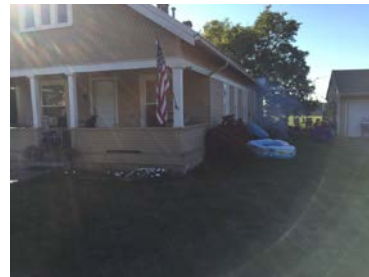
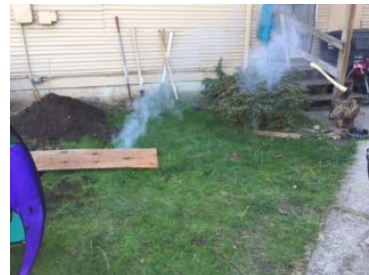
- Smoke from cleanout area. It appears the area is currently under repair/construction.

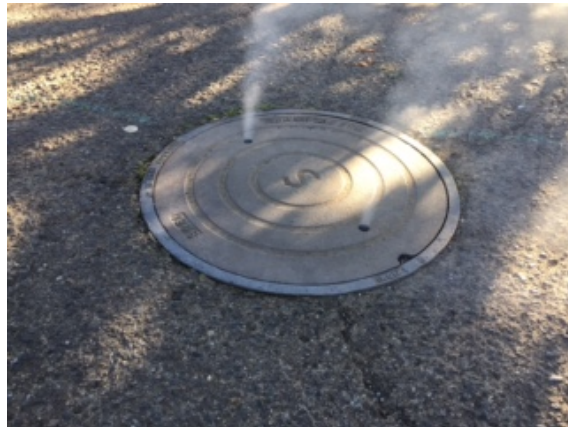
- Smoke coming up from the exterior of manhole TL\_B\_23.
- 
- 
- 
-

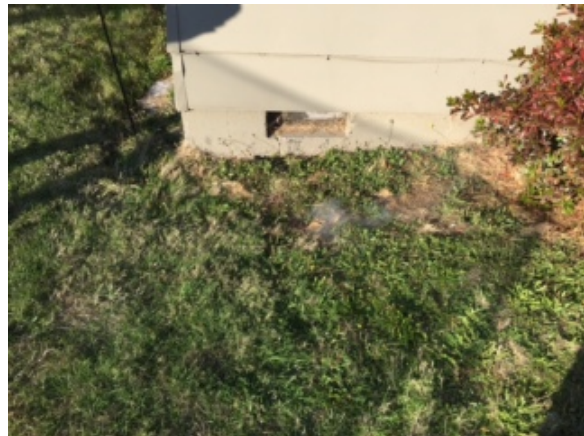
<table><tr> <th style="width: 15%; text-align: center;">No.</th> <th style="text-align: center;">Description</th> </tr><tr> <td style="text-align: center;">1</td> <td>Smoke from broken cleanout cap</td> </tr></table>

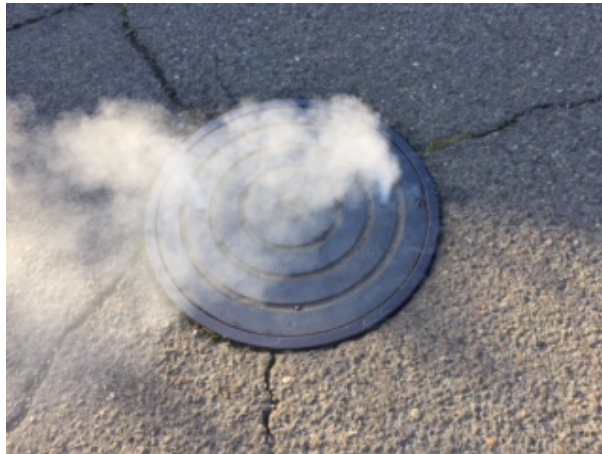
- Smoke coming from exterior of manhole TL\_B\_1.
- 
- 
- 
-

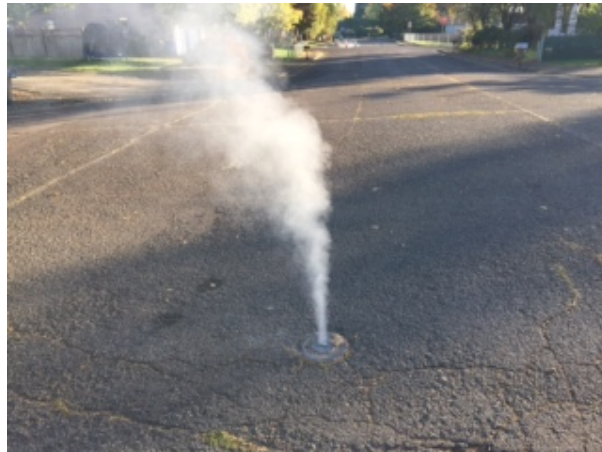
- Smoke coming from mainline cleanout in Park Pl. cul-de-sac.
- 
- 
- 
-

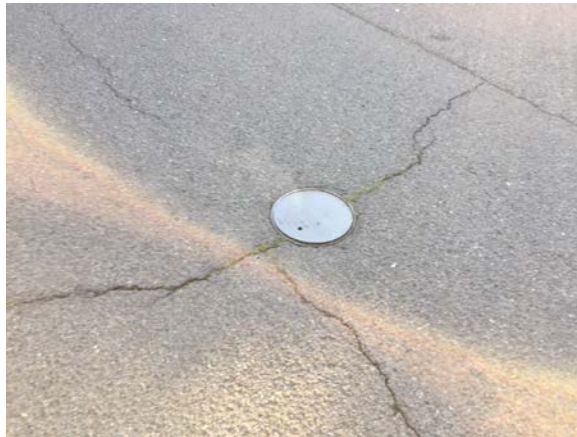
- Smoke coming from mainline cleanout 15' south of manhole TL\_B\_31.
- \_\_\_\_\_
- \_\_\_\_\_
- \_\_\_\_\_
- \_\_\_\_\_

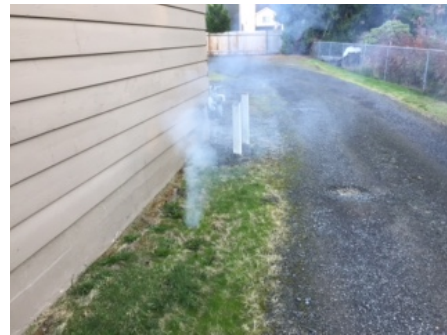
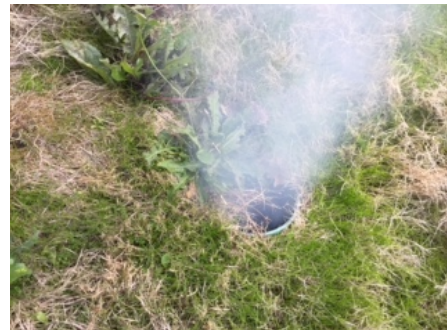
- Smoke from cleanout located adjacent to the northeast corner of the garage, behind fence.
- 
- 
- 
- 
-

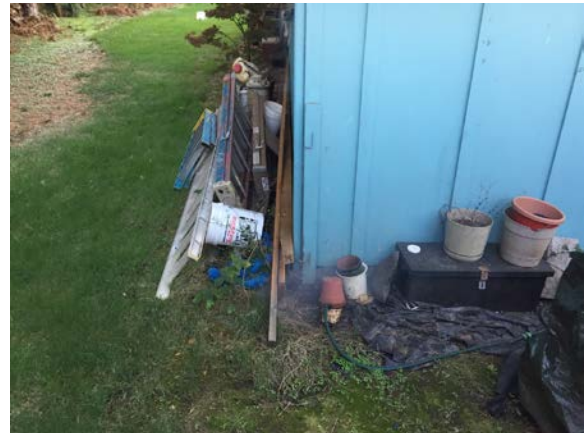
- Smoke from manhole rim and concrete above grade.
- 
- 
- 
-

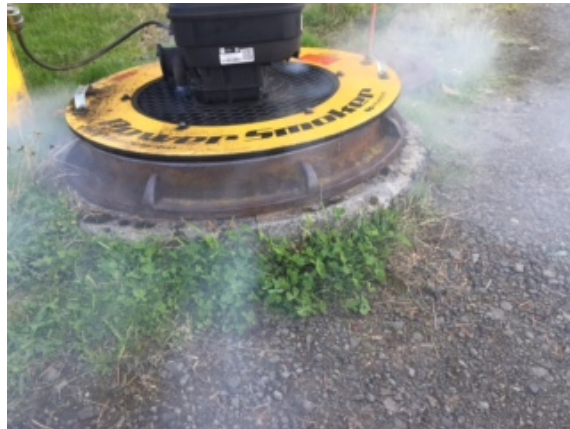
<table><tr> <th style="width: 15%; text-align: center;">No.</th> <th style="text-align: center;">Description</th> </tr><tr> <td style="text-align: center;">1</td> <td>Smoke from broken cleanout cap</td> </tr></table>

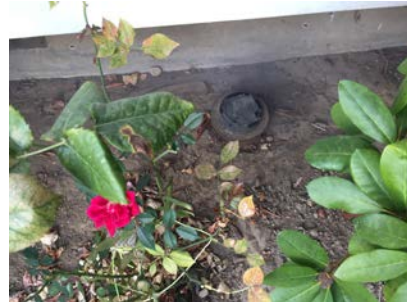
- Broken cleanout cap on north side of garage, adjacent to concrete sidewalk.
- 
- 
- 
- 
-

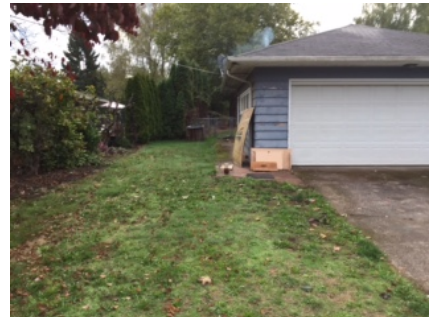
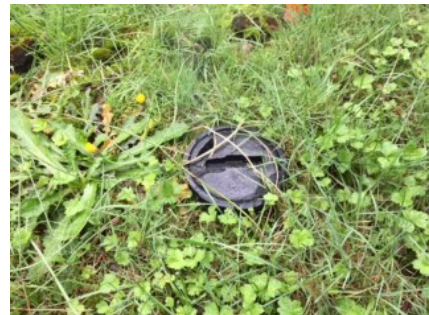
<table><tr> <th style="text-align: center;">No.</th> <th style="text-align: center;">Description</th> </tr><tr> <td style="text-align: center;">1</td> <td>Smoke from broken cleanout cap</td> </tr><tr> <td style="text-align: center;">2</td> <td>Smoke from broken cleanout cap</td> </tr></table>

- Broken cleanout cap on south side of house, between house and driveway.
- Smoke from landscape pond overflow pipe. Pond is southeast of house.
- 
- 
-

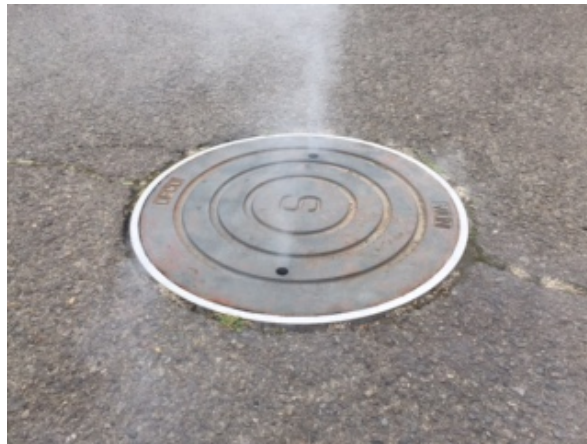
- Smoke coming up from exterior of manhole TL\_C\_16.
- 
- 
- 
-

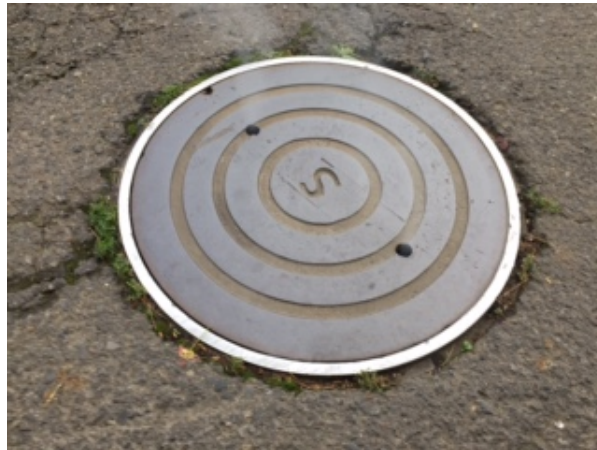
- Smoke coming up from exterior of manhole TL\_C\_34.
- 
- 
- 
-

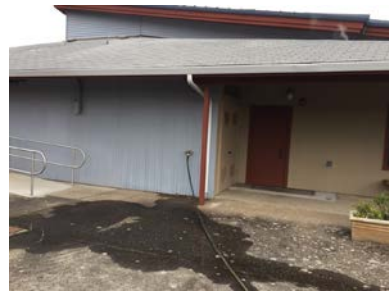
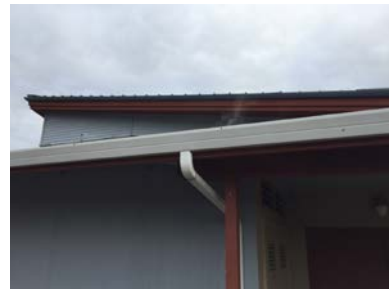
- Smoke coming from gutter on the south side of the main church building.
- 
- 
- 
- 
-

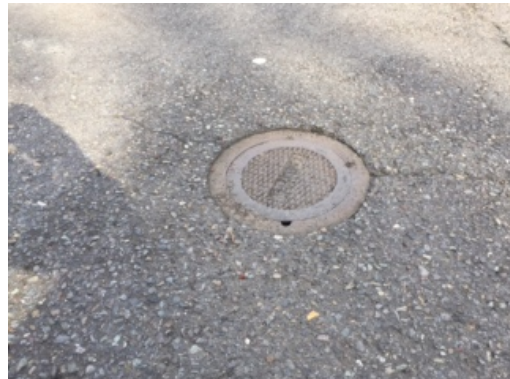
- Smoke coming from cleanout in the southwest parking lot of Molalla High School.
- 
- 
- 
-

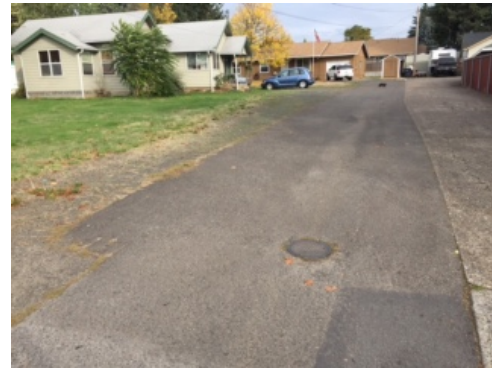
- Smoke coming from cleanout in the driveway serving flag lots at 165 Shirley St.
- 
- 
- 
- 
-

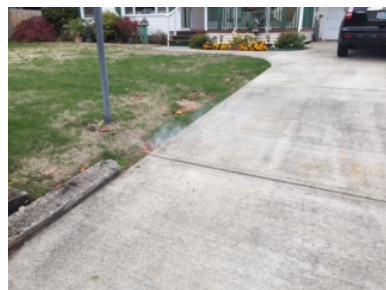
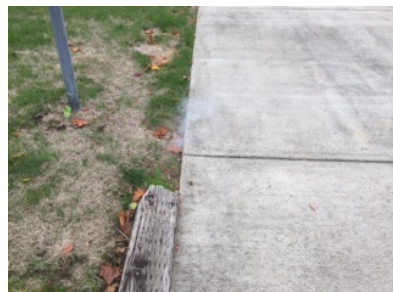
- Smoke coming up from a 13' section of the driveway edge.
- 
- 
- 
-

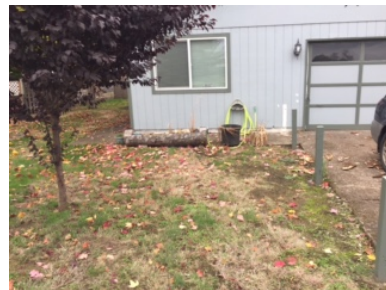
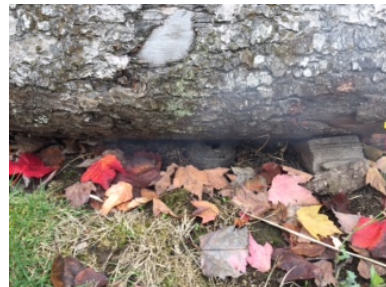
- .Smoke from broken cleanout cap, located next to concrete walkway, under planter.
- 
- 
- 
- 
-

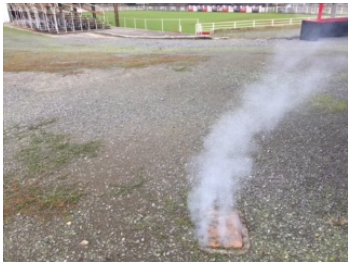
- Smoke from broken cleanout cap inside a water meter box. Cleanout is located on the north east side of the gravel parking area.
- 
- 
- 
-

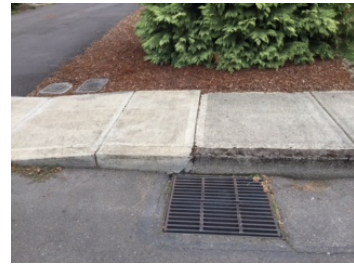
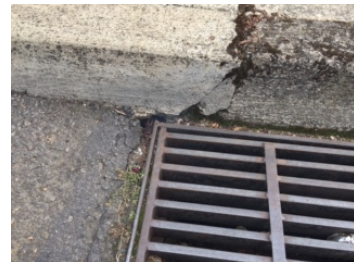
- Smoke coming from catch basin and crack in the concrete curb behind the catch basin on the east side of Eckerd Ave, approximately 75' south of manhole TL\_A\_21.

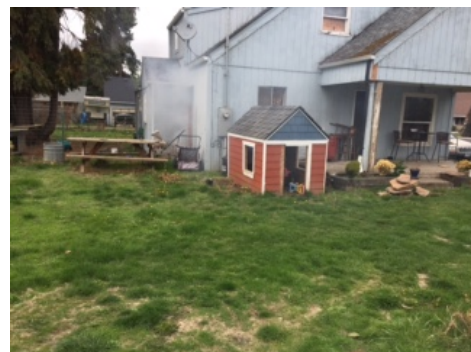
- Smoke from cleanout area. Could not confirm if the cap was broken or missing.
- 
- 
- 
-

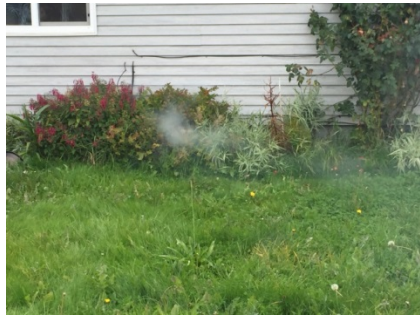
<table><tr> <th style="text-align: center; width: 15%;"><u>No.</u></th> <th style="text-align: center;"><u>Description</u></th> </tr><tr> <td style="text-align: center;">1</td> <td>Smoke from broken cleanout cap</td> </tr></table>

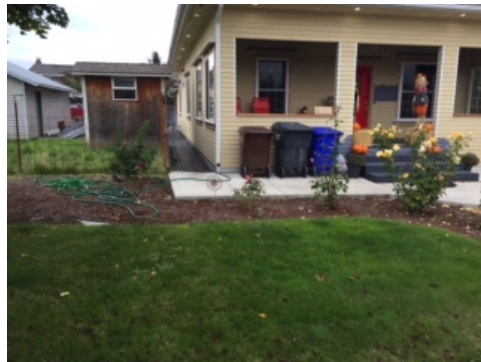
- Smoke from cleanout area. Could not confirm if the cap was broken or missing.
- 
- 
- 
-

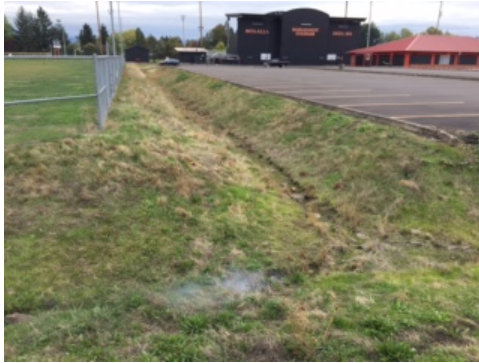
No. 1

- Smoke from ditch running north/south on east side of Eckerd Ave. Smoke was near the northwest corner of the football field parking lot.
- See attached for pictures.
- 
- 
-

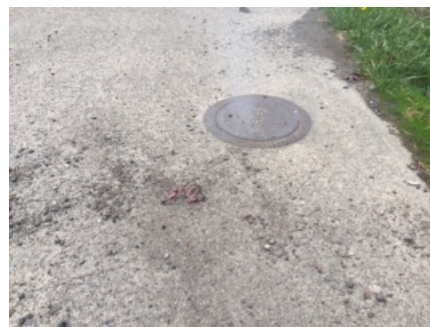
- Smoke from cleanout in flag lot driveway.
- 
- 
- 
-

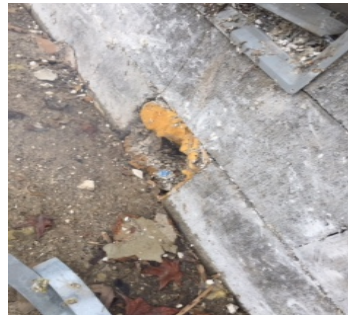
- House has been removed. Smoke from uncovered sewer connection in foundation.
- 
- 
- 
-

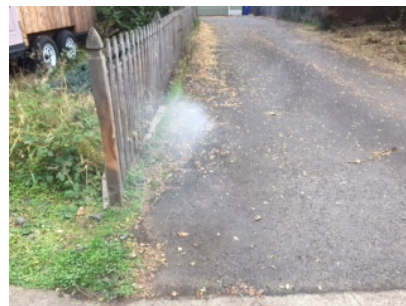
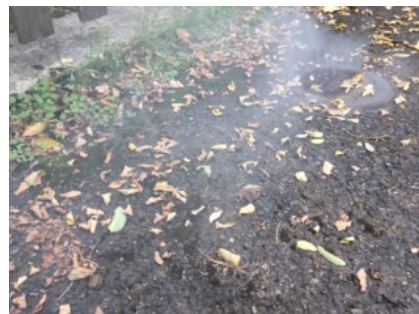
- Smoke from driveway cleanout cover on south side of driveway.
- Smoke is also coming up from edge of asphalt, adjacent to the cleanout cover.
- 
- 
-

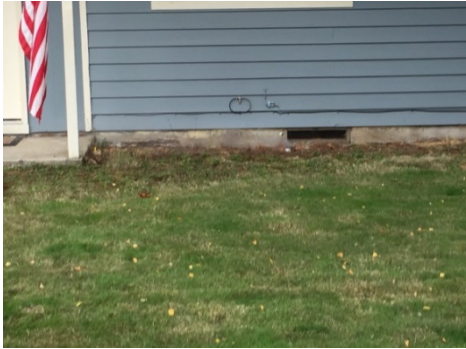
- Smoke from open cleanout, south of front porch, adjacent to front of house.
- 
- 
- 
-

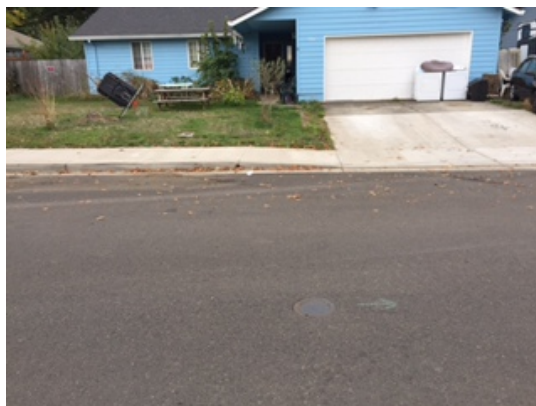
- Smoke from mainline cleanout cover on Stower Rd., in front of 503 Stower Rd.
- 
- 
- 
-

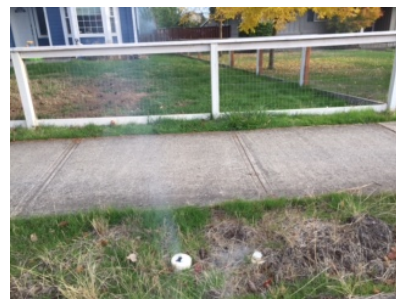
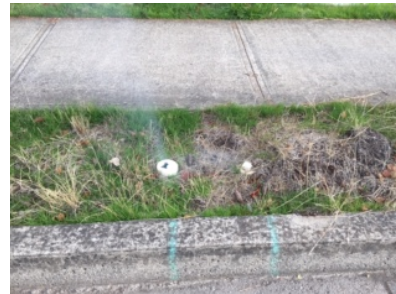
<table><tr> <th style="text-align: center;">No.</th> <th style="text-align: center;">Description</th> </tr><tr> <td style="text-align: center;">1</td> <td>Smoke from two broken cleanout covers</td> </tr></table>

- Smoke from two, adjacent cleanout covers, in beauty strip grass in front of 621 Main St.
- 
- 
- 
-

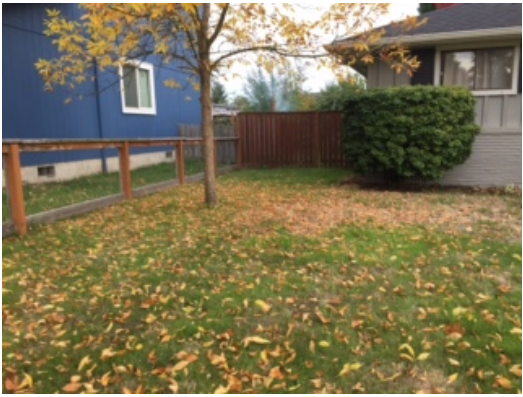
- Smoke from fence line, between backyards of 621 and 623 Main St.
- Could not confirm broken or uncovered cleanout.
- 
- 
-
