# CITY OF MOLALLA

## SMOKE TESTING REPORT

OCTOBER 2017

**Project No. 100.26**

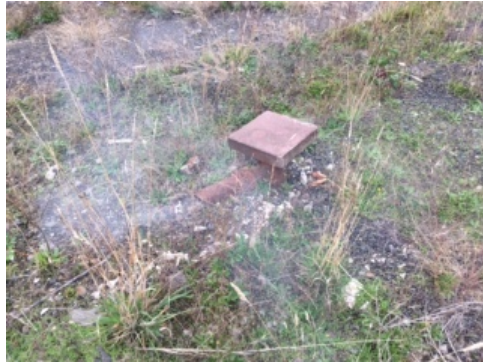
- See aerial for picture locations.
- No. 2 – Cleanout covered with concrete block and open stub out pipe.
- No. 3 – Smoke from gravel area covering broken service lateral.
- No. 5/6 – Smoke from fence line. Possible broken service lateral under fence line.

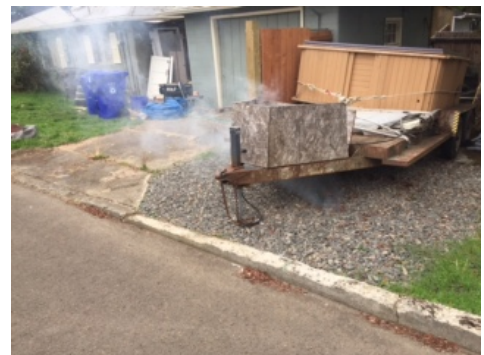
<table><tr> <th style="width: 15%; text-align: center;">No.</th> <th style="text-align: center;">Description</th> </tr><tr> <td style="text-align: center;">1</td> <td>Smoke from broken cleanout cap</td> </tr></table>

- Broken cleanout cap, located in gravel area under trailer.
- 
- 
- 
- 
-

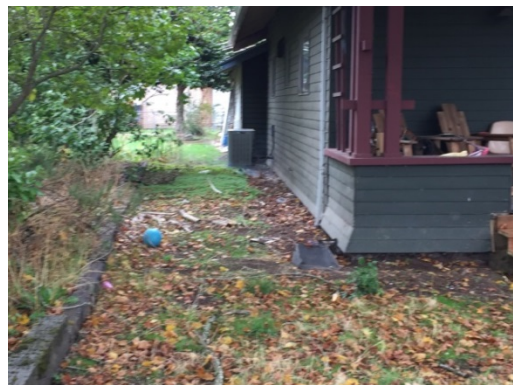
- Smoke from cleanout area on north side of house. Could not confirm broken or missing cap.
- 
- 
- 
- 
-

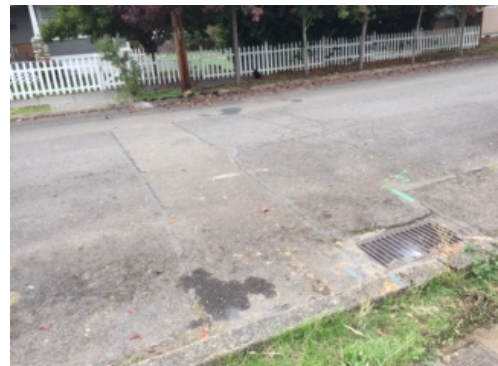
- Smoke from catch basins on east and west side of Engle Ave., between 2<sup>nd</sup> and 3<sup>rd</sup> Streets.
- 
- 
- 
-

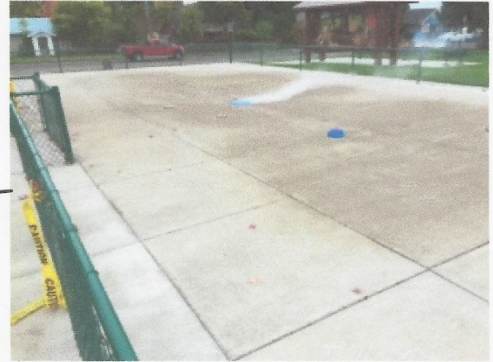
- See attached aerial for locations.
- Picture No. 1 – Smoke coming up from the new splash pad play area drain.
- Picture No. 3 & 4 – Approximate 10 sq. ft. area in the lawn was smoking. No cleanout found. Assumed to be broken sewer lateral or main. 20' north and 17' west of northwest bathroom corner.
- 
-

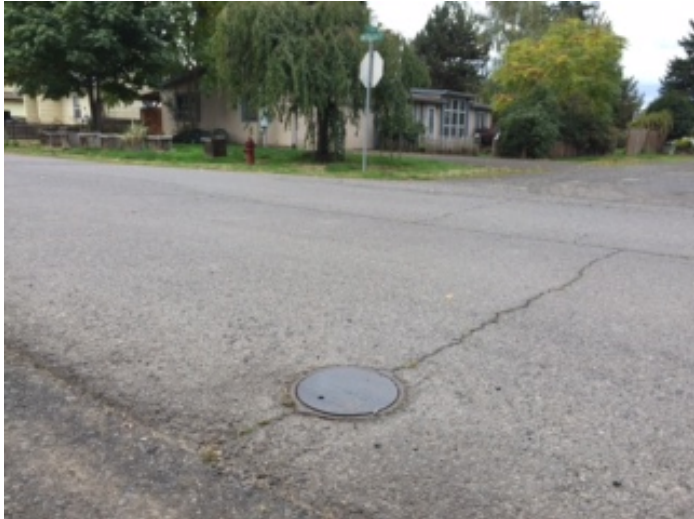
- Smoke from mainline cleanout cover located at 4<sup>th</sup> St. and Metzler Ave.
- 
- 
- 
-

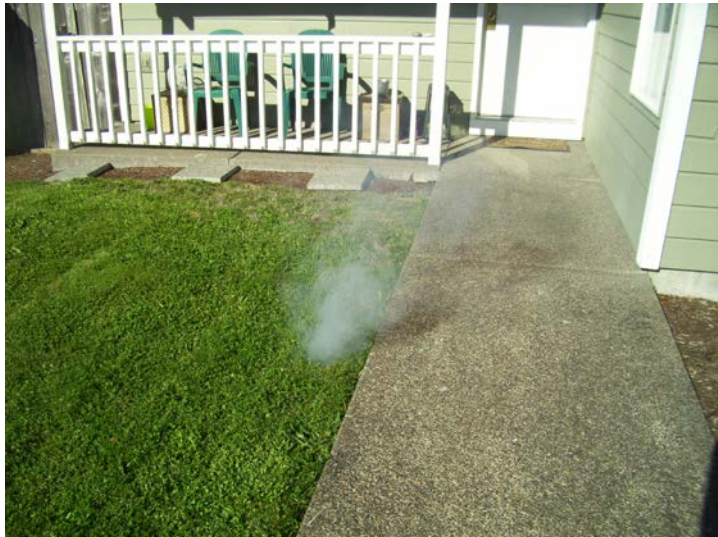
- Cleanout does not have lid.
- 
- 
- 
-

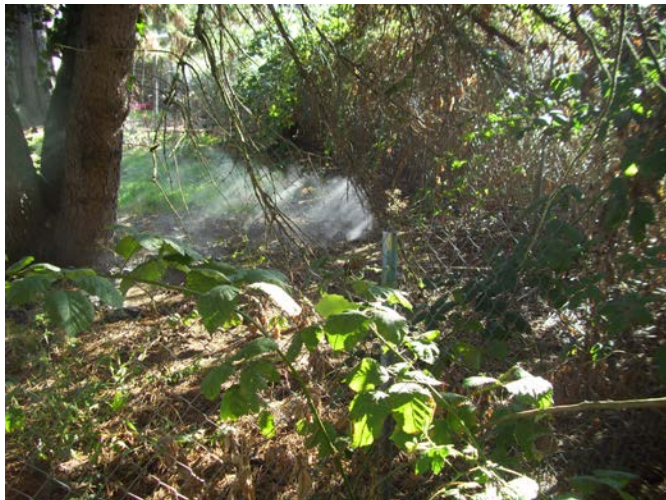
<table><tr> <th style="width: 15%; text-align: center;">No.</th> <th style="text-align: center;">Description</th> </tr><tr> <td style="text-align: center;">1</td> <td>Leaking Service Lateral?</td> </tr></table>

- Could not confirm (Private property).
- 
- 
- 
-

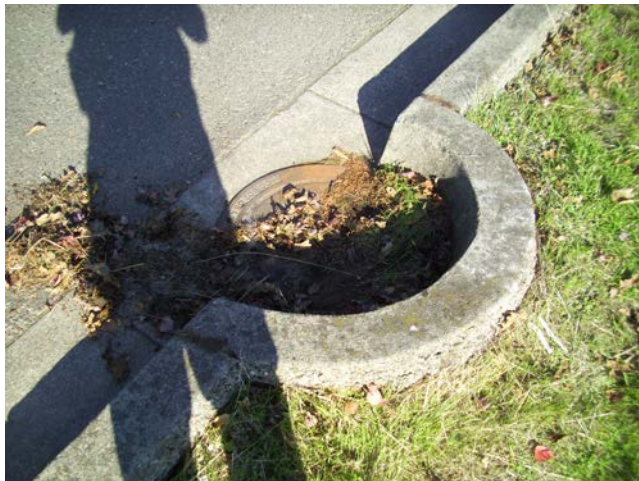
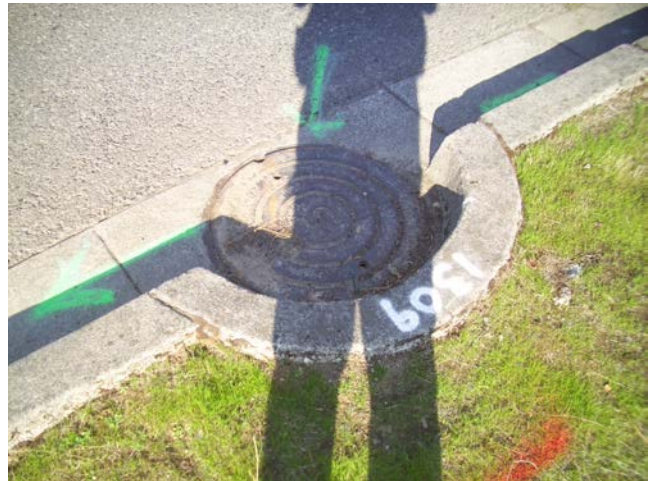
- Photo 1 (TL\_37): Design may allow for inflow.
- Photo 2 (TL\_36): Design may allow for inflow.
- Note: Manhole Inflow Protector may help with possible inflow issues.
- 
-

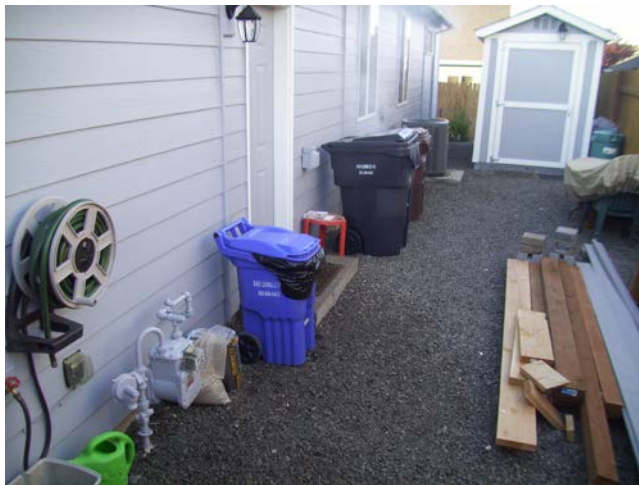
- Behind gate. Could not confirm (Private property).
- 
- 
- 
- 
-

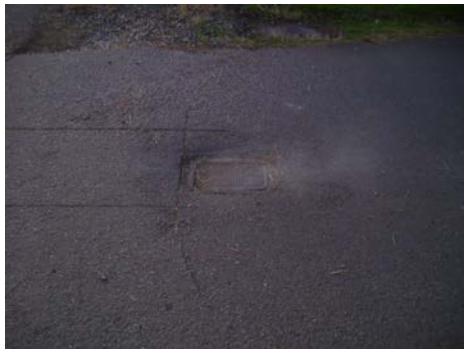
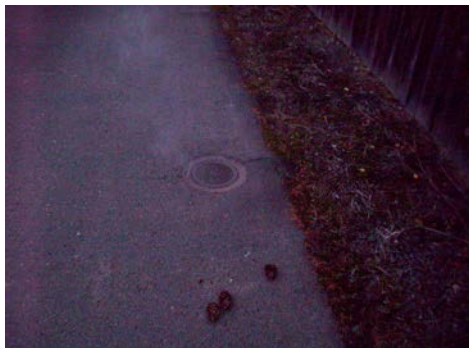
- Photo 1: Water meter lid smoking below grade.
- Photo 2: Smoke around cleanout lid and cracks in pavement.
- 
- 
-

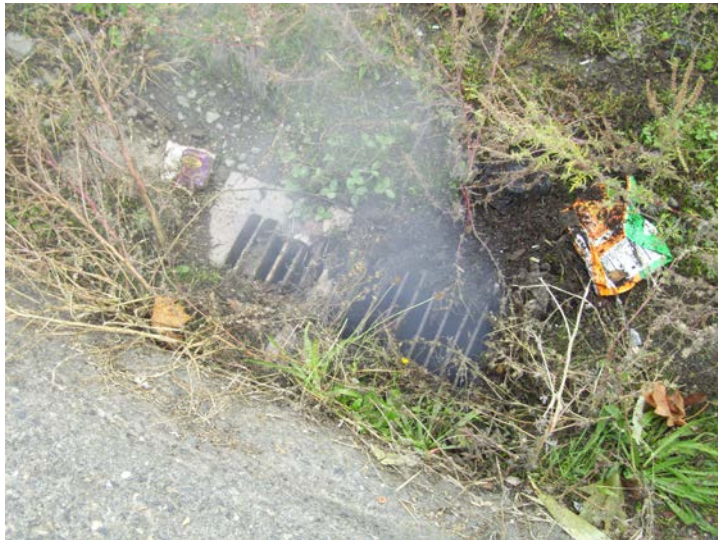
- Smoke coming from catch basin.
- 
- 
- 
-

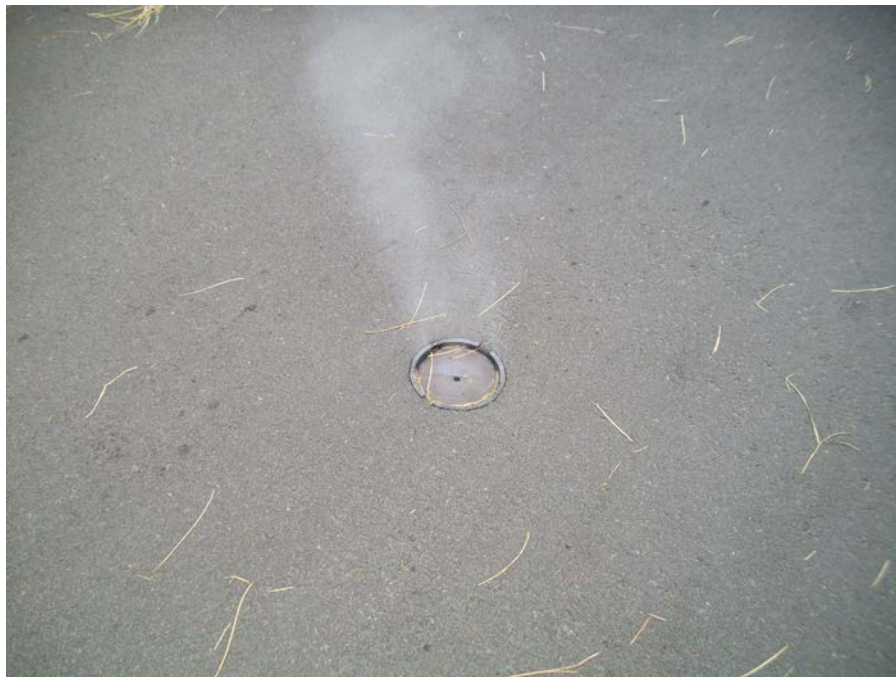
- Cleanout lid recessed below pavement grade. Smoke coming from sides of lid and center.
- 
- 
- 
-

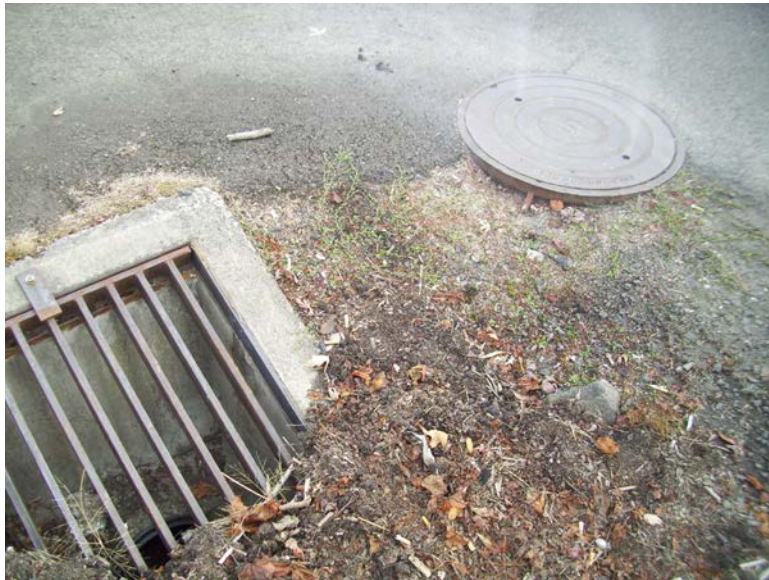
- Manhole smoking from southwest side next to ditch.
- 
- 
- 
-

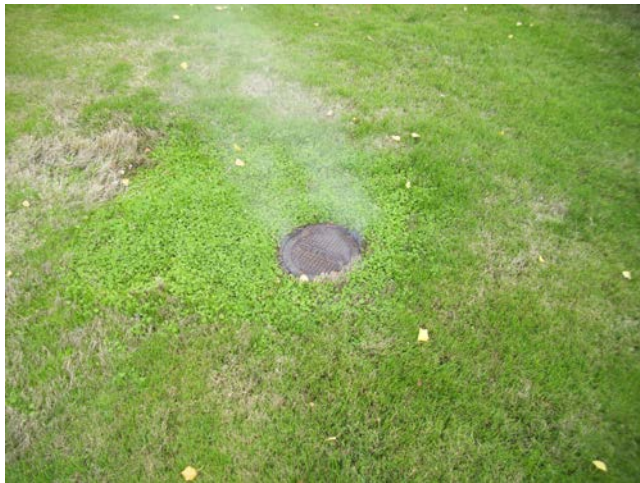
- Cleanout with cast iron lid smoking from sides of lid in yard.
- 
- 
- 
- 
-

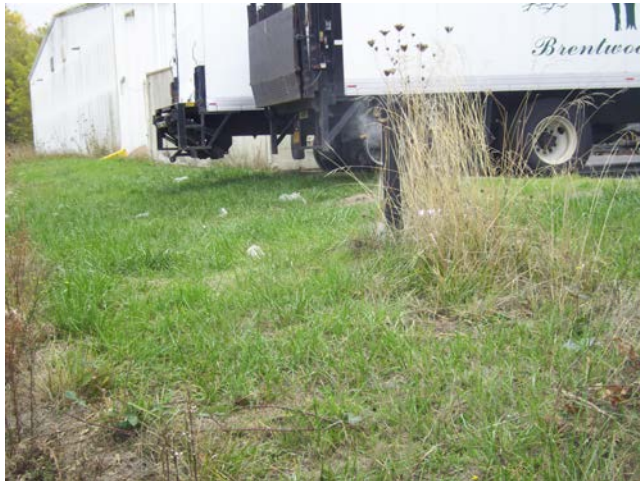
- Smoke coming from ground at base of cleanout riser pipe.
- 
- 
- 
- 
-

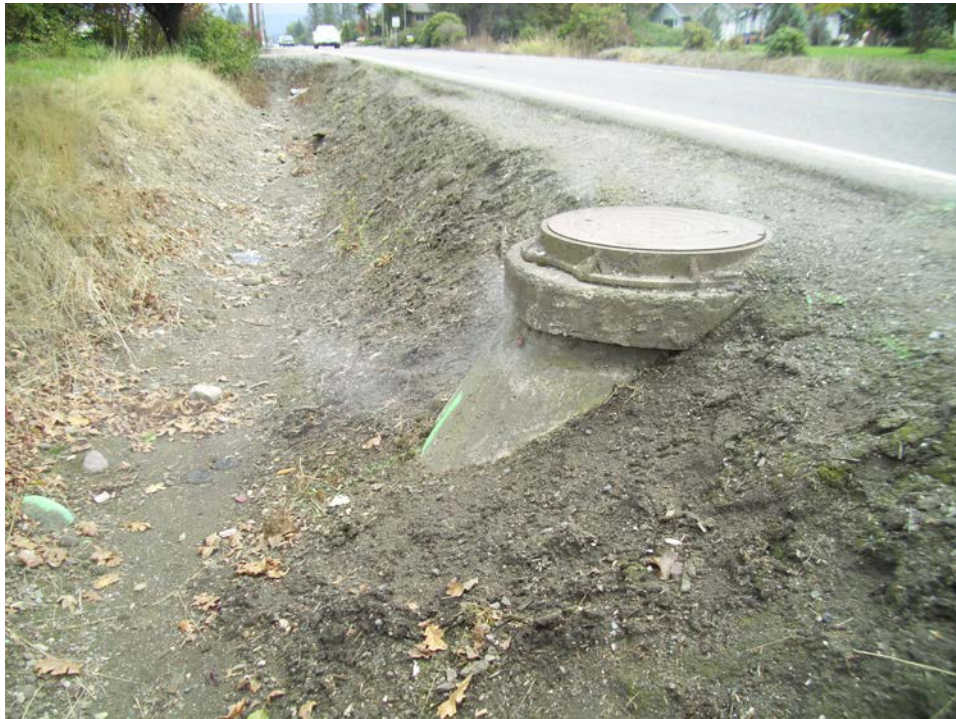
- Smoke coming from manhole cone and grade ring in ditch.
- 
- 
- 
-

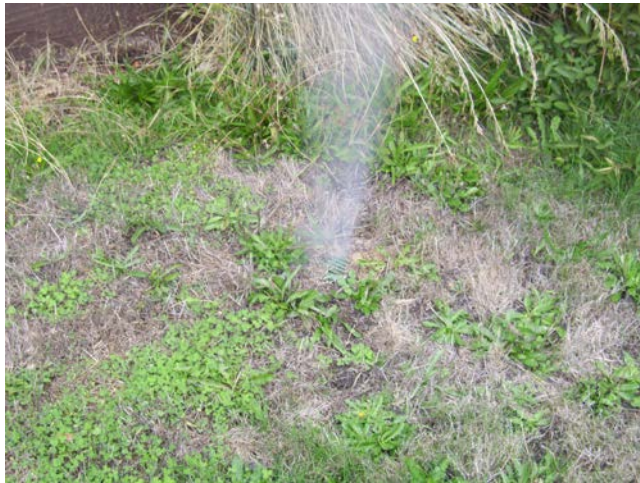
- Cleanout has grated lid.
- 
- 
- 
- 
-

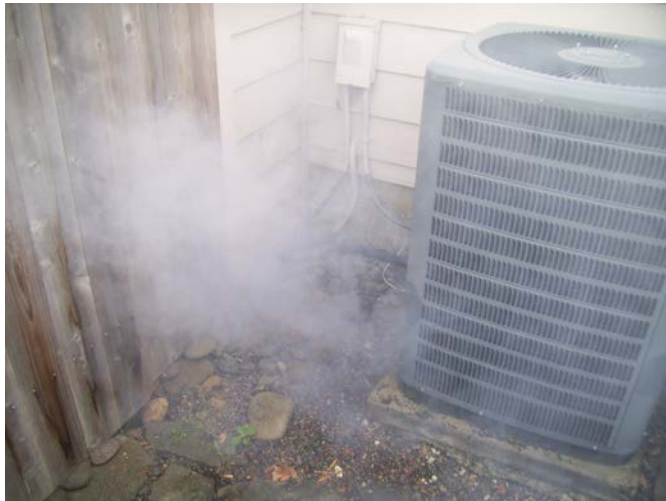
- Could not identify source of smoke.
- 
- 
- 
-

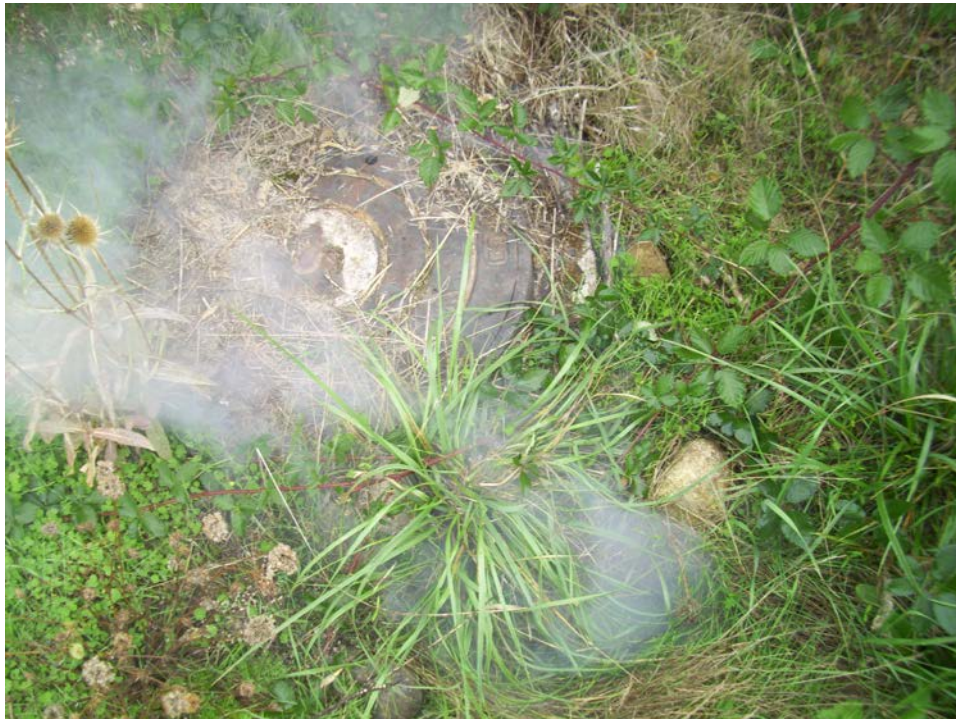
- Smoke coming from grass around manhole in wetland area.
- 
- 
- 
-

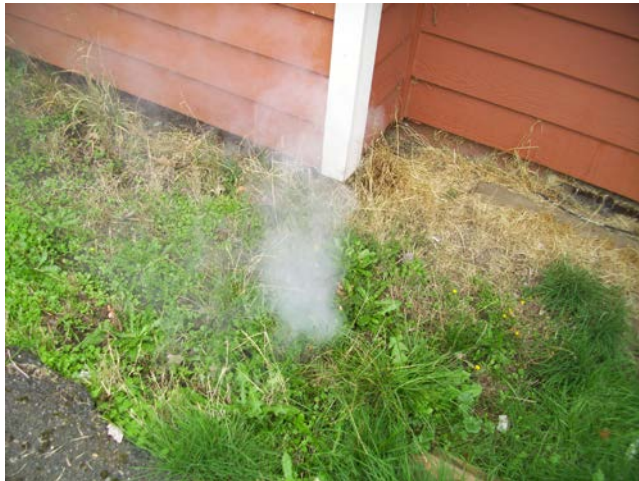
- Cleanout does not have cap.
- 
- 
- 
-

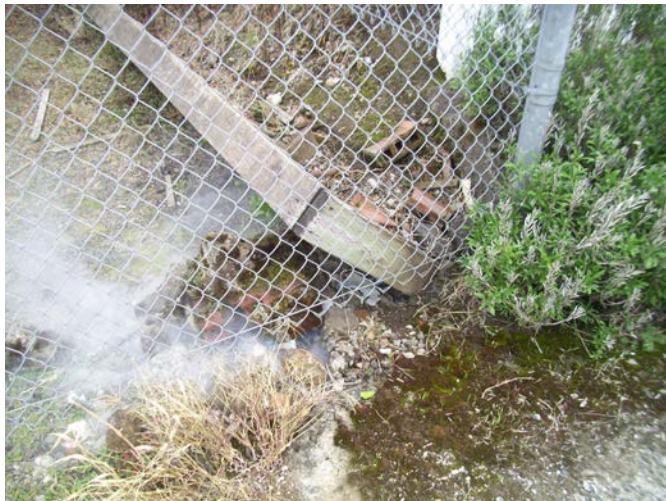
- Smoke coming from under bricks, rock, and old retaining wall.
- 
- 
- 
- 
-

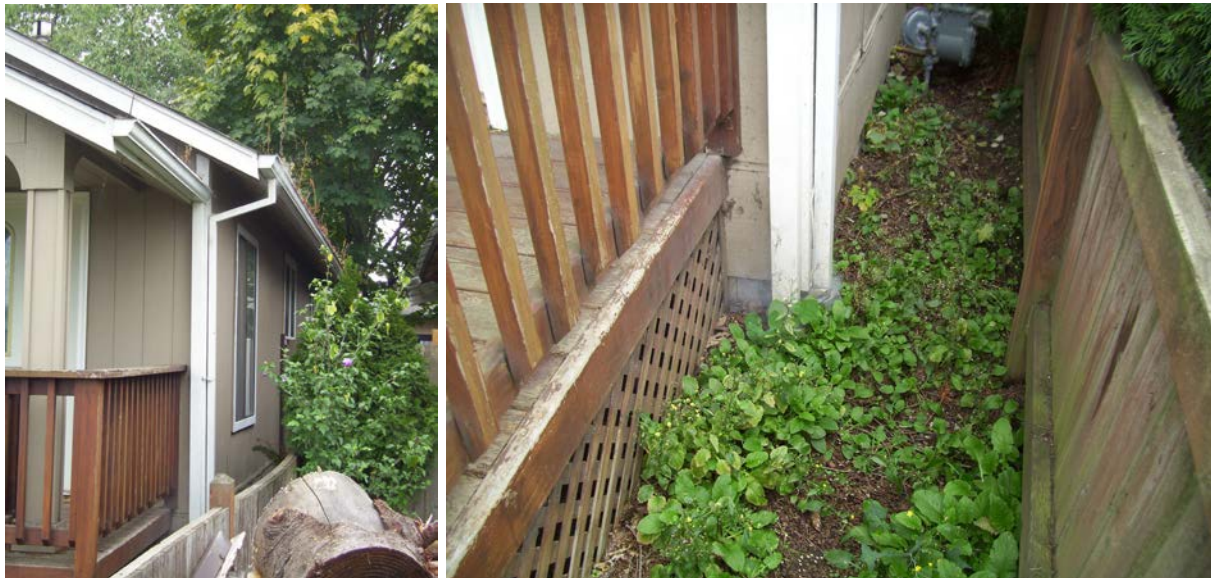
- Smoke coming from gutter drain. Roof drain might connect into open cleanout.
- 
- 
- 
- 
-

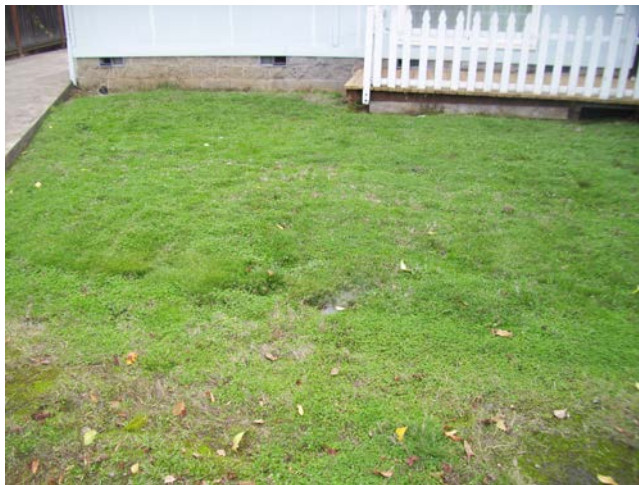
- Smoke coming from grass.
- 
- 
- 
-

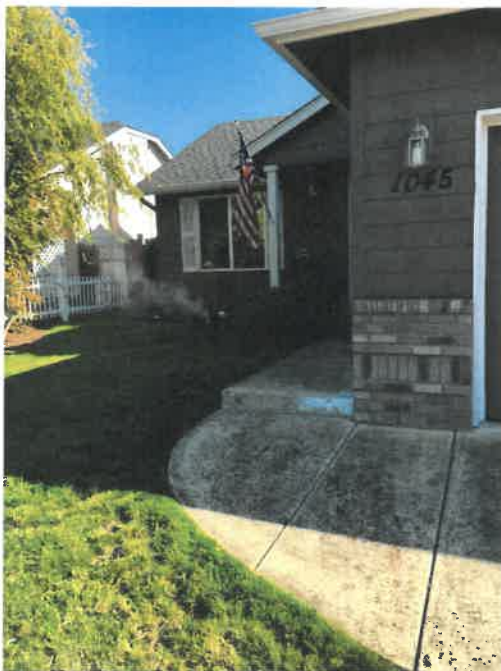
**SKETCH**

- Open cleanout located about 10 ft to the left of the front door. Right in front of the front window.
- Also refer to aerial on following page.

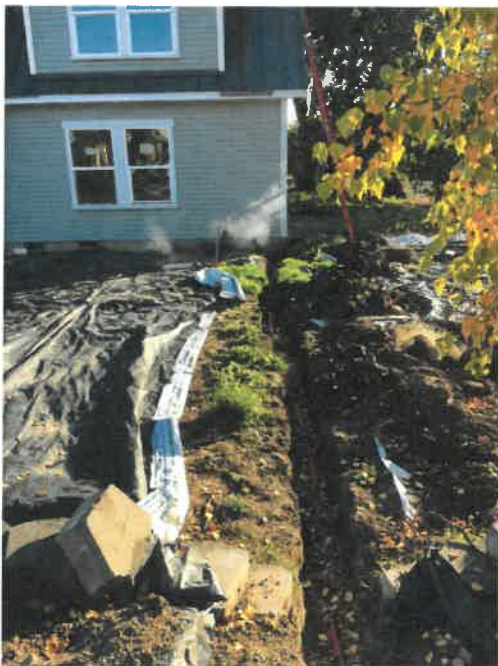
**SKETCH**

- Open cleanout. House was undergoing some landscaping and upgrades. Open cleanout may only be temporary.
- Also refer to aerial on following page.
- 
- 
-

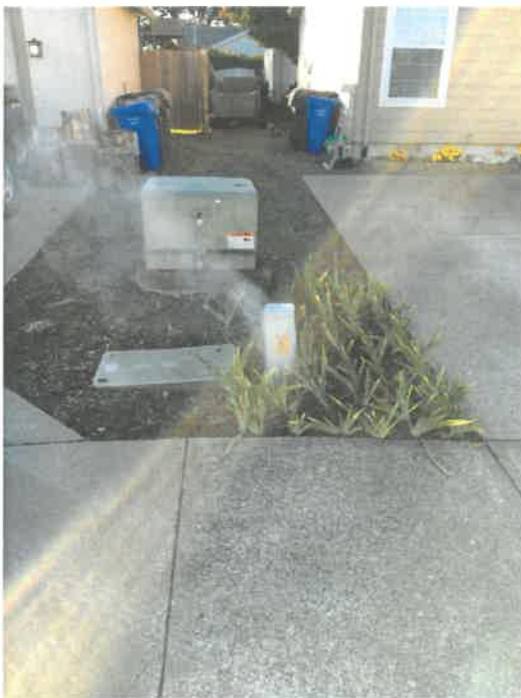
**SKETCH**

- Open cleanout adjacent to electrical box, in between driveways.
- Also refer to aerial on following page.
- 
- 
-

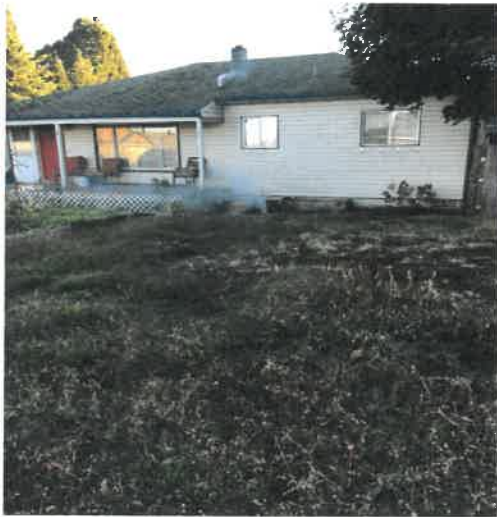
**SKETCH**

- Open cleanout located to the right of the front porch.
- 
- 
- 
- 
-

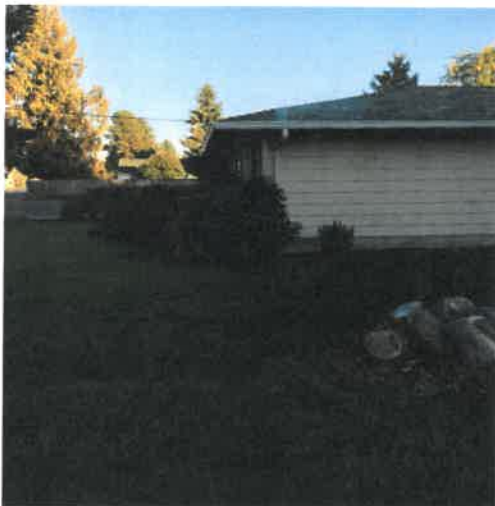
**SKETCH**

- Roof drain connected on northwest corner of house.
- Also refer to aerial on following page.

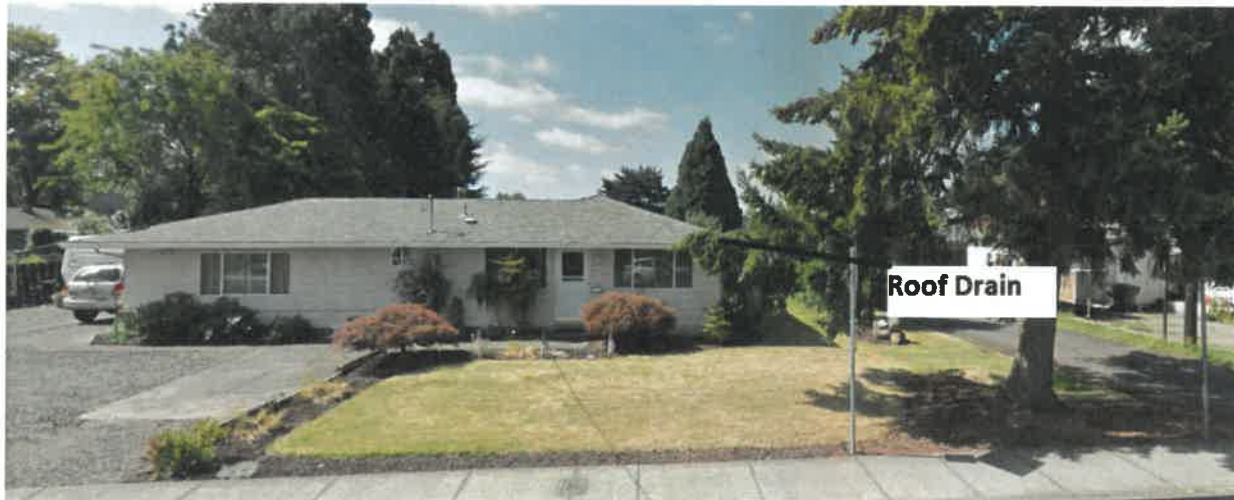
**PHOTOGRAPH No. 2**

<table><tr> <th style="width: 15%; text-align: center;"><u>No.</u></th> <th style="text-align: center;"><u>Description</u></th> </tr><tr> <td style="text-align: center;">2</td> <td>Location of deficiency.</td> </tr></table>

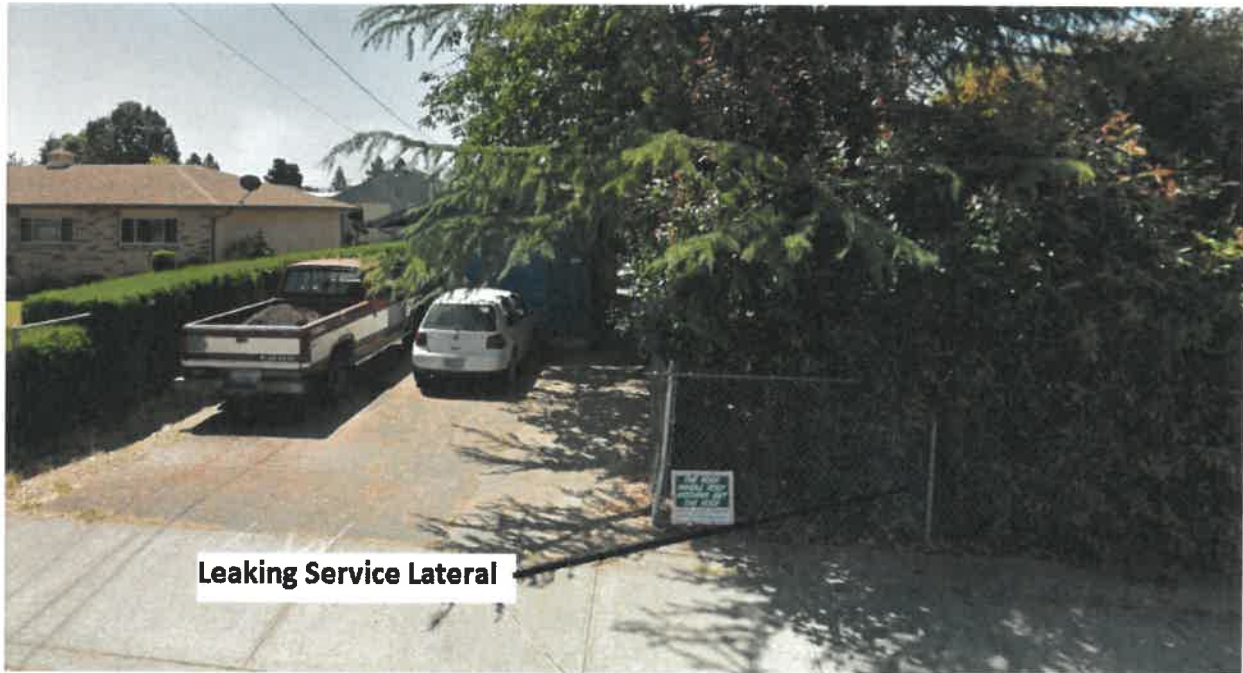
**PHOTOGRAPH No. 2**

- Service lateral was leaking significantly immediately south of chain link fence. With brush, it was difficult to see, but there was a large amount of smoke, and the area was recessed.
- Also refer to aerial on following page.
- 
- 
-

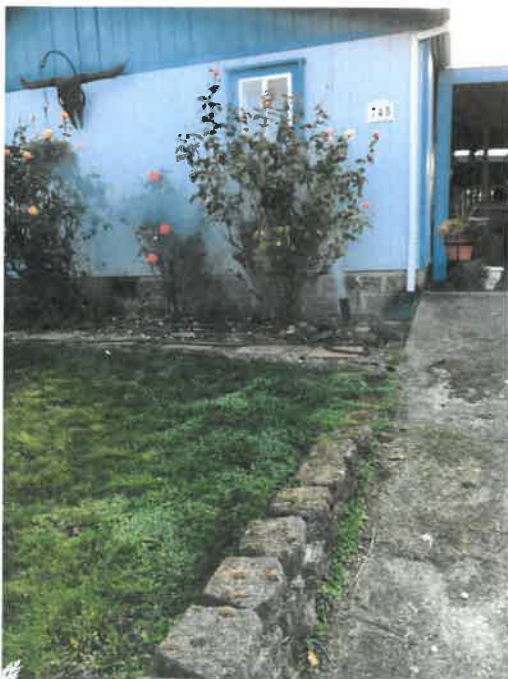
**SKETCH**

- Two open cleanouts located approximately two and five feet from north side of drive way.
- 
- 
- 
- 
-

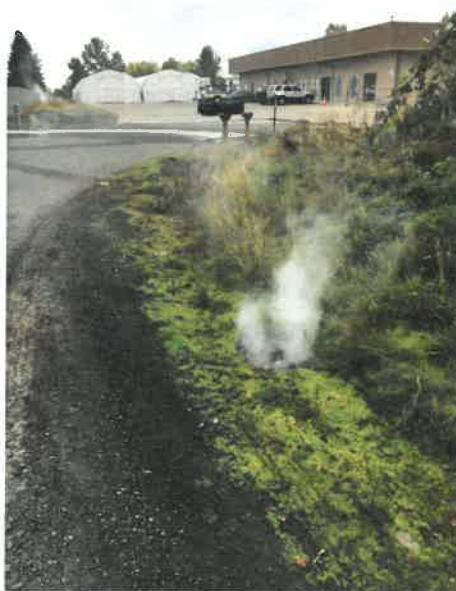
**SKETCH**

- Catch basin is tied into the sewer system. Catch basin is located in roadway ditch.
- Also refer to aerial on following page.
- 
- 
-

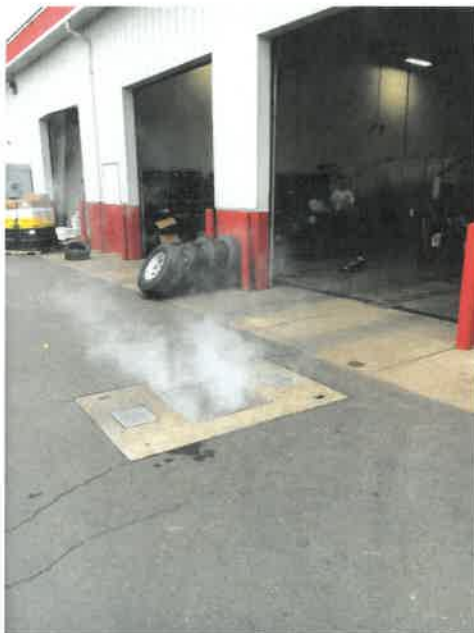
**SKETCH**

- All of the floor drains in Les Schwab are connected to the gravity sewer mains. Smoke exited throughout floor drains.
- Picture is showing location where all of the floor drains are connected, to the south of the building.
- Also refer to aerial on following page.
- 
-

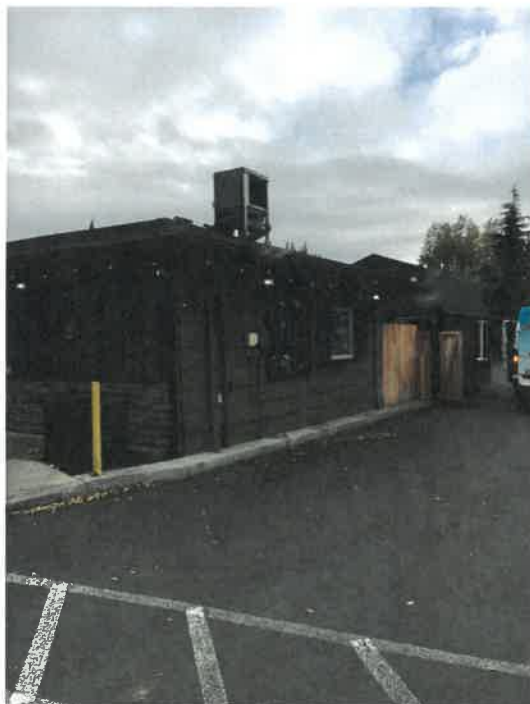
### SKETCH

- The roof drains on the Lumberjack Restaurant are all connected to the sewer system. The roof drains to the north and south of the building are all connected. Photo shows drains connected to the north.
- Also refer to aerial on following page.
- 
- 
-

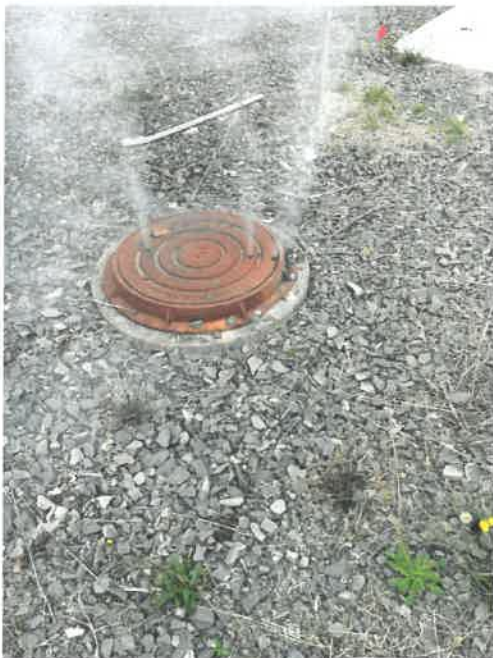
**SKETCH**

- Manhole was unmarked and located approximately 15ft to the west of the sidewalk, due west of BC B 12. Smoke exited from around manhole.
- Also refer to aerial on following page.
- 
- 
-

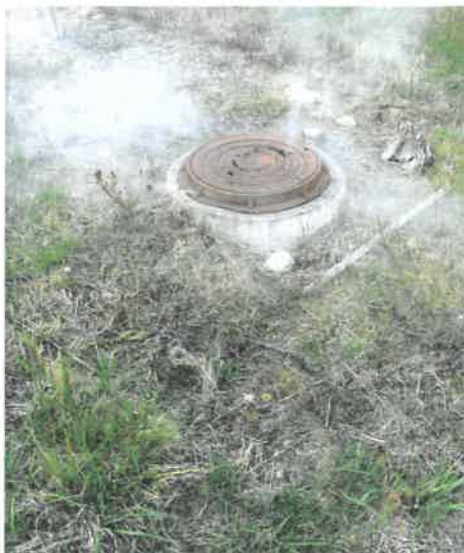
**SKETCH**

- Manhole was unmarked and located approximately 75 yards to the west of the sidewalk, due west of BC B 12. Smoke exited from around manhole. Manhole is located in field.
- Also refer to aerial on following page.
- 
- 
-

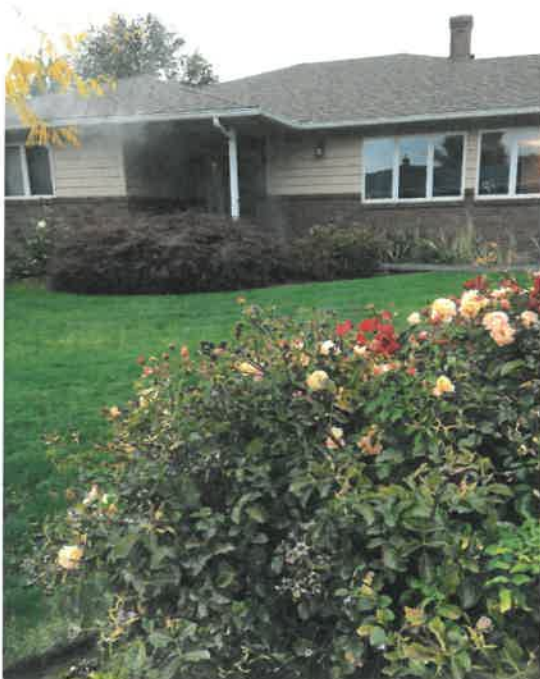
**SKETCH**

- Open cleanout located immediately to the right of the front door.
- 
- 
- 
- 
-

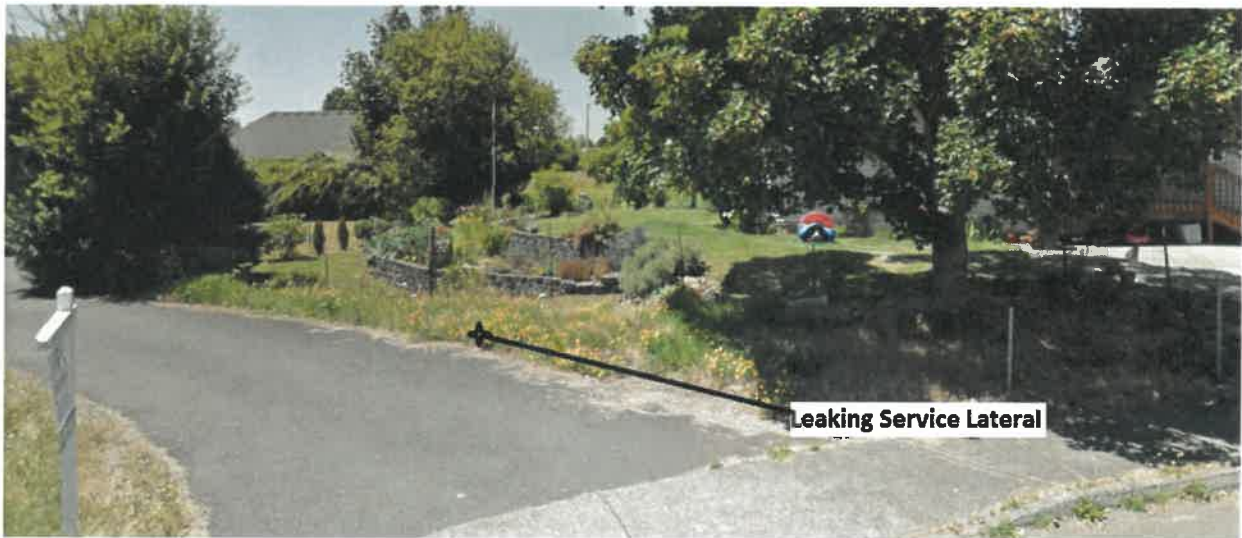
**PHOTOGRAPH No. 2**

- Service lateral was leaking to the west of the drive way, approximately 15 ft from May Street.
- Also refer to aerial on following page.
- 
- 
-

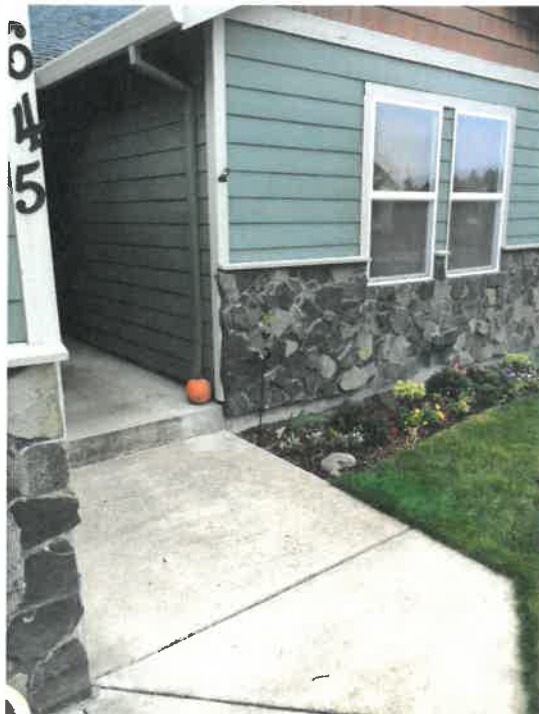
**SKETCH**

- Open cleanout located immediately to the right of the walk way, in the flower patches. It was leaking around the cleanout, suggesting something deficient underground.

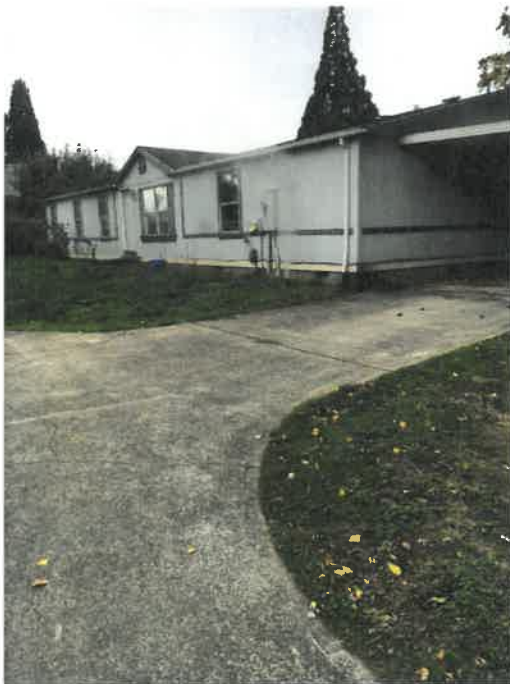
**SKETCH**

- Open cleanout located south of the concrete drive way, and just north of the electric meter.
- Also refer to aerial on following page.
- 
- 
-

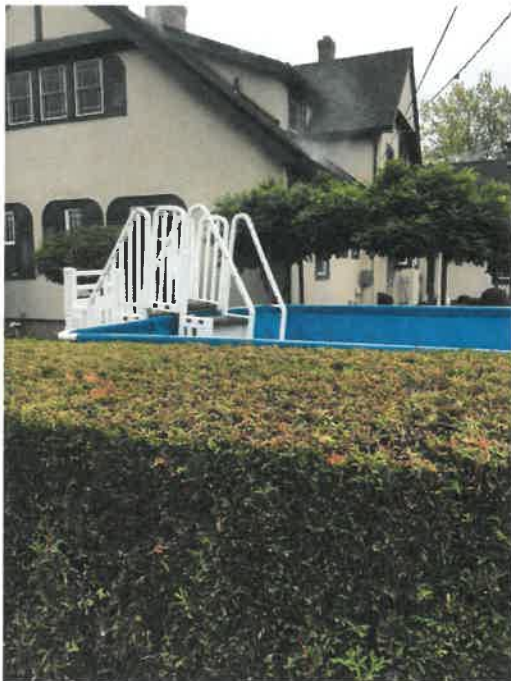
**SKETCH**

- The roof drain was connected to the sewer system. The drain on the southwest corner of the house was smoking.
- Also refer to aerial on following page.
- 
- 
-

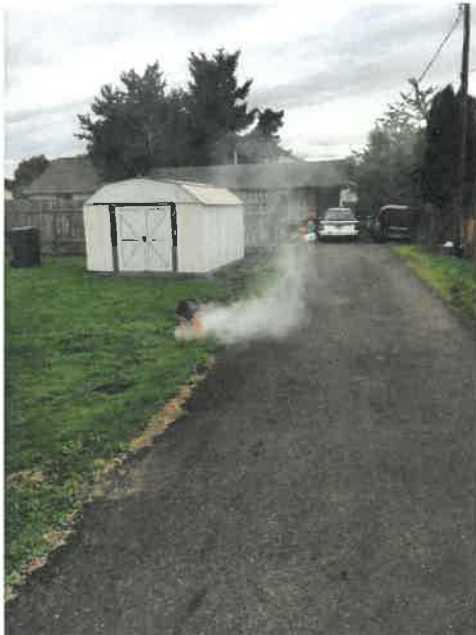
**SKETCH**

- Open cleanout is located to the north of the drive way. Suspected cleanout has 5 gallon bucket and concrete footing located above it. Smoke exited rapidly.
- Also refer to aerial on following page.

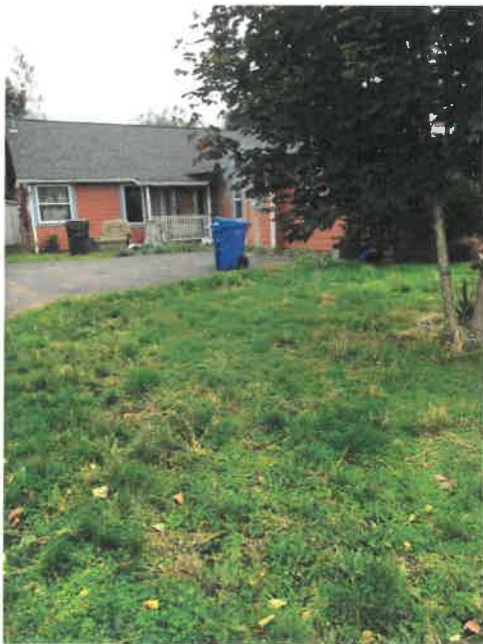
**SKETCH**

- Open cleanout located north of the driveway, immediately adjacent to the house.

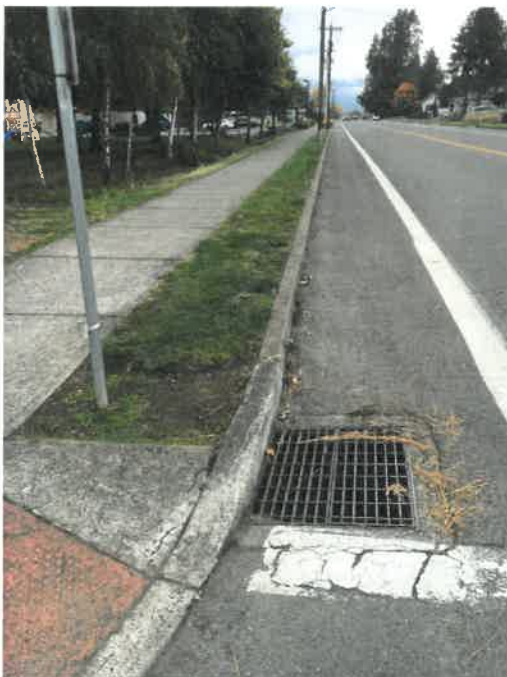
**SKETCH**

- Catch basin was only lightly smoking, but it is connected to the sewer system. It's the catch basin located in the northeast of the intersection of East 5<sup>th</sup> and South Molalla.
- It's hard to tell from the picture that it's smoking. It was light.
- Also refer to aerial on following page.
- 
-

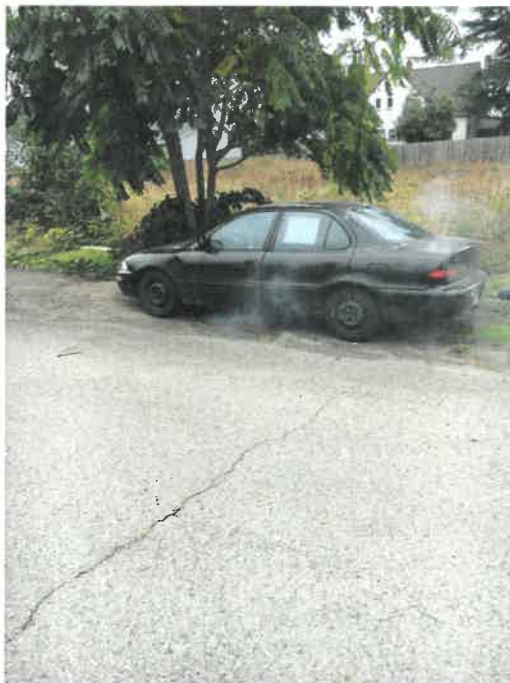
**SKETCH**

- Catch basin is located underneath the black car. Smoke was rapidly existing from catch basin.
- Also refer to aerial on following page.
