Public Works Department

RE: 2017 ANNUAL INFLOW & INFILTRATION REPORT

This report provides an annual summary of the actions the City of Molalla has taken for the 2017 calendar year in accordance with City's Inflow and Infiltration Assessment and Reduction Plan and NPDES Permit No. 101514.

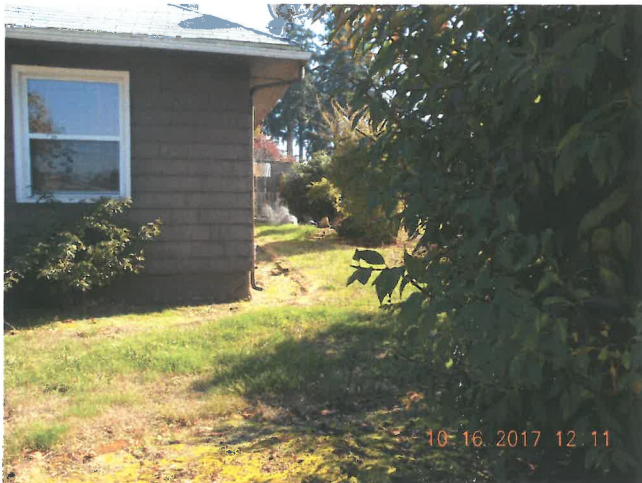
- Smoke coming from open cleanout
-
-
-
-
-

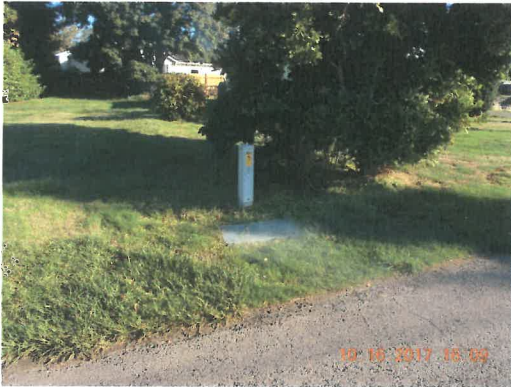
- 1-18. Smoke was exiting from a communication box located in front of telephone pedestal #127.
- 3-28. Smoke was exiting from a vault in the parking lot west of car wash.
- 4-20. Floor drains at Les Schwab Tire Center were connected to the gravity sewer.

- Smoke coming out of communication box located in front of telephone pedestal #127
-
-
-
-

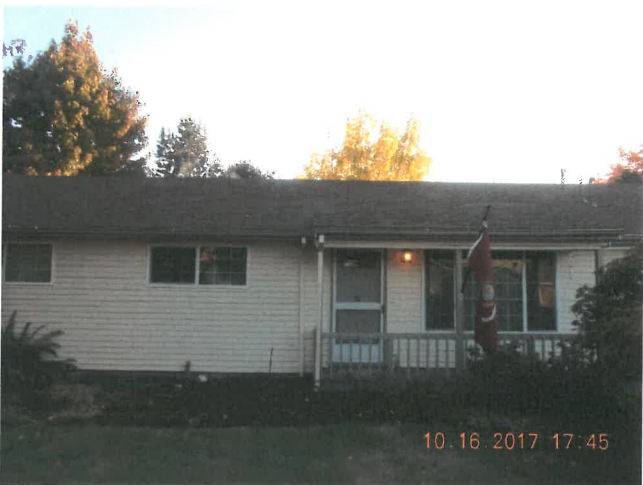
- Smoke coming out of gutter by front porch.
-
-
-
-

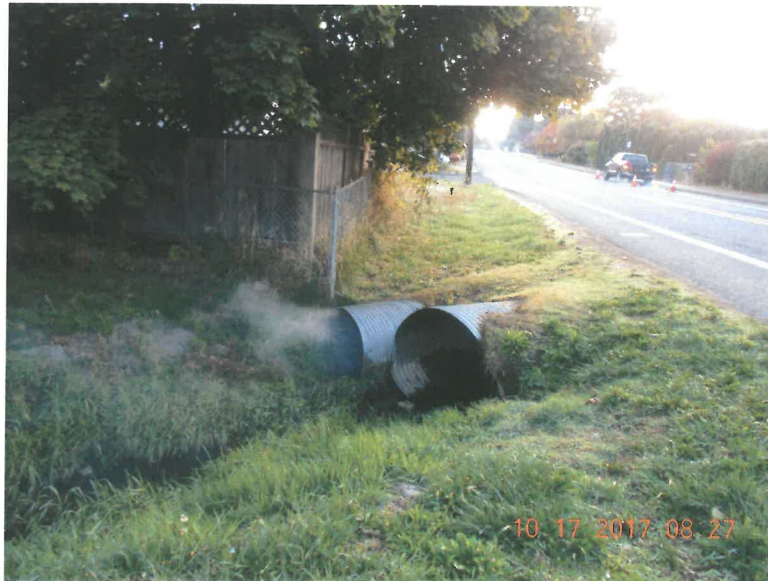
- Smoke coming out of the 36" diameter culvert. Smoke machine was set up on MH TL 21
-
-
-
-
-

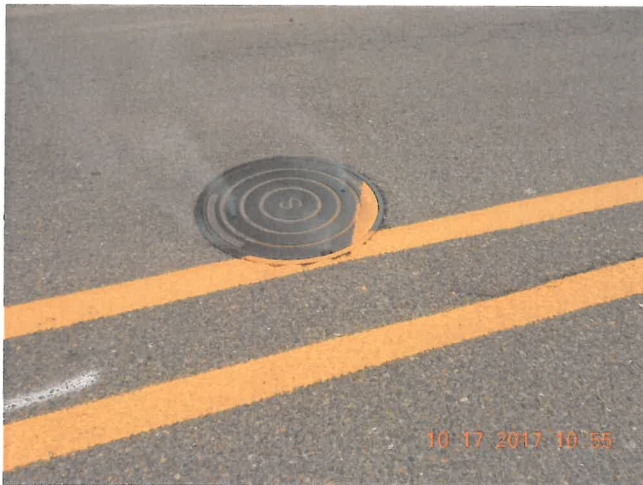
- Smoke coming out from around rim of manhole
- _____
- _____
- _____
- _____
- _____

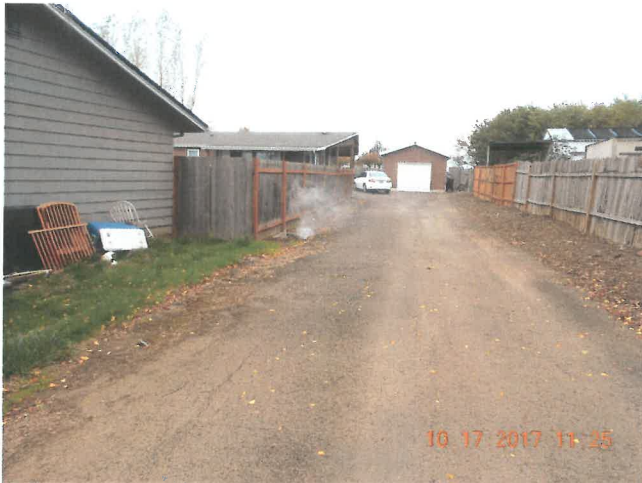
- Smoke coming out of cleanout with no cap

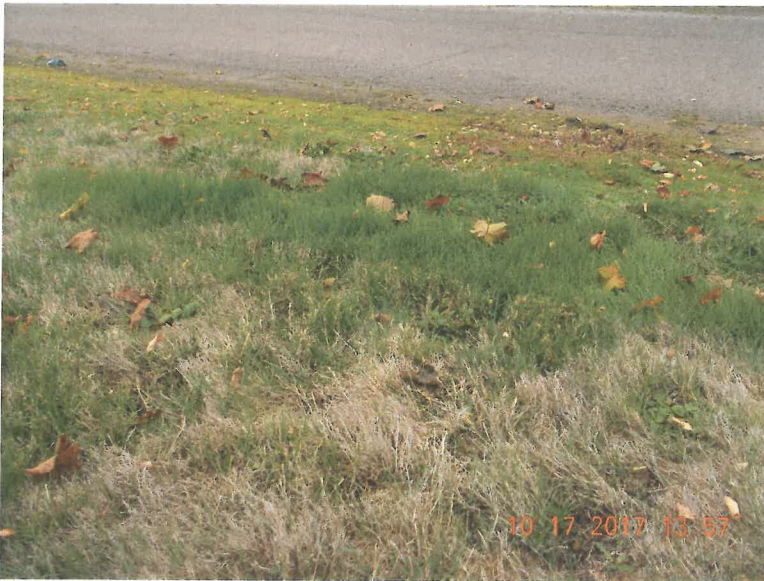
1.

- Resident has a plastic plate fastened down over the cleanout, smoke coming out of the ground near the road and the gas meter

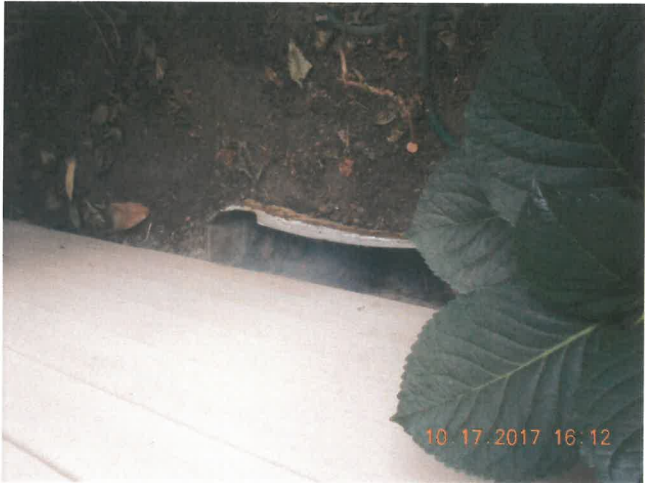
- Smoke coming out of cleanout, located in recessed house vent
-
-
-
-
-

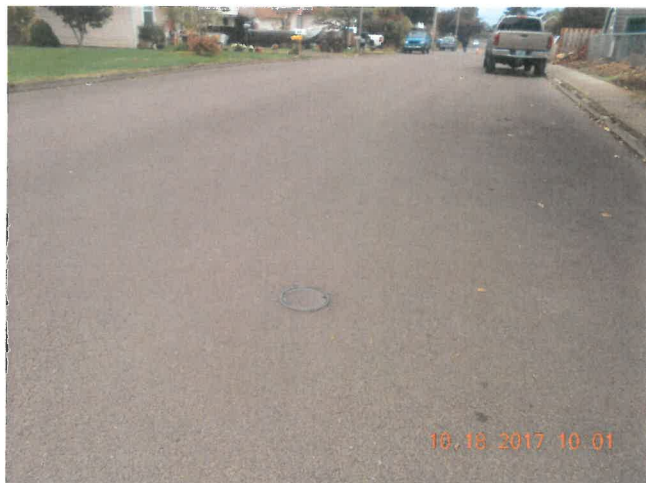
- Smoking coming out of cleanout

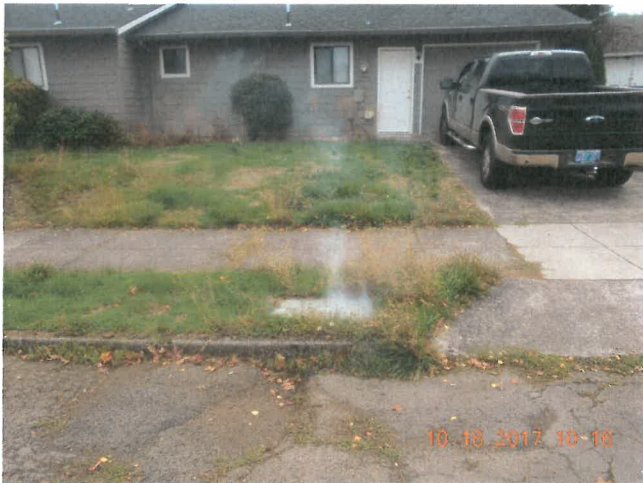
- Smoking coming out of communications vault
- _____
- _____
- _____
- _____
- _____

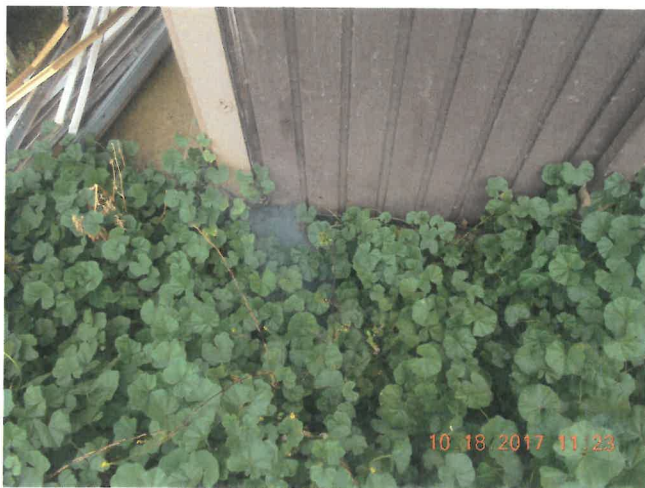
- 4" white drain pipe located on the north side of the building. Smoke coming out of the pipe at the northeast corner of the building. Hole in the pipe.

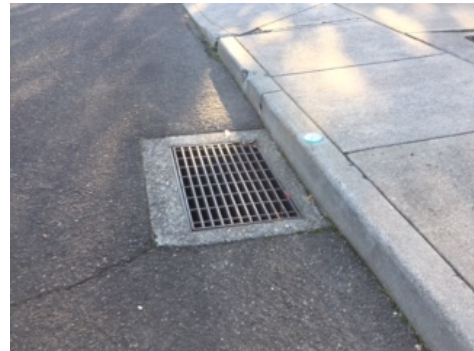
- Catch Basin on the south side of Taurus St., in front of 230 & 240 Taurus St.
-
-
-
-

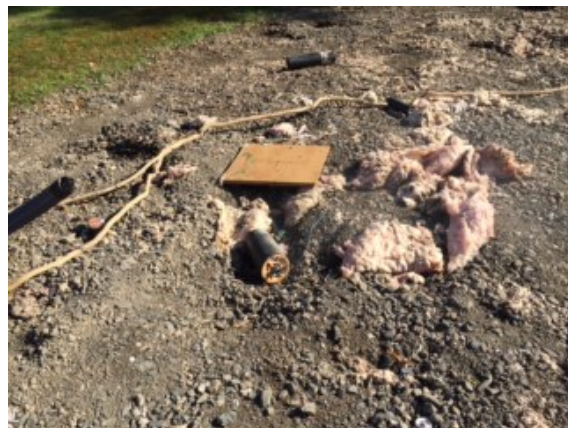
- Mobile home has been removed from Lot #7. Sewer connection wasn't capped and covered with plywood.

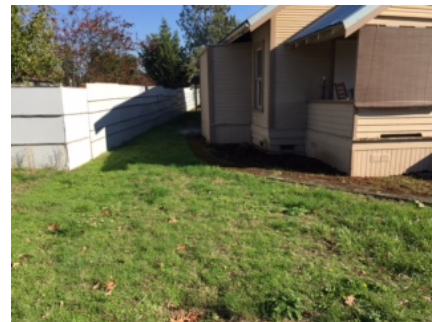
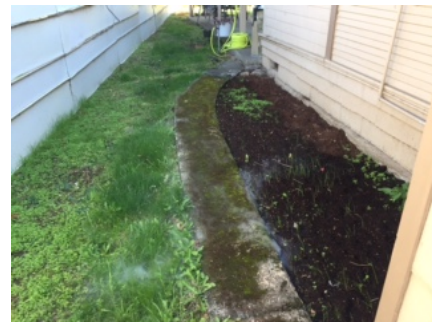
- A 10' section of concrete walkway on the north side of the residence had smoke coming up on both sides of the walk.

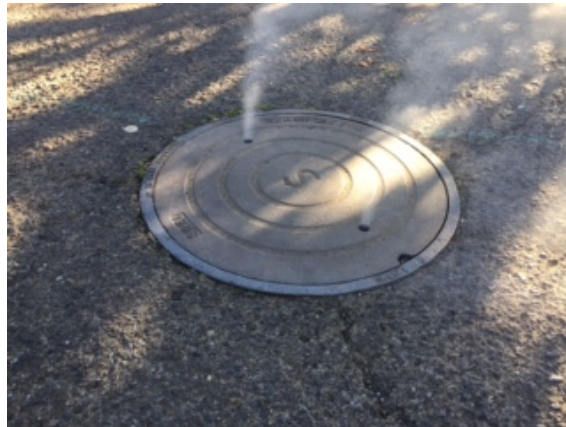
- Smoke coming up from the exterior of manhole TL_B_23.
-
-
-
-

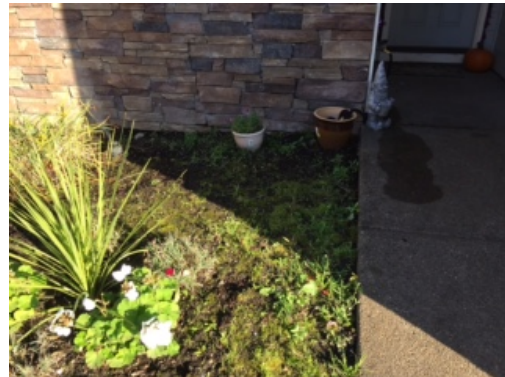
<table><tr> <th style="width: 15%; text-align: center;">No.</th> <th style="text-align: center;">Description</th> </tr><tr> <td style="text-align: center;">1</td> <td>Smoke from broken cleanout cap</td> </tr></table>

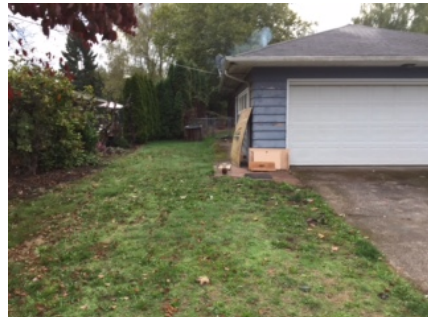
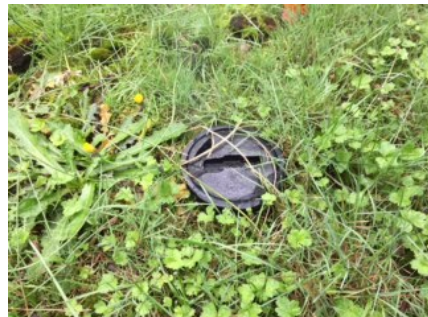
<table><tr> <th style="width: 15%; text-align: center;">No.</th> <th style="text-align: center;">Description</th> </tr><tr> <td style="text-align: center;">1</td> <td>Smoke from broken cleanout cap</td> </tr><tr> <td style="text-align: center;">2</td> <td>Smoke from broken cleanout cap</td> </tr></table>

- Broken cleanout cap on north side of garage, adjacent to concrete sidewalk.
-
-
-
-
-

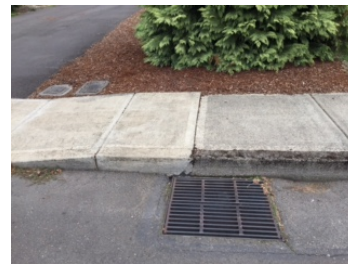
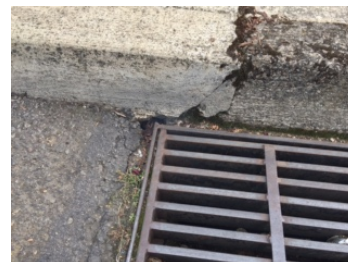
- Smoke coming from catch basin and crack in the concrete curb behind the catch basin on the east side of Eckerd Ave, approximately 75' south of manhole TL_A_21.

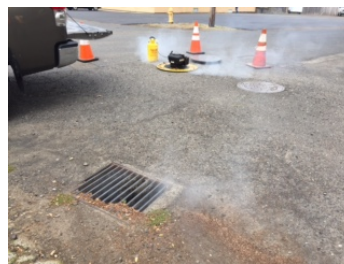
- Smoke from CB at the south east corner of Lola Ave. and 3rd St. intersection, with smoke machine setup on manhole TL_A_19.

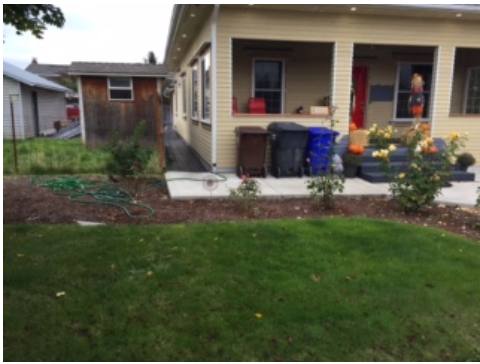
- Smoke from cleanout area. Could not confirm if the cap was broken or missing.
-
-
-
-
-

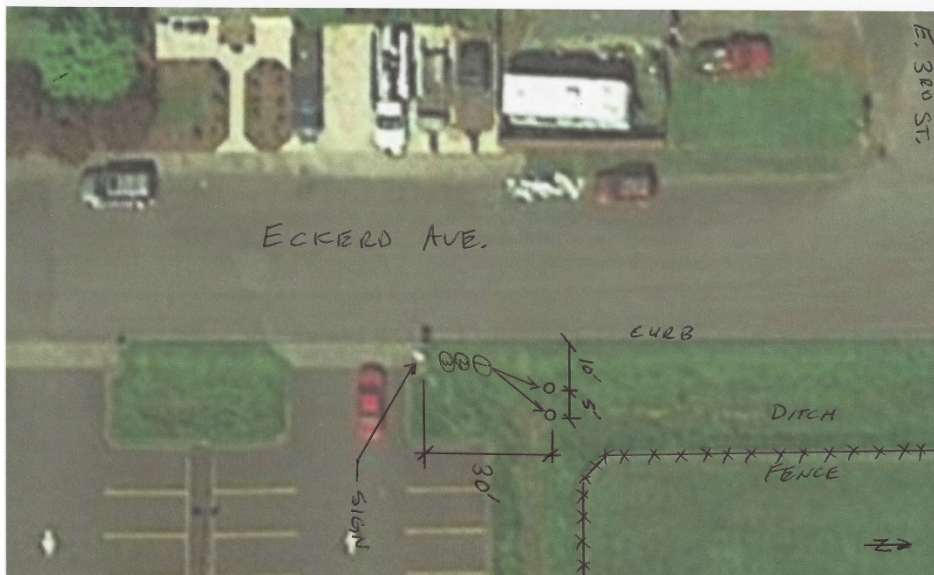
Molalla Smoke Testing
Report No. 2-47
MHS Football Field

- Smoke from ditch running north/south on east side of Eckerd Ave. Smoke was near the northwest corner of the football field parking lot.
- See attached for pictures.
-
-
-

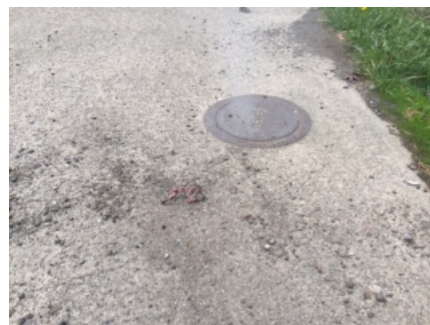
- Smoke from cleanout in flag lot driveway.
-
-
-
-

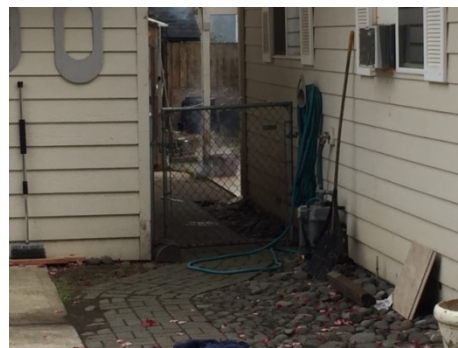
- Smoke from cleanout area. Could not confirm broken or missing cleanout cap.
-
-
-
-
-

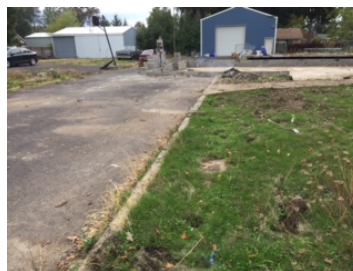
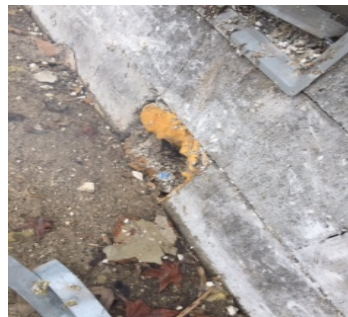
- House has been removed. Smoke from uncovered sewer connection in foundation.
-
-
-
-

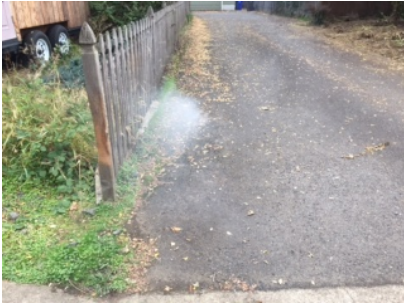
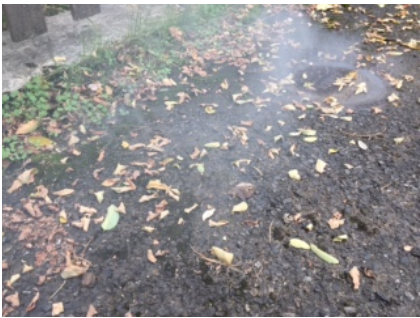
- Smoke from driveway cleanout cover on south side of driveway.
- Smoke is also coming up from edge of asphalt, adjacent to the cleanout cover.
-
-
-

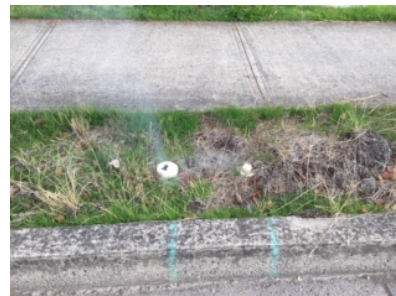
<table><tr> <th style="text-align: center;">No.</th> <th style="text-align: center;">Description</th> </tr><tr> <td style="text-align: center;">1</td> <td>Smoke from two broken cleanout covers</td> </tr><tr> <td style="text-align: center;">2</td> <td>Smoke from two broken cleanout covers</td> </tr></table>

- Smoke from two, adjacent cleanout covers, in beauty strip grass in front of 621 Main St.
-
-
-
-

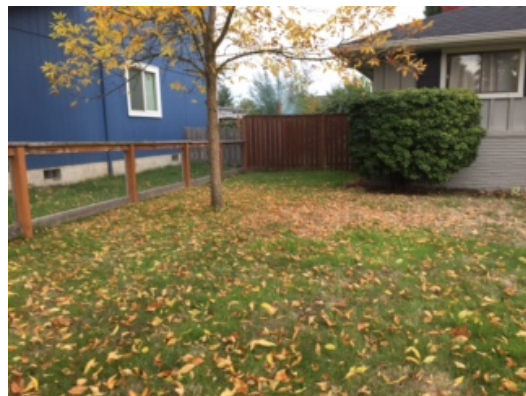
- Smoke from fence line, between backyards of 621 and 623 Main St.
- Could not confirm broken or uncovered cleanout.
-
-
-

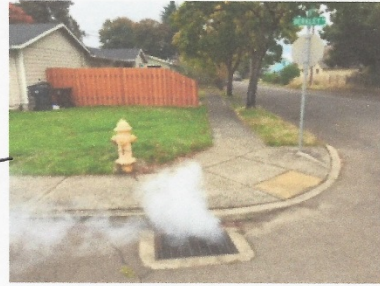
No. 1

TESTING CODE	PHOTOGRAPHS
LSL = Leaking Service Lateral	<u>No.</u> <u>Description</u>
LML = Leaking Main Line	1 Smoke from CB – 2 nd St. & Berkley Ave.
CB = Catch Basin	2 Smoke from CB – Berkley Ave.
LMH = Leaking Manhole	3 Smoke from CB – Berkley Ave.
OCO = Open Cleanout	4 Smoke from CB – 3 rd St. & Berkley Ave.
PHV = Plugged House Vent	5 Smoke from CB – 4 th & Berkley Ave.
RD = Roof Drain

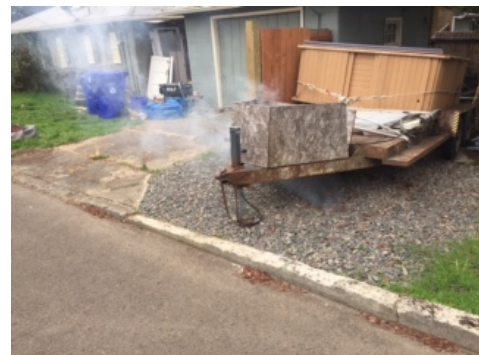
TESTING CODE	PHOTOGRAPHS
LSL = Leaking Service Lateral	<u>No.</u> <u>Description</u>
LML = Leaking Main Line	1 Smoke from broken cleanout cap
CB = Catch Basin	_____
LMH = Leaking Manhole	_____
OCO = Open Cleanout	_____
PHV = Plugged House Vent	_____
RD = Roof Drain	_____

- Broken cleanout cap, located in gravel area under trailer.
-
-
-
-

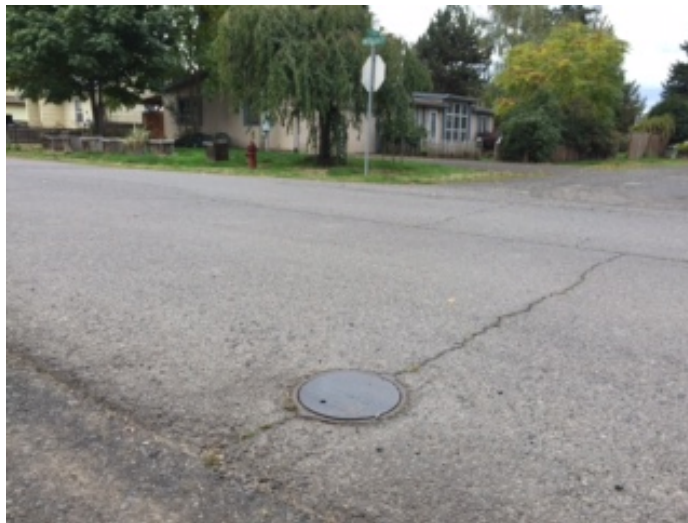
- Smoke from mainline cleanout cover located at 4th St. and Metzler Ave.
- _____
- _____
- _____
- _____

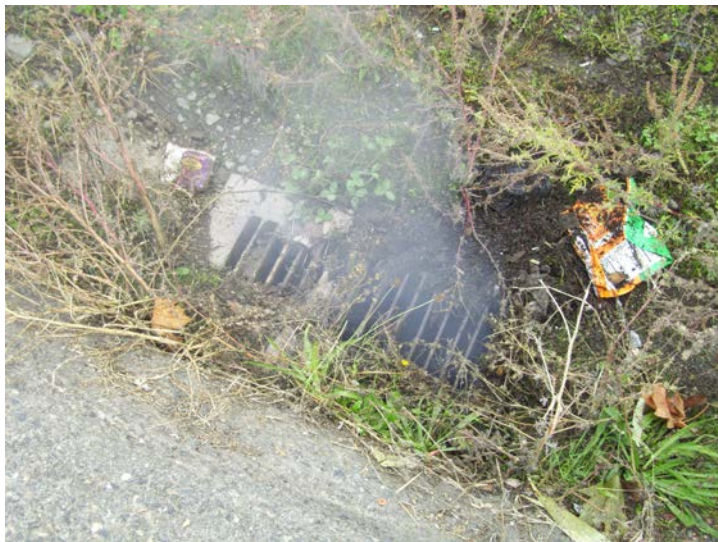
- Smoke coming from catch basin.
-
-
-
-

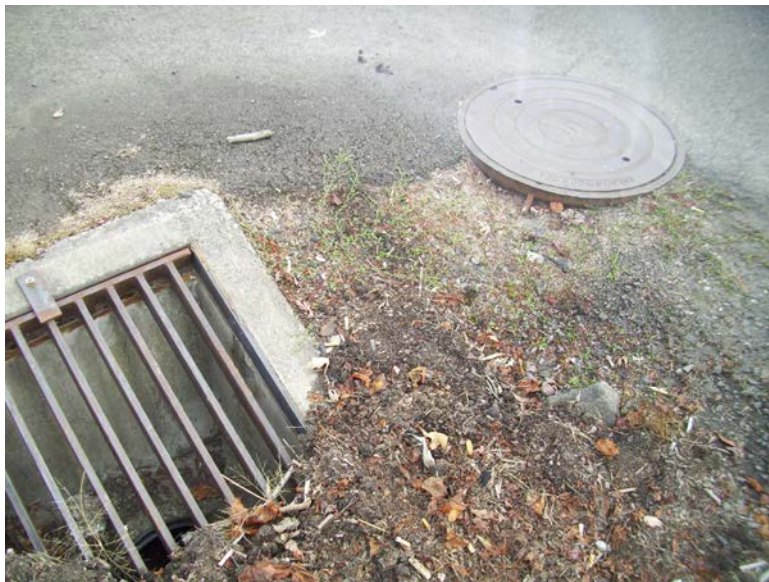
- Manhole smoking from southwest side next to ditch.
-
-
-
-

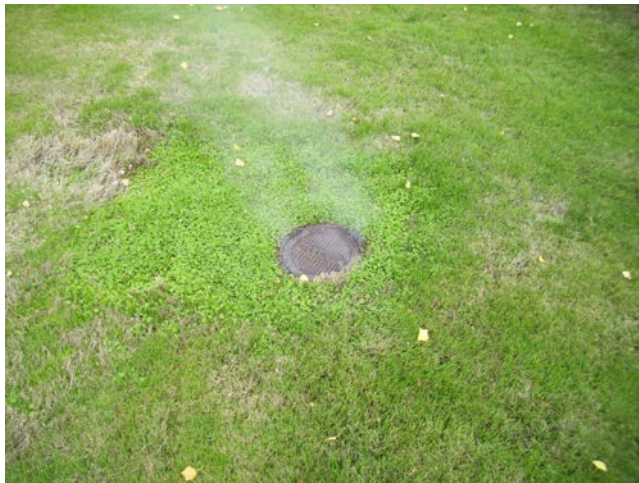
- Cleanout with cast iron lid smoking from sides of lid in yard.
-
-
-
-
-

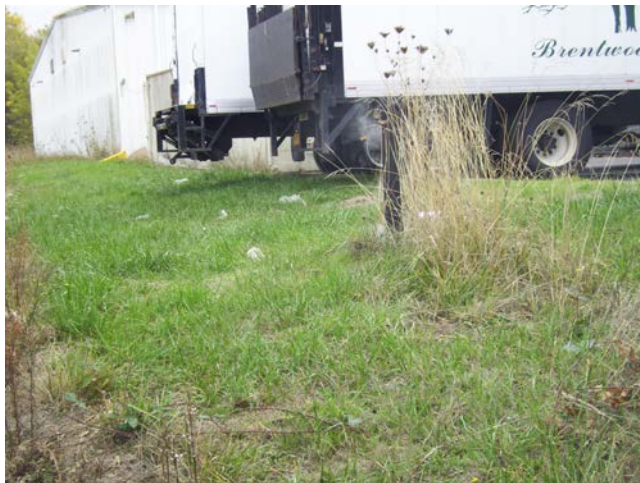
- Smoke coming from ground at base of cleanout riser pipe.
-
-
-
-
-

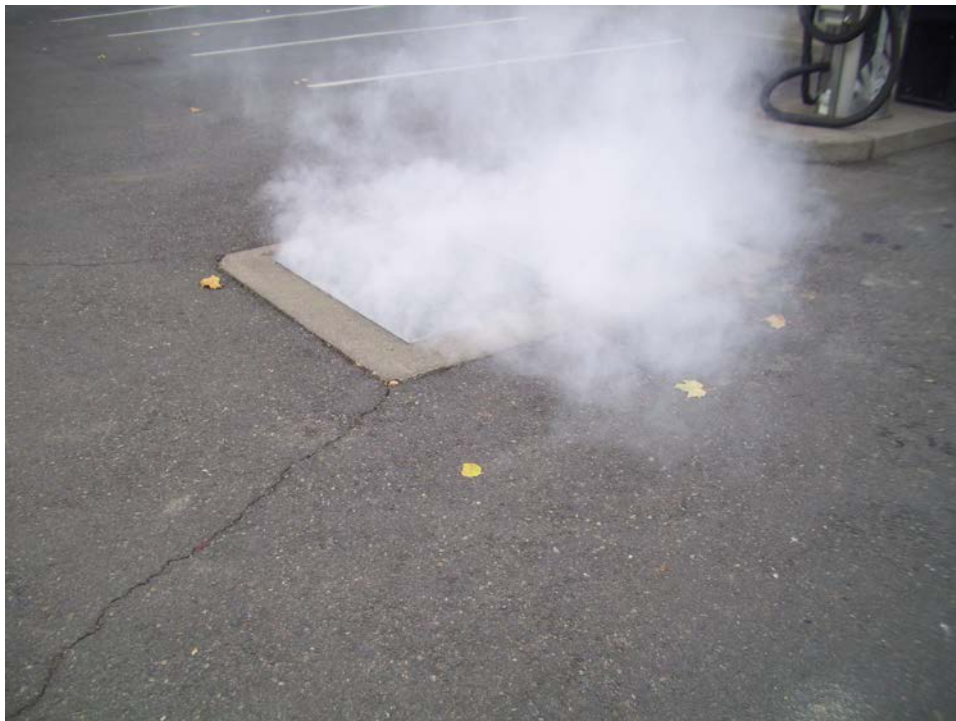
- Smoke coming from vault in parking lot west of car wash.
-
-
-
-

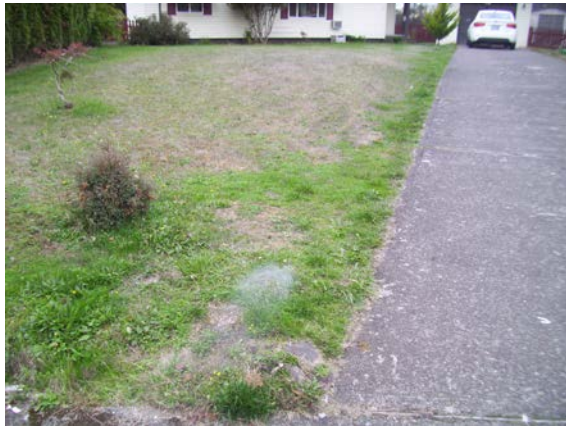
- Cleanout does not have cap.

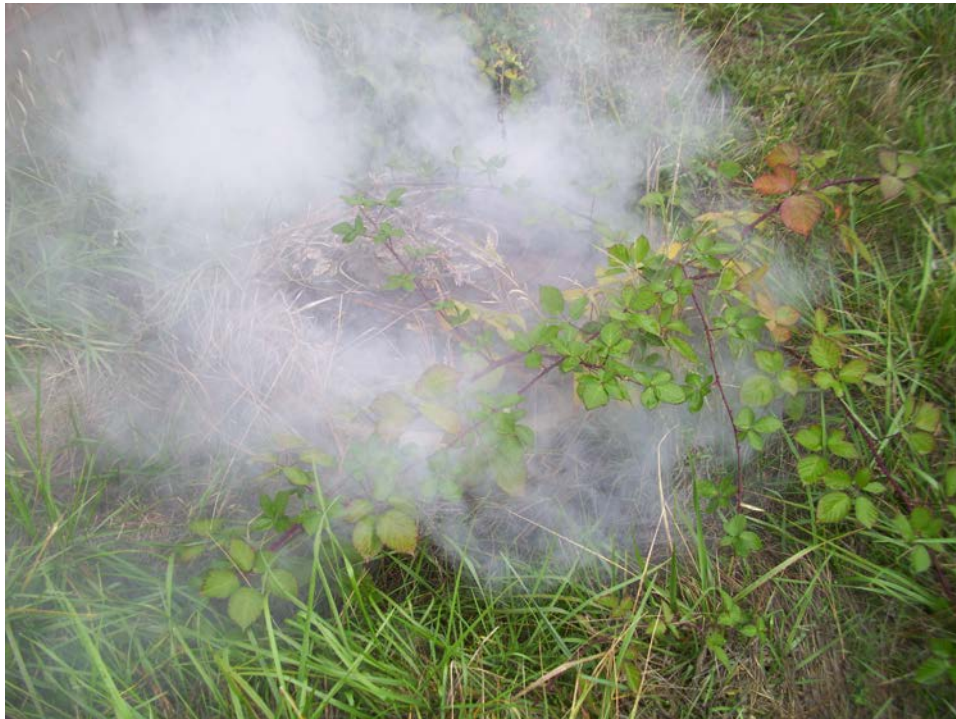
- Smoke coming from grass around manhole in wetland area.
-
-
-
-

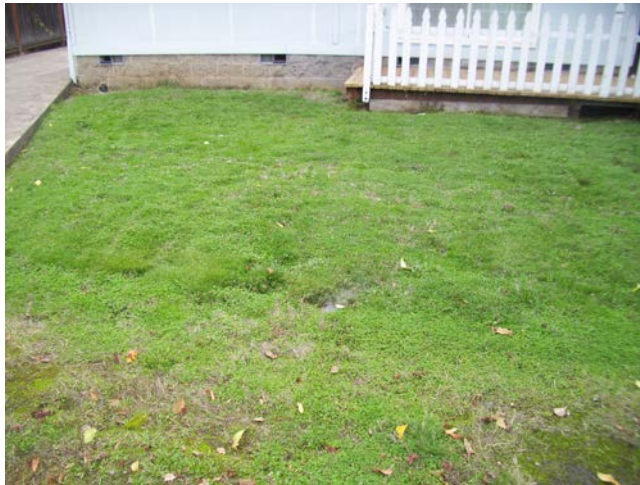
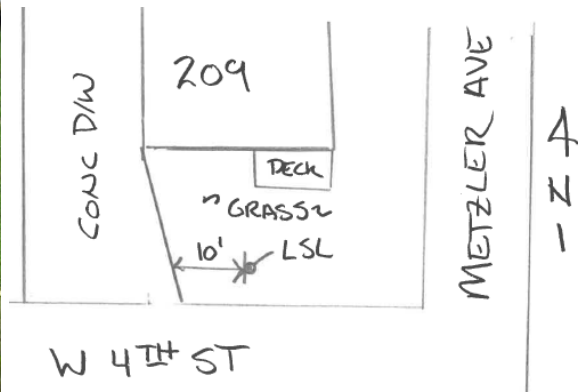
- Smoke coming from grass.
-
-
-
-

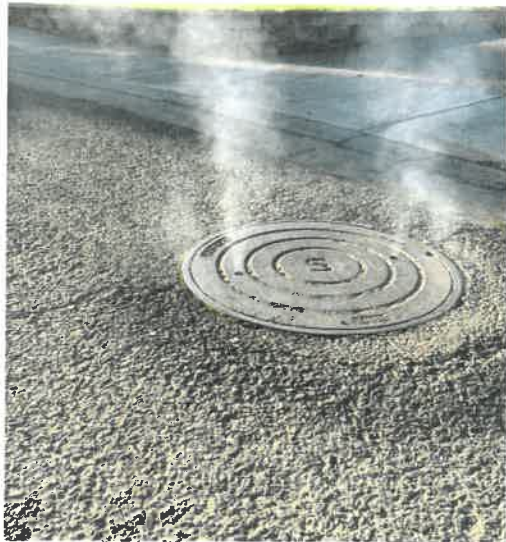
- Leaking around manhole rim.
-
-
-
-
-

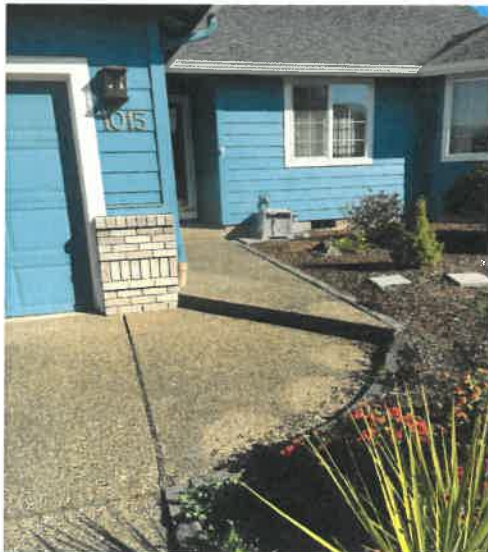
- Open cleanout located immediately to the right of the front door. Right next to hose reel.
- Also refer to aerial on following page.

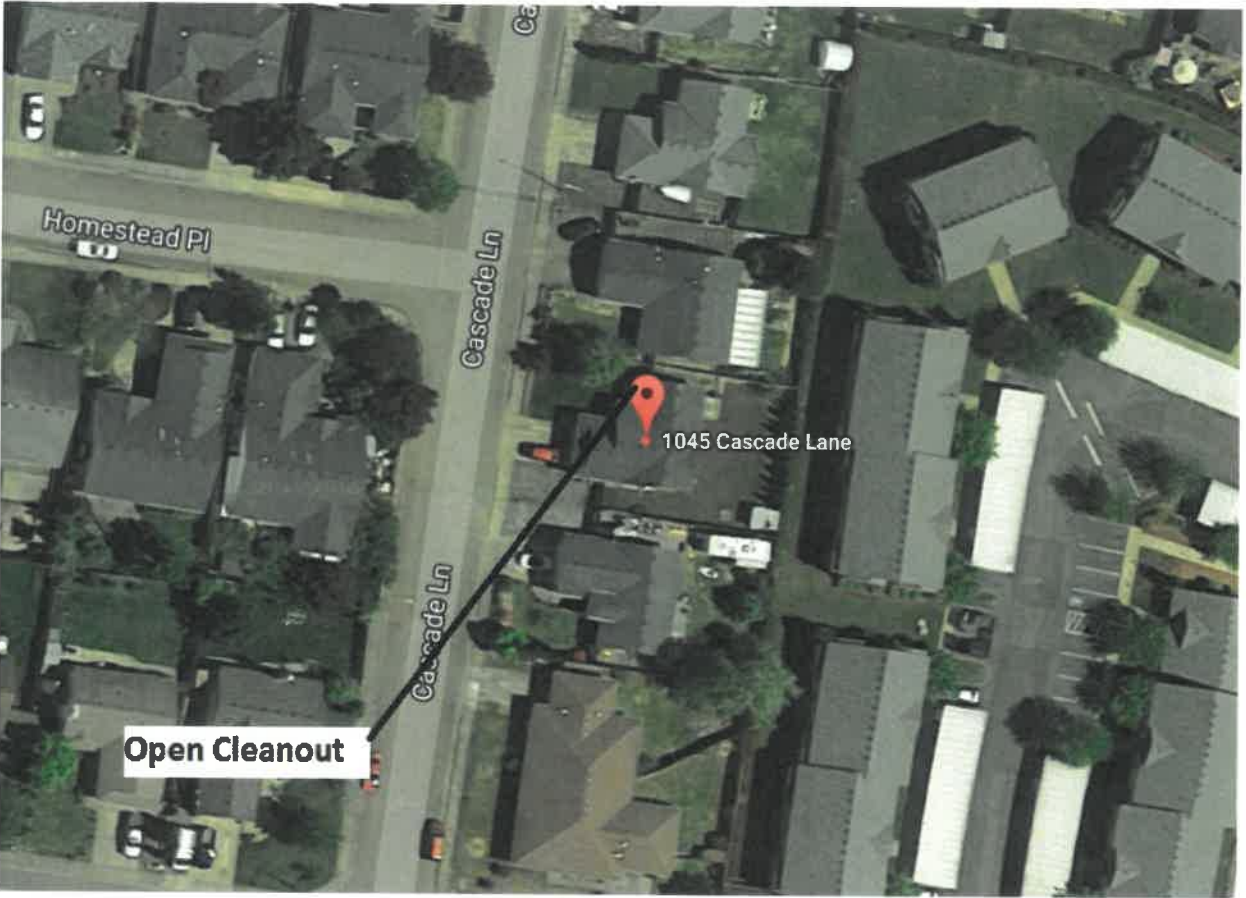
- Open cleanout located about 10 ft to the left of the front door. Right in front of the front window.
- Also refer to aerial on following page.
-
-
-

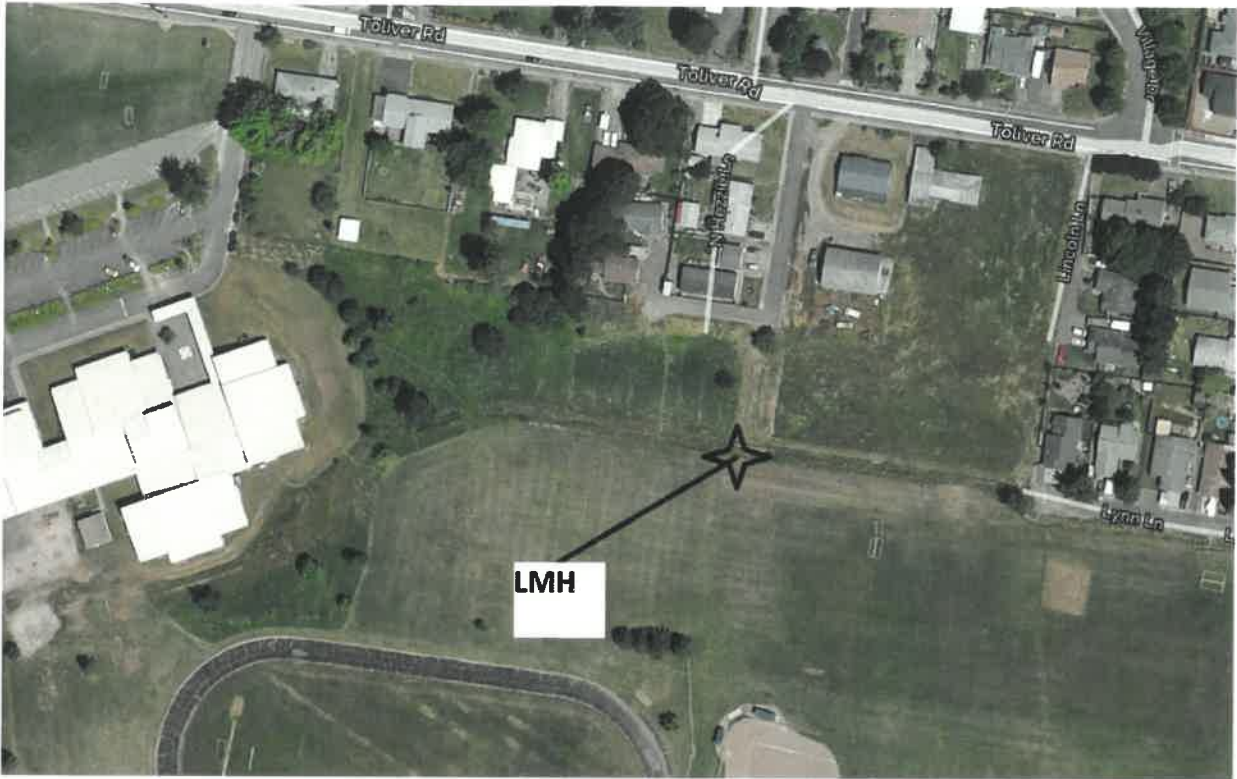
AERIAL No. 1

- Manhole was located at perimeter of soccer field. Manhole was leaking significantly around adjacent soil.
- Also refer to aerial on following page.
-
-
-

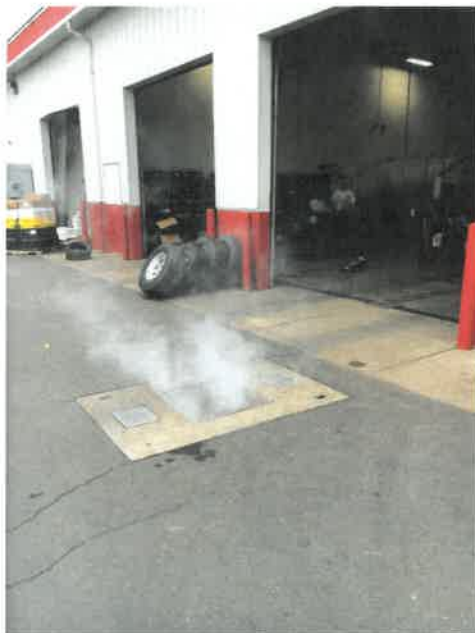
SKETCH

- All of the floor drains in Les Schwab are connected to the gravity sewer mains. Smoke exited throughout floor drains.
- Picture is showing location where all of the floor drains are connected, to the south of the building.
- Also refer to aerial on following page.
-
-

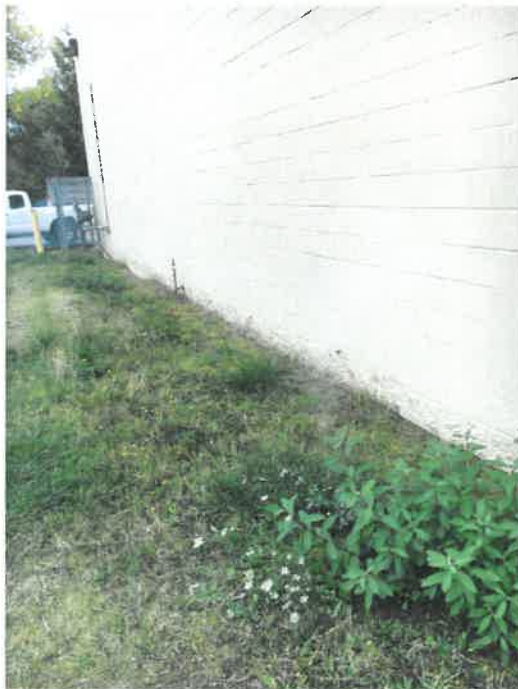
SKETCH

- There was an open cleanout to the north of the Safeway building. The pipe is a few inches below ground level, and probably receives quite a bit of inflow.
- Also refer to aerial on following page.
-
-
-

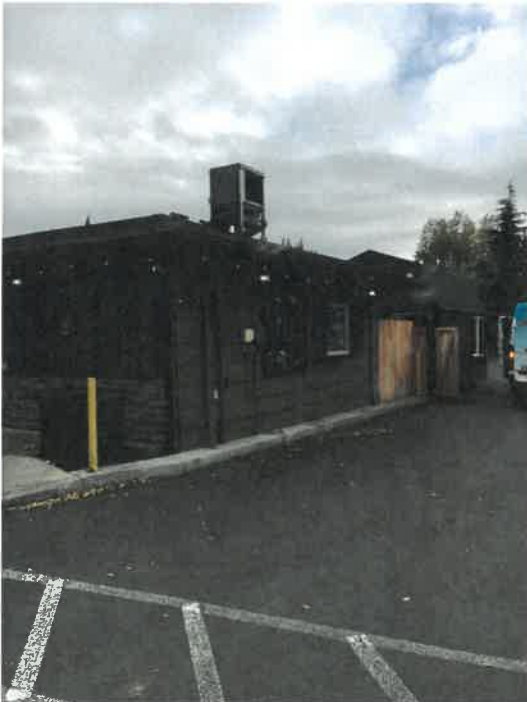
SKETCH

- The roof drains on the Lumberjack Restaurant are all connected to the sewer system. The roof drains to the north and south of the building are all connected. Photo shows drains connected to the north.
- Also refer to aerial on following page.
-
-
-

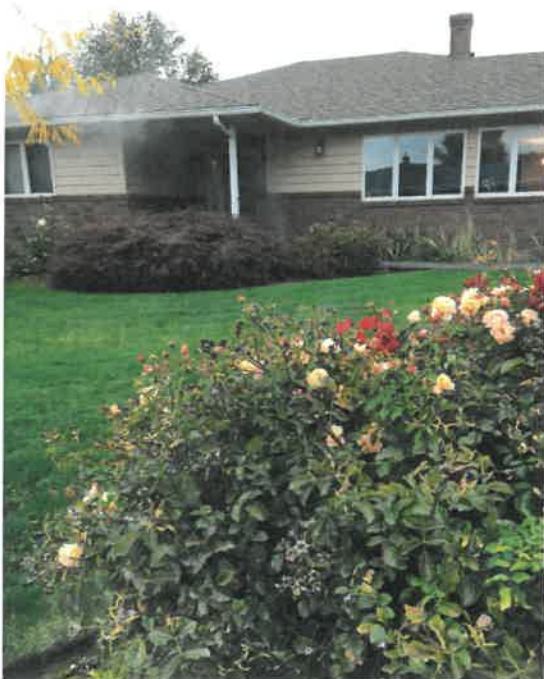
SKETCH

- Open cleanout located immediately to the right of the front door.
- _____
- _____
- _____
- _____
- _____

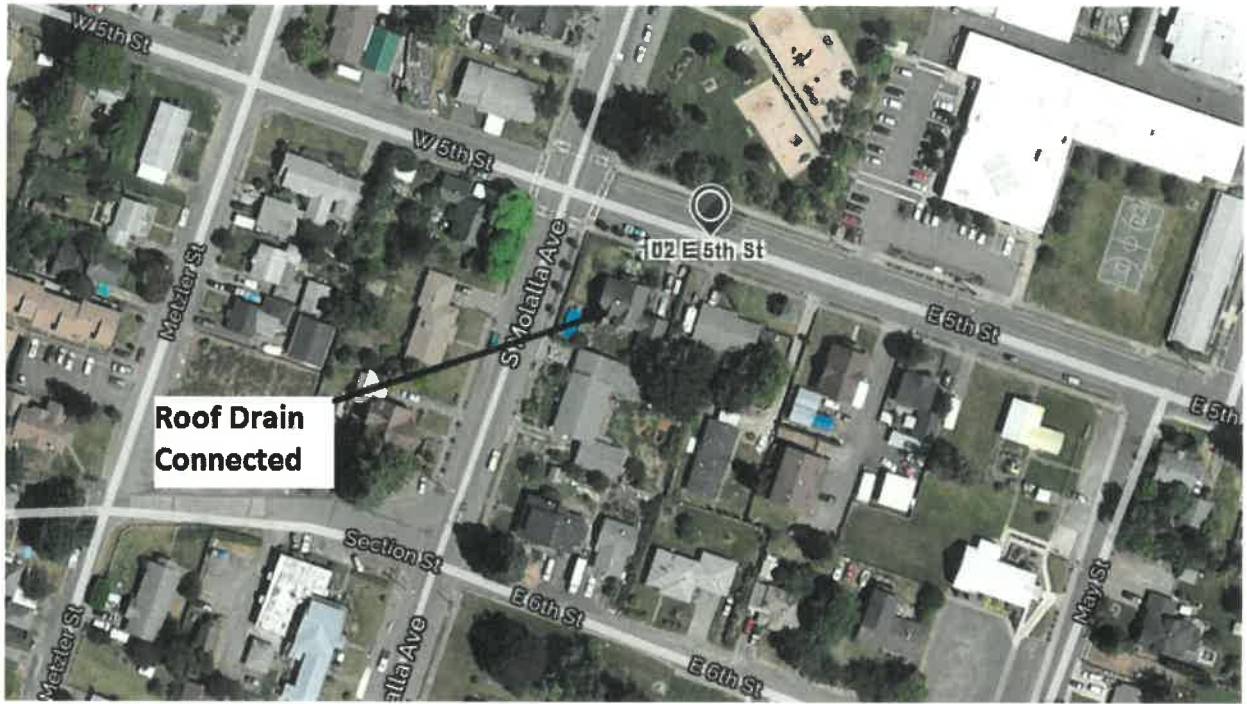
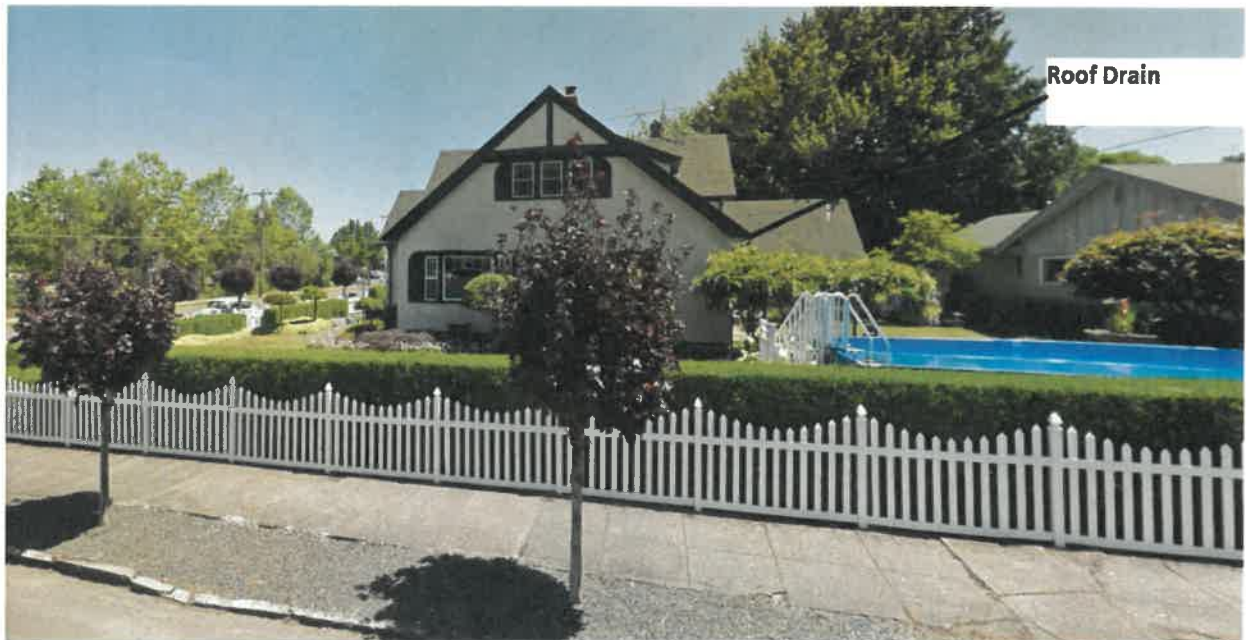
PHOTOGRAPH No. 2

No.	Description	1	Roof drain connected	2	Location of deficiency.						
No.	Description												
1	Roof drain connected												
2	Location of deficiency.

- The roof drain was connected to the sewer system. The drain on the southwest corner of the house was smoking.
- Also refer to aerial on following page.
-
-
-

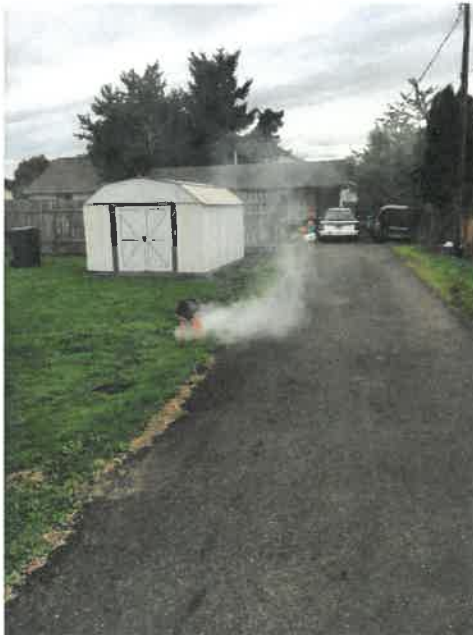
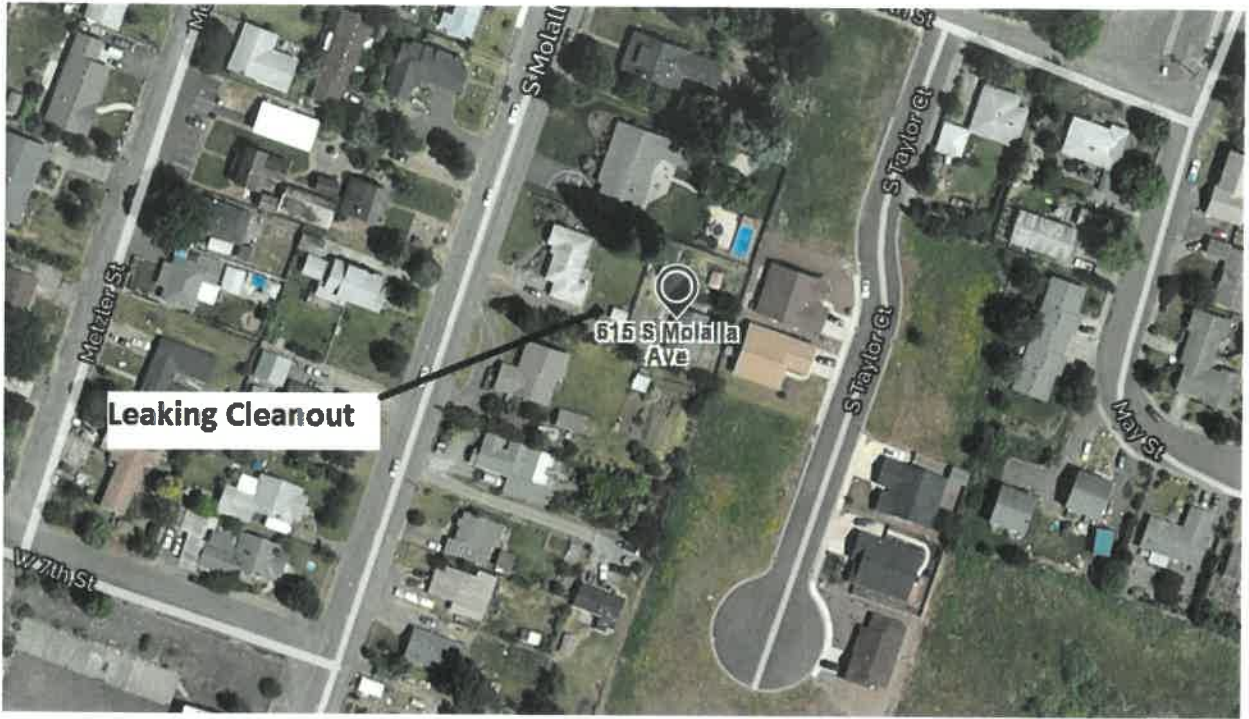
- Open cleanout is located to the north of the drive way. Suspected cleanout has 5 gallon bucket and concrete footing located above it. Smoke exited rapidly.
- Also refer to aerial on following page.

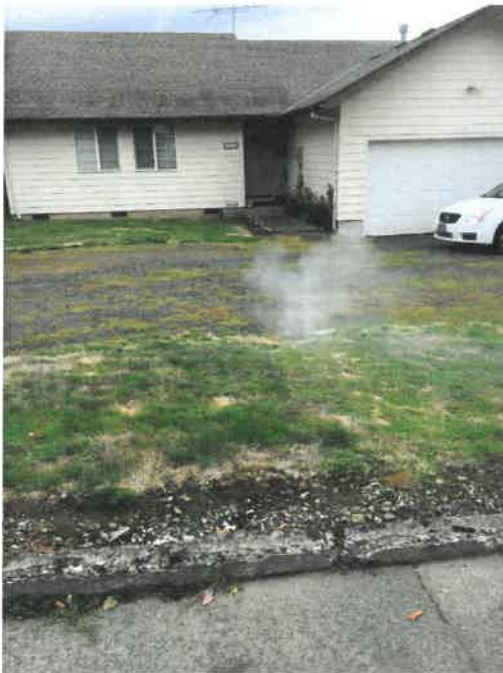
No.	Description	1	Leaking service lateral								
No.	Description												
1	Leaking service lateral

- Leaking service lateral or open cleanout located on western edge of gravel drive way. Smoke exited significantly.
- Also refer to aerial on following page.
-
-
-

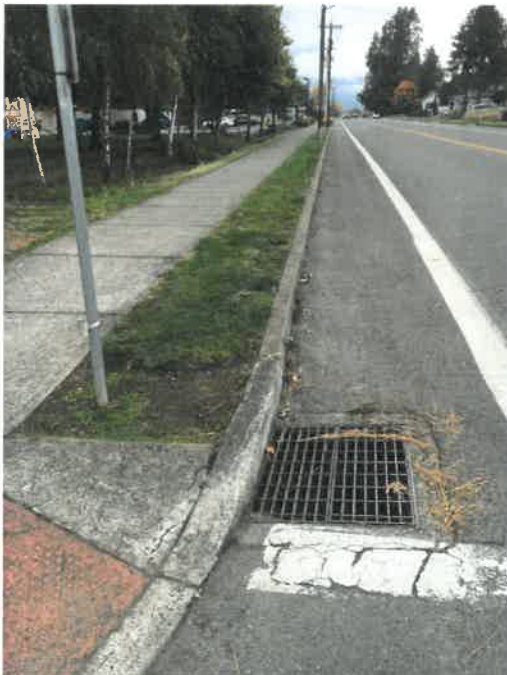
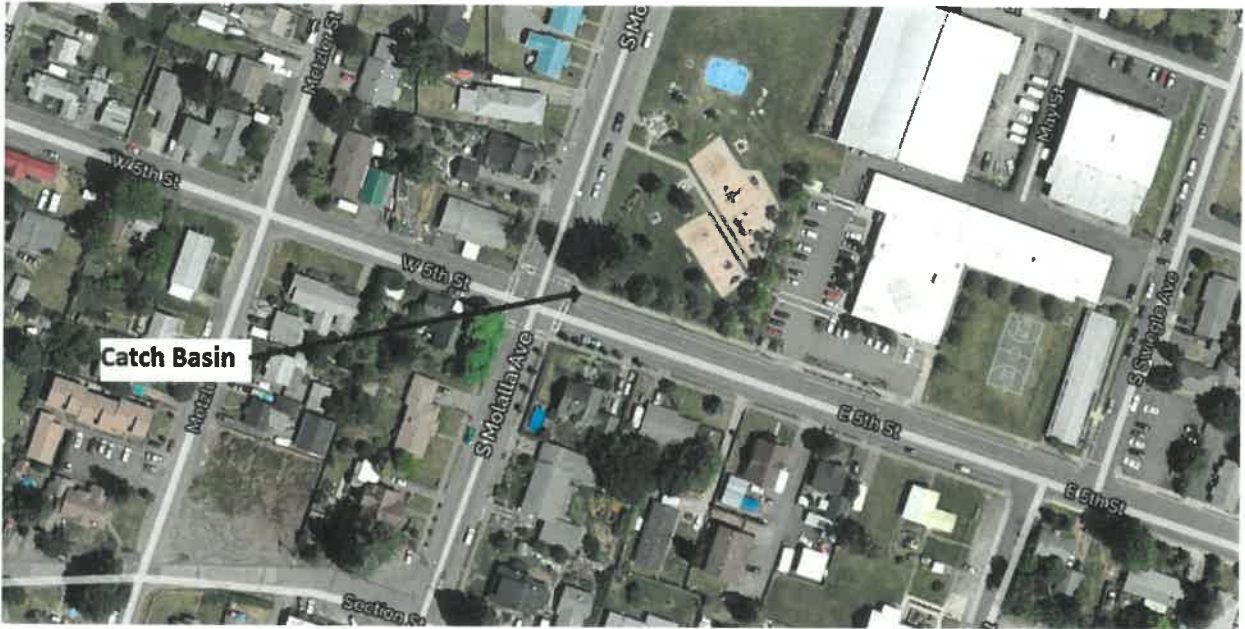
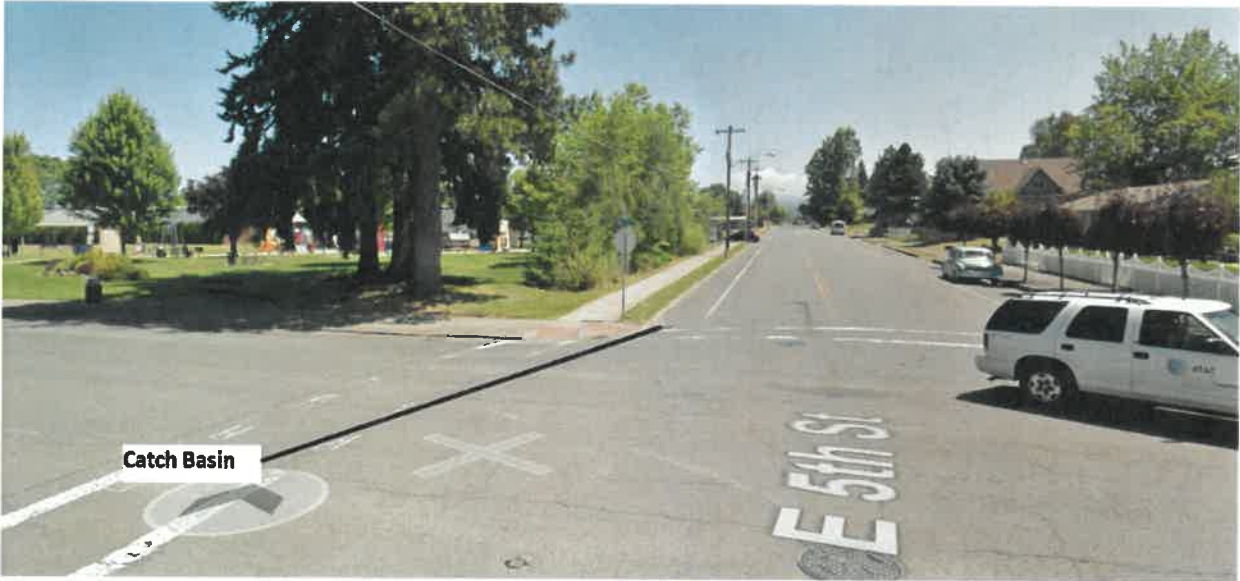
PHOTOGRAPH No. 2

- Catch basin was only lightly smoking, but it is connected to the sewer system. It's the catch basin located in the northeast of the intersection of East 5th and South Molalla.
- It's hard to tell from the picture that it's smoking. It was light.
- Also refer to aerial on following page.
-
-
