Public Works Department

RE: 2017 ANNUAL INFLOW & INFILTRATION REPORT

This report provides an annual summary of the actions the City of Molalla has taken for the 2017 calendar year in accordance with City's Inflow and Infiltration Assessment and Reduction Plan and NPDES Permit No. 101514.

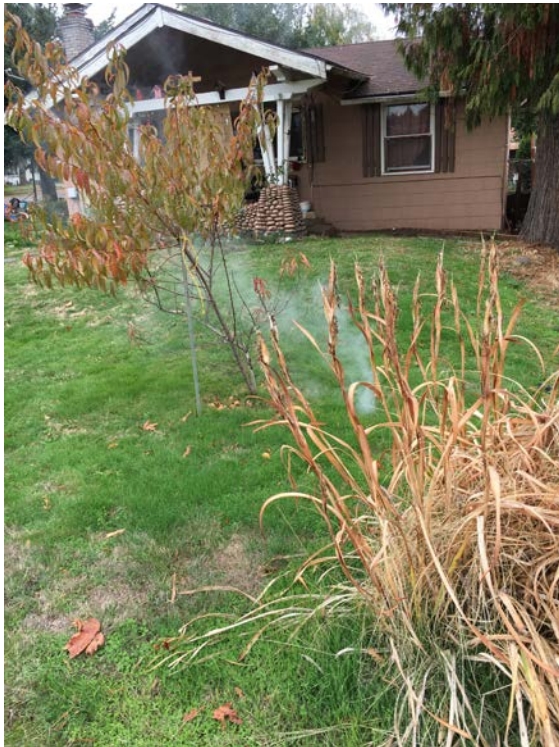
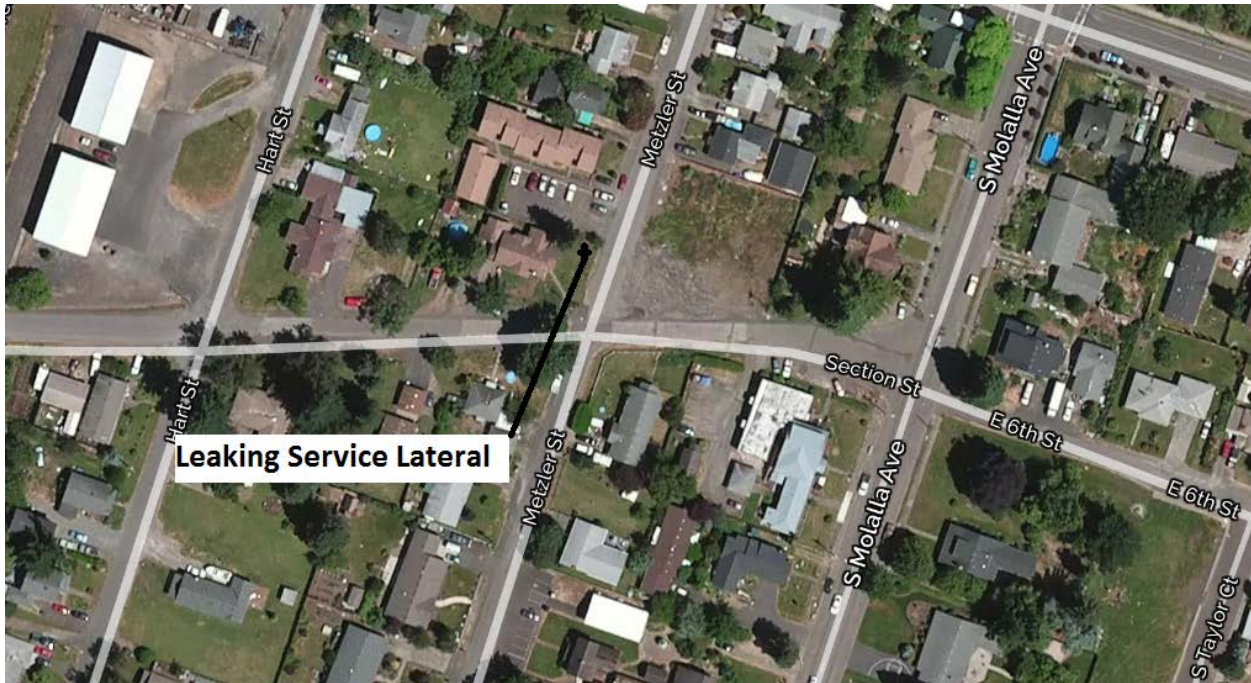
No.	Description	1	Leaking service lateral								
No.	Description												
1	Leaking service lateral

- Leaking service lateral located to the north of a small tree.
- Also refer to aerial on following page.
-
-
-

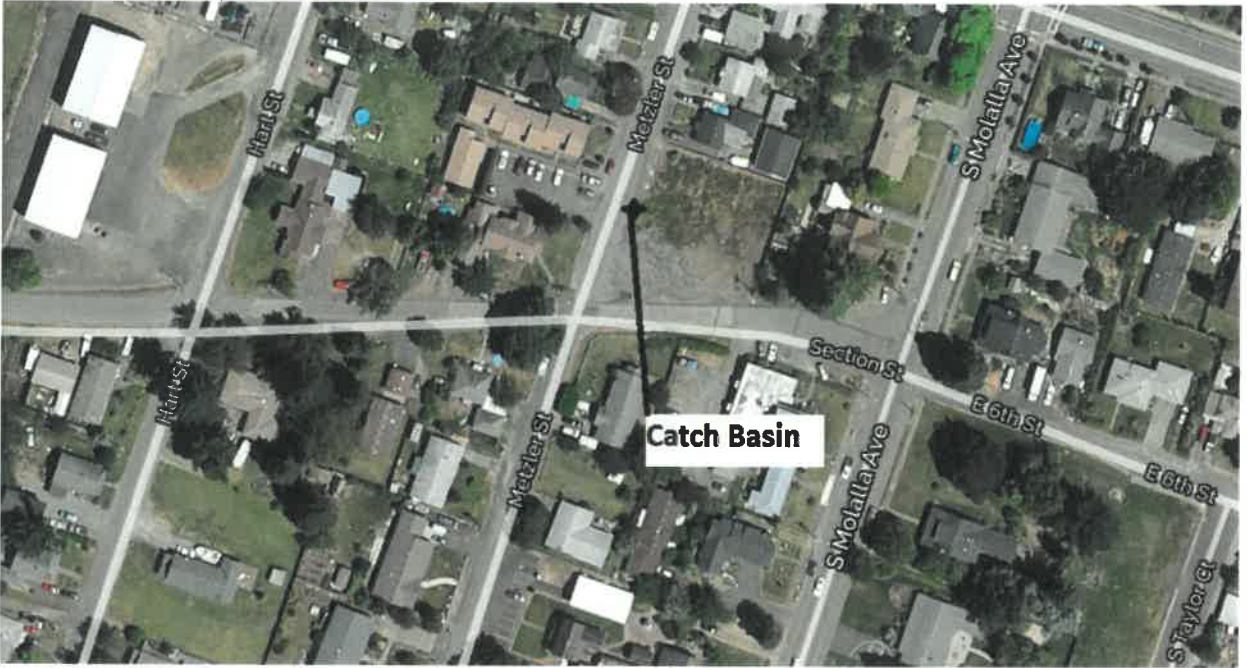
- Catch basin is located underneath the black car. Smoke was rapidly existing from catch basin.
- Also refer to aerial on following page.
-
-
-

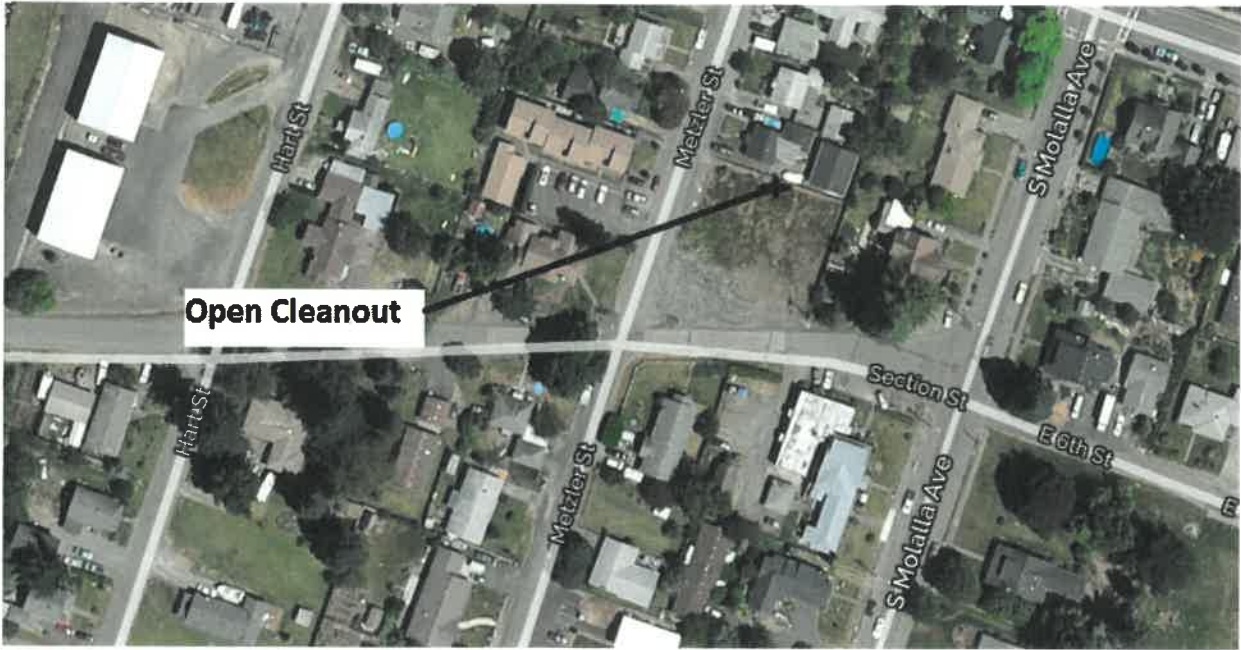
- Open cleanout located to the south of the fence. Pipe extends approximately six feet into the air. Property is an abandoned house.
- Also refer to aerial on following page.
