**Public Works Department**

**RE: 2018 ANNUAL INFLOW & INFILTRATION REPORT**

This report provides an annual summary of some of the more important I/I reduction actions the City of Molalla has taken for the 2018 calendar year, in accordance with City's Inflow and Infiltration Assessment and Reduction Plan and NPDES Permit No. 101514.

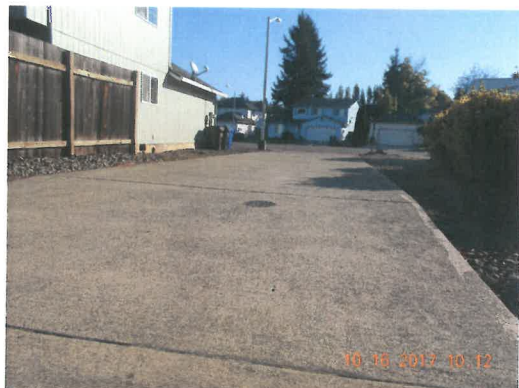
- Located in concrete driveway for 120 Toliver Ct.
- Smoke coming from cleanout cap, Did not open to verify actual issue
- 
- 
-

Repaired on WO#908

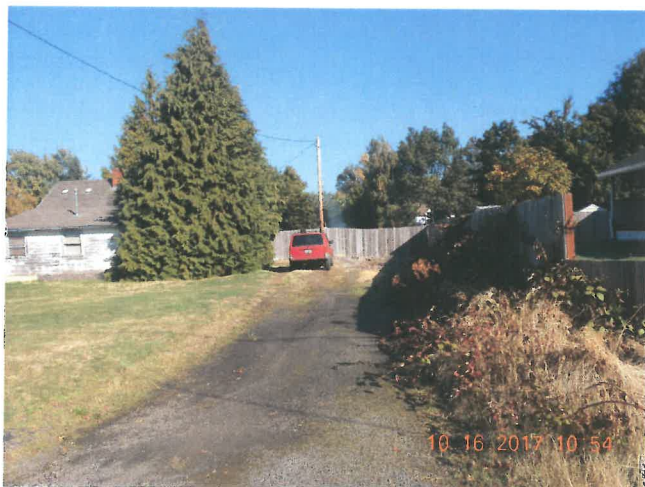
- Smoke coming from behind wooden fence, could not gain access to verify issue
- There was an exposed section of PVC pipe at the fence.
- \_\_\_\_\_
- \_\_\_\_\_
- \_\_\_\_\_

Repaired on WO#908

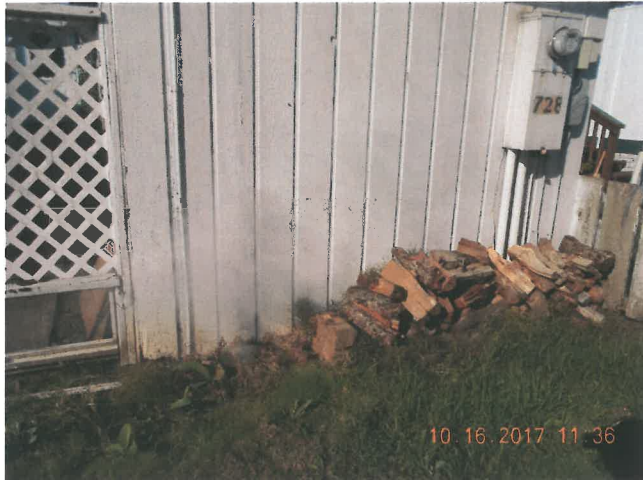
- Located at Unit #728 of Twin Firs Mobile Home Park
- Smoke coming from open cleanout, located behind the shed
- 
- 
-

Repaired on WO#908

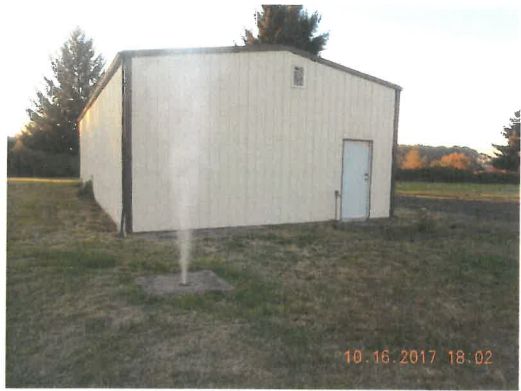
- Smoke coming out of open cleanout next to shop T@ Church of the Nazarene
- 
- 
- 
- 
-

Repaired on WO#956

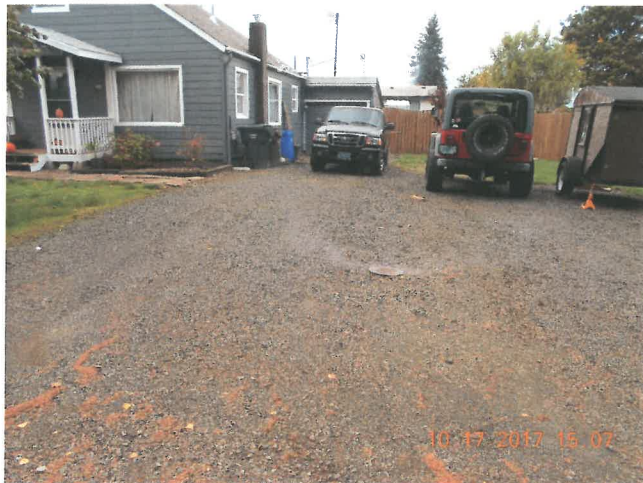
- Smoke leaking around the cleanout cap

Repaired on WO#956

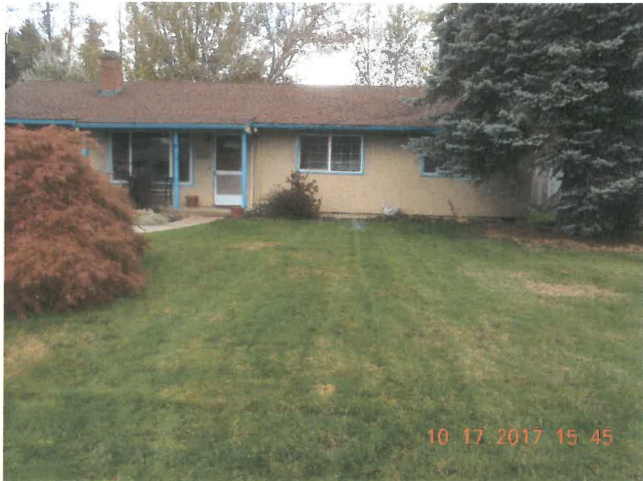
- Smoke coming out of cleanout
- 
- 
- 
- 
-

Repaired on WO#956

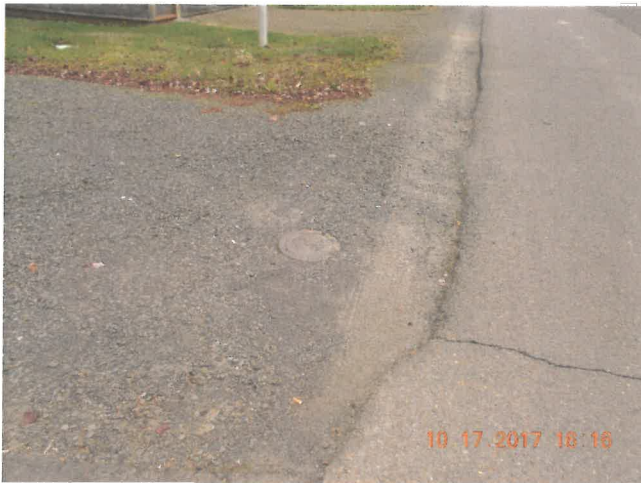
- 1. Smoke leaking around cleanout cap
- 2. Smoke coming out of irrigation valve box
- 3. Smoke coming out of cleanout with no cap
- 
-

Repaired on WO#956

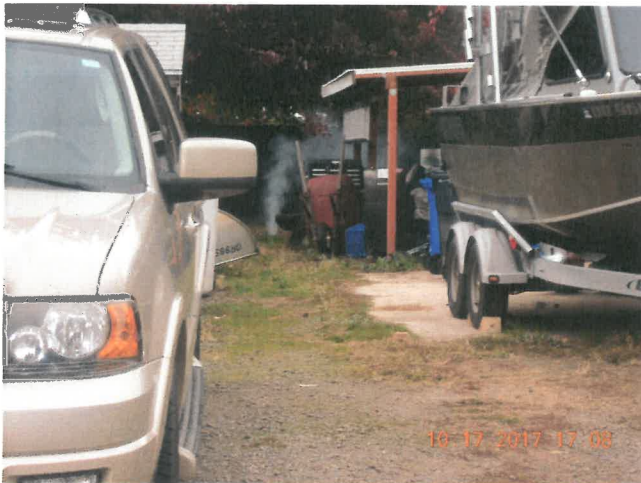
- Smoke coming out of cleanout with no cap
- 
- 
- 
- 
-

Repaired on WO#956

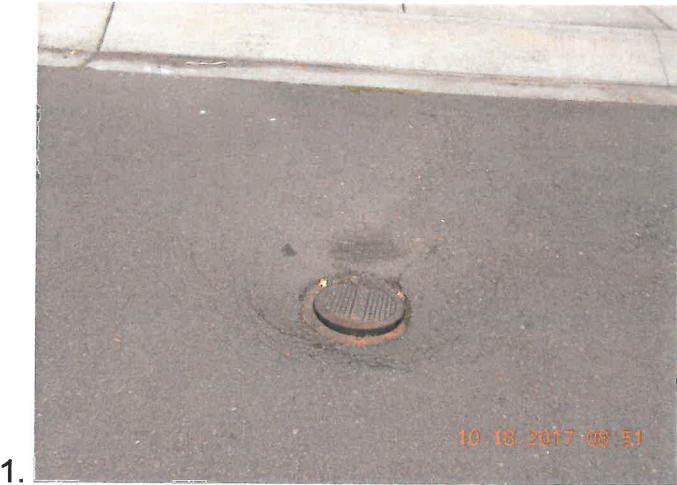
- Smoke coming out of cleanout cap for both units
- 
- 
- 
- 
-

Repaired on WO#1038

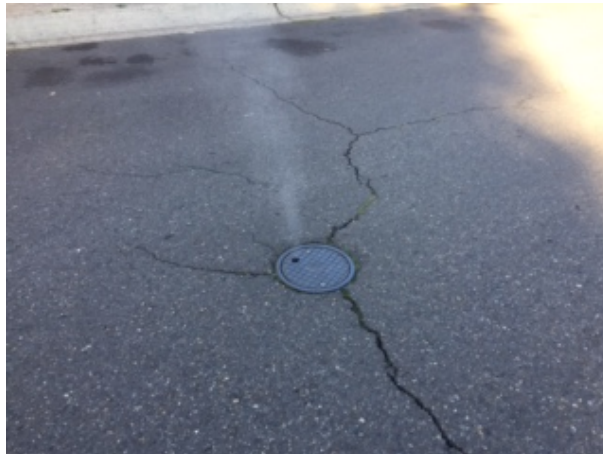
- Mainline cleanout on Toliver Dr., +/-65' south of manhole TL\_E\_6.
- 
- 
- 
-

Repaired on WO#1066

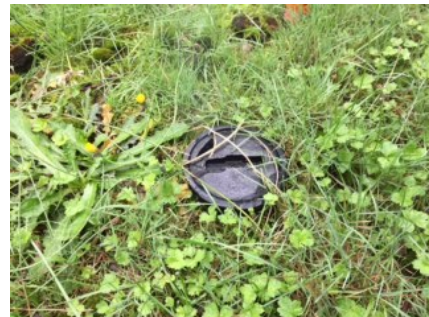
No.	Description	1	Smoke from broken cleanout cap	2	Smoke from broken cleanout cap								
No.	Description														
1	Smoke from broken cleanout cap														
2	Smoke from broken cleanout cap

- Broken cleanout cap on north side of garage, adjacent to concrete sidewalk.
- 
- 
- 
- 
-

Repaired on WO#1384

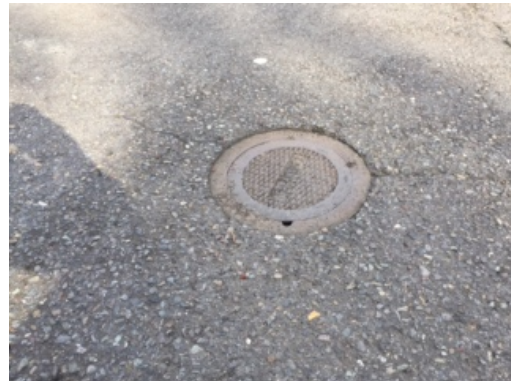
- Smoke coming from cleanout in the southwest parking lot of Molalla High School.
- 
- 
- 
-

Repaired on WO#1384

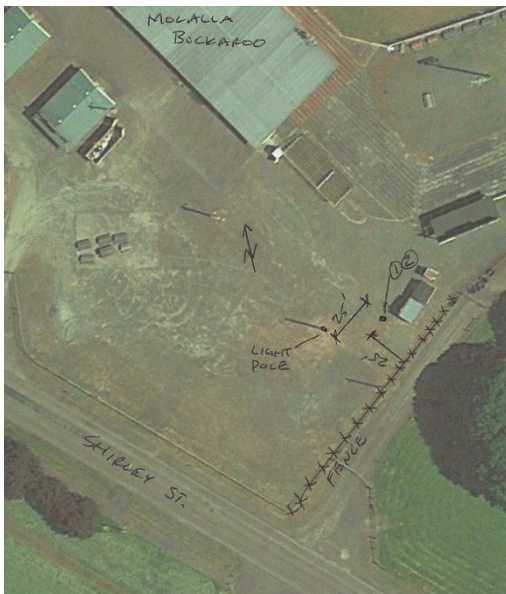
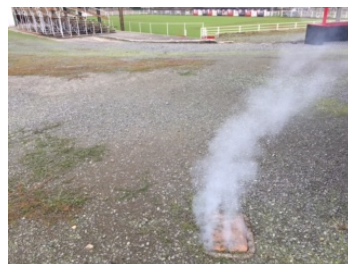
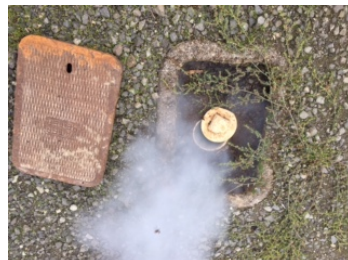
- Smoke from broken cleanout cap inside a water meter box. Cleanout is located on the north east side of the gravel parking area.

Repaired on WO#1529

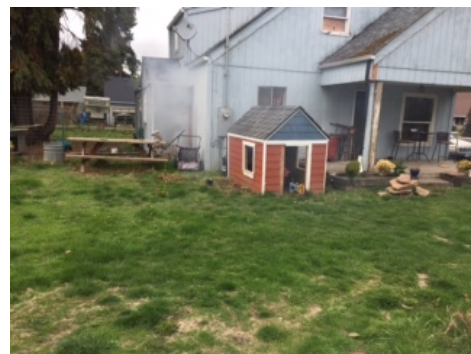
- Smoke from cleanout area. Could not confirm if the cap was broken or missing.
- 
- 
- 
- 
-

Repaired on WO#1529

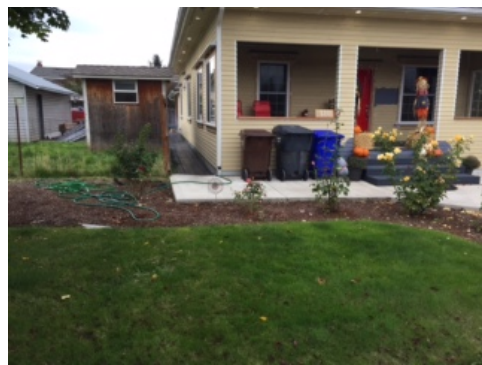
- Smoke from cleanout area. Could not confirm if the cap was broken or missing.
- 
- 
- 
-

Repaired on WO#1529

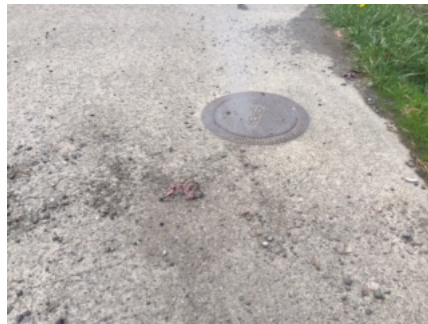
- Smoke from cleanout in flag lot driveway.
- 
- 
- 
-

Repaired on WO#1529

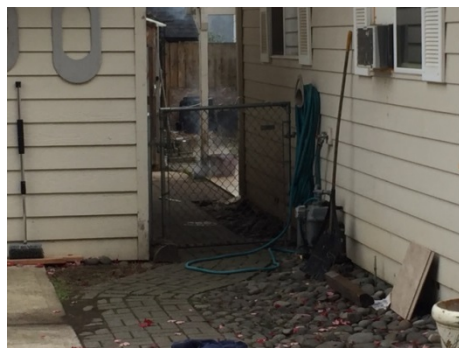
- Smoke from cleanout area. Could not confirm broken or missing cleanout cap.
- 
- 
- 
- 
-

Repaired on WO#1529

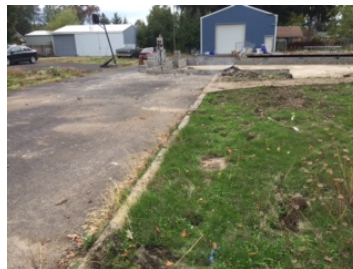
- House has been removed. Smoke from uncovered sewer connection in foundation.
- 
- 
- 
-

Repaired on WO#1529

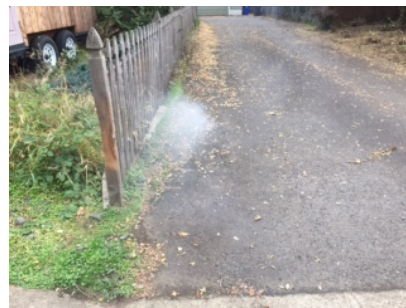
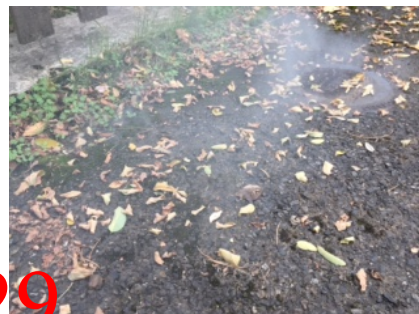
- Smoke from driveway cleanout cover on south side of driveway.
- Smoke is also coming up from edge of asphalt, adjacent to the cleanout cover.
- 
- 
-

Repaired on WO#1529

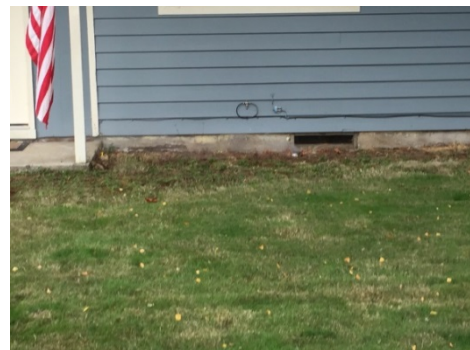
- Smoke from open cleanout, south of front porch, adjacent to front of house.
- 
- 
- 
-

Repaired on WO#1529

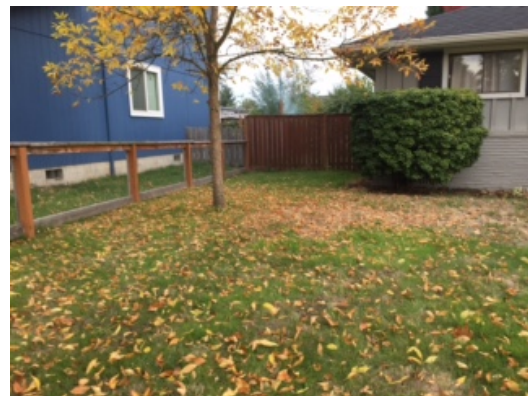
- Smoke from fence line, between backyards of 621 and 623 Main St.
- Could not confirm broken or uncovered cleanout.
- 
- 
-

Repaired on WO#3150

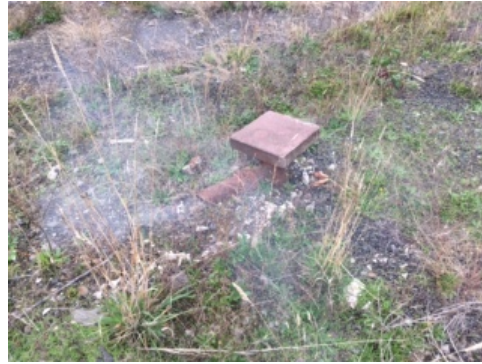
- See aerial for picture locations.
- No. 2 – Cleanout covered with concrete block and open stub out pipe.
- No. 3 – Smoke from gravel area covering broken service lateral.
- No. 5/6 – Smoke from fence line. Possible broken service lateral under fence line.

**Repaired on WO#3150**

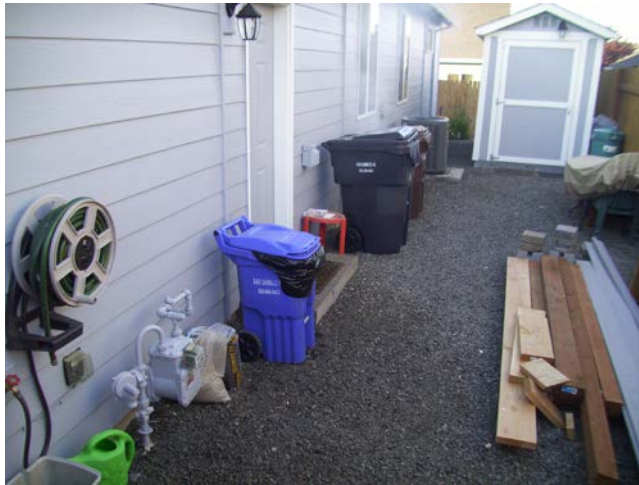
- Behind gate. Could not confirm (Private property).
- 
- 
- 
- 
-

Repaired on WO#3224

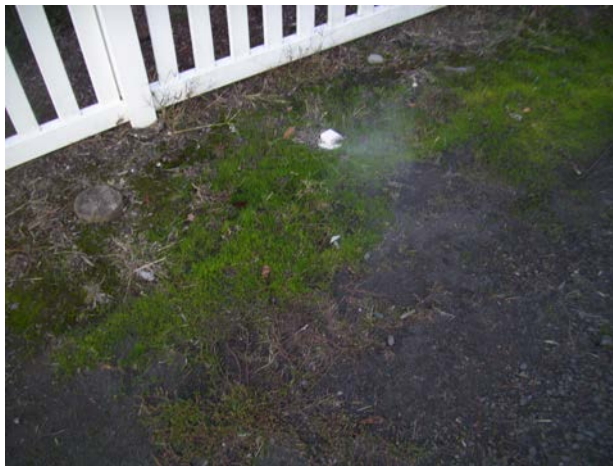
- Broken cleanout lid.
- 
- 
- 
-

Repaired on WO#3224

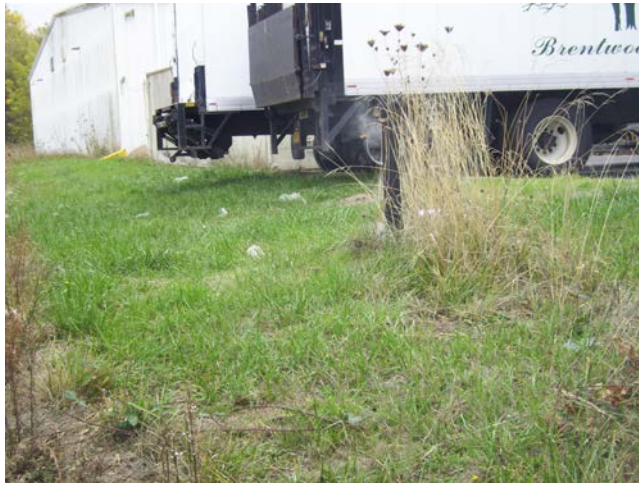
- Smoke coming from ground at base of cleanout riser pipe.
- 
- 
- 
- 
-

Repaired on WO#3445

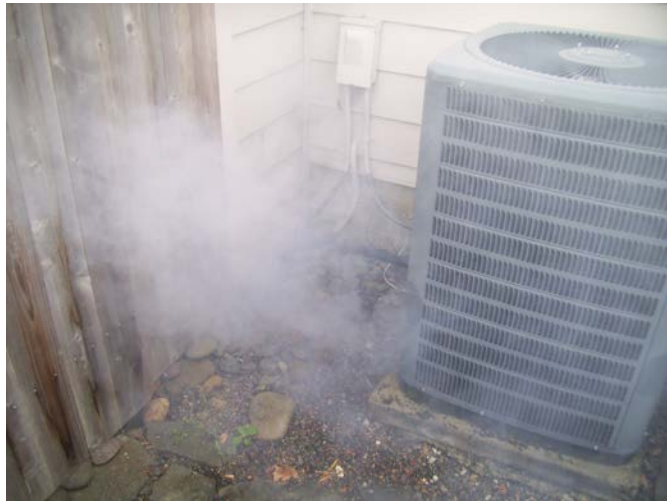
- Could not identify source of smoke.
- 
- 
- 
-

Repaired on WO#3445

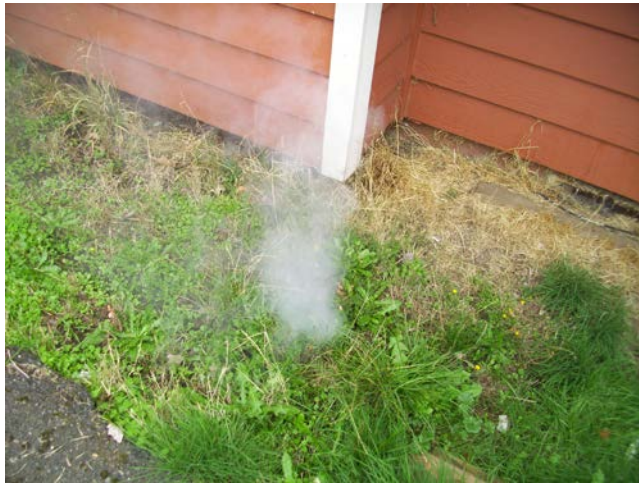
- Cleanout does not have cap.
- 
- 
- 
-

**Repaired on WO#3445**

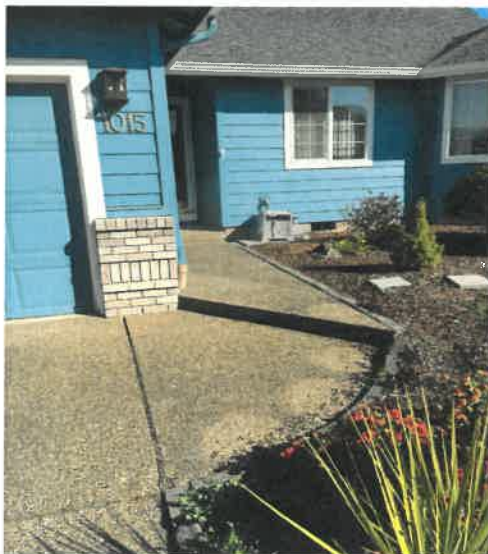
- Open cleanout located immediately to the right of the front door. Right next to hose reel.
- Also refer to aerial on following page.

Repaired on WO#3515

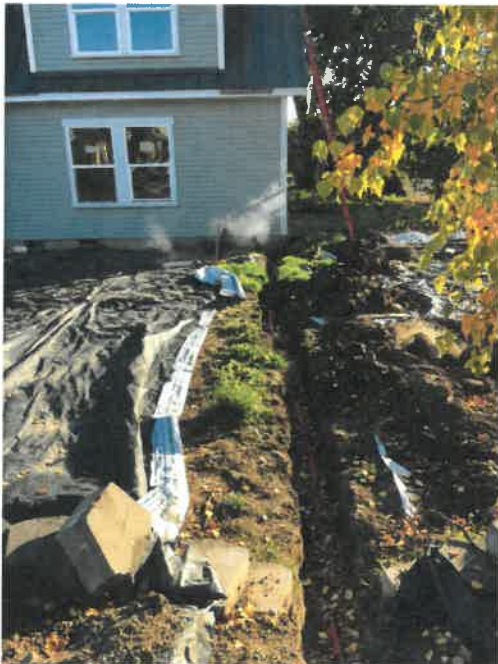
- Open cleanout. House was undergoing some landscaping and upgrades. Open cleanout may only be temporary.
- Also refer to aerial on following page.
- \_\_\_\_\_
- \_\_\_\_\_
- \_\_\_\_\_

**Repaired on WO#3515**

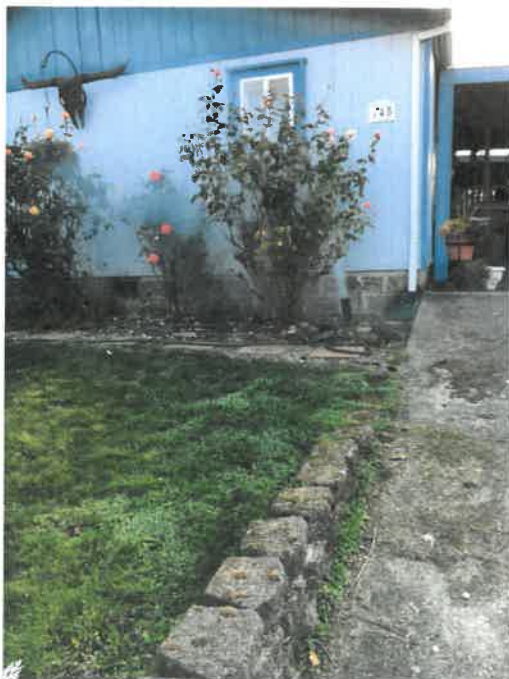
- Two open cleanouts located approximately two and five feet from north side of drive way.
- 
- 
- 
- 
-

Repaired on WO#3515

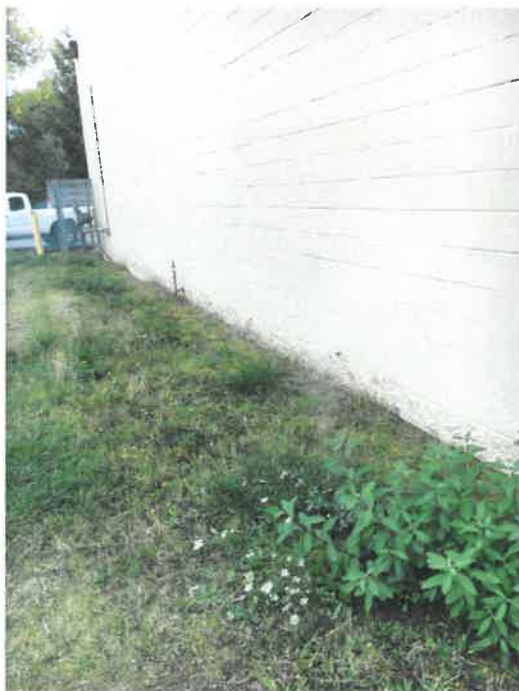
- There was an open cleanout to the north of the Safeway building. The pipe is a few inches below ground level, and probably receives quite a bit of inflow.
- Also refer to aerial on following page.
- 
- 
-

Repaired on WO#3515

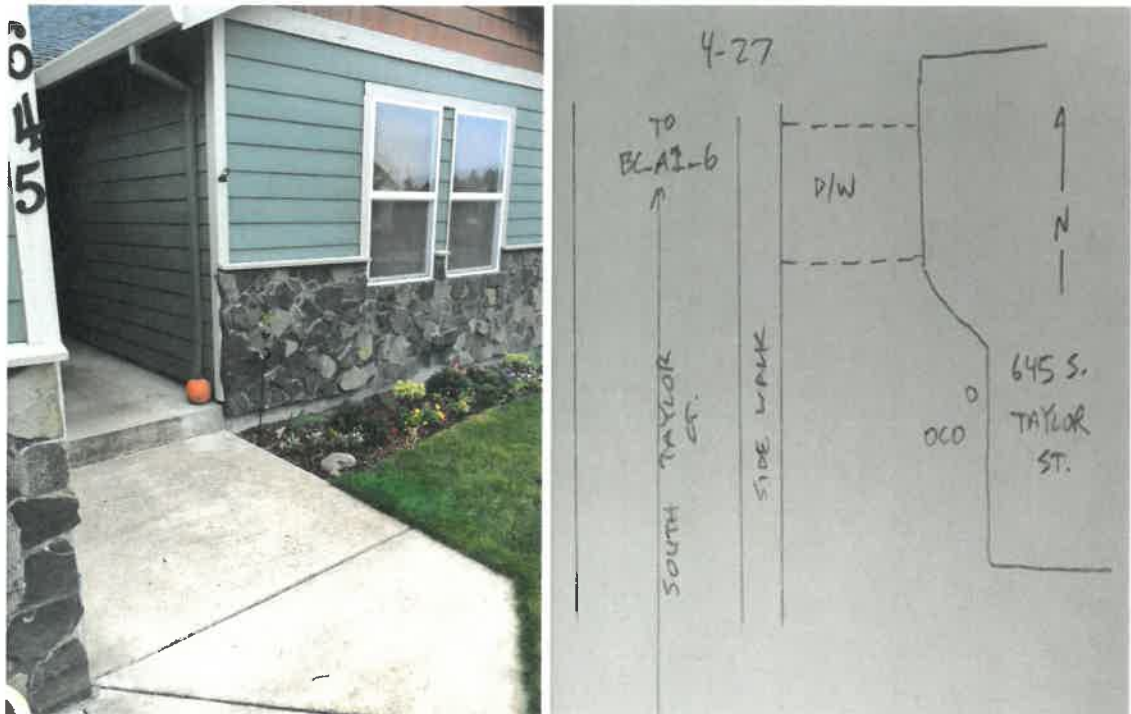
- Open cleanout located immediately to the right of the walk way, in the flower patches. It was leaking around the cleanout, suggesting something deficient underground.

Repaired on WO#3858

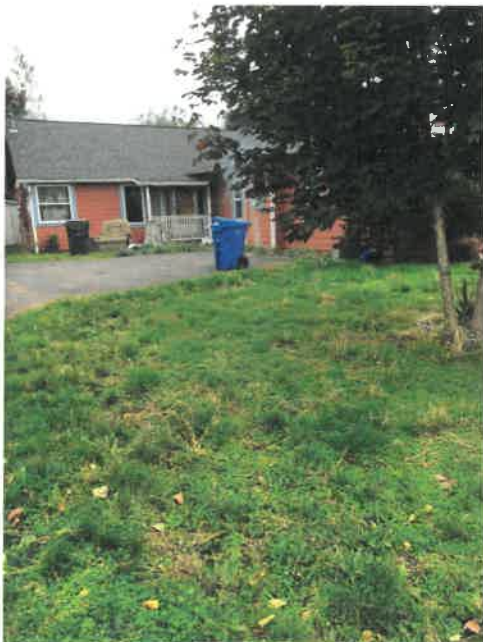
- Open cleanout located north of the driveway, immediately adjacent to the house.
- \_\_\_\_\_
- \_\_\_\_\_
- \_\_\_\_\_
- \_\_\_\_\_
- \_\_\_\_\_

Repaired on WO#3858
