# CITY OF MOLALLA

## SMOKE TESTING REPORT

OCTOBER 2018

**Project No. 100.26**

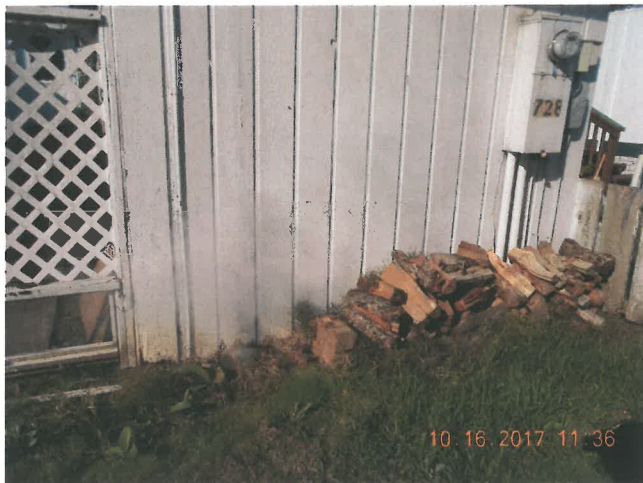
- Located at Unit #728 of Twin Firs Mobile Home Park
- Smoke coming from open cleanout, located behind the shed
- 
- 
-

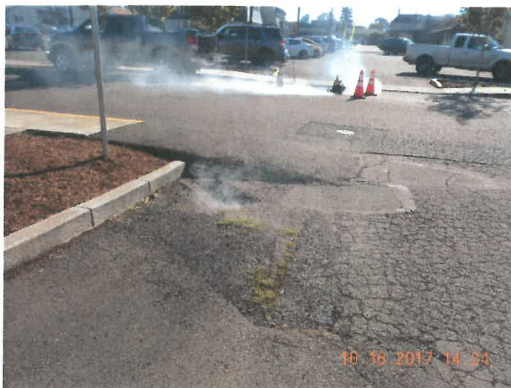
- Smoke coming from catch basin
- Located in the northeast corner of intersection of E. Ross Street & Marson Court, on the north side of the asphalt ramp.
- 
- 
-

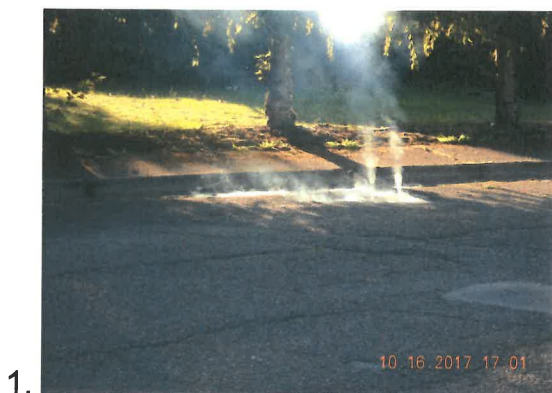
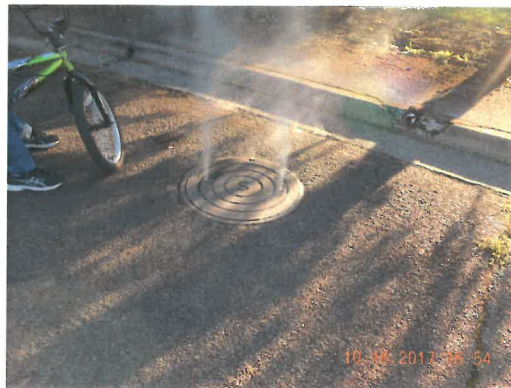
- Smoke leaky out around the rim of the manhole, the cracks in the road around the manhole and along the joint between the ac pavement and concrete gutter
- 
- 
- 
-

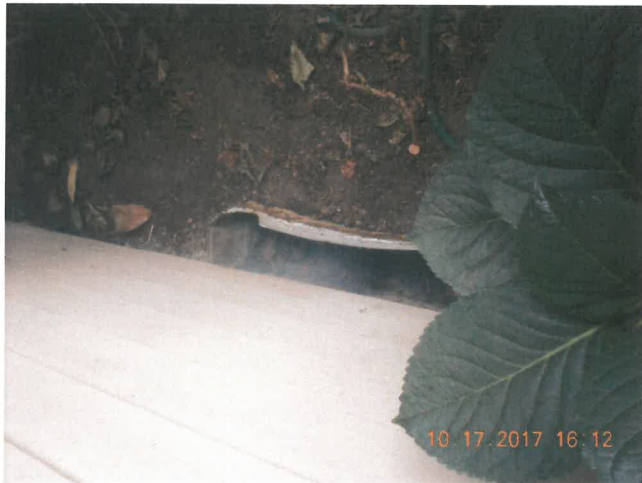
- Smoke coming out of cleanout, located in recessed house vent
- 
- 
- 
- 
-

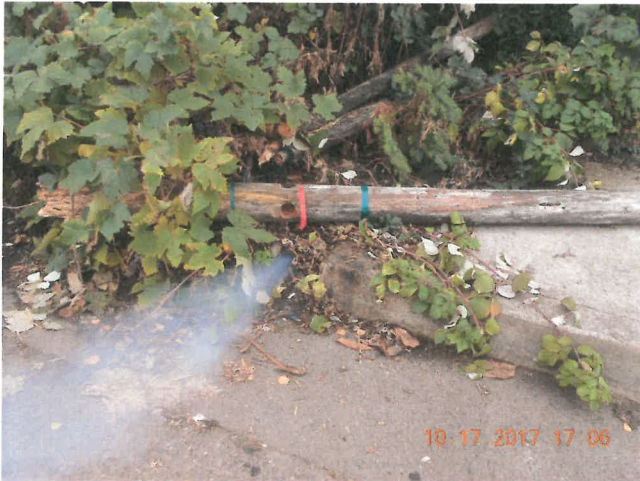
- Smoke coming out of drain located in the sidewalk
- 
- 
- 
- 
-

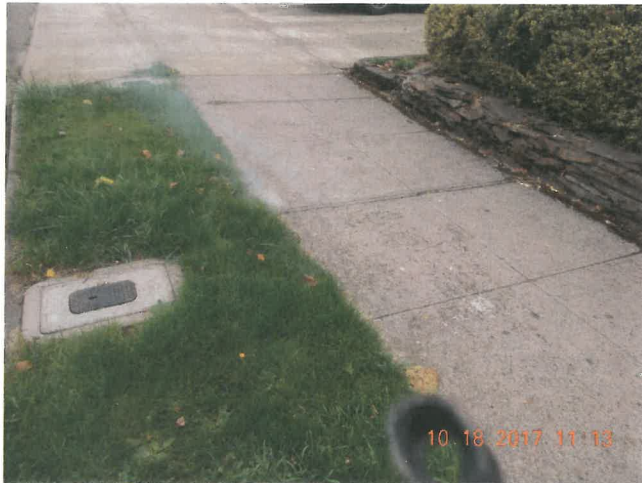
- Smoke coming out of the joint in the concrete sidewalk
- 
- 
- 
- 
-

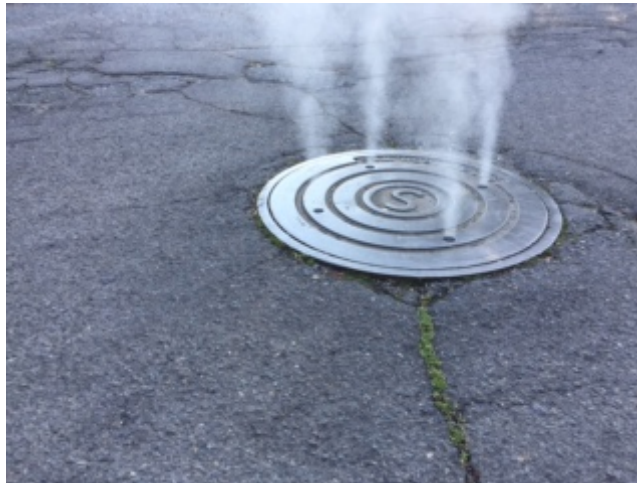
- Smoke was coming up from exterior of manhole TL\_SB1\_3 rim.
- \_\_\_\_\_
- \_\_\_\_\_
- \_\_\_\_\_
- \_\_\_\_\_
- \_\_\_\_\_

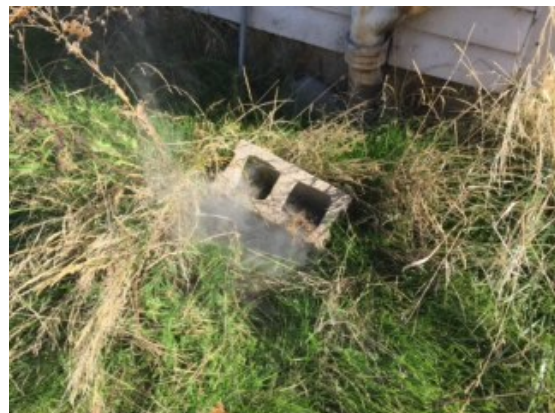
- Cleanout without cap. Covered with cinder block.
- 
- 
- 
- 
-

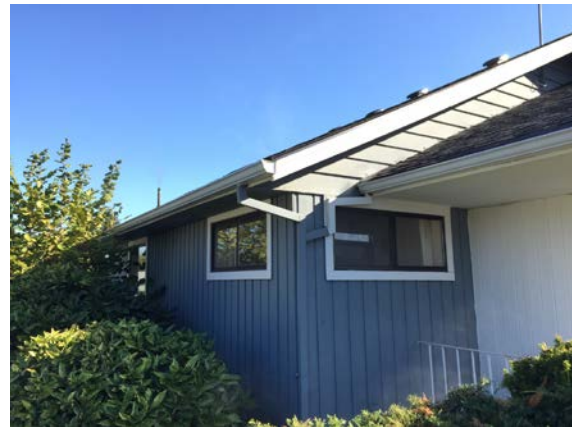
- Smoke coming from gutter/downspout on northwest corner of house.
- 
- 
- 
- 
-

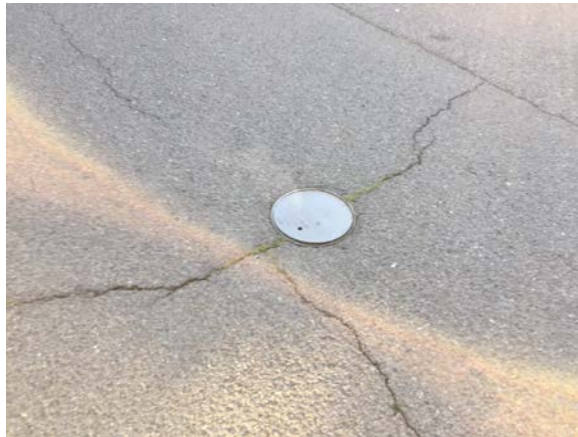
- Smoke coming from mainline cleanout 15' south of manhole TL\_B\_31.
- 
- 
- 
-

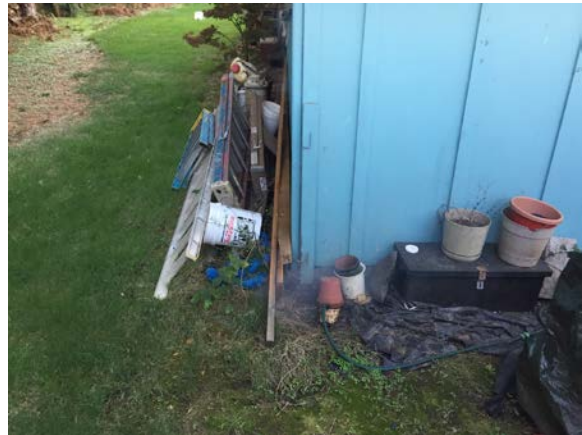
- Smoke from cleanout located adjacent to the northeast corner of the garage, behind fence.
- 
- 
- 
- 
-

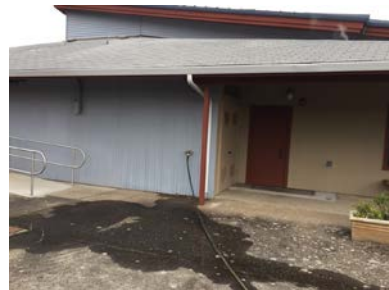
- Smoke coming from gutter on the south side of the main church building.
- 
- 
- 
- 
-

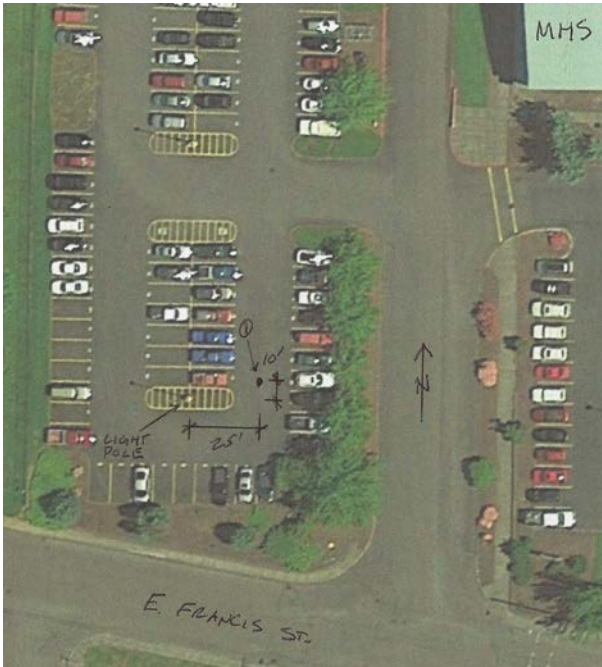
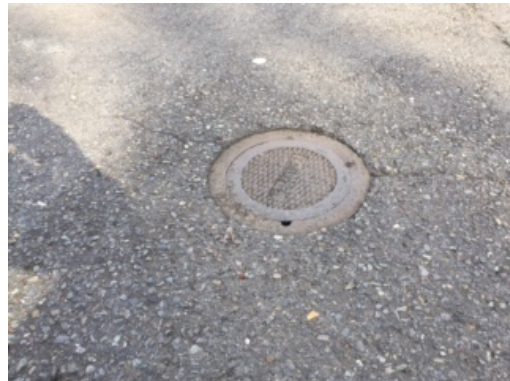
- Smoke coming from cleanout in the southwest parking lot of Molalla High School.
- 
- 
- 
-

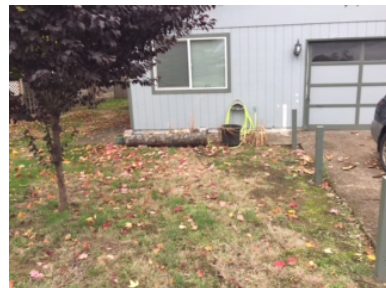
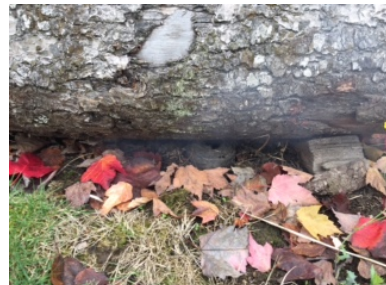
- .Smoke from broken cleanout cap, located next to concrete walkway, under planter.
- 
- 
- 
-

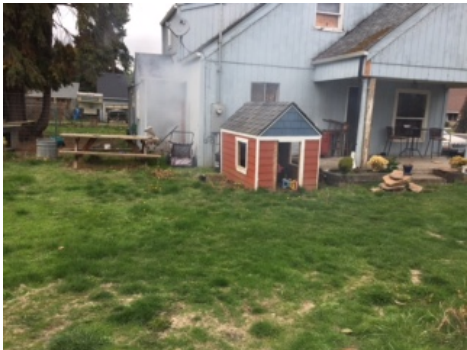
- Smoke from cleanout area. Could not confirm if the cap was broken or missing.
- 
- 
- 
-

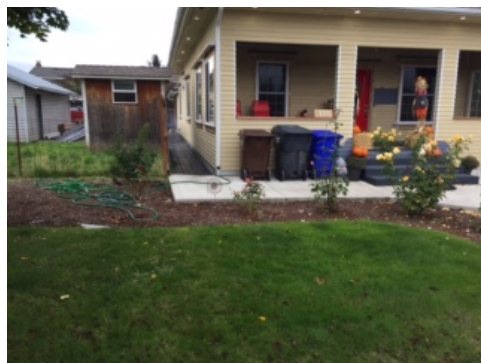
- Smoke from cleanout area. Could not confirm if the cap was broken or missing.
- 
- 
- 
-

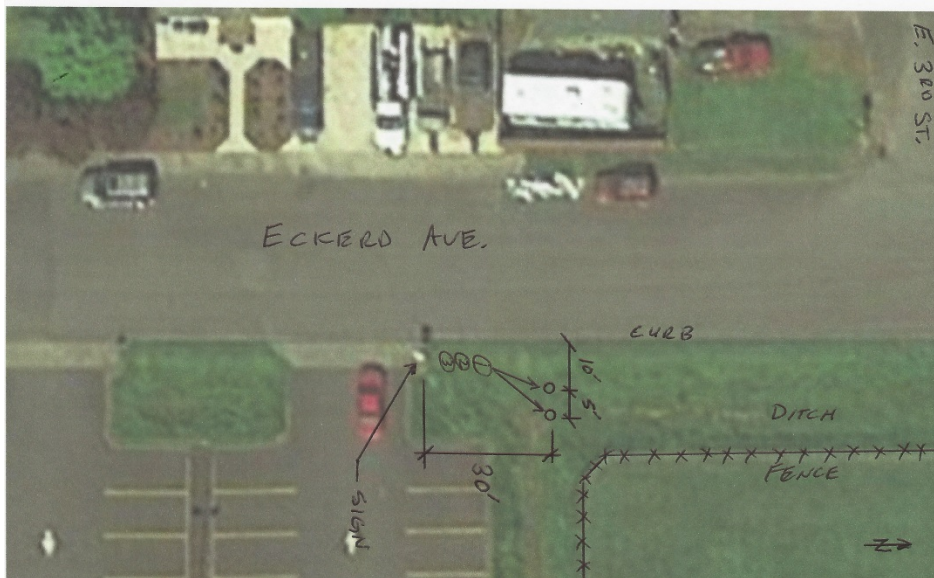
- Smoke from ditch running north/south on east side of Eckerd Ave. Smoke was near the northwest corner of the football field parking lot.
- See attached for pictures.
- 
- 
-

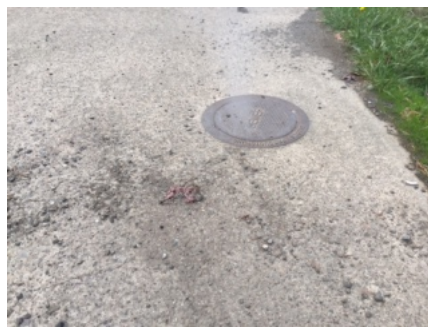
- Smoke from cleanout in flag lot driveway.
- 
- 
- 
-

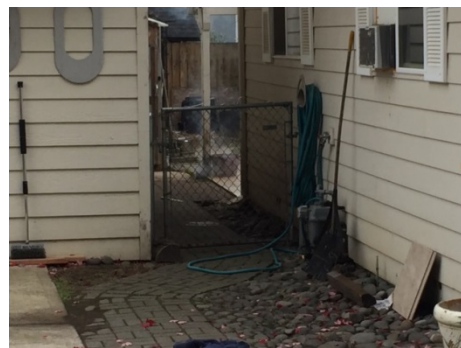
- Smoke from cleanout area. Could not confirm broken or missing cleanout cap.
- 
- 
- 
- 
-

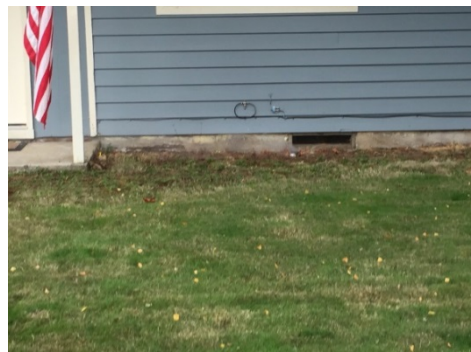
- Smoke from open cleanout, south of front porch, adjacent to front of house.
- 
- 
- 
-

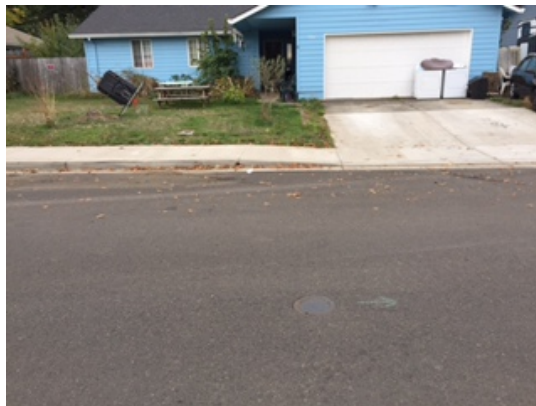
- Smoke from mainline cleanout cover on Stower Rd., in front of 503 Stower Rd.
- 
- 
- 
-

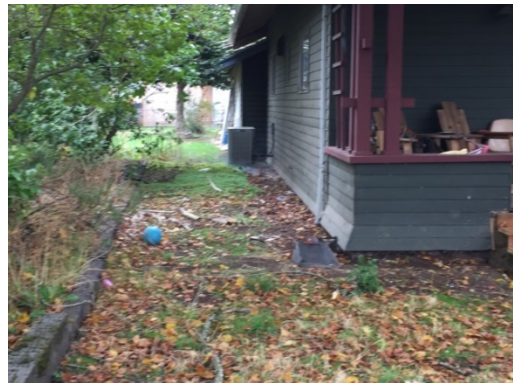
- Smoke from cleanout area on north side of house. Could not confirm broken or missing cap.
- 
- 
- 
- 
-

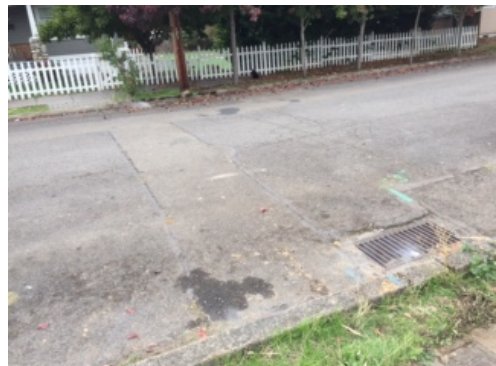
- Smoke from catch basins on east and west side of Engle Ave., between 2<sup>nd</sup> and 3<sup>rd</sup> Streets.
- 
- 
- 
-

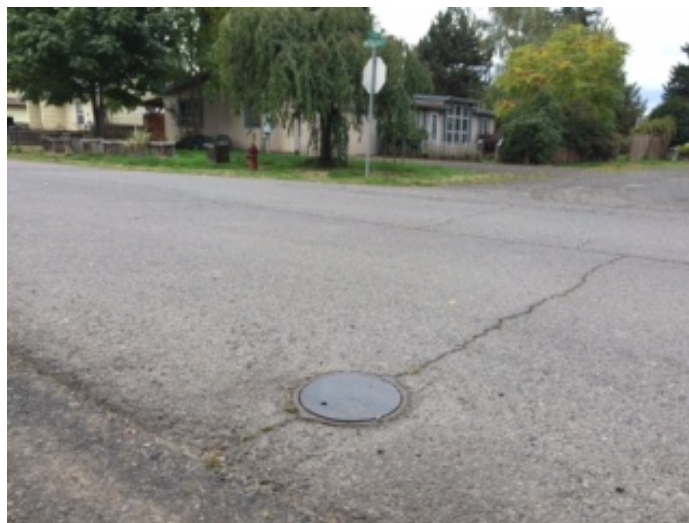
- Smoke from mainline cleanout cover located at 4<sup>th</sup> St. and Metzler Ave.
- \_\_\_\_\_
- \_\_\_\_\_
- \_\_\_\_\_
- \_\_\_\_\_

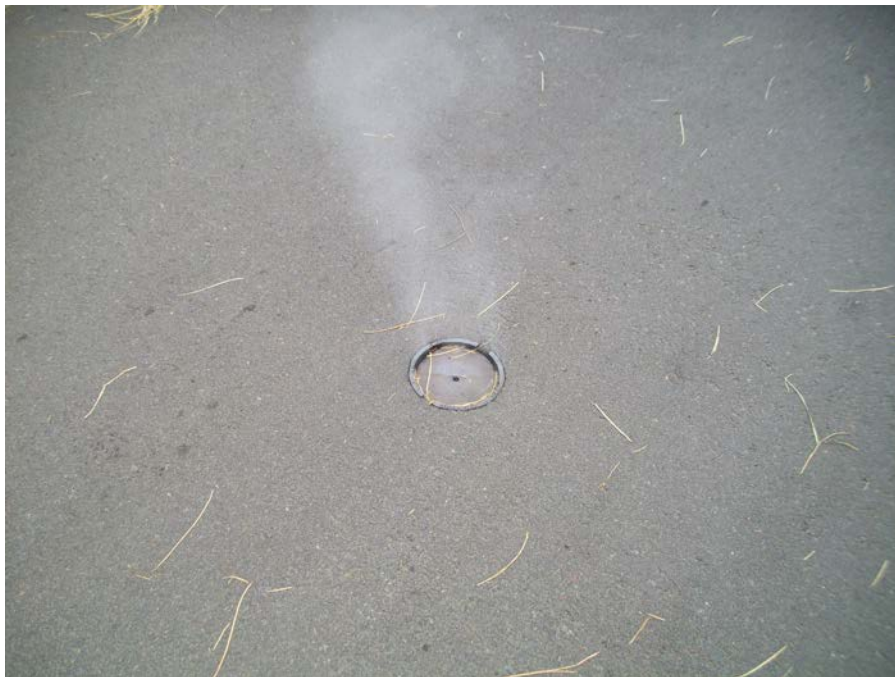
- Cleanout lid recessed below pavement grade. Smoke coming from sides of lid and center.
- 
- 
- 
-

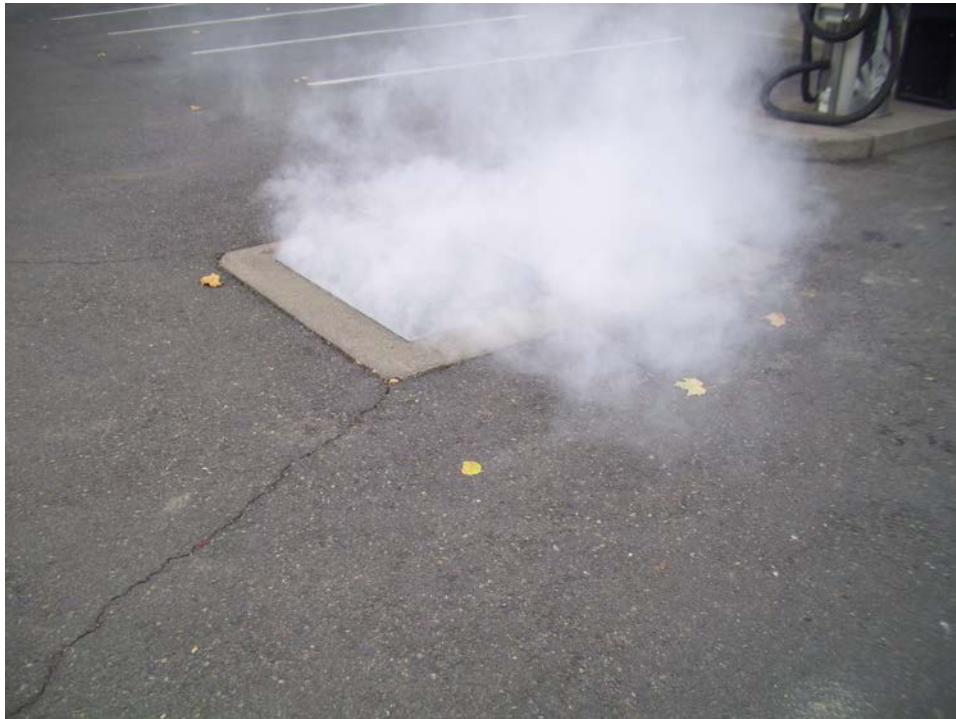
- Smoke coming from vault in parking lot west of car wash.
- 
- 
- 
-

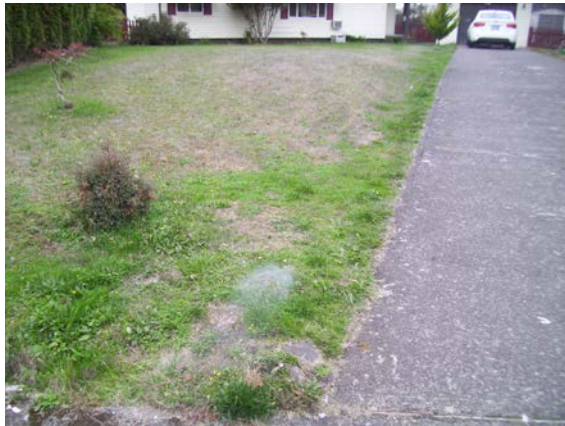
- Cleanout does not have cap.
- 
- 
- 
-

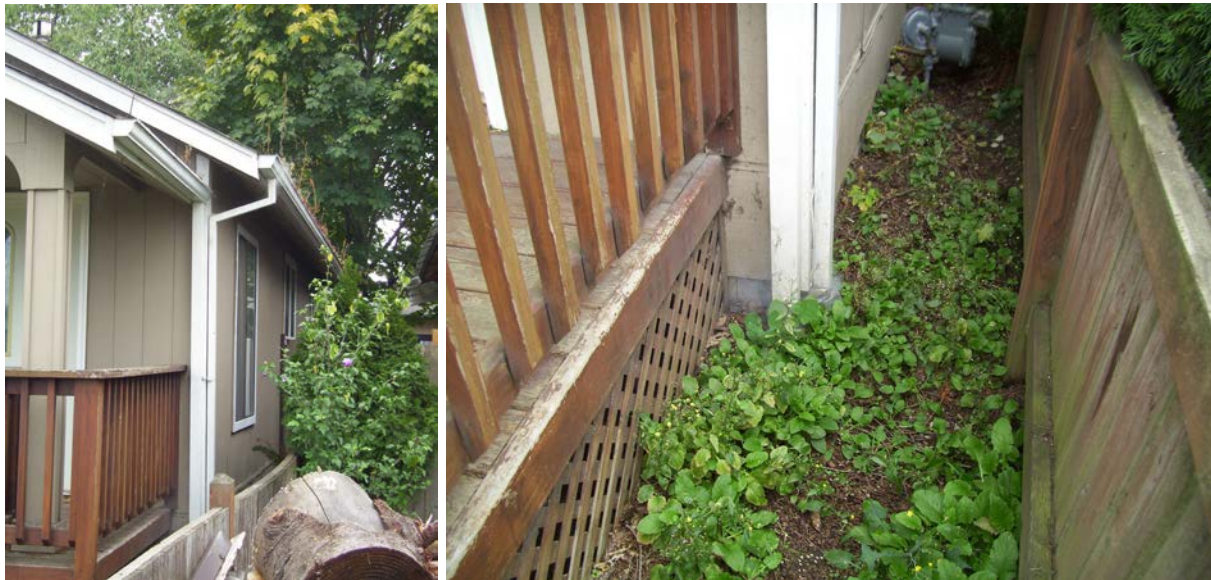
- Smoke coming from gutter drain. Roof drain might connect into open cleanout.
- 
- 
- 
- 
-

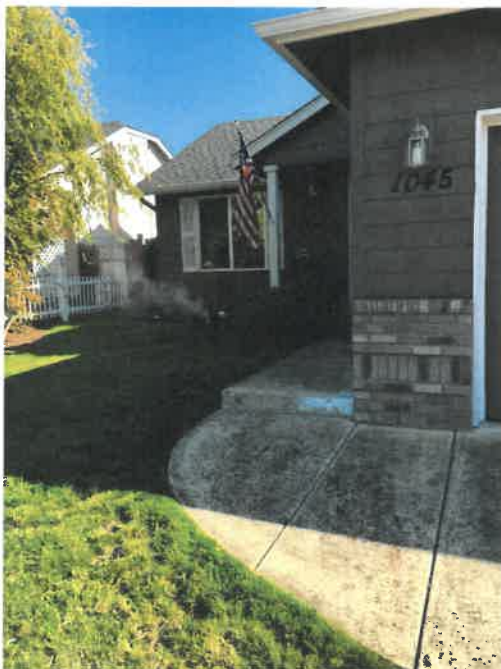
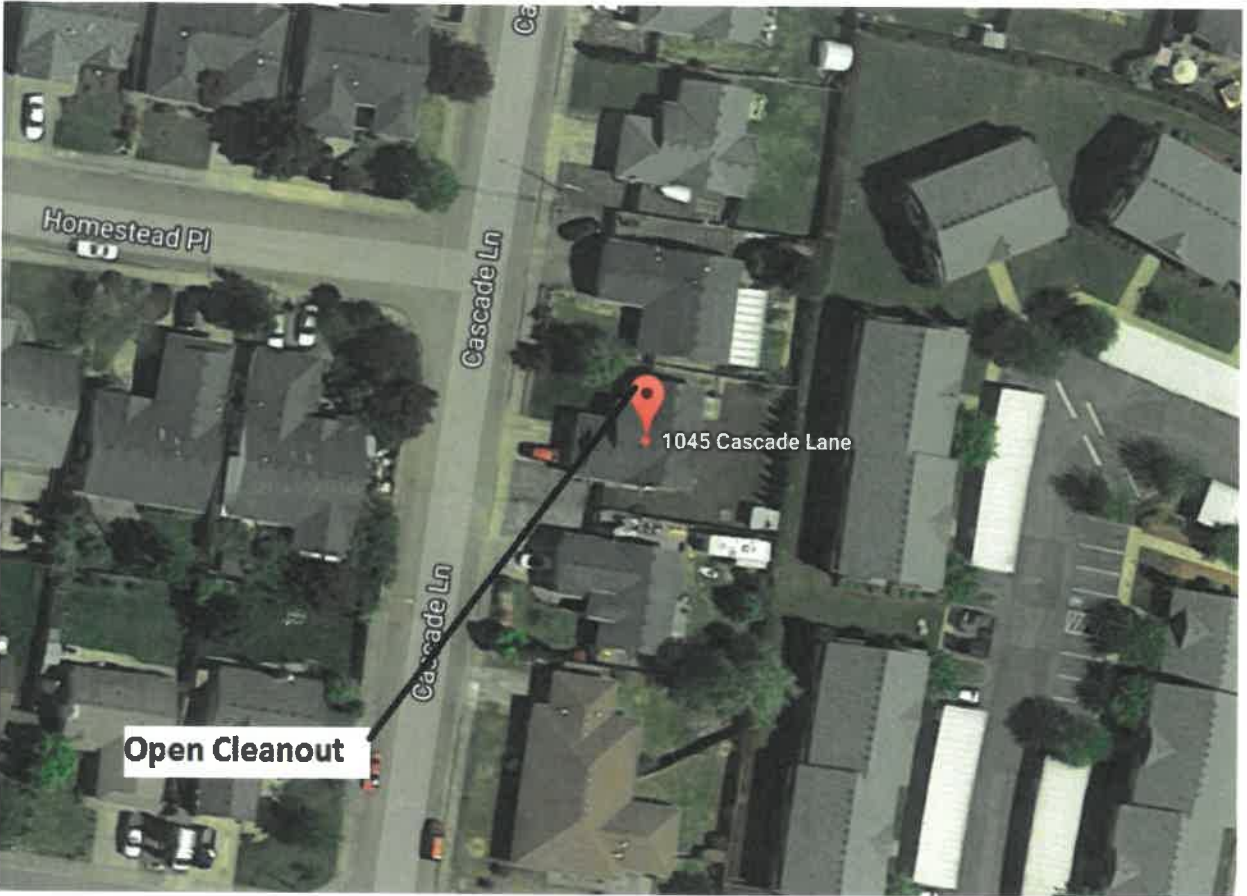
- Open cleanout located about 10 ft to the left of the front door. Right in front of the front window.
- Also refer to aerial on following page.
- 
- 
-

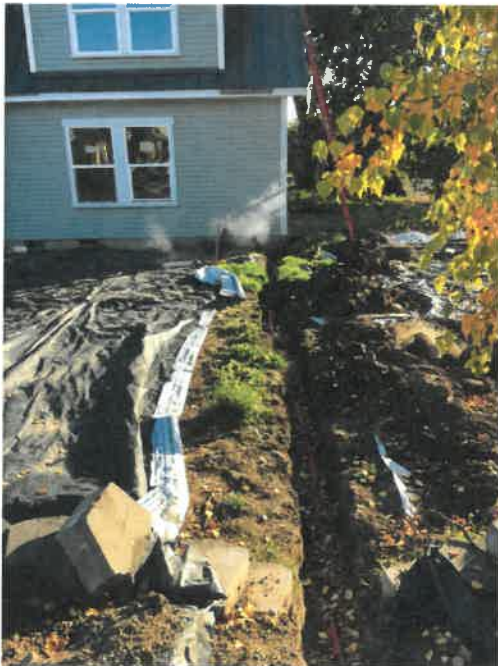
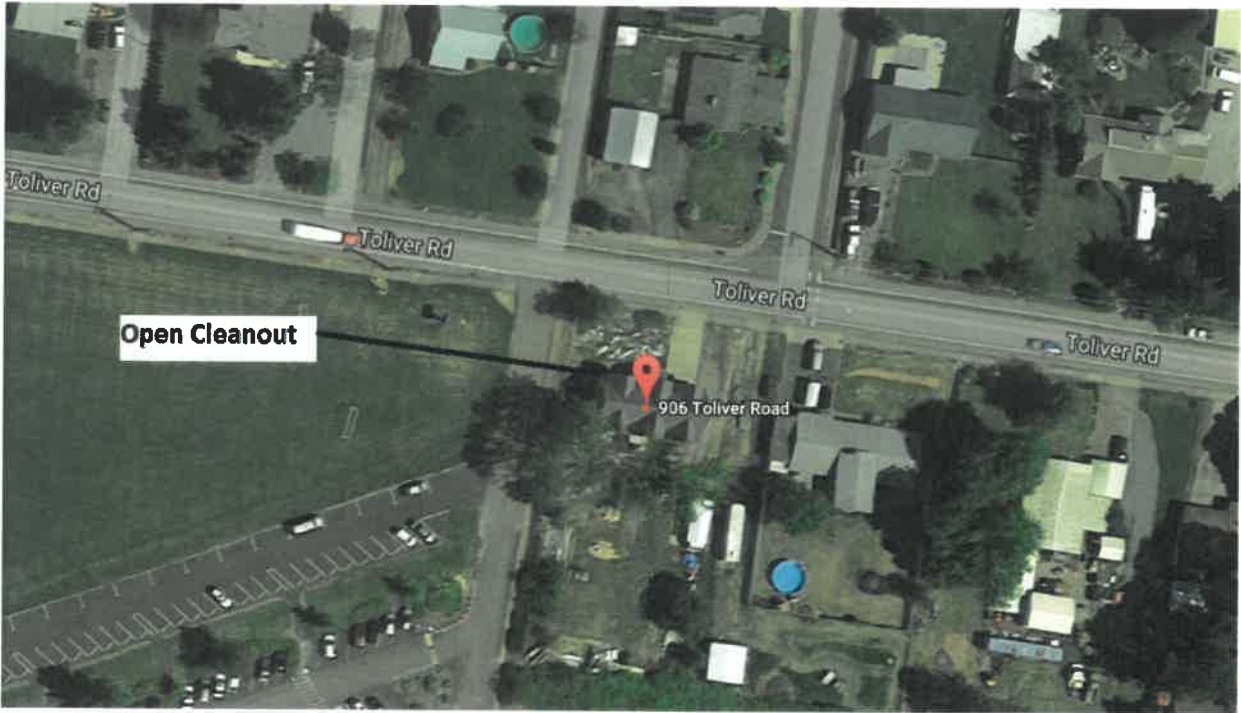
- Open cleanout. House was undergoing some landscaping and upgrades. Open cleanout may only be temporary.
- Also refer to aerial on following page.
- 
- 
-

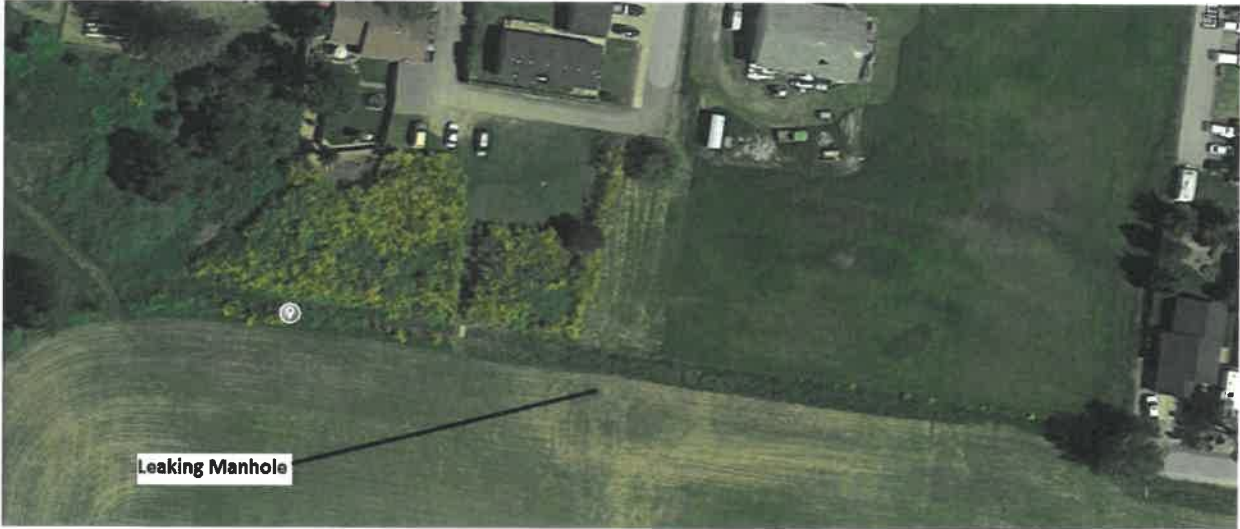
- Manhole was located at perimeter of soccer field. Manhole was leaking significantly around adjacent soil.
- Also refer to aerial on following page.
- 
- 
-

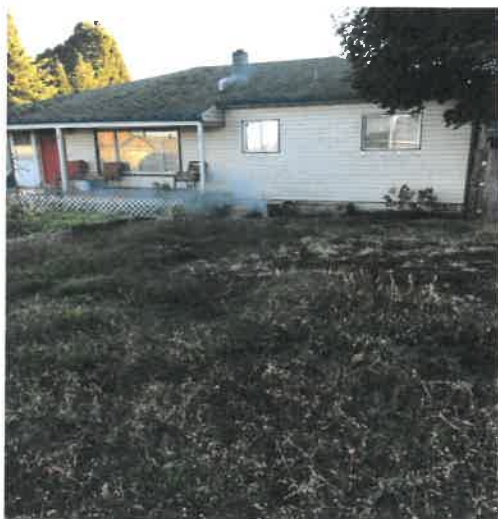
- Open cleanout located to the right of the front porch.
- 
- 
- 
- 
-

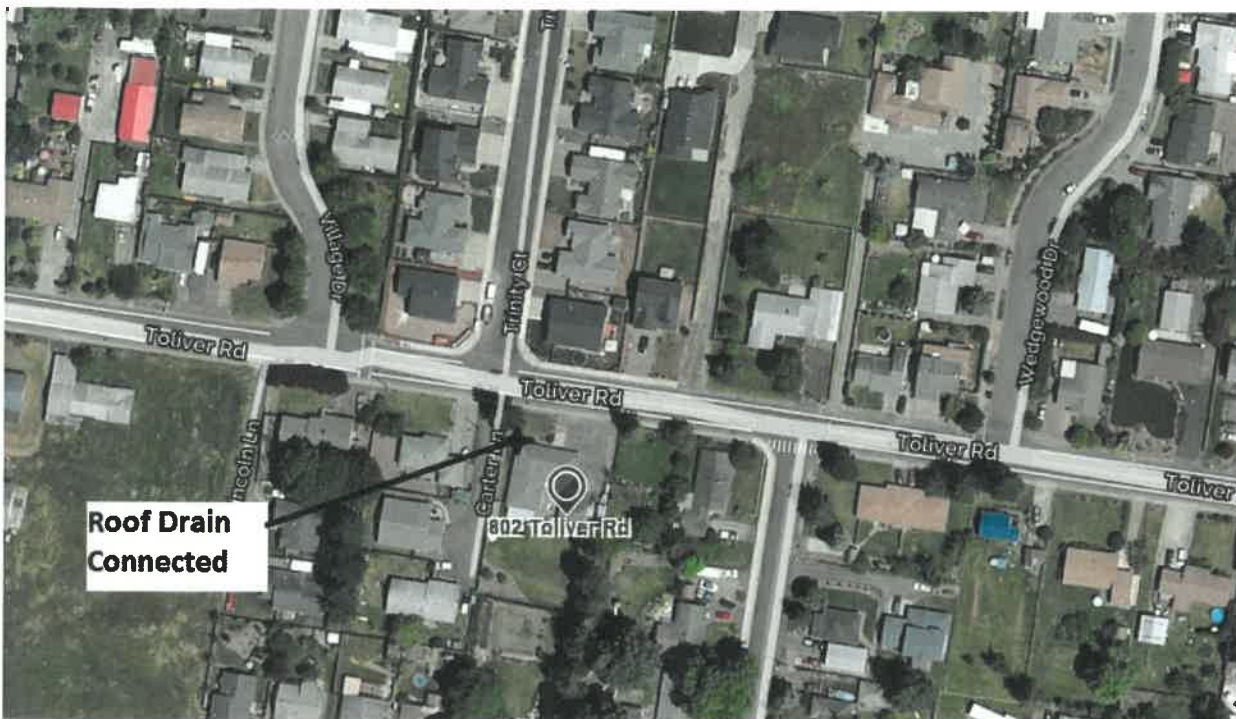
- Roof drain connected on northwest corner of house.
- Also refer to aerial on following page.

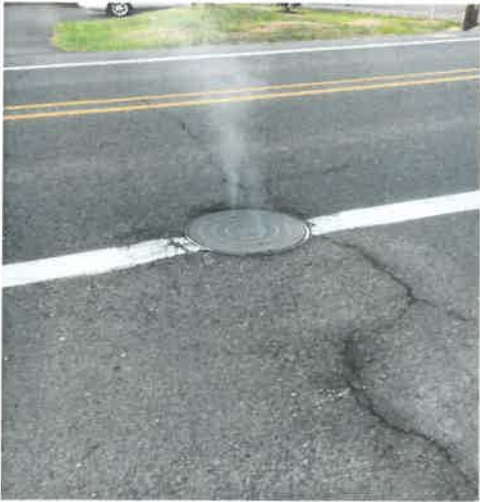
- Manhole was leaking around rim and surrounding cracks around manhole.
- \_\_\_\_\_
- \_\_\_\_\_
- \_\_\_\_\_
- \_\_\_\_\_
- \_\_\_\_\_

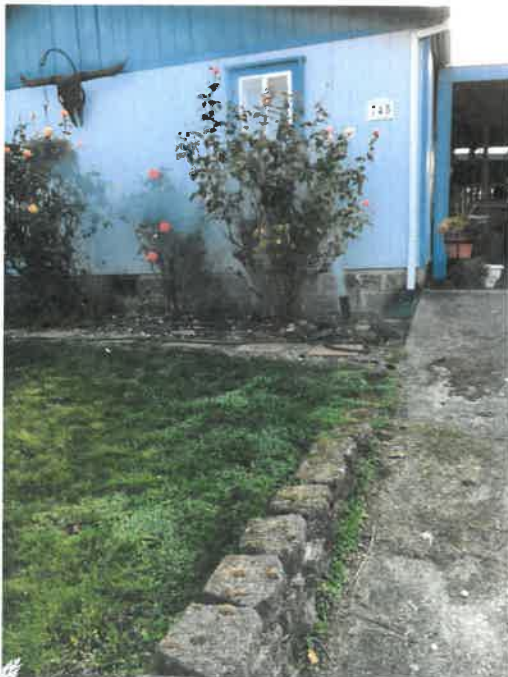
- Two open cleanouts located approximately two and five feet from north side of drive way.
- 
- 
- 
- 
-

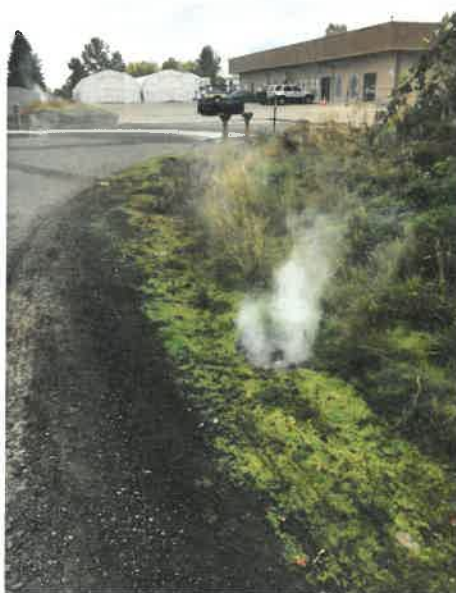
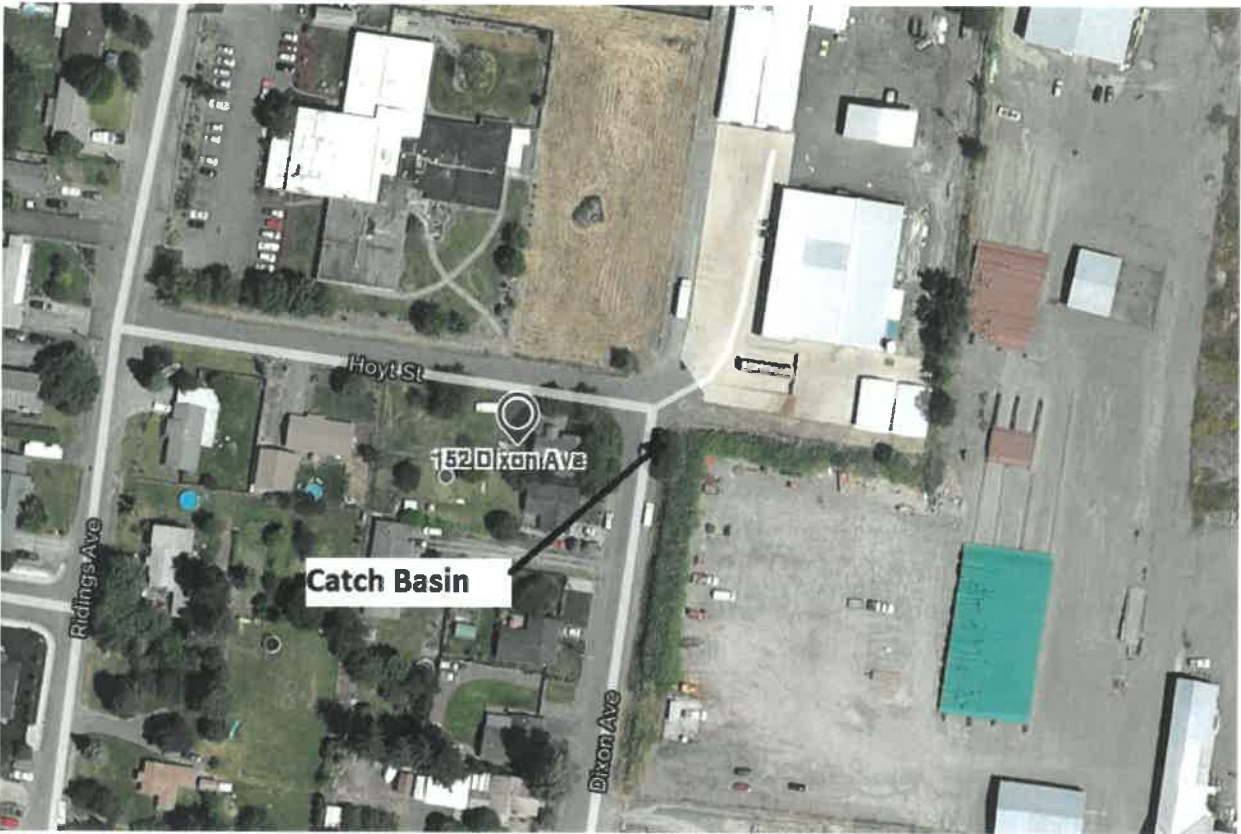
- Catch basin is tied into the sewer system. Catch basin is located in roadway ditch.
- Also refer to aerial on following page.
- 
- 
-

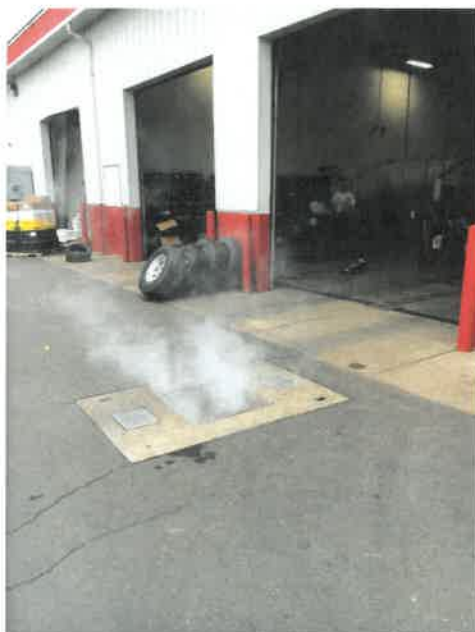
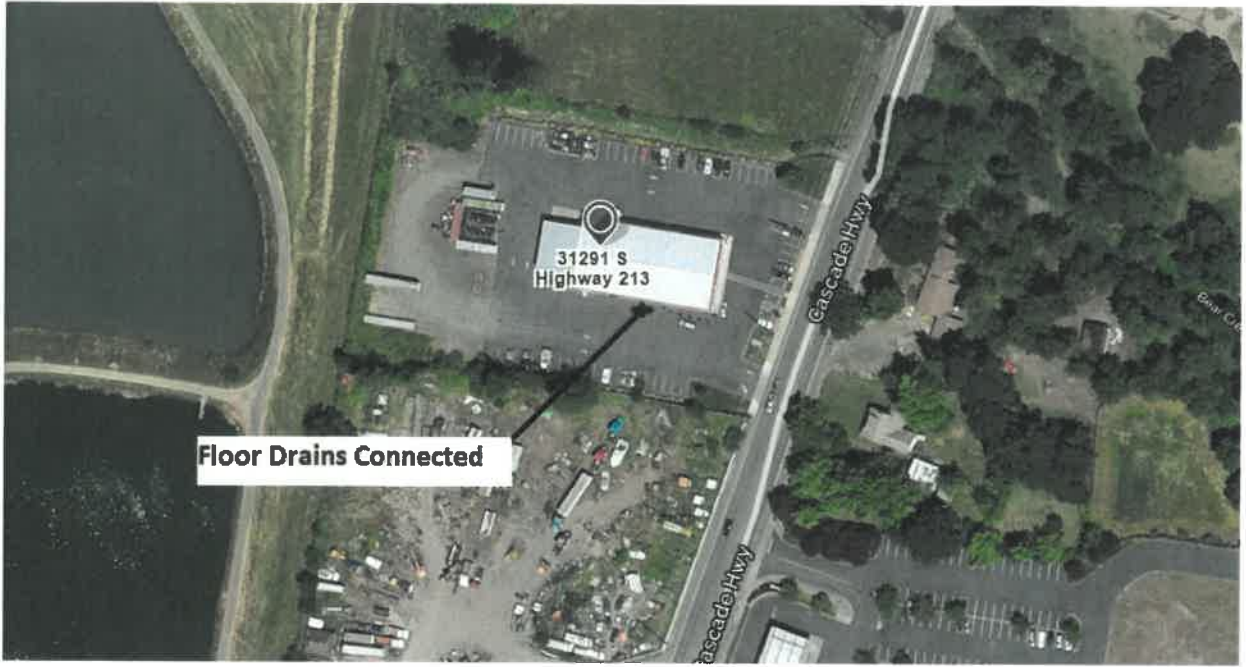
- All of the floor drains in Les Schwab are connected to the gravity sewer mains. Smoke exited throughout floor drains.
- Picture is showing location where all of the floor drains are connected, to the south of the building.
- Also refer to aerial on following page.
- 
-

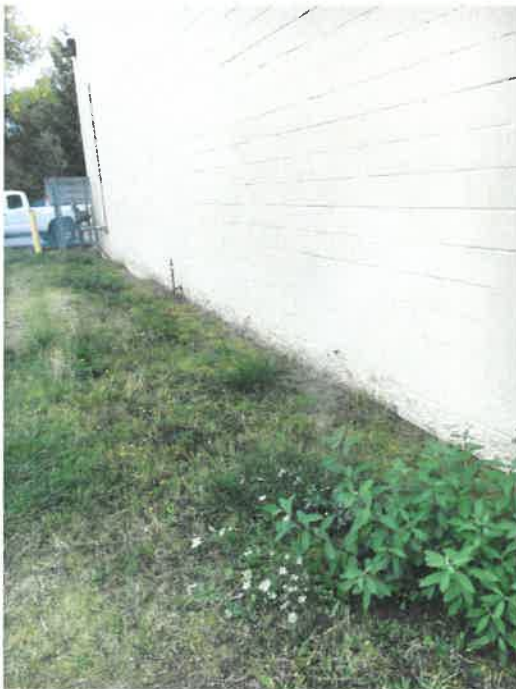
- There was an open cleanout to the north of the Safeway building. The pipe is a few inches below ground level, and probably receives quite a bit of inflow.
- Also refer to aerial on following page.
- 
- 
-

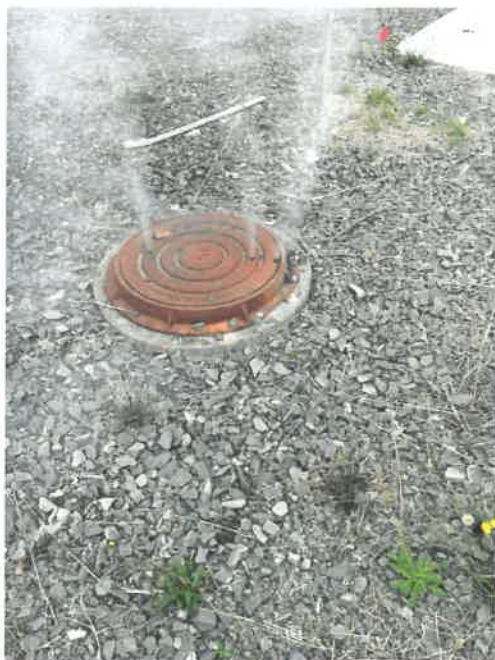
- Manhole was unmarked and located approximately 15ft to the west of the sidewalk, due west of BC B 12. Smoke exited from around manhole.
- Also refer to aerial on following page.
- 
- 
-

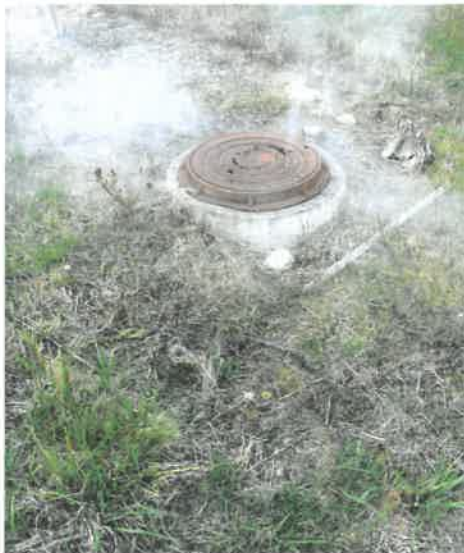
- Manhole was unmarked and located approximately 75 yards to the west of the sidewalk, due west of BC B 12. Smoke exited from around manhole. Manhole is located in field.
- Also refer to aerial on following page.
- 
- 
-

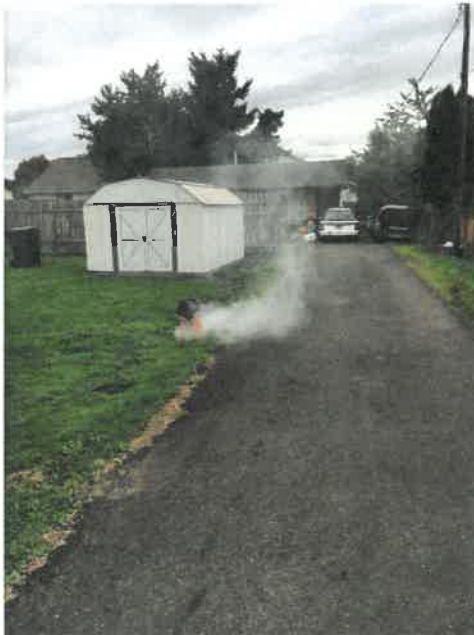
- Open cleanout is located to the north of the drive way. Suspected cleanout has 5 gallon bucket and concrete footing located above it. Smoke exited rapidly.
- Also refer to aerial on following page.
